A452 Leamington-Kenilworth Improvements

Environmental Assessment

Part 2: Cultural Heritage

June 1994

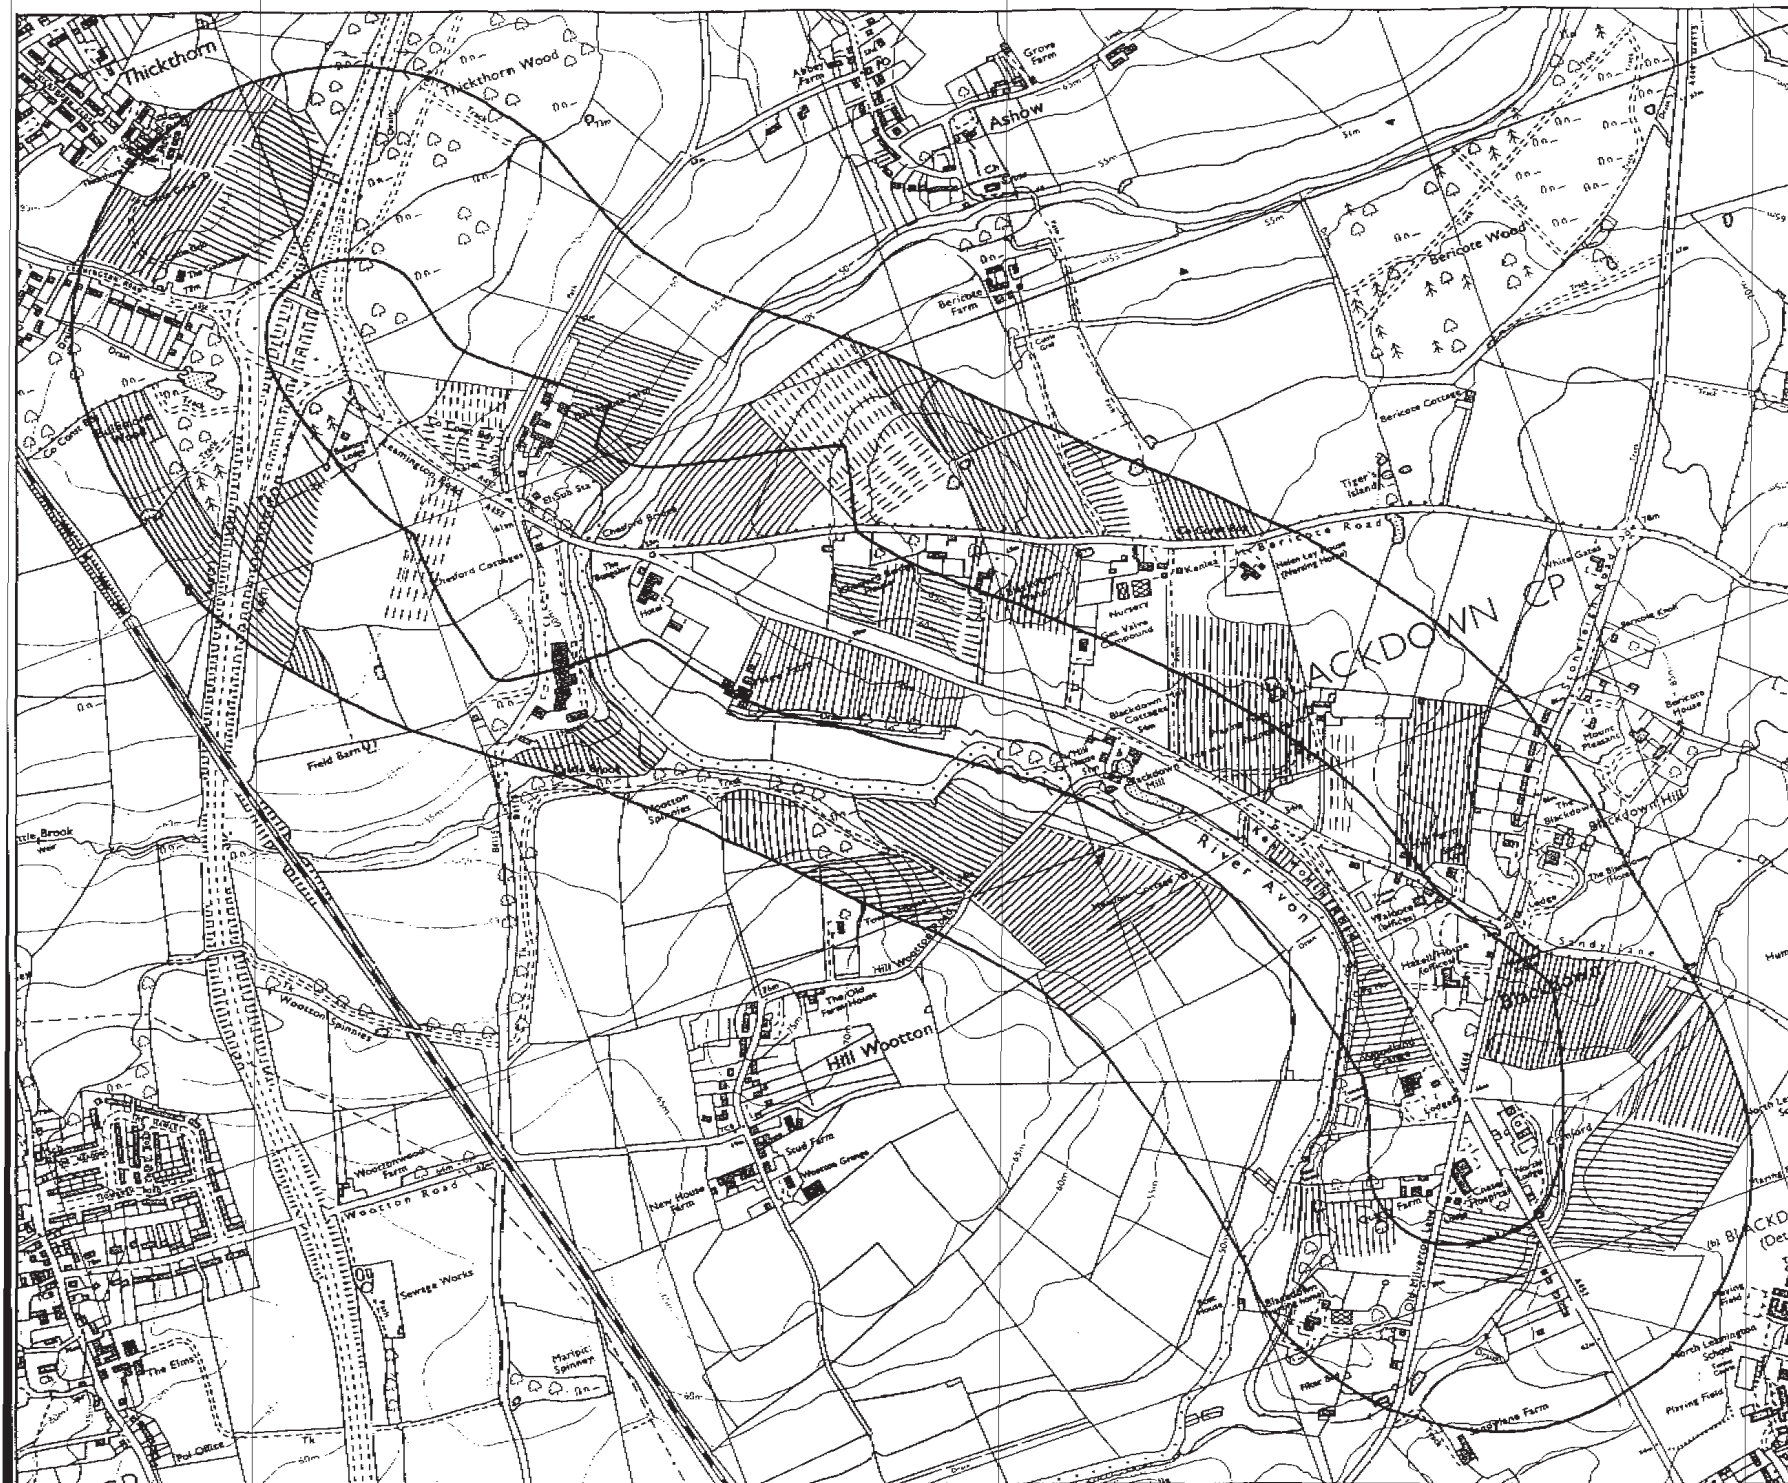
Fig. 2: Medieval ridge and furrow field systems visible on air photographs

Ridge and Furrow

Probable Ridge and Furrow

- 2.2 A high proportion of archaeological sites are discovered from the air. National and local collections of air photographs were therefore consulted. Approximately 19 oblique photographs and 136 vertical photographs (from 14 sorties) showing parts of the assessment corridor taken between 1946 and 1990 were examined (See Appendix A). The early photographs, mainly RAF verticals, are particularly important for showing the remains of medieval ridge and furrow field systems (Fig. 2), most of which do not survive today.

- 3.14 The distribution of ridge and furrow in the north east part of Leek Wootton (Fig. 2) suggests that the Leek Wotton Heath was also cultivated in the medieval period, although again it may have been brought under the plough at a late date. It is possibly identifiable with an area of uncultivated woodland mentioned in Domesday (VCH 1951, 169). Thus in the assessment area only Thickthorn Wood and the land along the floodplain of the river which would have been meadow is free of ridge and furrow and would have been uncultivated at the height of the medieval expansion of agriculture in the early 14th century.
