**FIVE SIGNAGE PITS ON THE A46
ROAD CORRIDOR, EAST STOKE, NOTTINGHAMSHIRE**

**ARCHAEOLOGICAL WATCHING
BRIEF REPORT**

Site code	ESNN 06
NGR:	SK 7580 5020 - SK 7480 4870
PCA Job No	200-B

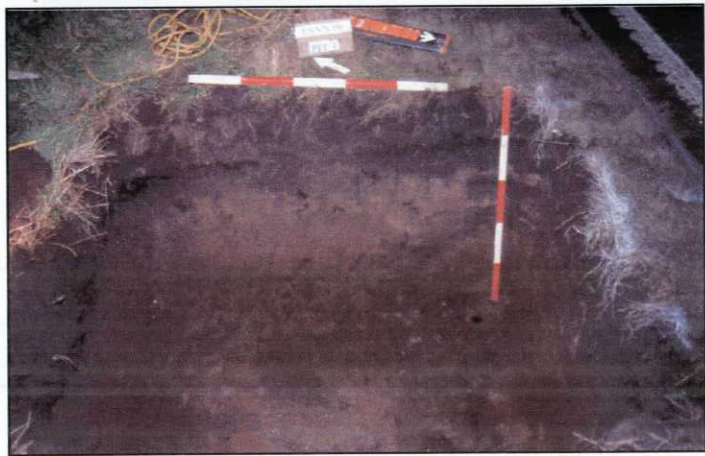
Plate 2 (right): Signage Pit S1, looking northeast.

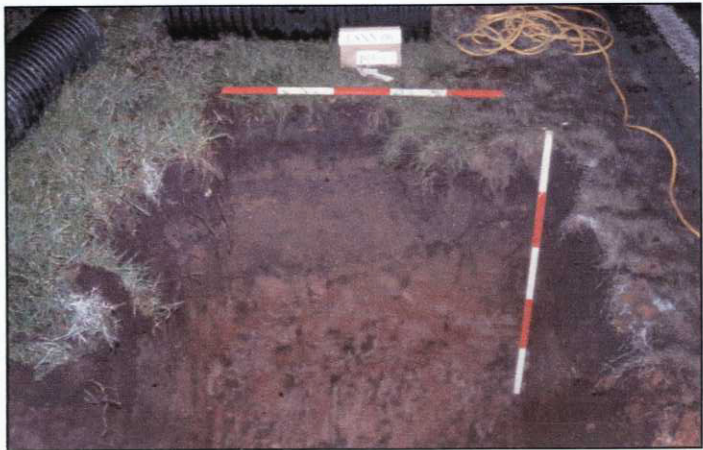
Plate 4 (right): Signage Pit S11, looking northeast.

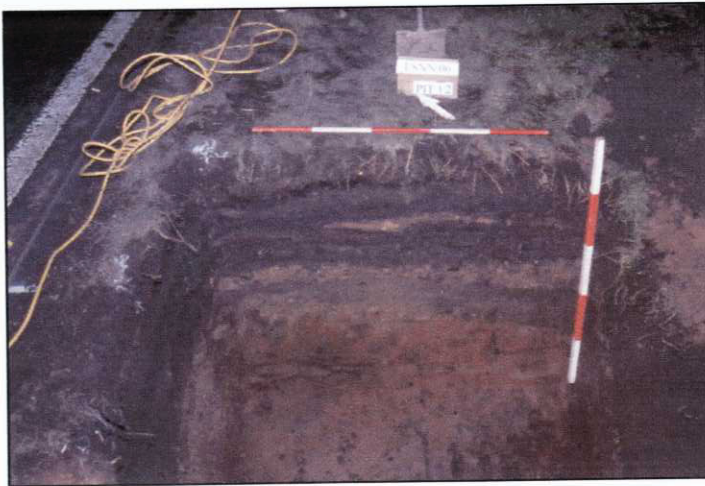
Plate 5 (left):
Signage Pit S12,
looking northeast.

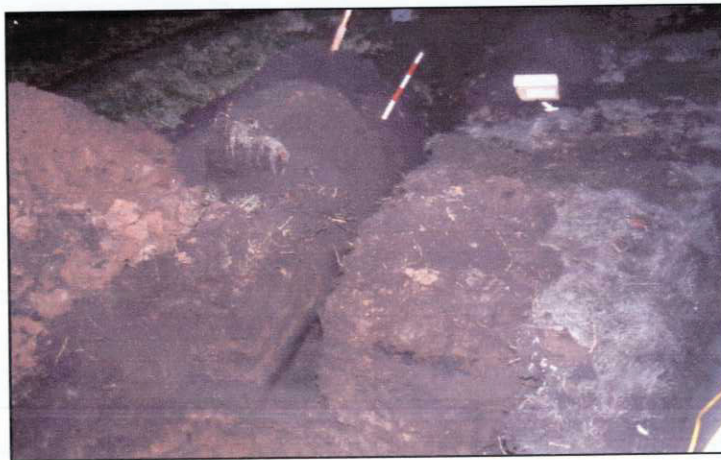
Plate 6 (right):
Trench 12,
running southwest
from Pit S12,
looking southwest.

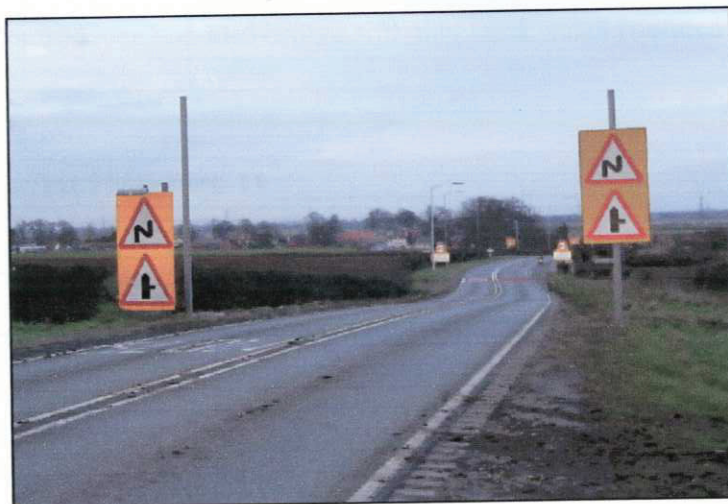
Plate 11 (left):
General view of the location of trench 3, which ran from S3 (on left in shot) down the hill to lamp-post GL 476 (in centre of shot in front of speed limit).

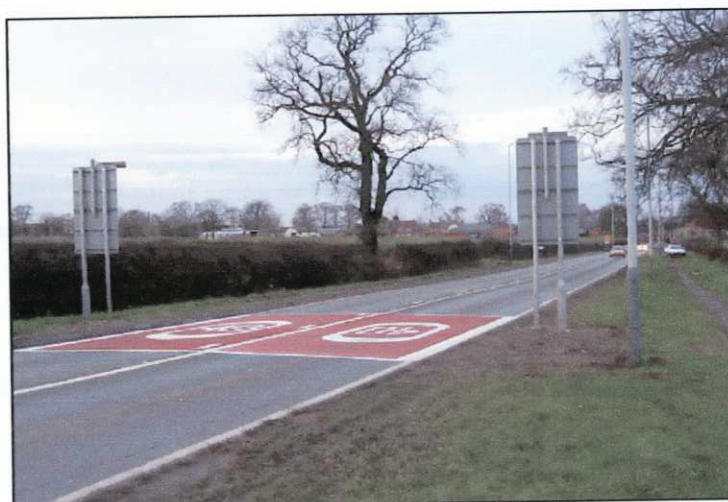
Plate 12 (right):
General view of the location of trench 11, which ran from S11 (on left in shot) down the hill to lamp-post GL 508 (behind sign S12 on right).
