#### AREA 7 SAFETY CAMERA SIGNING, A46 AND A52 ROAD CORRIDOORS, NOTTINGHAMSHIRE

#### ARCHAEOLOGICAL WATCHING BRIEF REPORT

Site code

CBCN 06

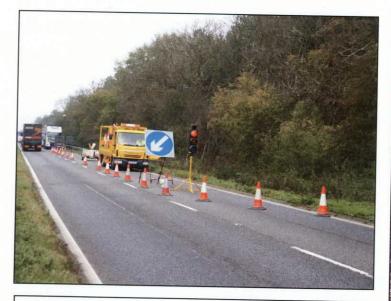
Plate 1 (above left): General view of the location of pit 1, looking northeast.

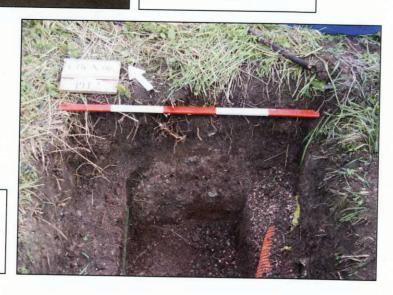
Plate 4 (right): SW-facing section of pit 2, looking northeast.

This pit was situated approximately 1km to the northeast of Cotgrave on the northbound side of the A46 carriageway 75m SW of the northbound SPECS camera site and 340m SW of the Stragglethorpe crossroads; it was 1m square and 0.8m deep.

The deepest material encountered in this pit was context (202), a clean pinkish brown marl which was interpreted as the natural underlying geological material, this material was sealed below a mixed pinkish brown and white marl (201), which contained occasional limestone pebbles (Type 1 structural fill) and small asphalt chunks – the product of modern road construction. Two service trenches were present within the pit, both running parallel to the road at a depth of c.0.6m below modern ground level. On the northwest side of the pit, the electricity supply for the SPECS cameras could be identified, while the service on the SE side was not identified. Layer (201) was sealed below the modern topsoil, context (200), a dark brown humic slightly silty clay.

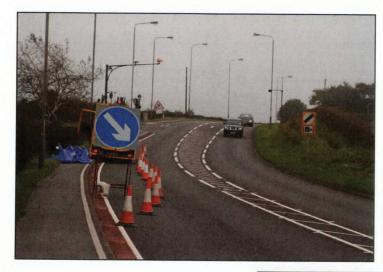
Plate 5 (left): General view of the location of pit 3, looking east.

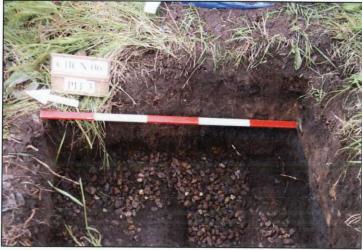
Plate 6 (right): West-facing section of pit 3, looking east.

This pit was situated some 500m to the north of Upper Saxondale on the eastbound side of the A52 carriageway; 65m west of the SPECS camera site located at the west end of the scheme, at the junction with Oatfield Lane. It was 0.9m in length, 1m wide and 1m deep. The pit encountered a concrete culvert running parallel to the road at a depth of 0.8m. This was set in a layer of loose pebbles (context 304) and backfilled with a dark greyish-brown silty sand (303). This material was sealed below a layer of tarmac scalpings (302), which was in turn sealed below a loose mid orange medium sand (301). Layer (301) was interpreted as sub-base material from the construction of the footpath, which had spread downslope. Layer (301) was sealed by the modern topsoil, context (300), a mid greyish brown humic silty sand. All of the layers in this pit are more recent than the culvert found at the base of the pit and are either associated with the culvert itself or with the construction of the modern road or adjacent footpath.

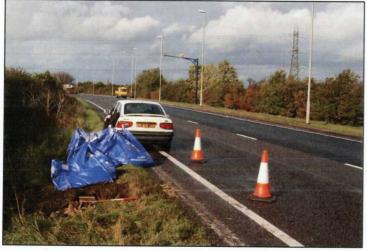
Plate 7 (left): General view of the location of pit 4, looking northwest.

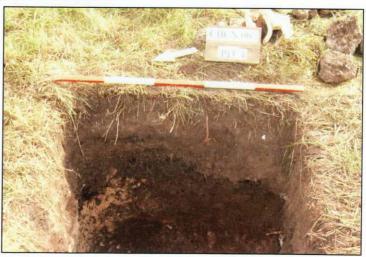
Plate 8 (right): West-facing section of pit 4, looking east.

This pit was situated on the westbound side of the A52 carriageway, 56m east of the SPECS camera site on the opposite carriageway at the east end of the scheme. It was located approximately 600m east of Bingham, some 400m west of the junction with Granby Lane. This pit was 0.9m in length, 0.8m wide and 0.8m deep. The northern half of the pit was occupied by a service trench. The deepest material encountered in the southern part of the pit was a clean pinkish brown marl (context 403) which was interpreted as the natural underlying geological material. This material was sealed below a mid/dark brown silty sand containing occasional small rounded pebbles and charcoal flecks (402). Layer (402) was interpreted as a buried topsoil; it yielded a single base sherd of a large jar or bowl of Staffordshire/Ticknall ware pottery, which has been dated to the mid 17<sup>th</sup> to 18<sup>th</sup> century. A layer of orange brown sandy clay (401) which contained frequent medium asphalt lumps and a concrete kerbstone fragment sealed layer (402). It was interpreted as the product of recent road building activity. This material was sealed below the modern topsoil, context (400), a dark greyish brown humic sandy silt.
