**A48 Lydney Bypass, Eastern Section - Archaeological Watching Brief**  
4.5.93 - 13.5.93 (ref 477.19)

# A48 LYDNEY BYPASS (EAST) ARCHAEOLOGICAL SURVEY

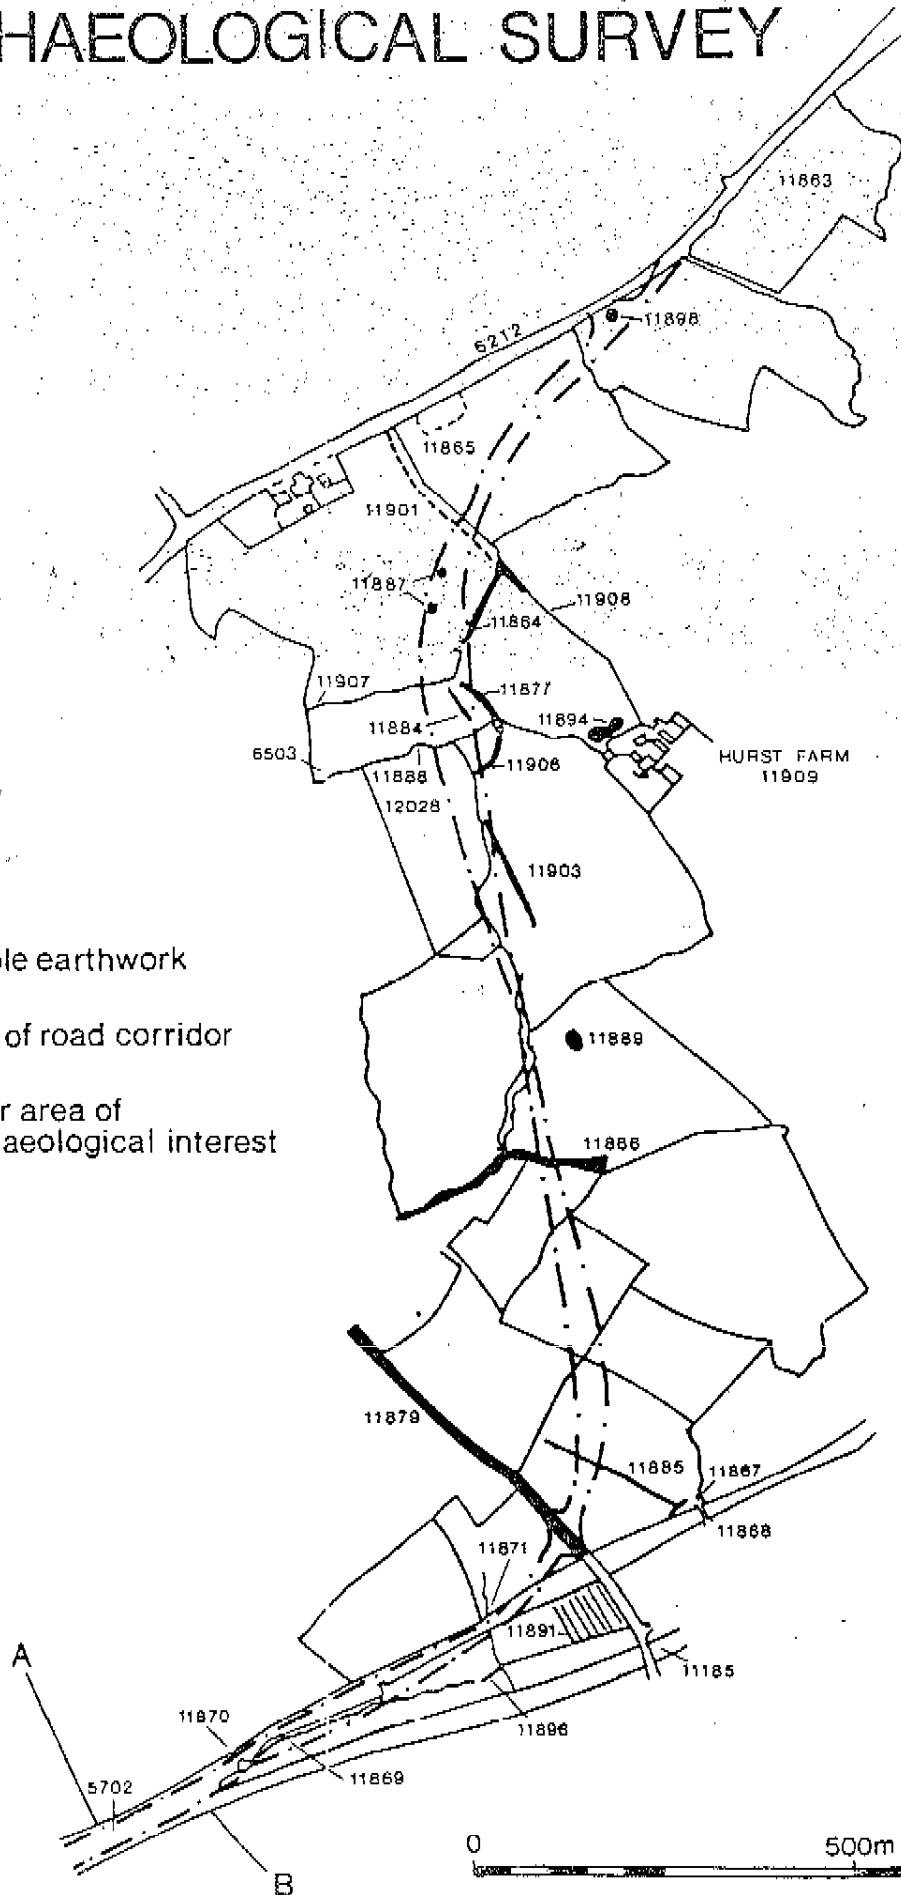
8.2 A48 Lydney Bypass (east) archaeological survey 1:10000

10.2 Mrs. W. Greenhalgh, Archaeology Section, Gloucestershire County Council,  
drew figure 8.2
