**A59/A56 JUNCTION IMPROVEMENT,  
WEST OF SKIPTON,  
NORTH YORKSHIRE**

**REPORT ON AN  
ARCHAEOLOGICAL  
WATCHING BRIEF**

**1998 FIELD REPORT  
NUMBER 57**

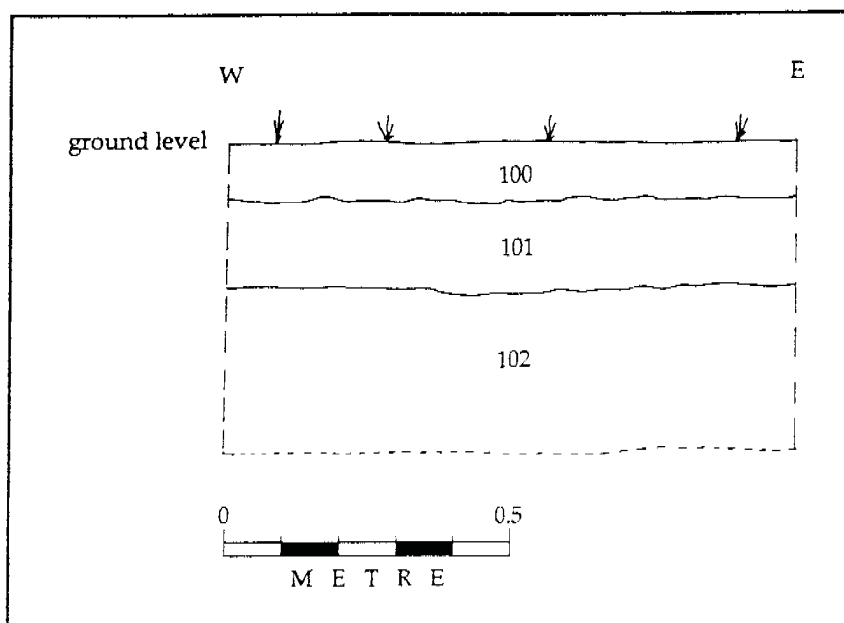
Figure 3. Section 1, south facing

The earliest deposit reached was a compact pale orange brown sandy clay (102) at 0.25m BGL which was machined out to a depth of 0.30m. Directly above this was a plastic pale orange brown sandy clay sub-soil (101) 0.16m deep. This was sealed by a friable mid grey brown sandy clay silt with occasional small pebbles and small angular stone fragments that formed the present day plough soil (100) 0.10m deep. The area was under a crop of wheat at the commencement of the watching brief.

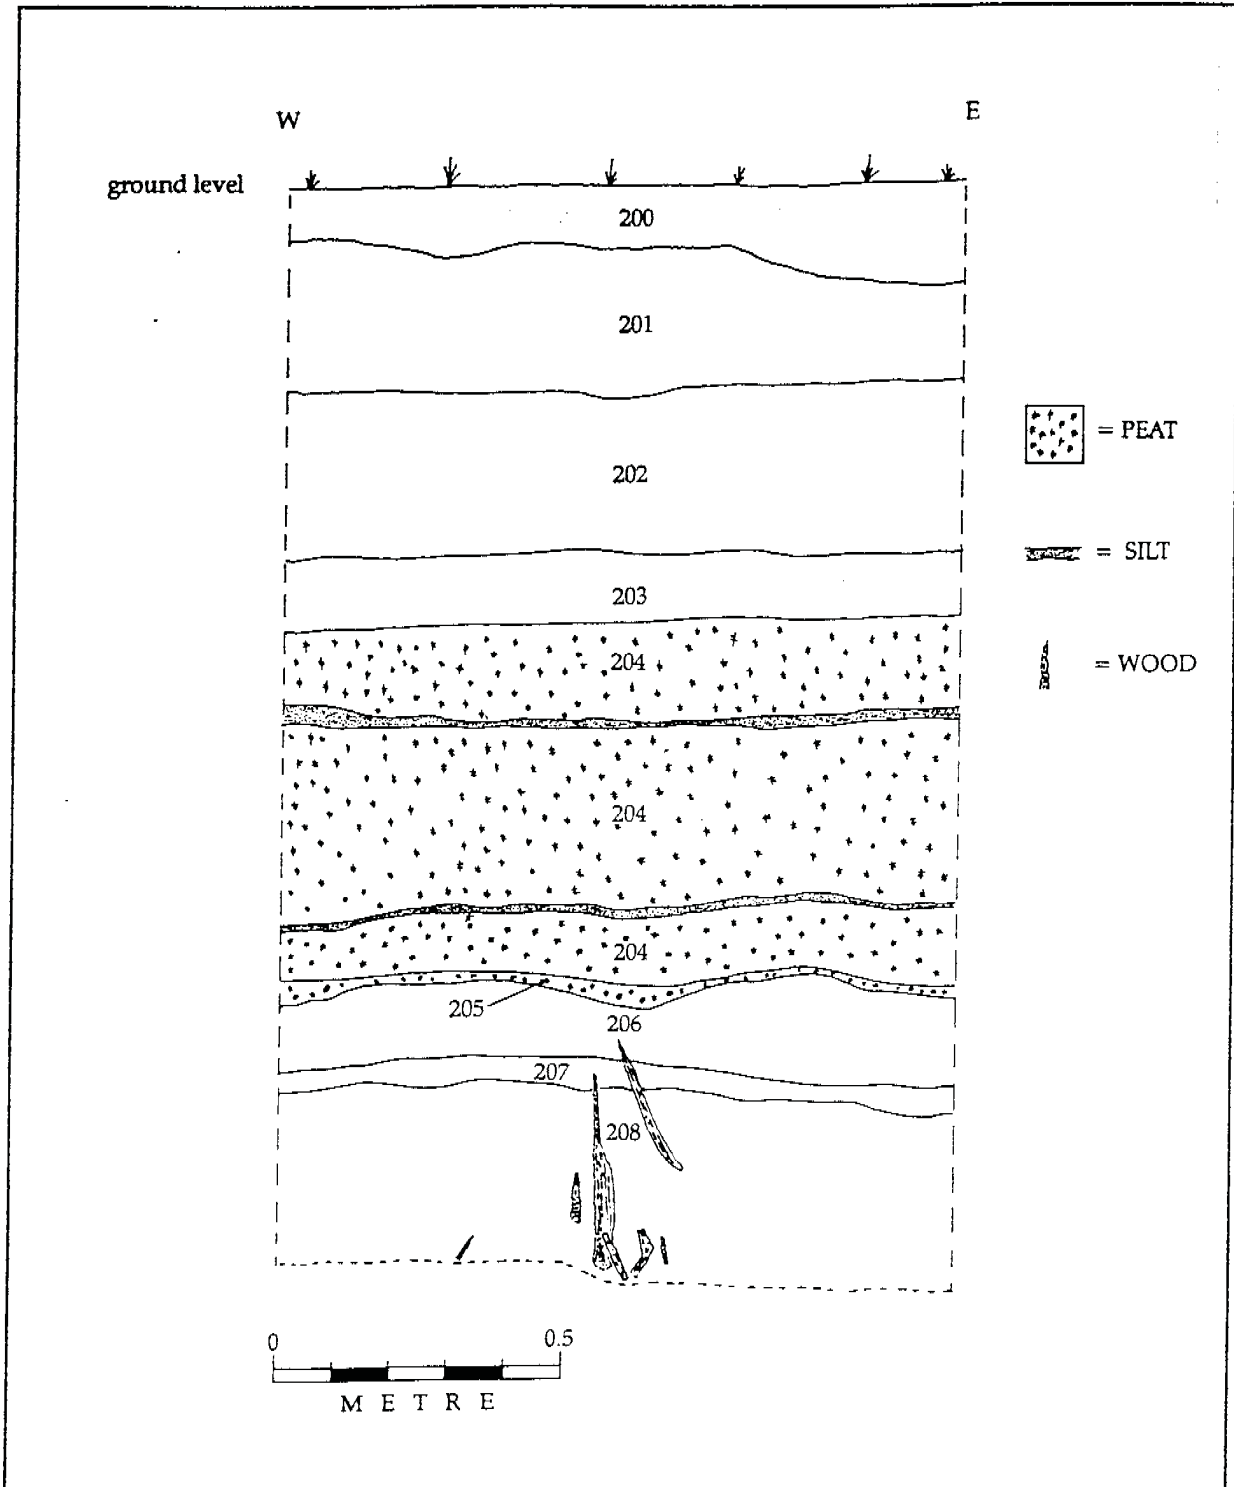
Figure 4. Section 2, south facing

The earliest deposit seen in this section was at 1.60m BGL and was machined out to a depth of 0.35m. This consisted of a compact mid grey gritty sandy clay (208), with inclusions of occasional small pebbles and angular stone fragments. Also present were fragmentary decayed tree roots.

Directly above this was a similar deposit of gritty sandy clay (207), up to 0.06m deep, with frequent small angular stone fragments and occasional small pebbles. This was believed to be the same deposit as 208 that had been 'washed out' by running water.

207 was sealed by a plastic, moist off white sand silt (206), 0.40m thick, which contained inclusions of moderate small snail shell fragments, occasional complete snail shells and black rootlets.

Overlying context 206 was a deposit of moist plastic dark brown fibrous peat (205), up to 0.04m deep which contained moderate numbers of small snail shell fragments. This lay below a similar deposit of peat (204) which, although similar in structure to context 205, was lacking the snail shell inclusions and had formed a considerably thicker deposit. 204

was up to 0.65m deep and varied in colour, ranging from pale reddish brown to a dark chocolate brown. Within this deposit were two thin lenses of pale grey silt which indicated that the formation of the peat had been disrupted on two separate occasions, possibly when the area was inundated by flood water.

The peat bed was sealed by a series of natural clays. The earliest of these was a plastic pale grey silty clay (203) which was beneath a compact light brown flecked pale grey clay (202), itself sealed by a compact stiff orange/yellow silty clay (201). These layers had collectively formed a 0.66m deep deposit underlying the present day plough soil (200) which was 0.19m deep.

The majority of deposits encountered proved to be natural in origin. The earliest of these may represent an ancient ground surface (208), which had been subject to erosion by running water (207)(Figure 4). It appears that ponding occurred and a deposit consisting mainly of snail shells (206) built up prior to the formation of a bed of peat (205, 204) (Figures 2 and 4).

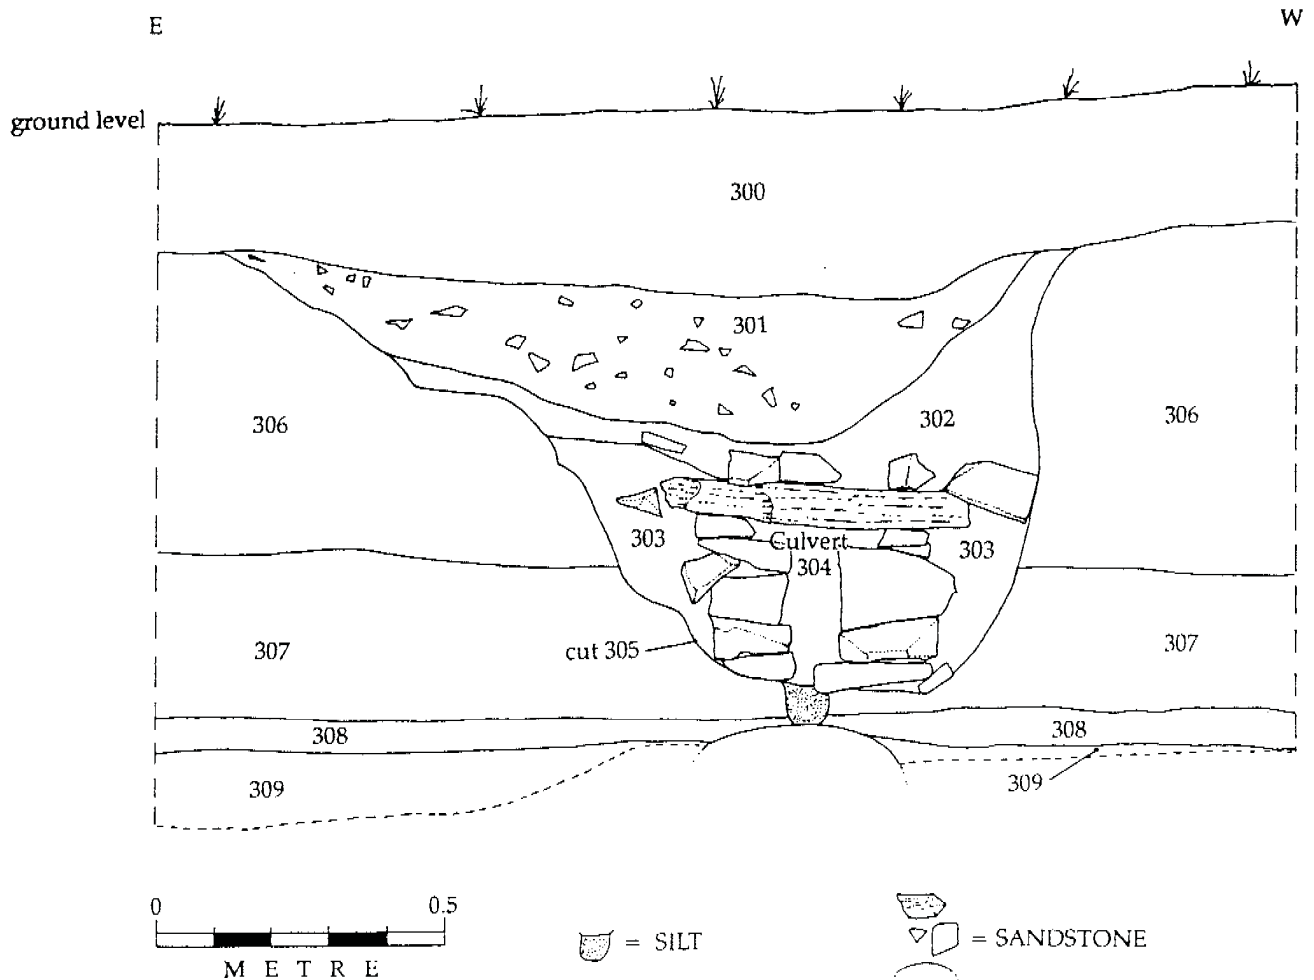
Figure 5. Section 3, north facing

This was located 10m to the south west of section 2 just beyond the western limits of the peat bed. The earliest deposit seen was at 1.17m BGL and was excavated to a maximum depth of 0.11m. This consisted of a plastic pale orange brown silty clay (309), with inclusions of occasional small to large sandstone pebbles and millstone grit fragments.

309 was sealed by a plastic blue grey silty clay (308), 0.06m deep, which lay beneath a plastic purplish brown peaty clay (307), 0.30m deep. The 'peaty' nature of this deposit suggested that it had formed on the fringes of the peat bog. Directly above this was a 0.62m deep deposit of compact mid brown flecked orange brown natural clay (306), which had been truncated by the 1.50m wide x 0.75m deep 'U' shaped construction cut (305) for a stone culvert.

The culvert (304) measured 0.26m high and 0.10m wide internally with an external height of 0.35m and width of 0.43m. The sides were constructed from roughly worked dry-coursed sandstone blocks, four courses on the east side, three on the west. Any irregularity in the construction was remedied by the use of 'chock' stones. The culvert was roofed with a large sandstone slab, 0.54m wide by 0.06m thick with the floor remaining unlined, hence the narrow silt filled erosion gully in the base.

The construction cut was packed, up to the top of the capstone, with a pale brown clay silt (303). The remainder of the construction cut was back-filled with crumbly orange brown clay silt with occasional small sandstone fragments (302) below friable mid grey brown sand silt (301) with moderate small to medium sandstone fragments. The cut was sealed beneath the present day plough soil (300), which was 0.32m thick.

The top of the natural clays was truncated by the construction cut (305) for a stone culvert (304) (Figure 5), which may have formed part of the drainage system for the field in which the roadworks took place. It does, however, seem to be excessively large and too well constructed to have performed this function alone. Its alignment suggests that it may have functioned as a drain to remove the surface water from a forerunner to the current A59 trunk road (Figure 2). No dating evidence was recovered from the culvert or its cut but the method of construction would suggest a date of no later than the 19<sup>th</sup> century.
