M1 Junctions 10 to 13 HSR Improvements

Archaeological Monitoring of Geotechnical Trial Pits

Report No: D123845/AR/CON/02

June 2010

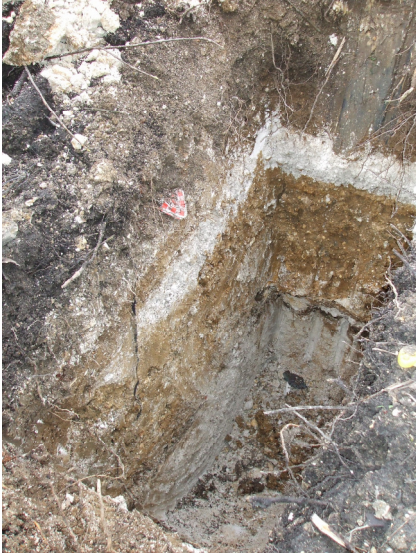
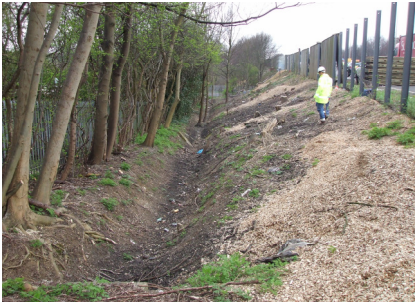
Record Sheet 1/3

Depth m BGL	Composition	Test Pit Section and Location				
0.0 – 0.2	Dark brown grey topsoil

0.2 – 0.3	Light grey brown degraded chalk (embankment)					
0.3 – 0.5	White chalk (embankment)					
0.5 – 1.1	Light grey brown degraded chalk (embankment)					
1.1 – 2.0	White chalk (natural)					
Notes	The trial pit was excavated on a low section of the M1 embankment on the west side of Junction 11. The trial pit penetrated through the embankment material to the natural chalk below. No buried soils were revealed below the embankment.					
	Located on plan	Photographed	Drawn	Artefacts	Archaeology present	
Yes		√				
No	√		√	√	√

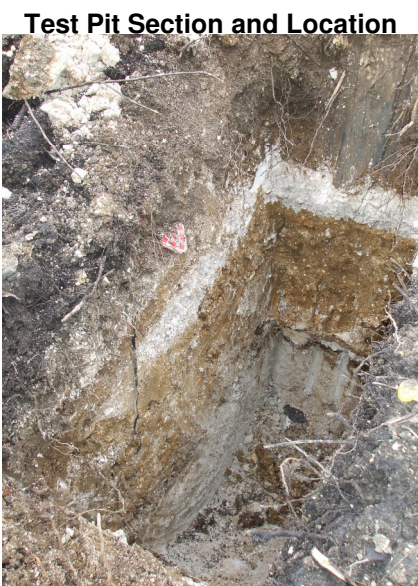
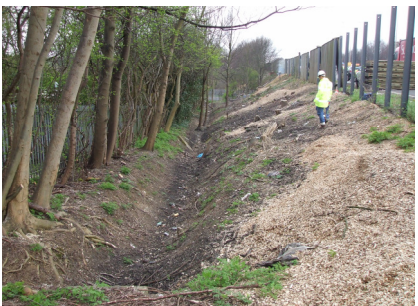
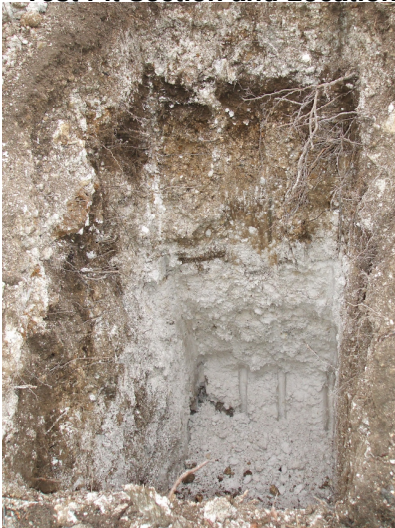
Depth m BGL		Composition			Test Pit Section and Location	
0.0 – 0.2		Dark brown grey topsoil

0.2 – 0.3		Mid brown grey chalky loam (embankment)				
0.3 – 0.5		Mottled grey white chalk (embankment)				
0.5 – 0.6		Dark grey brown degraded chalk (embankment)				
0.6 – 0.9		Light grey brown degraded chalk (embankment)				
0.9 – 1.5		White chalk (embankment)				
		</

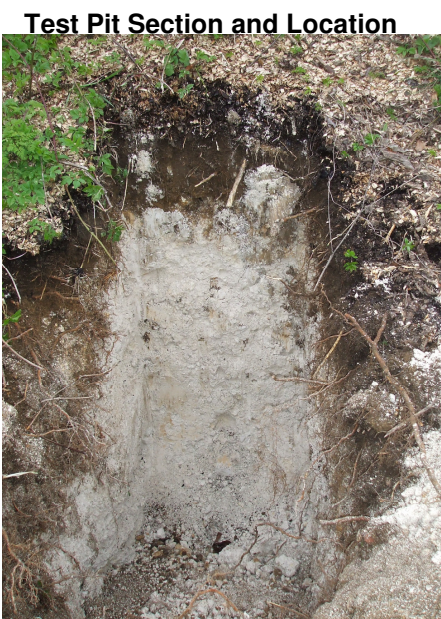
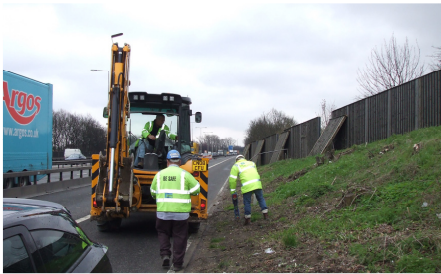
Record Sheet 2/3

Depth m BGL	Composition				
0.0 – 0.2	Dark brown grey topsoil				
0.2 – 0.4	Mid brown grey chalky loam (embankment)				
0.4 – 1.5	White chalk (natural)
