Higher Treliever Farm

Mabe, Cornwall Photographic Recording

Authors: Matt Mossop MA MGSDip MIAI and Stuart Randall BA Report Date: September 2011

Authors:		Matt Mossop MA MGSDip MIAI and	
		Stuart Randall BA	
Report Date:		September 2011	
Client:		Mr Paul Mann	
Proposal:		Conversion of barns to form five dwellings and installation of four septic tanks.	
Planning Reference:		PA10/00090/F	
Statutory Protection:		None	
Project No:		AC11003E	
Civil Parish:		Mabe	
District:		West 2	
County:		Cornwall	
National Grid Reference:		SW 75631 34954	
Fieldwork Dates:		March 2011	
Accession No:		Forthcoming	
List of Fig	gures		
Figure 1	Site Location. Courtesy of Cornwall Council		
Figure 2			
Figure 3	Extract of Ordnance Survey 1801 map12		
Figure 4	Extract of Mabe Parish Tithe Map 1840. Reproduced with kind permission of Cornwall Record Office12		
Figure 5	Ordnance Survey 1879 map extract13		
Figure 6	Ordnance Survey 1	<i>907 Map extract</i> 13

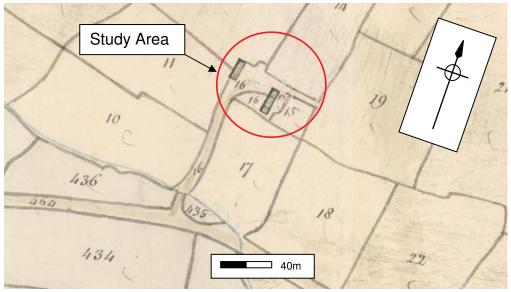
Figure 4 Extract of Mabe Parish Tithe Map 1840. Reproduced with kind permission of Cornwall Record Office.

Maps give us the most detailed picture of the development of the barns within the study area. The 1801 Ordnance Survey (OS) map (Figure 3) shows the existing farmhouse accessed by a lane to the north, with additional access to the stream to the south. The 1840 Tithe map (Figure 4) depicts two rectangular buildings in the vicinity of the current barns, including the current farmhouse. By this stage the northern access has disappeared, whilst to the south a new road approximately on the line of the modern A394 provides access. The accompanying Tithe Apportionment of 1842, records that Higher Treliever was still owned by the Bishop of Exeter. The croft and moor (plots 1-9) was occupied by Henry Bishop whilst the remaining plots 10-37, including the house, were occupied by Caleb Bath. The census of 1841, records two households at 'Treliever' and nine further households at 'Trelever' all of which were farmers, agricultural labourers or dairy-keepers, though Caleb Bath is recorded at Carveth. It seems Caleb may have sub-let Higher Treliever at this

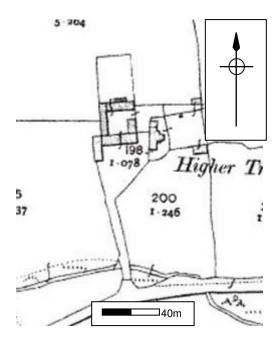
Figure 6 Ordnance Survey 1907 Map extract

Buildings 1, 4, 5, 6 and 7 are shown on the 1907 Ordnance Survey map (Figure 6), though Building 4 incorporated part of a building shown on the Tithe map. These developments formed an almost completely enclosed farm courtyard

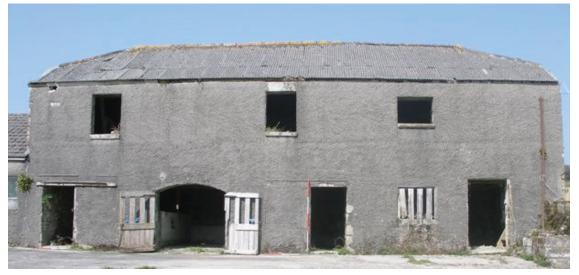
Plate 1 Building 3 looking north.

Built between 1840 and 1879, probably in 1861. This is a granite-built twostorey agricultural building terraced into the natural slope (Plate 1). Building 3 has a largely cobbled ground floor and a corrugated asbestos or fibre-cement sheet half-hipped roof.

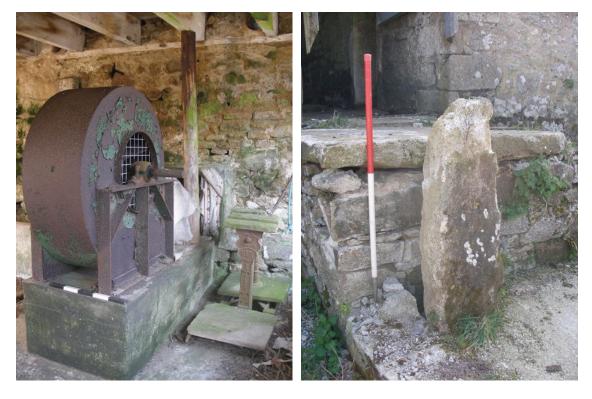
Plate 2 Machinery and scales in the eastern ground-floor room of Building 3, looking northwest. Scale 0.5m.

The eastern ground-floor room has a feeding trough for cattle or horses, along the inside of the north wall. The room presently houses a sack-scales and machinery probably for drying grain stored above (Plate 2). The sack scales was made by Bartlett of Bristol for M.L.Blamey and Sons of Truro, to weigh up

to two hundredweight (CWT) or 224lbs. M.L.Blamey and Sons was an agricultural merchant active in the late 19th and early 20th century. A wooden ladder connects the two floors though an opening in the first-floor. The first floor was additionally accessed by exterior granite steps to the north.

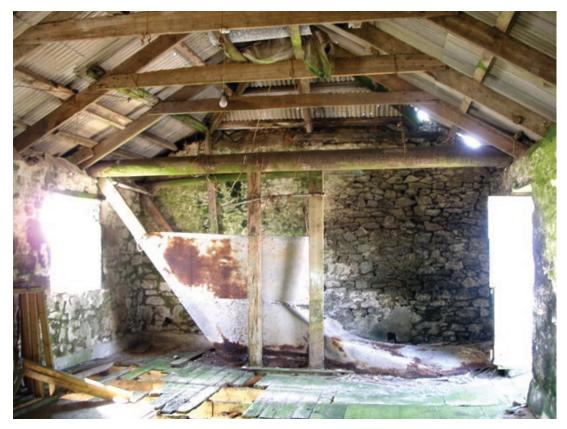
Plate 4 Inserted hopper on the first floor of Building 3.

The western ground-floor room has a large arched opening in the south wall, a feeding trough along the north wall and modern concrete block built partitions. A galvanised iron sheet built hopper was inserted into the first floor above at the west end, with a telegraph pole reused as a tie beam above (Plate 4).

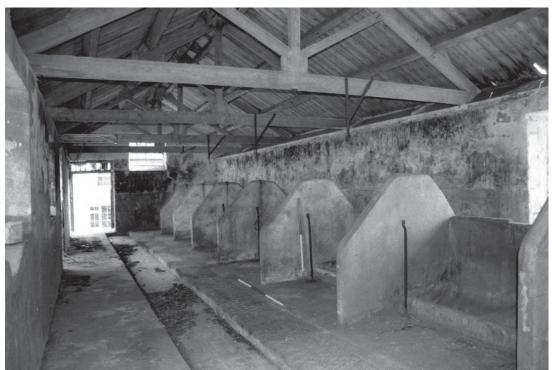
Built between 1879 and 1907. This is a granite-built single-storey cow house, terraced into the natural slope. The south wall foundation extended considerably below the ground floor to retain the terrace on which the building sat. Building 5 had a slate gabled roof with ventilators and a similar king post roof frame to Building 4. At the time of recording, Building 5 had a concrete floor, stalls and troughs with slate name-plates for each cow along the south wall (Plate 5).

Plate 5 Building 5 cow stalls looking east, showing the gabled slate roof structure including tie beams, king post and principal rafters braced with struts.
