Proposed Wind Turbine on Land at Hillside Farm Chacewater, Cornwall Archaeological Assessment

Project No: AC12009E
Project Officer: Hayley Goacher BA (Hons) PlfA
Project Manager: Matt Mossop MA (Hons) MGSDip MIAI MIfA
Editor: Emma Ruddle BA (Hons) MIAI AlfA

Client: Migrid
Proposal: Installation of one wind turbine
Planning Reference: PA12/02415
Statutory Protection: World Heritage Site

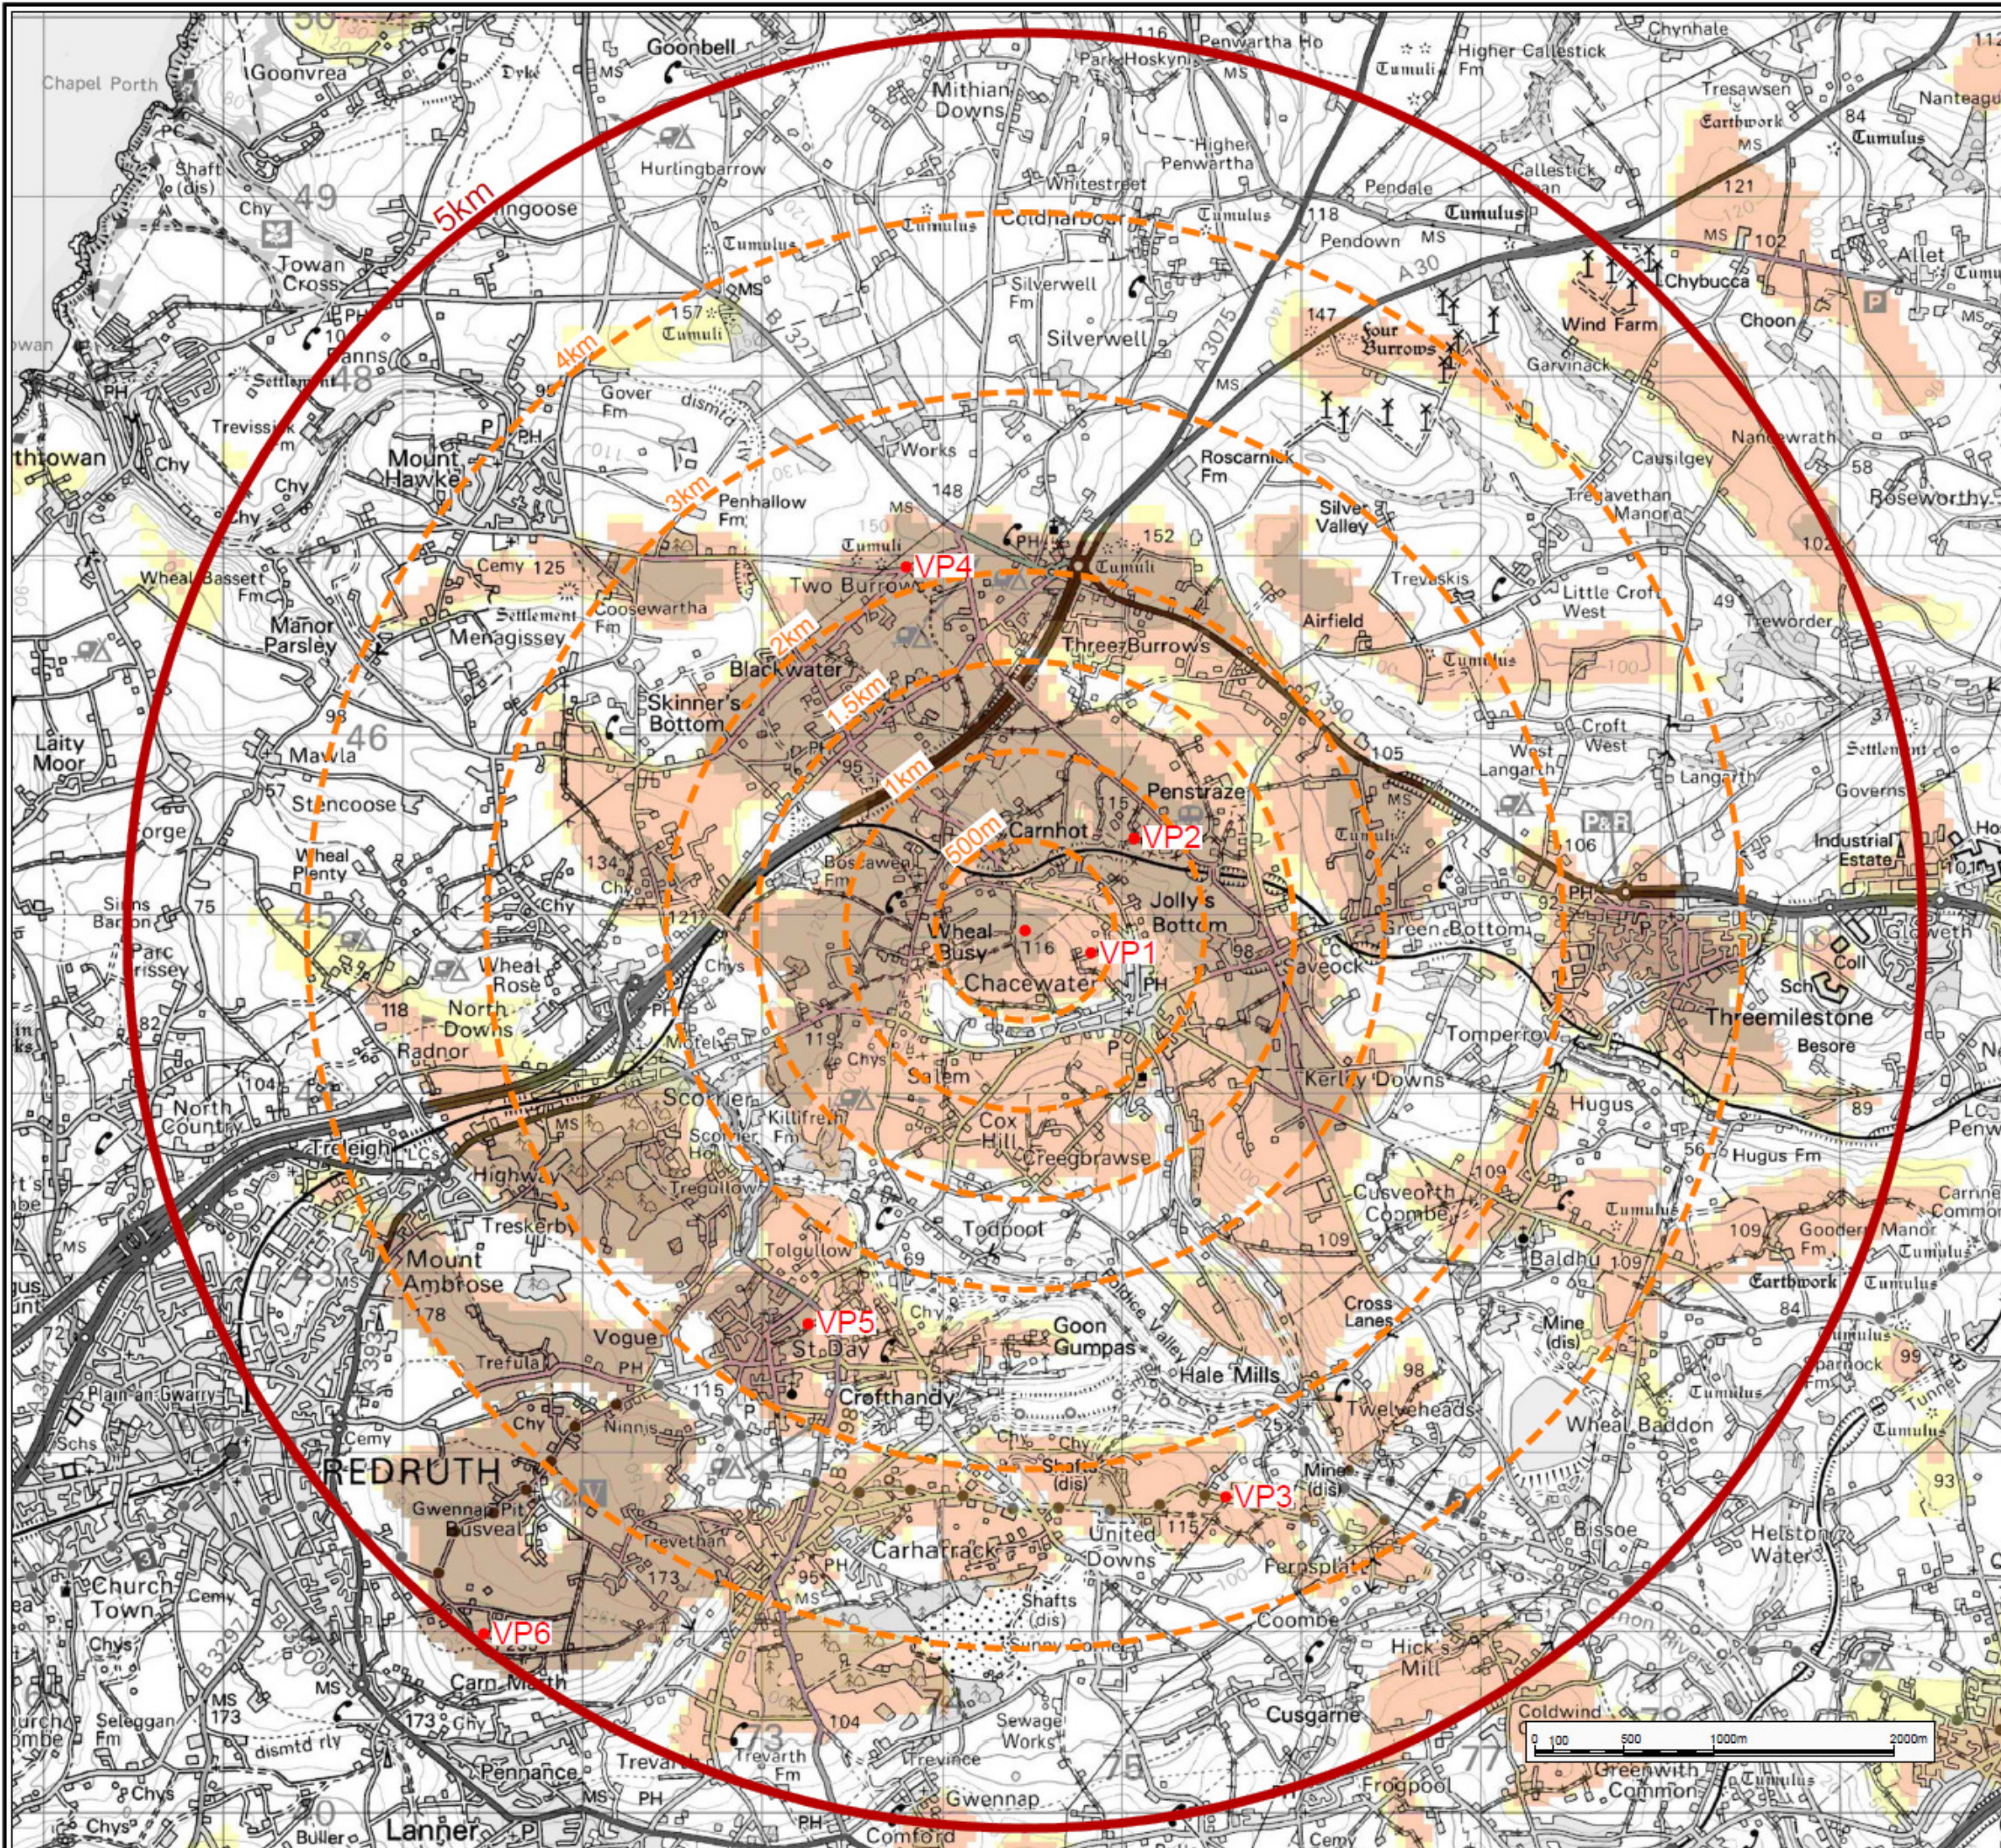
Figure 8 Zone of Theoretical Visibility Map. Courtesy of Cornwall Environmental Consultants Ltd.

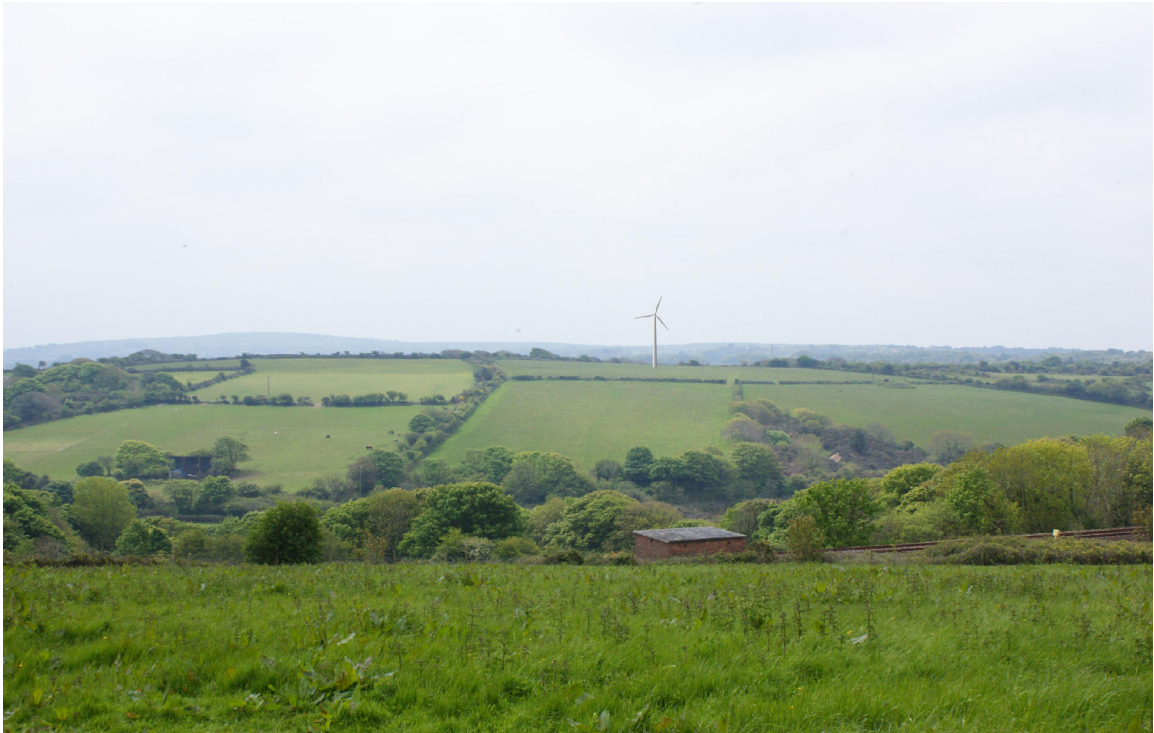
Plate 2 Photographic montage of theoretical view of proposed wind turbine from point VP2 above (Figure 8).

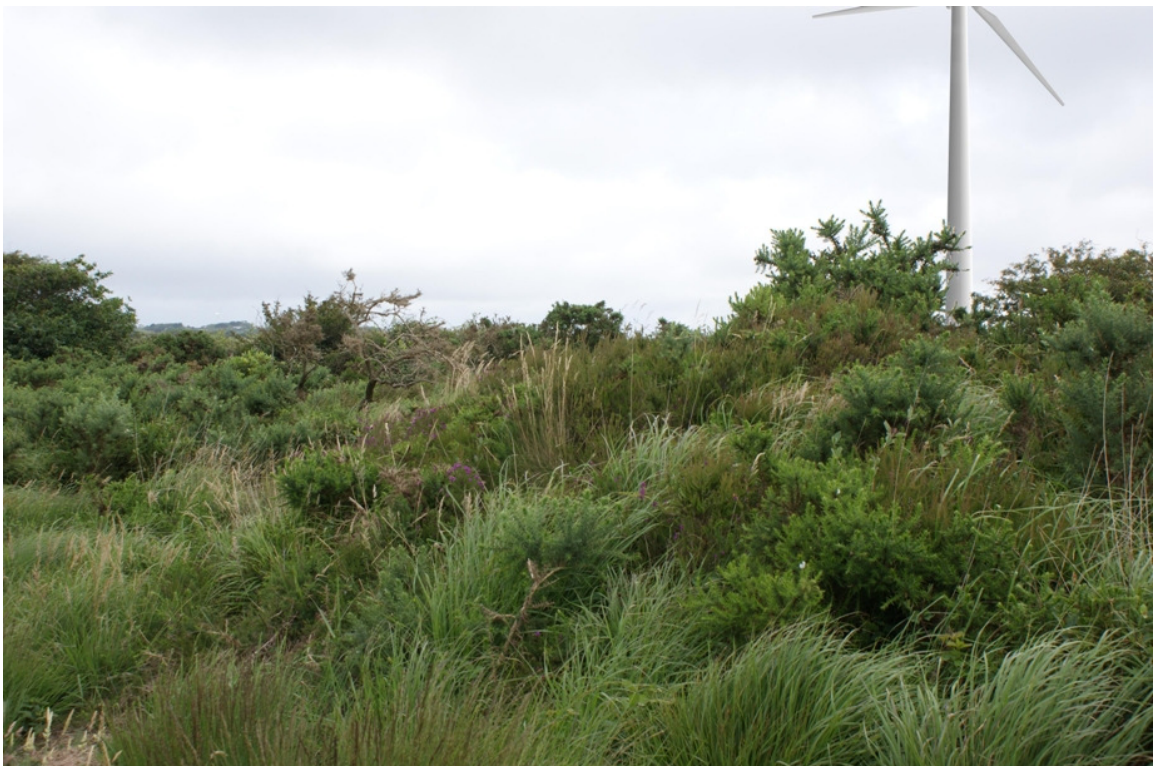
Plate 3 Photographic montage of theoretical view of proposed wind turbine from Wheal Busy SAM (Site 1 Figure 7 above)

Site No.	Name	NGR (SW)	Description including Location and Intervisibility details	Probable date	Significance	Condition	Sensitivity	Magnitude of Impact	Overall Impact
1	Great Wheal Busy Engine House and Mining Buildings DCO1689 MCO12146 MCO25208 SAM32992 (Plate 7)	78566 43484	Scheduled Monument citation: "Despite limited disturbance, the remains of Wheal Busy survive well. The complex of earthworks in the eastern area of the monument, and the Brunton calciner, are particularly well preserved. The various structures and earthworks represent well the range of mining activity here, and its development over time. The eastern complex is of outstanding importance for its visual impact and significance as a mining landscape; the pits and shafts illustrating the scale and methods of 18th century mining, and the reservoirs and leats showing the lasting importance and management of surface water resources. There is also great potential for buried remains associated with pioneering water, horse, and steam powered engines; the earliest of the series of major steam engines employed on the mine being sited within the monument. Overall, Wheal Busy provides an excellent example of a larger Cornish copper mine, which had a prolonged impact on settlement and transport patterns in the area." Area of heathland with mines, waste heaps and other workings visible. Majority of turbine will be visible and audible from a most areas of the site.	17 th -20 th Century	WHS S	3	Very High	Minor	Moderate Negative

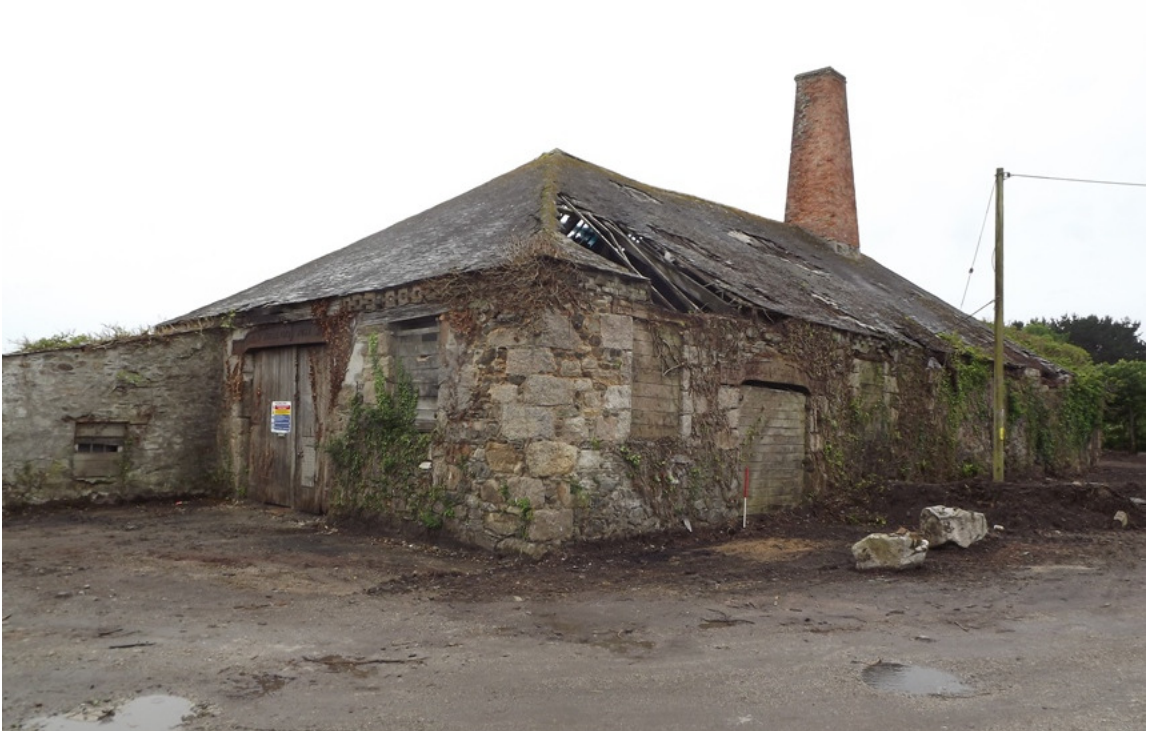
Plate 6 Site 3 Wheal Busy Smithy. Looking southeast.

Site No.	Name	NGR (SW)	Description including Location and Intervisibility details	Probable date	Significance	Condition	Sensitivity	Magnitude of Impact	Overall Impact
3	Wheal Busy Smithy DCO5839 MCO9070 LBS492506 (Plate 6; Plate 7)	7388 4475	Listed Building citation: "Former blacksmith's and workshop. Built c.1872 for Wheal Busy Mine. EXTERIOR: A tall single storey building of random granite rubble with granite quoins and some modern repairs of brick and block work in places. A large and impressive, hipped scantle slate roof with ridge tiles. The tall central stack for the furnace has a lower stage of stone and upper of brick. The front elevation has cart entrances at either end; the one to the right is arched and has brick dressings, whilst that to left has a granite lintel. Two further doorways and a window opening are positioned in the central part of this elevation. An extension to the right is of rubble stone with a single pitch roof. Map evidence indicates that there was a further extension to the left but this, with the exception of a low projecting stone wall, has been demolished. There is a particularly fine cast iron lintel above the right side entrance to the building bearing "GREAT WHEAL BUSY MINE 1872", cast by Perran Foundry, near Truro, and a further cast iron lintel to the rear entrance. INTERIOR: Two internal bays, formed by a partition wall of rubble stone and the base of the chimney, and open to roof. It has a tie beam hipped roof with angle struts. The purpose-built forge dominates the larger space and is constructed of granite rubble that has been lime-washed. HISTORY: From the early C18 this area of Cornwall became the focus of intense mining activity and Wheal Busy was the site at which James Watt introduced some of his most historical improvements in steam engine design. In its heyday, Wheal Busy was a major employer and the mine's existence greatly contributed to the development of the village and new parish of Chacewater. It also influenced the development of regional transport networks, using a pioneering horse-drawn tram road for the transportation of copper and tin ores. Mining was suspended at Wheal Busy in 1873, although arsenic was produced at the site during the late	19 th Century	WHS L Grade II	2	Very High	Minor	Moderate Negative

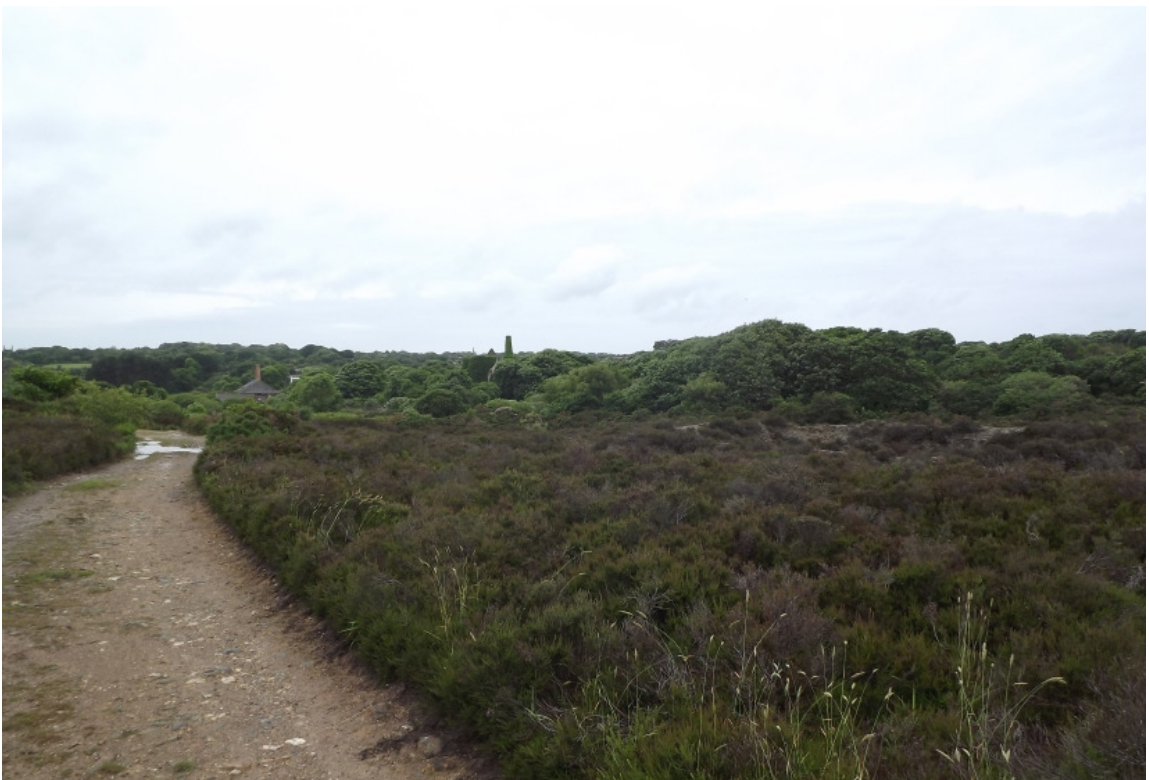
Plate 7 Wheal Busy SAM with Smithy (Site 3) and Engine House (Site 1) in the distance. Looking southwest.
