Scott's Quay

Archaeological, Ecological and Structural
Assessment.

Project No: AC12007E

Report Date December 2012

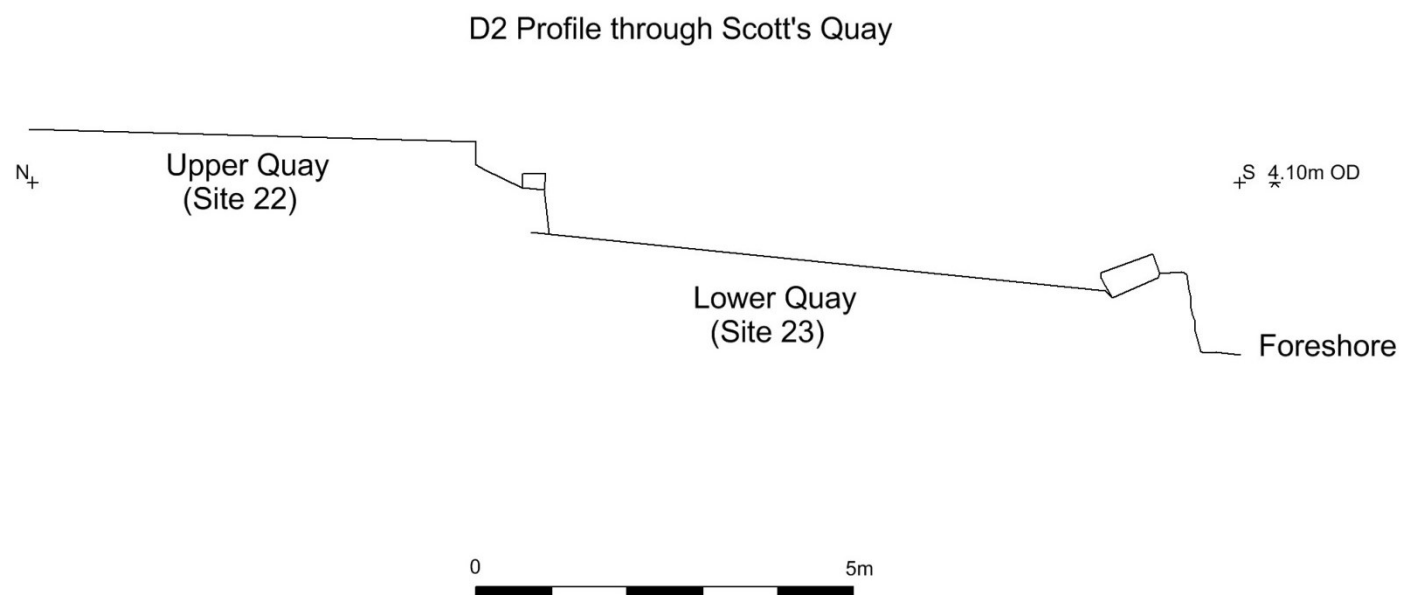
Figure 8 Profile drawing through Scott's Quay

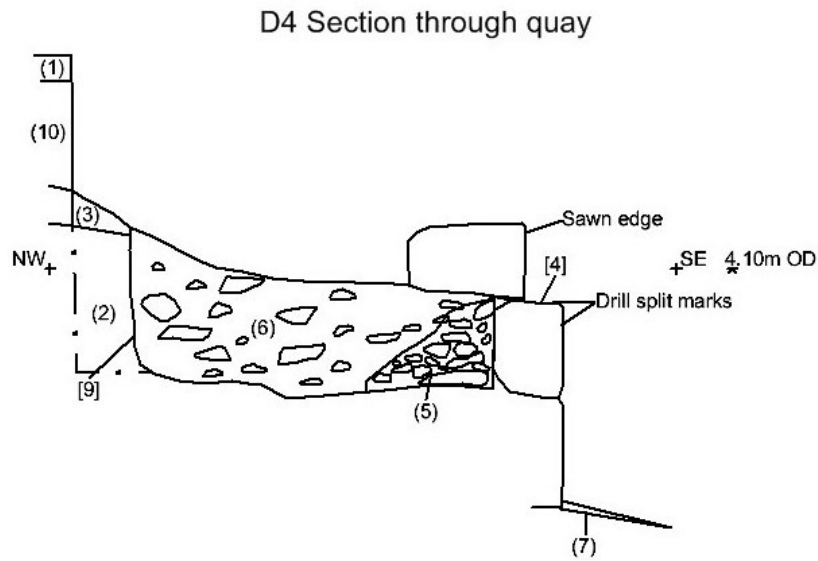
Figure 9 Section drawing through the Upper Quay wall in test-pit 2

The thick burnt layer (3) identified beneath the slate consolidation layer in test-pit 2, may predate or be related to the early 19th century Quay. The inclusion of shell fragments within this may be residual or point to the cooking of shellfish on site. Either way this may not have been the primary or only purpose for the fire. Archaeological monitoring of consolidation works should seek to record the extent of the spread and may provide dating and faunal evidence, enabling better interpretation.

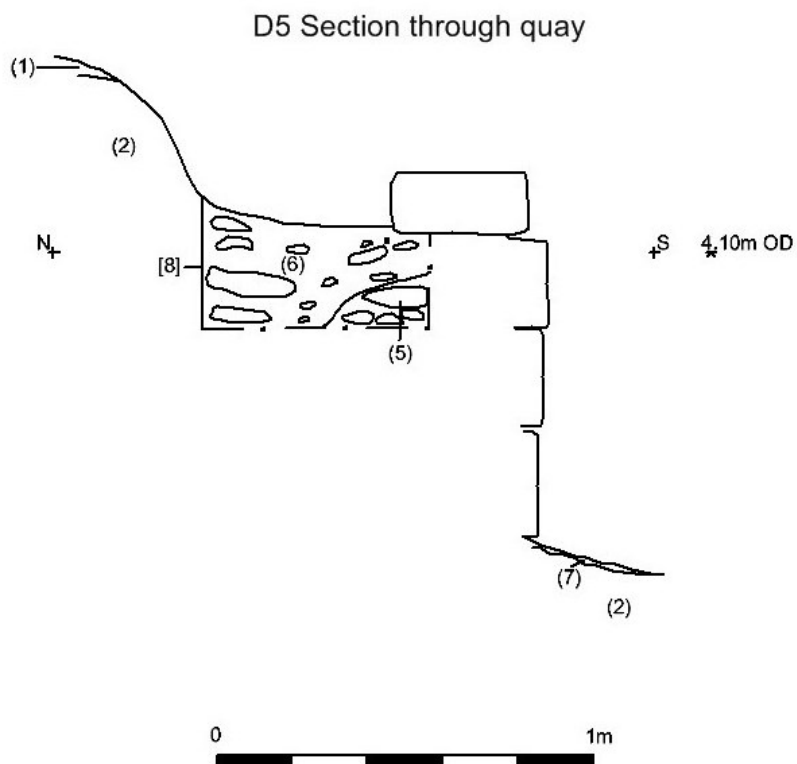
Figure 10 Section drawing through the Upper Quay wall in test-pit 1

The 100mm mesh synthetic fish netting found in the top of the slate backfill (5) confirms that the top of this part of the Quay (test-pit 1) was repaired in the later 20th century, corresponding well with the structural evidence. Whilst nylon was advertised in America from 1939, synthetic monofilament netting (both gill and tangle) became more widespread in the fishing industry in the 1960s. Its discovery in the backfill of the Quay walling appears to suggest that fishing from the Quay may have included some small scale commercial fishing in the mid to late 20th century as well as the more recreational line fishing.

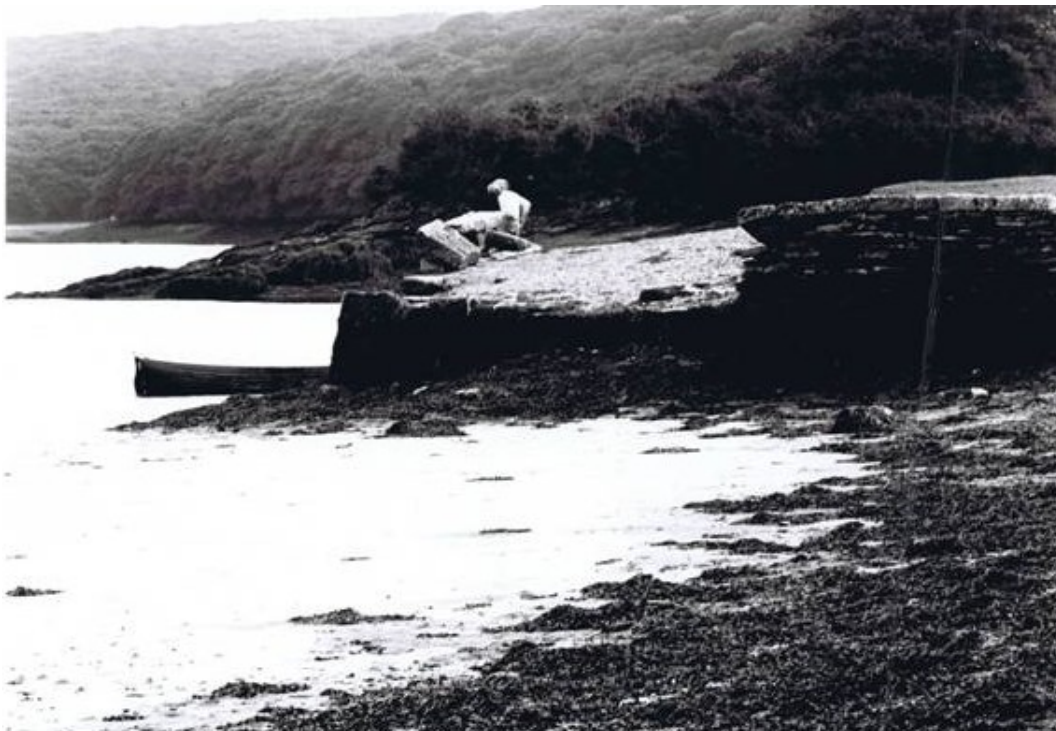
Plate 2 Historic photograph of Scott's Quay c1910, looking southwest, apparently showing work on-going on the Lower Quay. Courtesy of Charles Pugh.

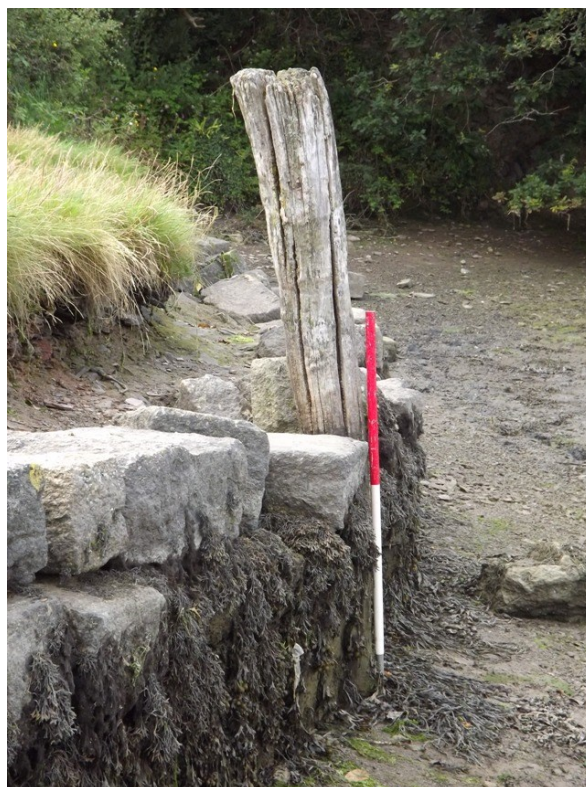
This movement and subsequent degradation of the Quay walling is especially evident along the east wall, where an extant mooring is associated with softer foreshore mud. The mooring post (Site 25) has clearly been let in to the earlier Quay wall structure.

Plate 14 Site 25 Mooring Post looking north. AC/DP/2012/08/06/031

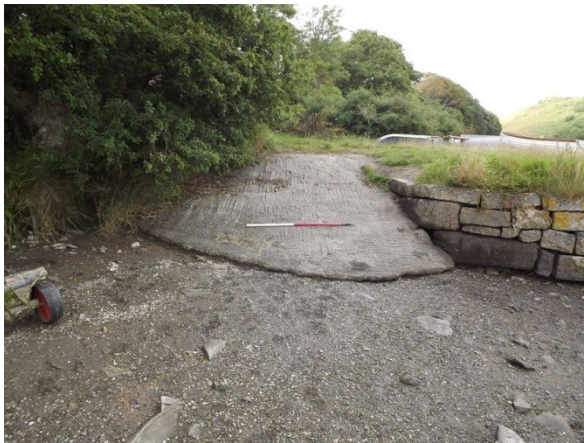
Plate 16 Site 24 Slipway looking northeast. AC/DP/2012/08/06/022

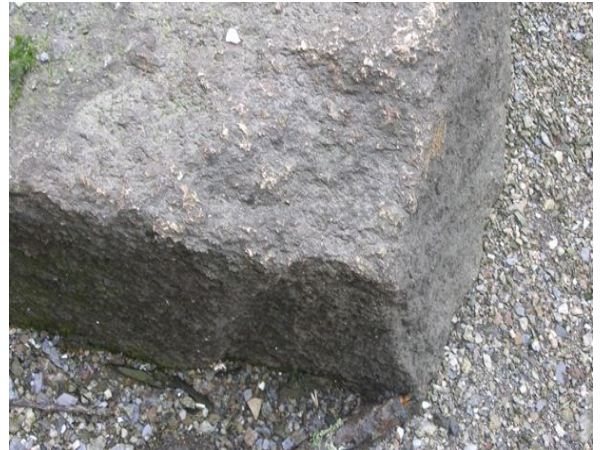
Plate 18 Wedge split-mark on a granite block on the Lower Quay. AC/DP/2012/01/06/012

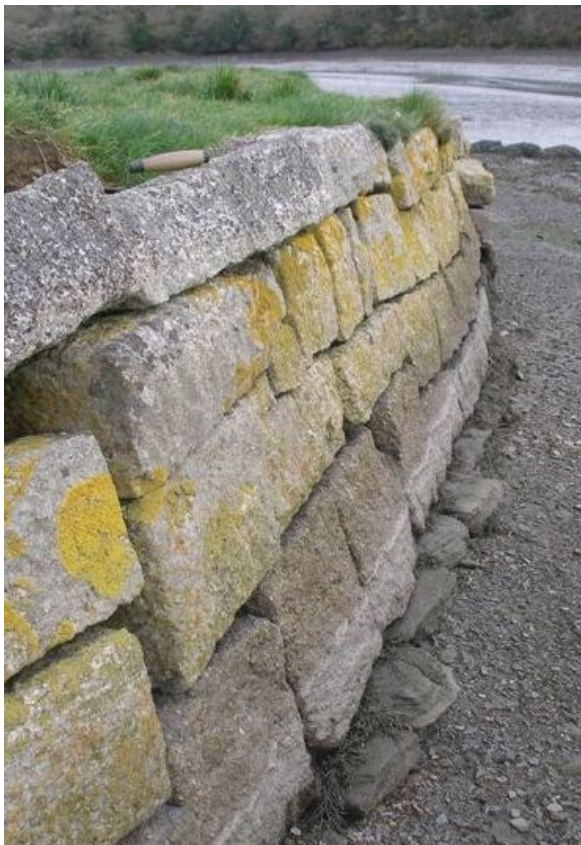
The Upper Quay wall ranged from 0.3-1.2m in surviving wall height and was generally defined by three courses of smaller granite blocks with some coping surviving above this and one section of slate foundation course (11). The blocks generally averaged 0.25-0.6m length by 0.25-0.4m in width and 0.2-0.35m in depth, whilst the coping averaged 0.5-0.9m in length by 0.3-0.4m in width and 0.25-0.35m in depth. The granite blocks were generally squared, though a number of them only had squared outer edges, with less regular, inner edges. The blue-grey granite appeared consistent with deep unweathered material

Plate 17 Upper Quay walling showing battered wall face (4) on a slate foundation course. AC/DP/2012/01/12/005

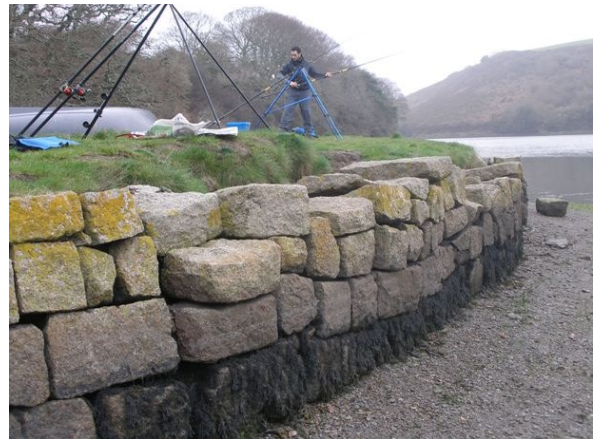
Relatively haphazard repairs of the displaced granite blocks has failed to re-instate the running (stretcher) bond and has not generally been accompanied with suitable backfill material.

Plate 19 Battered 1930s walling to the left with vertical repairs to the right, looking northeast. AC/DP/2012/01/06/014

Clean off existing masonry where necessary. Remove sections in poor condition (estimated 20-30%) and excavate 0.3m width trench behind down to slate backfill and store in stockpile for re-use section by section. Rebuild partially reinstating running bond, coping and 70-80° batter where possible. Build up key weaker points with limited additional granite to help tie-in and strengthen wall. Consider the import of a limited number of granite coping stones to re-enforce key areas. Imported coping may be pre-drilled to allow pinning with iron cramps to be fixed with epoxy resin. Backfill behind the repaired walling with inert free-draining stone (granite or slate). Reinststate surface with excavated material sealing uppermost walling, the a layer of suitable reinforcement mesh and turf or seeded geotextile.

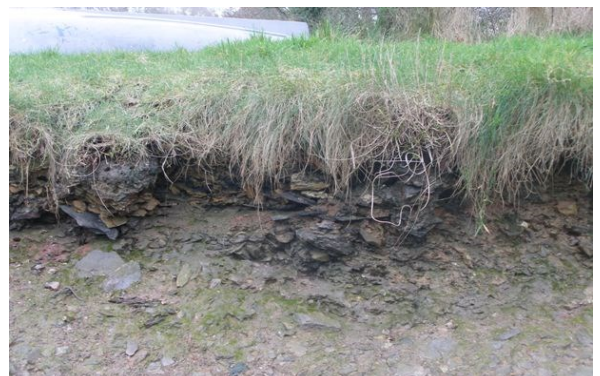
Plate 20 Slate consolidation (10) for the Upper Quay surface looking west. AC/DP/2012/01/06/022

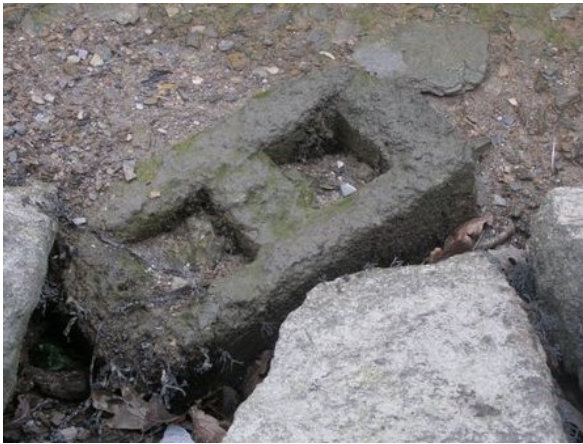
Plate 21 Concrete block used in the backfill to the Upper Quay wall. AC/DP/2012/01/06/021

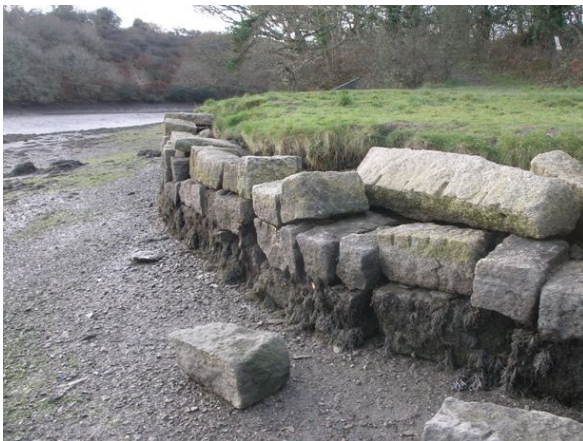
Plate 22 Re-used granite gate-post failing to consolidate the top of the Upper Quay walling. Looking west. AC/DP/2012/01/12/003
