Nancegollan Farm

Crowan, Cornwall

Photographic Recording

Date: November 2010

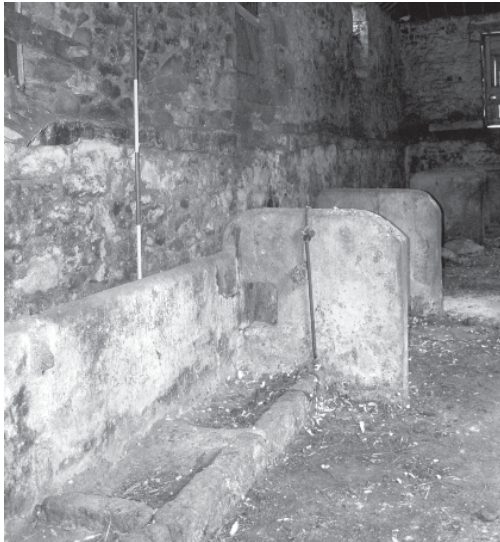
A test pit through the extant (1950s) concrete floor revealed two earlier granite cobbled floors with a layer of levelling in between. A range of concrete block built cattle stalls and feeding troughs on the west side appeared to have replaced earlier granite troughs and possible wooden partitions (Plate 1). Opposite the stalls an engine to power a belt drive was loose on the floor.

Plate 1 Granite troughs and 1950s cattle stalls in Building 1, looking northwest. BW1/28

The concrete cattle stalls with feeding troughs, water and drainage are likely to mimic the original layout, allowing cows to be fed, watered, milked and mucked out efficiently. The upper cobbled floor is likely to be contemporary with the construction of Building 1 though the lower floor may be part of an earlier cobbled farmyard.

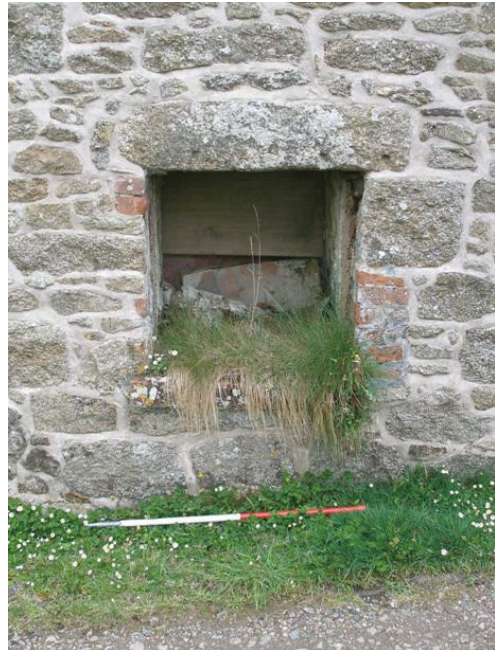
Although only roughly arranged in courses, the west wall has two level lines of stonework at a height of 1.20m and 1.60m. It has only one ground floor window crudely inserted at a later date (Plate 3). This is apparently compensating for the lack of windows to the east where Building 2 adjoins, but it is currently blocked with modern hardboard. Internally, at a height of 1.90m, there is a clear break in the whitewash and rectangular 0.2-0.7m long granite blocks protrude approximately 0.10m from the ground floor walling. Above this the first floor walling narrows, creating a more substantial ledge on the east and west walls to accommodate the first floor joists, which along with the floorboards do not survive.

Plate 3 Inserted ground floor window in west wall of Building 1, looking east. CP1/2

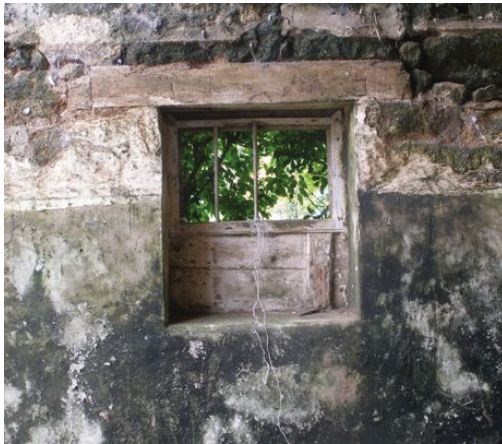
In the south wall, the window has a wooden lintel with truncated carpenters marks and a rebate suggesting it's re-use. A wooden frame and half of a horned sash frame have been inserted (Plate 2).

Plate 2 Building 1 ground floor window in south wall with carpenter's marks on lintel, looking south. CP2/17

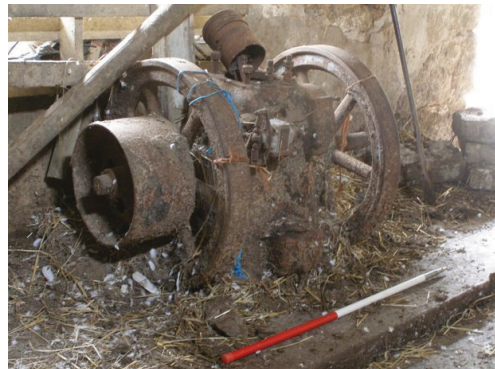
Plate 4 Building 1 engine with belt drive, looking south east. CP1/16

The loading doors probably allowed grain or fodder to be loaded straight from the farm carts into the first floor. An engine powering a belt drive in the ground floor of Building 1 could have been used to power lifts to facilitate this. The multiple openings could be used to control the draft thus keeping the produce dry whilst in storage.

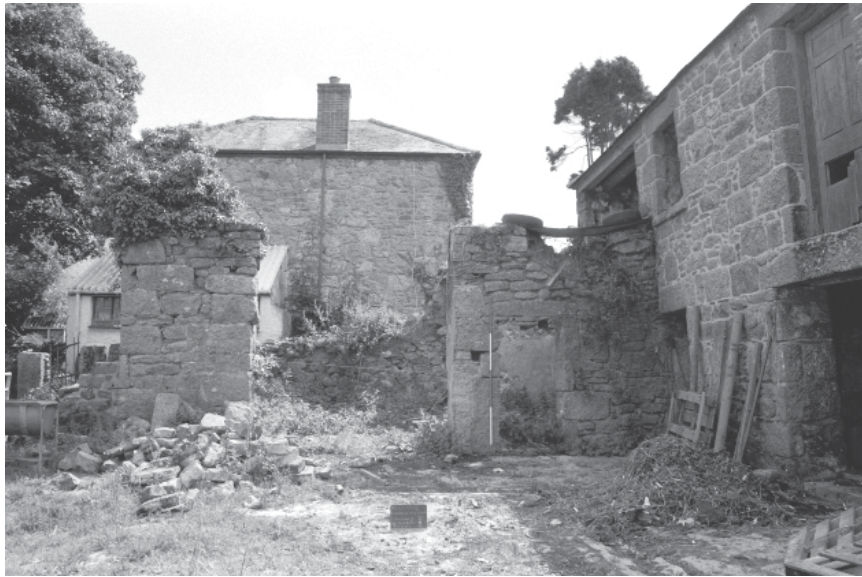
Building 2 is a small, dilapidated two storey rectangular structure extending eastwards from the southern end of Building 1 with an eastern external stair and a number of modern repairs. The first floor, roof and parts of the first floor walling have not survived. The earth-bonded, uncoursed granite rubble walling has dressed granite quoins and lintels, where they survive (Plate 5 and 6).

The north 0.65m thick wall is constructed of uncoursed granite rubble with dressed granite quoins. It has a 0.9m wide doorway, with granite quoins and lintel. There is a second, much wider, opening to the east that has a single gate hinge. The remaining wall has been repaired with concrete blocks, Portland cement and concrete with granite inclusions especially at first floor level, though quoins suggest a first floor window.

Plate 5 North elevation of Building 2 with Building 1 to the right and Nancegollan Farmhouse to the rear, looking south. BW1/11

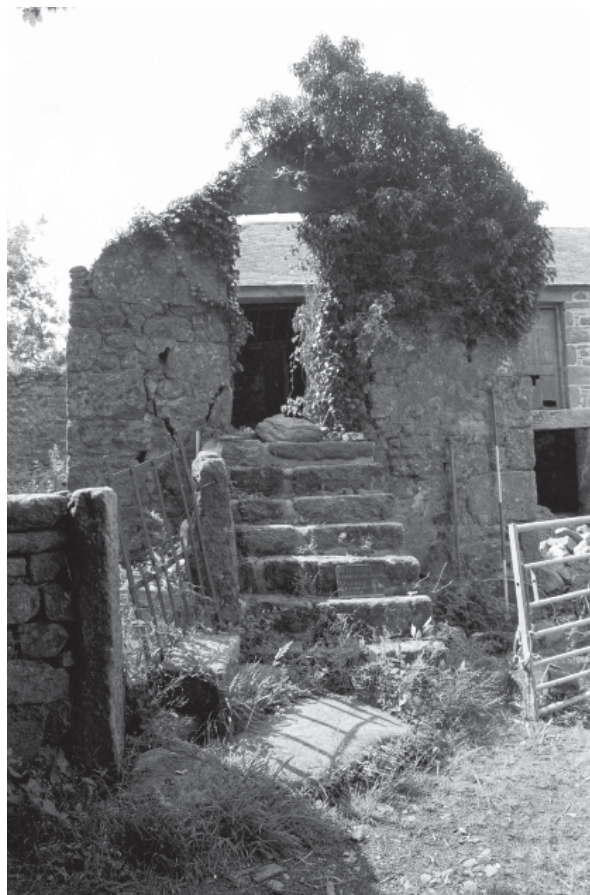
The east wall has lime mortar pointing with exterior granite steps leading to a doorway 1.54m above ground level (Plate 6).

Plate 6 East elevation of Building 2, looking west. BW1/10
