Transport for London Cycle Hire Scheme

Archaeological Watching Brief Report

Docking Station 08/610802

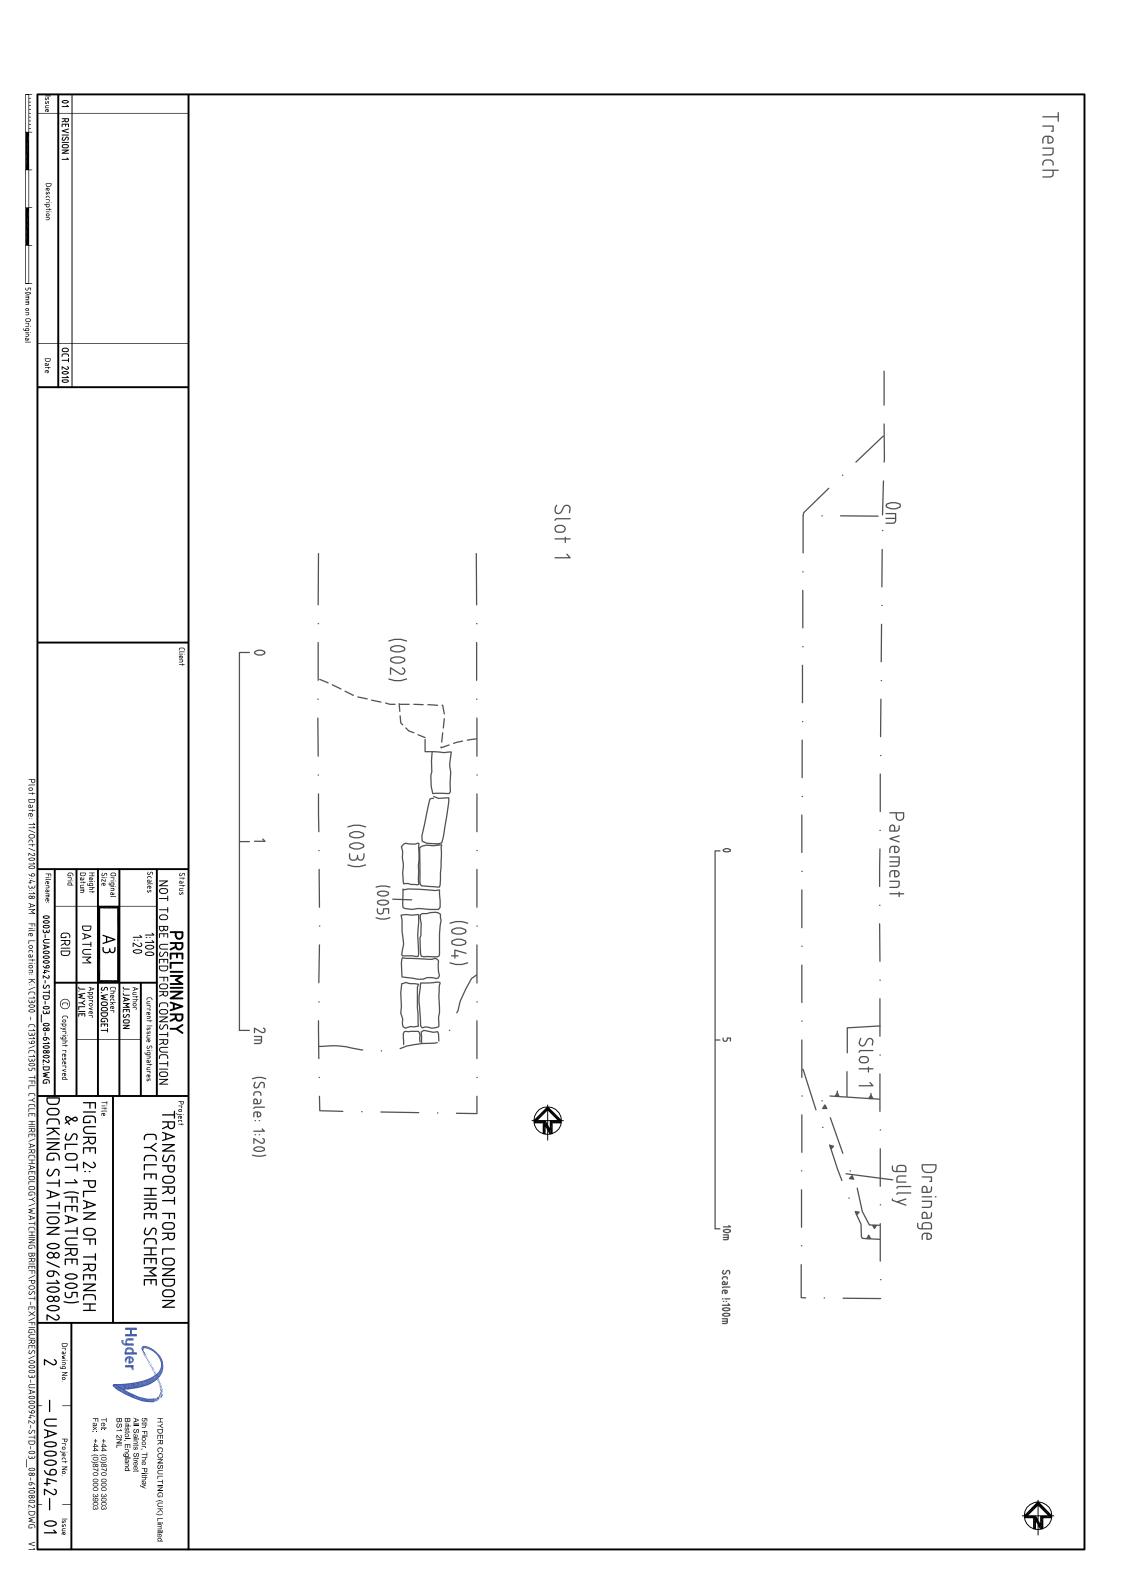
Figure 2: Plan of trench and slot 1 (feature 005)

Feature 005 was orientated north to south, was linear in plan and was constructed out of bonded, red brick (figure 2 and plate 1). The brick was Late Red Brick Type 3046 (dated 1600-1700) (pers comm. PCA) and the bonding was a soft light grey mortar with chalk inclusions and occasional charcoal flecks. The feature was only visible in plan as it was located at the maximum depth of excavation (0.56-0.54m below ground level, 2.84-2.84m AOD). Apart from disturbance of a couple of bricks the feature was left intact. The feature was 0.20m wide (two courses) and observed for a length of 1.80m. At its northern limit there was a possible western return which has been truncated. The base of the feature was not reached and no construction cut was observed. The feature appeared to continue beyond the southern limit of excavation

Feature 005 has been interpreted as a wall. Apart from a couple of bricks the wall was intact and was only potentially truncated at the northern end where the wall possibly returned to the west. As the wall is largely intact it is possible to determine that it is the remains of an unsubstantial wall, possibly a garden wall or less substantial building to rear of a main property on Park Street. Analysis of the bricks used to construct the wall dated it to the 17th Century (pers comm. PCA). Individual properties that were indicated on 18th century maps in the area no longer exist today. It is possible that the remains observed here were associated with these properties.
