**Church of St Mary and St Nicolas
Spalding**

**Foundations for New Vestry
Archaeological Watching Brief**

**Report for
Spalding Parochial Church Council**

**LAS Report No. 321
September 1998**

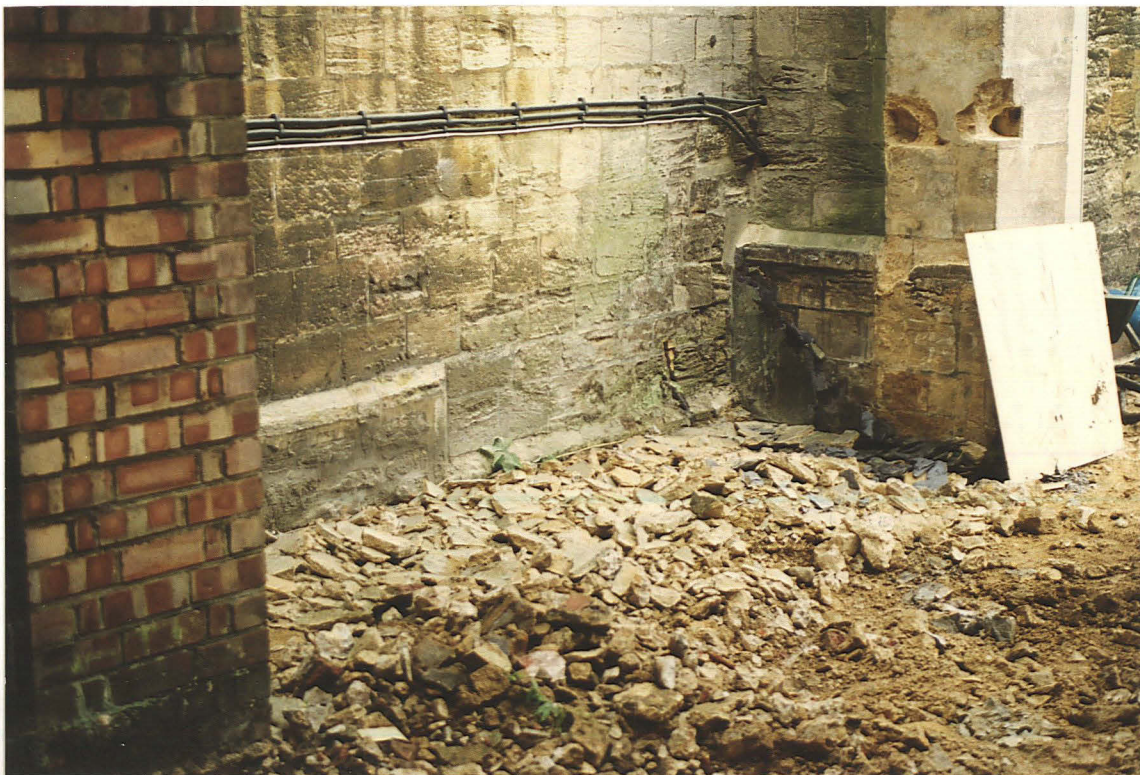
Pl. 3 North wall of St Thomas' Chapel, looking south-east, showing the door to the demolished passageway and the butress on the north-east corner of the building.

The east wall of the south transept is constructed from coursed but undressed blocks. It has a large Decorated window, but is otherwise plain, with no mouldings. The north wall of St Thomas' Chapel has a similar coursed-rubble construction. It has no window, but a door has been cut at the east end, to give access to the passageway to the chancel (Pl. 3).

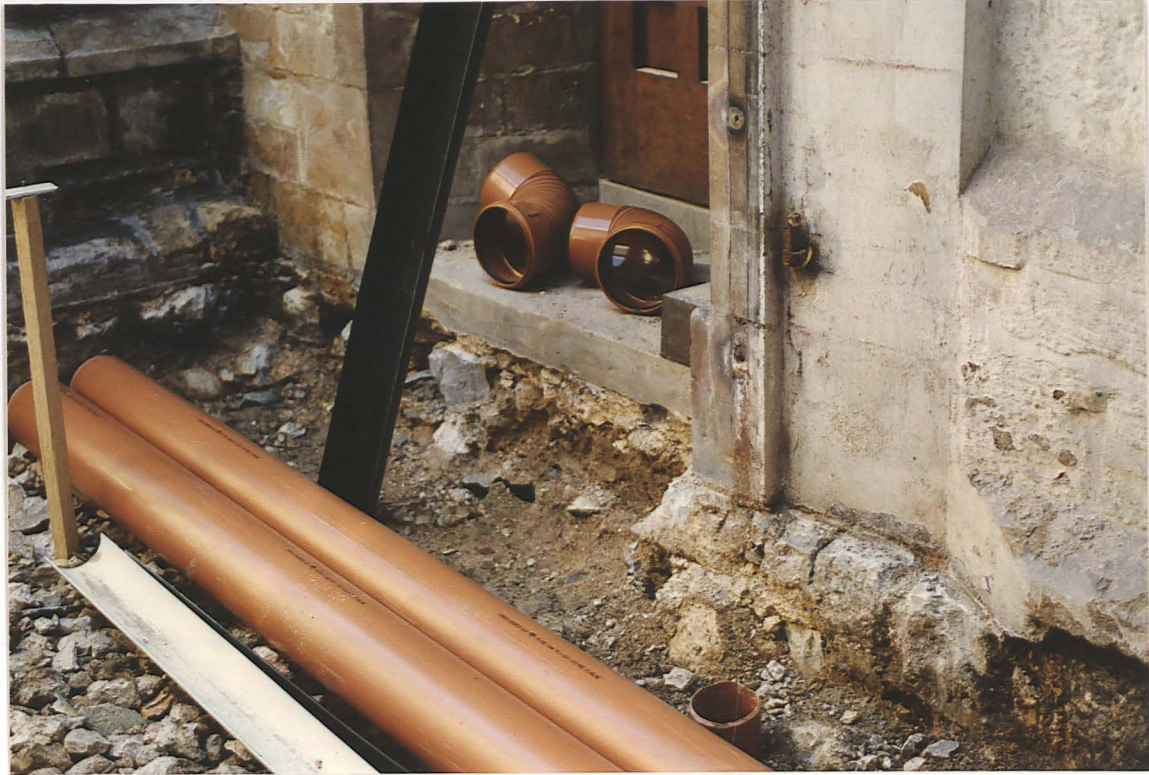
Pl. 4 Foundation of the chancel butress, looking north; scale 50cm.

The foundations of the buttress between the first and second bays of the chancel were exposed in the trench. This buttress apparently dates from the Victorian restoration of the church. A row of rough limestone blocks extending up to 400mm southward from its base at a depth of about 600mm below the present ground level (Pl. 4). These blocks were 250-300mm across. Lying over them, was a layer of compacted earth, approximately 100mm thick, above which was a mortared rubble footing supporting the dressed stone plinth of the buttress. The row of blocks did not appear to be directly supporting the footing, which was only slightly wider than the base of the buttress.

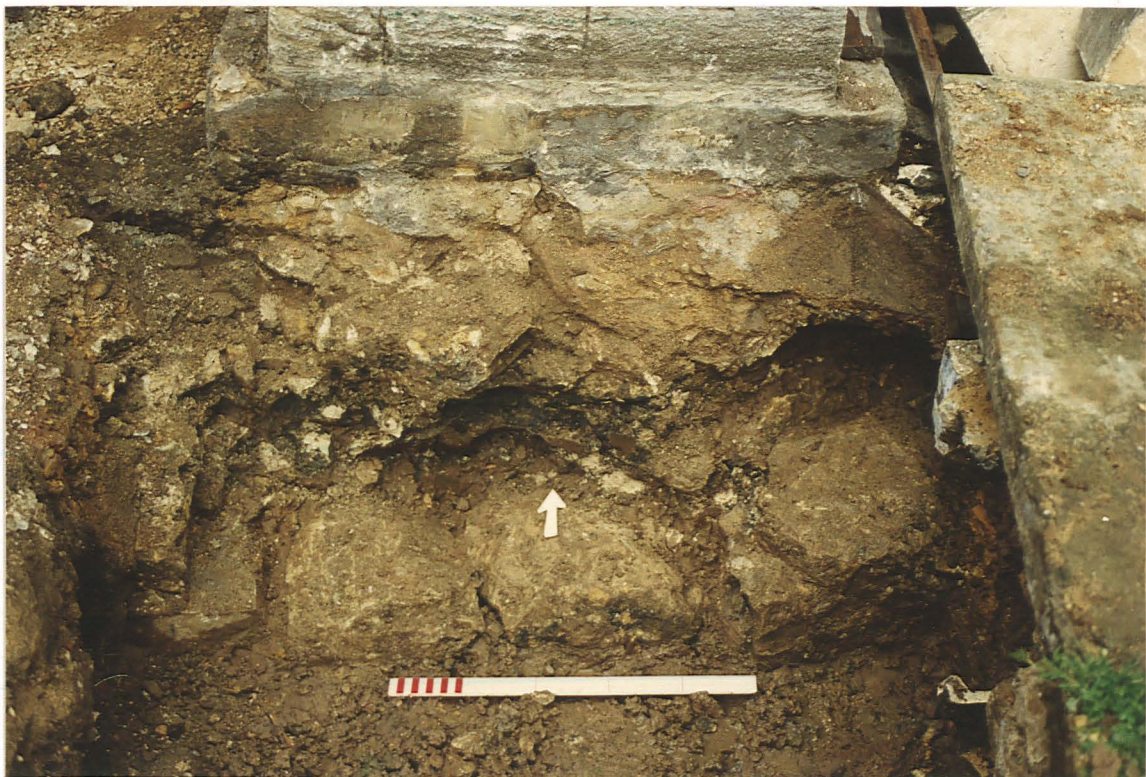
Pl. 5 Foundation of the buttress on the north-east corner of St Thomas' Chapel, looking south-west.

The other point at which the trench meets the existing building is the angle between the buttresses of the north-east corner of St Thomas' Chapel (Pl. 5). Here the foundations were much simpler, consisting of a course of mortared, undressed limestone blocks about 0.30m thick and resting directly on the natural silt substrate.

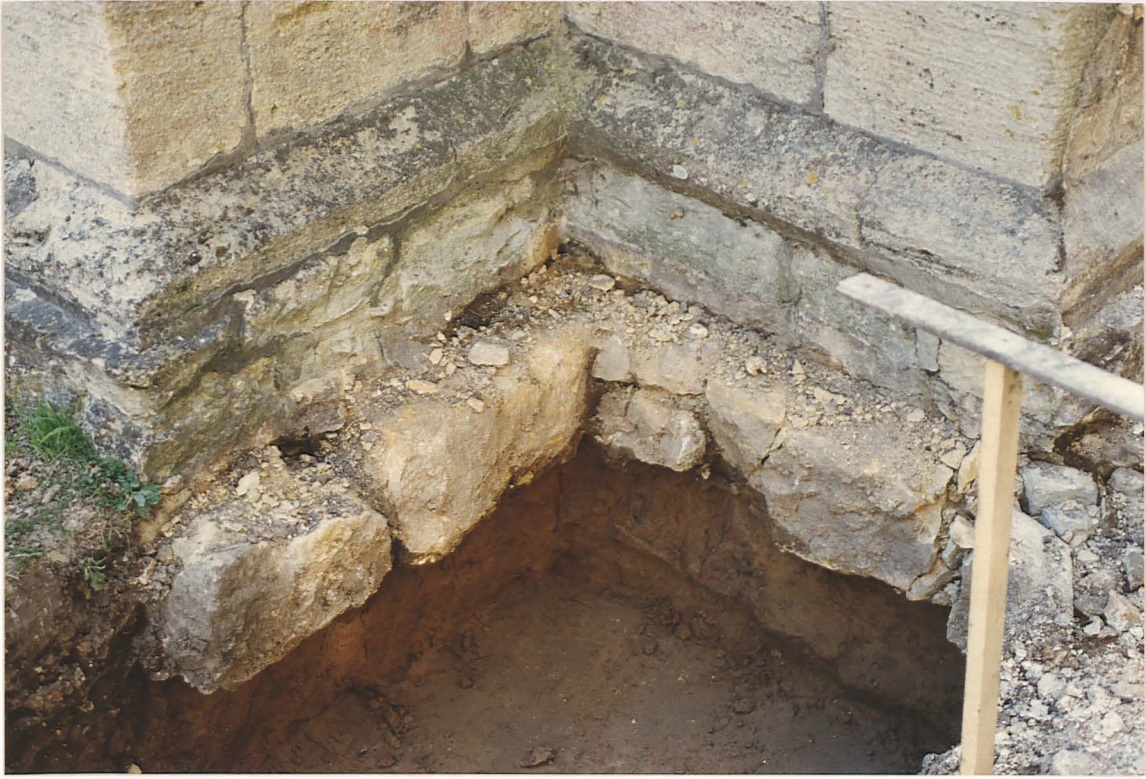
Pl. 6 Base of the east wall of the south transept, looking west, showing stepped out foundations; scale 50cm.

Elsewhere, lowering the ground level to form the floor slab exposed the foundations of the south transept, and the north wall of St Thomas' Chapel. The transept foundations were distinct from those seen elsewhere, being stepped out in two stages to extend approximately 0.40m from the wall (Pl. 6, 7). This contrasts with the rather meagre foundations of the chapel (Pl. 8).

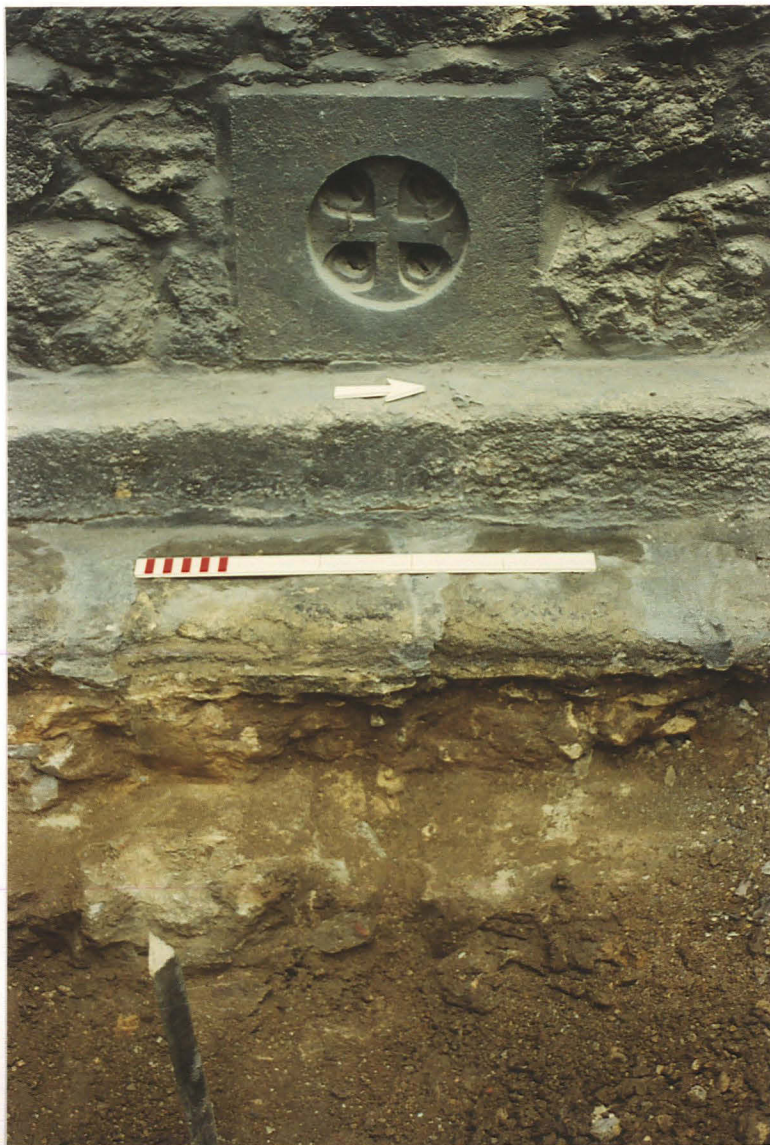
Pl. 7 Corner of south transept and chancel wall, looking north-west, with housing for organ bellows on the right, showing contrast in foundations.

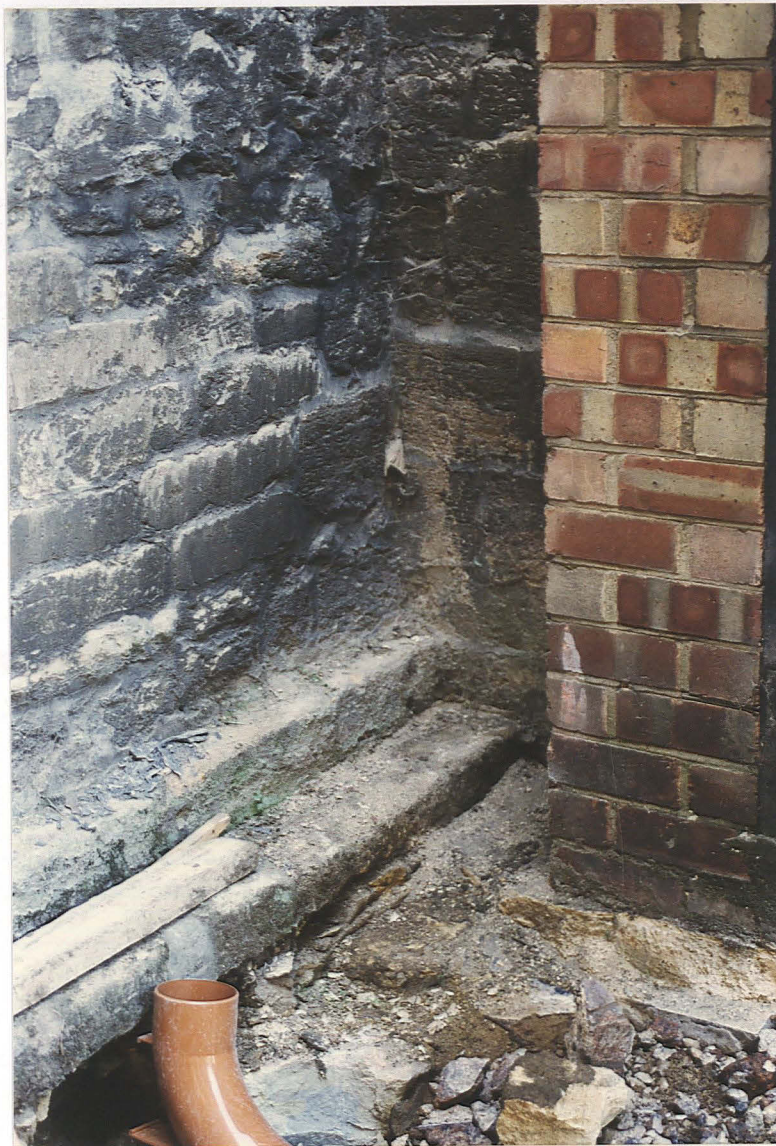
Pl. 8 Foundation to north wall of St Thomas' Chapel, looking south-west, with foundation of south transept showing to the right.

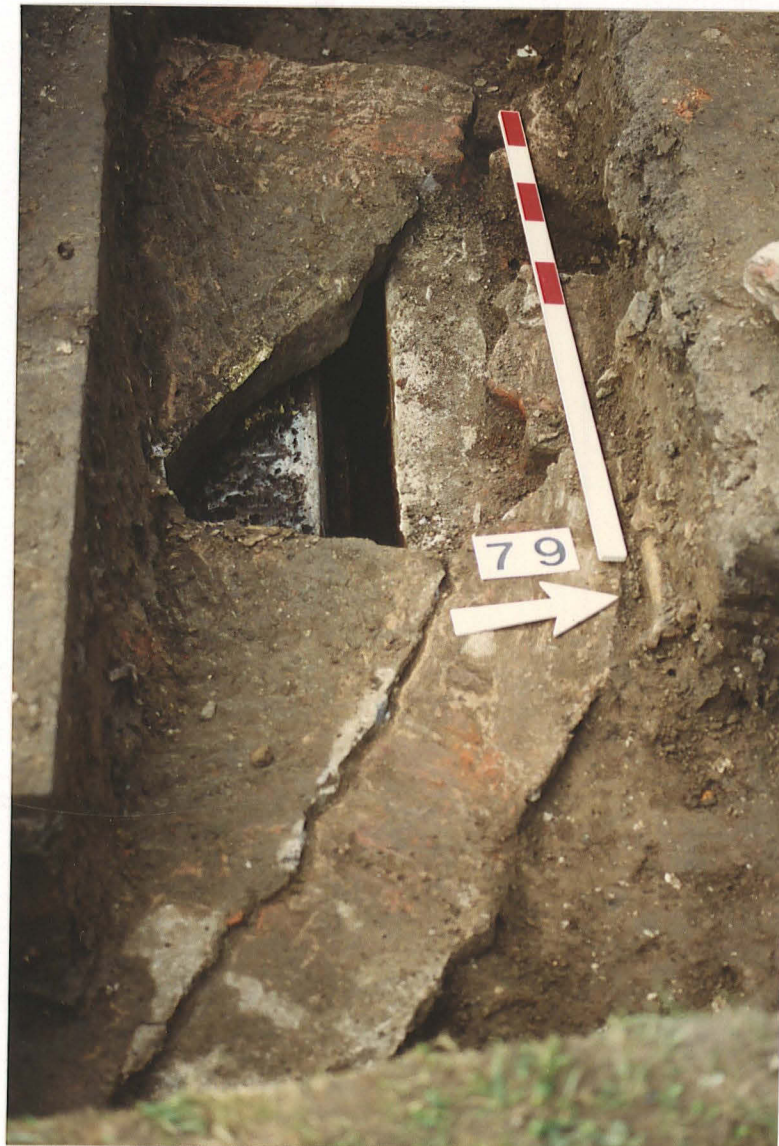
Pl. 36 Vault containing lead-lined coffin, looking west. The lead coffin lining can be seen in the middle of the photograph to the left of the vault-lining. This visible part is just above the left 'shoulder' of the coffin; scale 1m.

In the area corresponding to the south-east corner of the new building, a vault containing a lead coffin was exposed (Pl. 36, 37). This was not excavated. The vault was covered by a stone slab, approximately 40mm thick, and 0.43m below the ground surface. This slab was cracked, allowing removal of a small section to reveal the inner face of one side of the vault. A row of mortared bricks around the edge of the slab, where it overlapped the top of the vault, sealed it in place. The side of the vault were smooth and appeared to be concrete, or rendered stonework. There was a gap of approximately 150mm between the vault and the lead lining of the coffin. The vault was around 400mm deep, and had standing water in the base. The wooden side of the coffin, though soft and spongy in texture, was fairly well preserved below this level. This confirmed that the sealed lead container had originally formed the lining to a wooden coffin. Items of metal coffin furniture, including handles and decorative foil swags, were still in place, attached over a soft outer layer of leather or fabric.

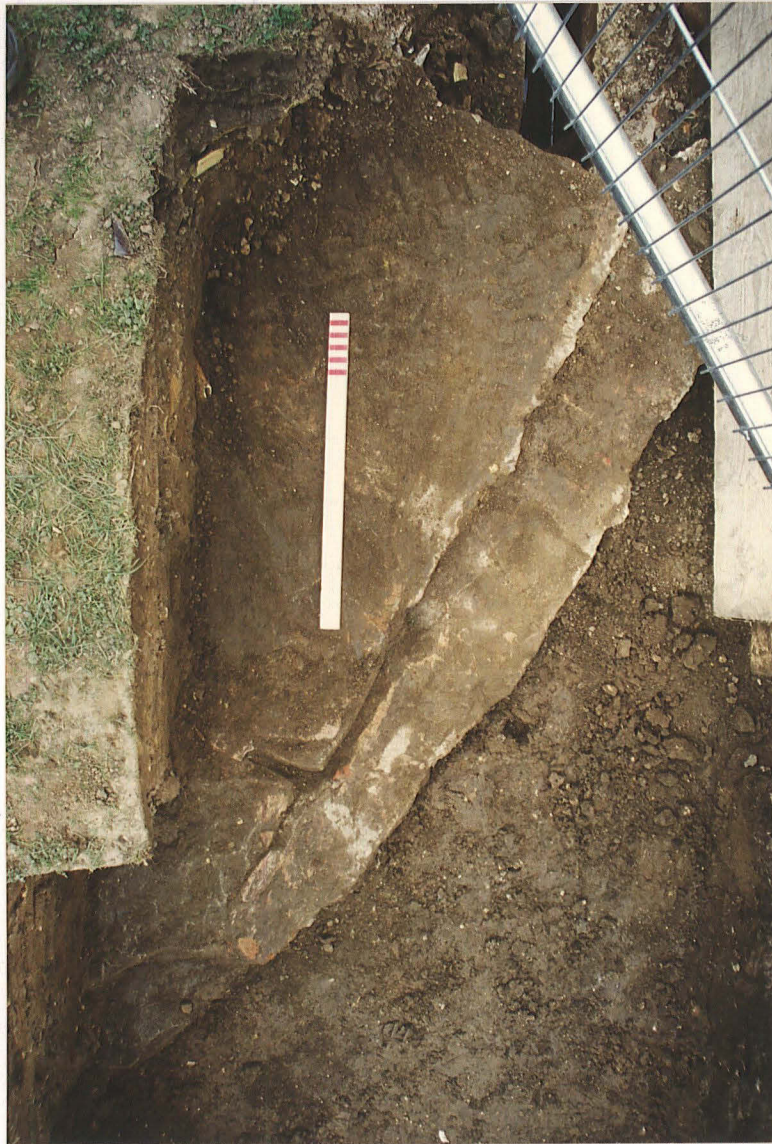
PI. 37 The top of the vault with the lead-lined coffin, looking west, after extension of the trench to the east; scale 50cm.

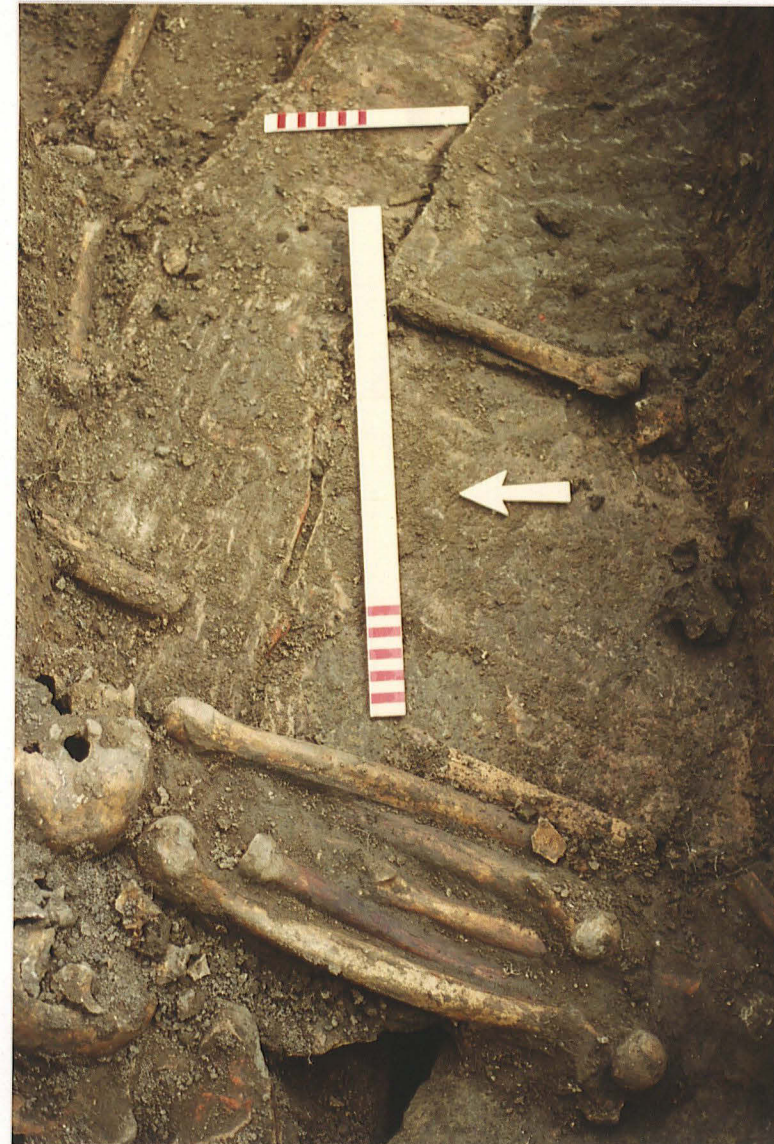
PI. 38 Arm and leg bones and two skulls resting on cover of the lead-lined coffin vault, looking east; scales 20cm and 50cm.
