**ARCHAEOLOGICAL WATCHING BRIEF REPORT  
64 MONSON ST LINCOLN.**

Site Code: MSL98  
LCNCC Acc No. 189.98  
NGR SK 973557047-  
Planning Ref: 98/393/CAC & 98/590/RD

Report prepared for Beemac Construction Ltd.  
by James Albone BSc., PIFA.  
November 1998

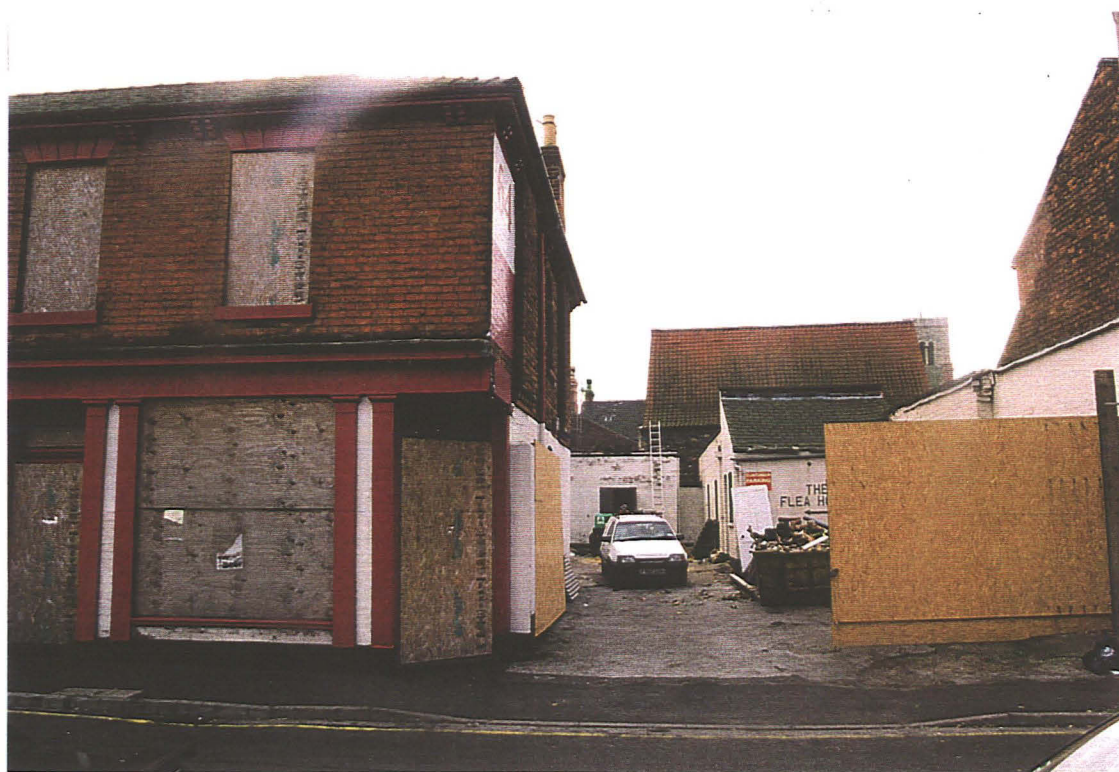
**Pl.1:** A general view of the existing buildings at 64 Monson Street prior to the commencement of work. The nineteenth century brick shop frontage in the foreground was retained for conversion and the other buildings visible in the yard have been demolished. St. Mary's Guildhall (with the pan-tiled roof) and the tower of St. Peter-at-Gowts' church are visible to the south of the site.

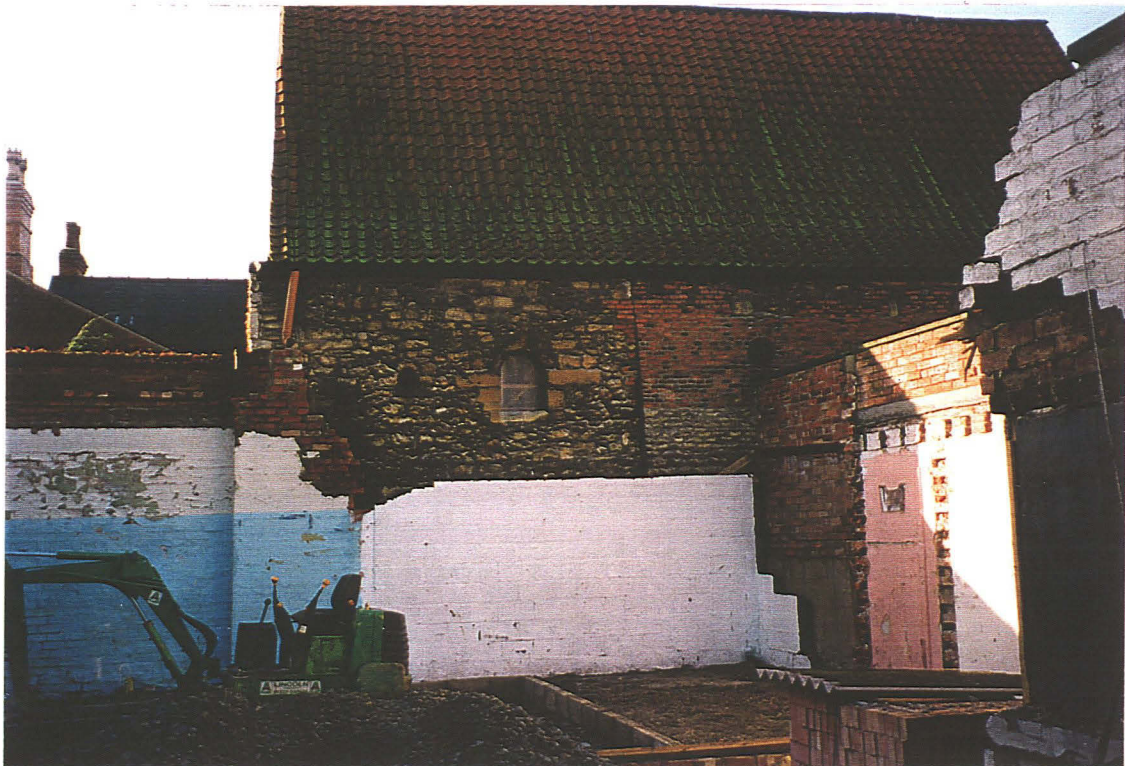
Pl. 3: View of the north face of the east range of the Guildhall as exposed following the demolition of the existing buildings (Compare with Pl. 1.).

The demolition of the range of buildings on the south side of the site exposed the north face of the east range of the Guildhall. It was recognised that the first floor of the new development would obscure this again and a brief photographic record was made. A copy of one of these photographs is reproduced in this report (Pl.3).
