ARCHAEOLOGICAL WATCHING BRIEF AT THE CATHEDRAL CHURCH OF THE BLESSED VIRGIN MARY, LINCOLN, LINCOLNSHIRE (LCL 98)

Work Undertaken For Dean and Chapter of Lincoln

December 1998

A.P.S. Report No: 59/98

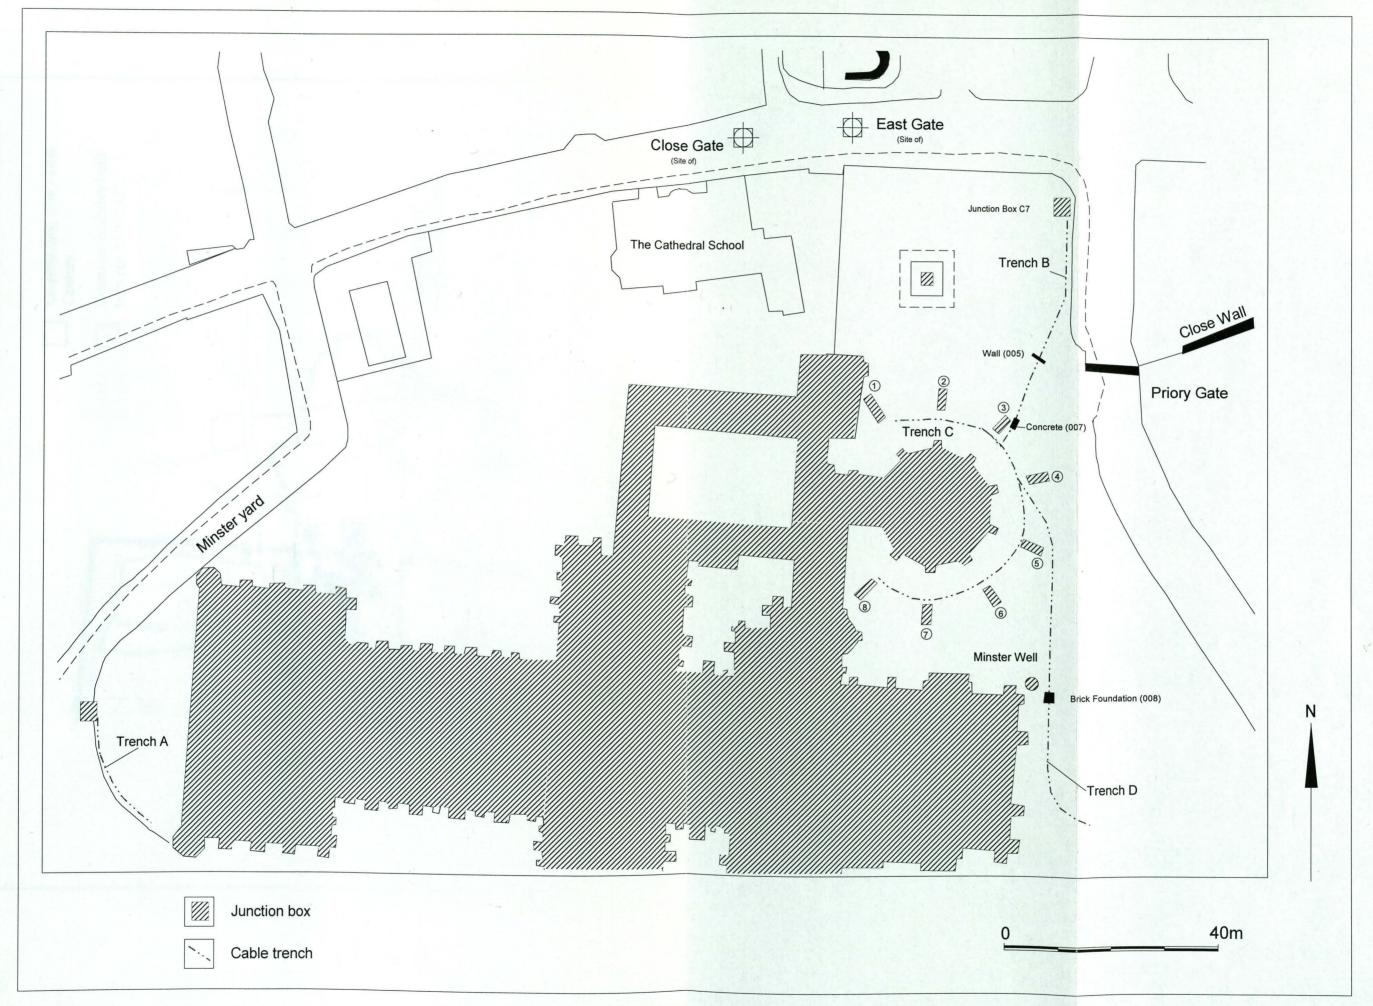
Figure 3 - Lincoln Cathedral, showing cable trench layout

All cable trenches were allocated a letter ranging from A - D (Fig. 3). Trenches A and C followed the route of existing cable trenches.

Located 32m south of the junction box (C7 on Fig. 3) was a brick structure aligned northwest to southeast (005). A width of 0.32m was established, although this brick wall also continued beyond the limit of excavations.

Im east of the northeastern buttress to the Chapter House (marked '3' on Fig. 3). Located at a depth of 0.25m its extent was no more than 0.46m along the trench. As the cable trench was only excavated to the surface of this deposit, interpreting the nature of this concrete was impossible.

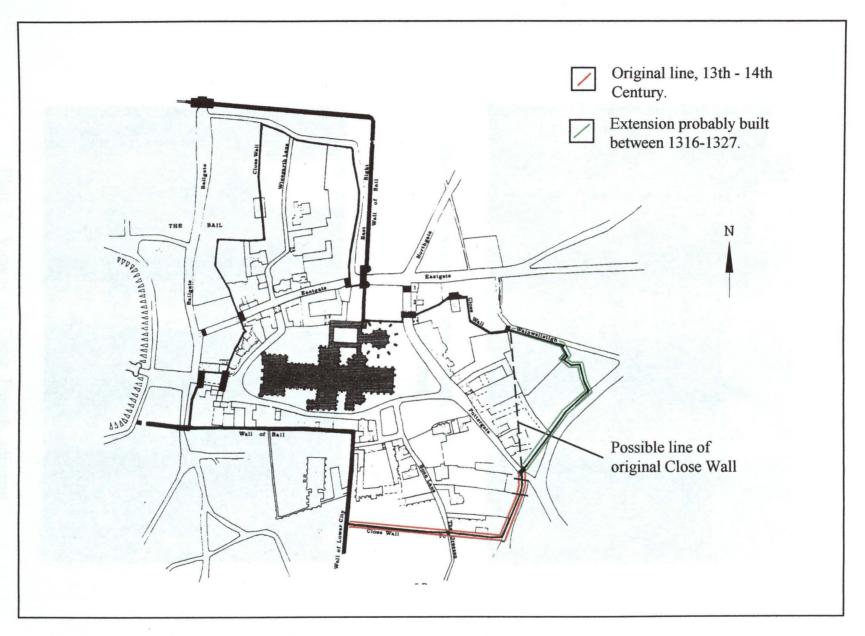
Figure 4 - Location of Close Wall

Archaeological investigations within the cathedral grounds have recorded a number of undated features and deposits (Phase 1). A brick wall was encountered west of Priory Gate, with an area of brick and mortar rubble to the south. These two deposits are located in the vicinity of the conjectured line of the Close Wall (Fig. 4). The Close Wall would originally have been a substantial limestone wall, although repairs to the wall are known to have utilised bricks (Mouraille and Trimble 1998, 4).

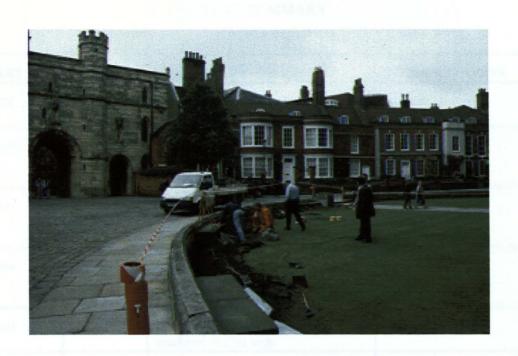
Plate 1 - View of the Cable Trench, at the west end of the Cathedral

The only deposit encountered in Trench A was a 0.35m thick layer of topsoil (001), comprising dark brown humic sandy silt. To the east of the cathedral, topsoil was also sandy silt, but slightly lighter in colour (002).

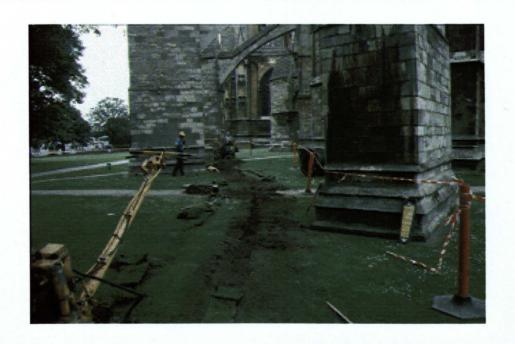
Plate 2 - View of the Cable Trench, adjacent to the Chapter House

Adjacent to the flying buttresses of the Chapter House was an area of concrete. The small size of the cable trench makes interpretation difficult, although it is unlikely that it is related to the medieval construction of the cathedral. It may

represent a later support to the buttress. Between the flying buttresses and the Chapter House there were no indications of hidden sleeper walls. However, the depth of the trench precludes against this being firm evidence for freestanding structures, as sleeper walls may exist at depth.
