Thorpe on the Hill, The Farm

**Archaeological Watching Brief
during Groundworks for an Estate Access Road**

LAS Report No. 329

December 1998

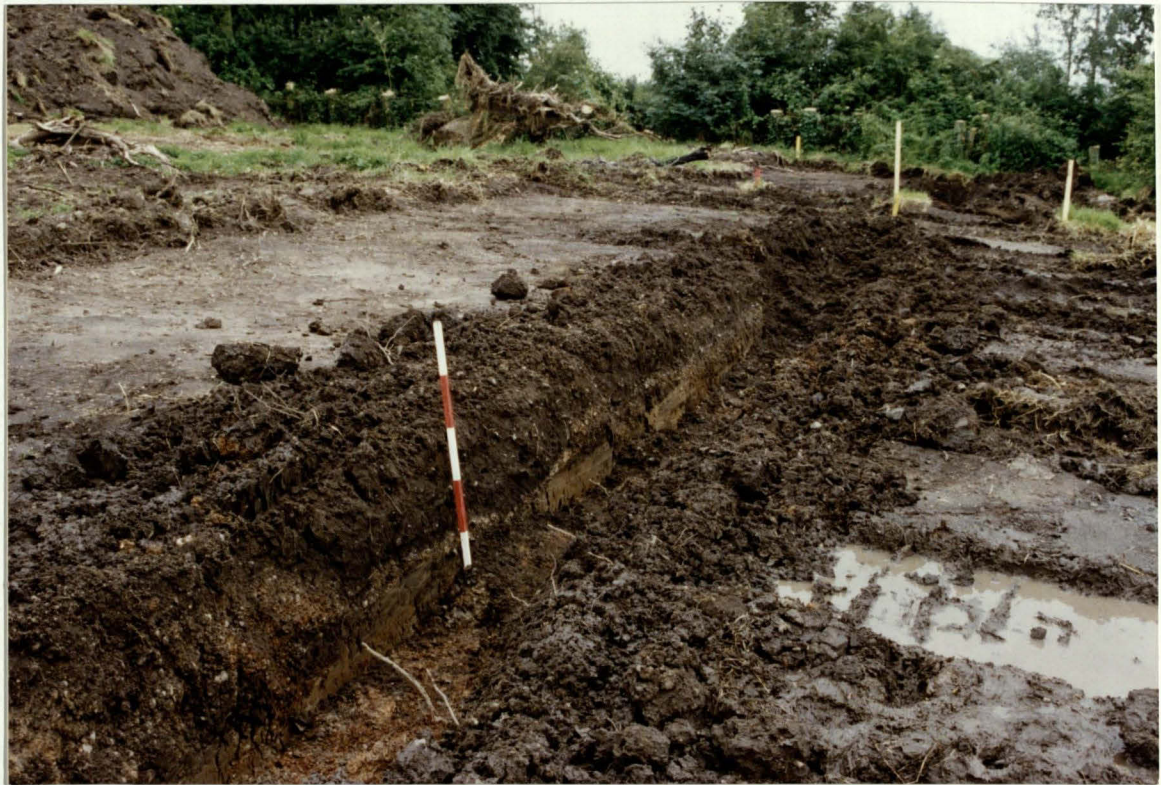
Pl. 1 The estate access road trench during monitoring (looking SE).
The 1m red/white pole is in front of 21, a possible small ditch.

safer conditions (Pl. 1). Part of the east-west road line was excavated in the same way. A small area at the junction of the two trenches could not be opened at that time but there were no indications of features at that location. During subsequent monitoring visits, the access road line was extended to the west and some further information was obtained. Unfortunately the trench was too deep for safe access and close examination could not be conducted.

Layer **7**, a dark brown clay loam, was recorded only in the central part of the access road, where it appeared to represent a thin subsoil layer below **2**. Nearby small features including possible post-holes **4** and **22**, and scoop **21** had removed the layer, assuming it to have been more than a restricted spread (Pl. 2). This concentration of features might in fact be the product of an uprooted bush or small tree, but it was observed that **21** was in line with a change in angle of the eastern hedge boundary, and this may have been a minor boundary ditch between fields. A single sherd of late fourth century Romano-British pottery was found in **7**. The sherd was part of a bowl, and was probably produced at kilns in the Trent Valley rather than the closer kiln sites at Swanpool (App. 2).

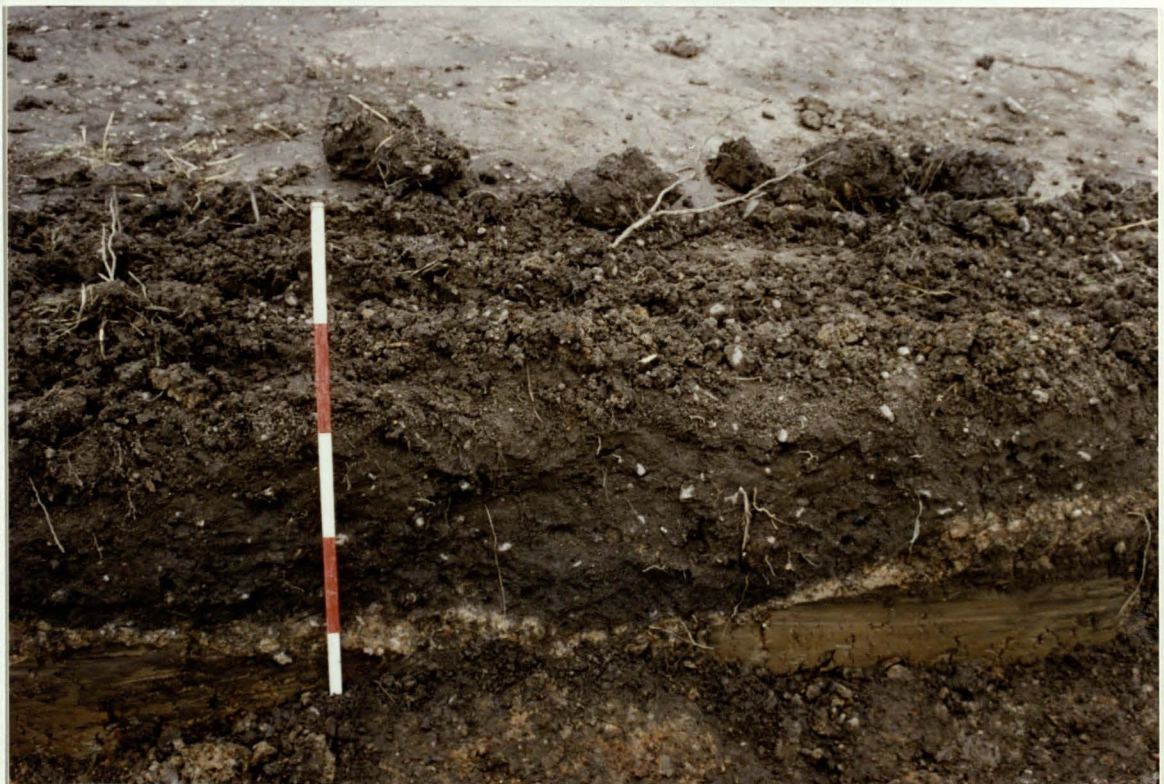
Pl. 2 Dark soil filling the depression at 21. Scale divisions 0.2m.

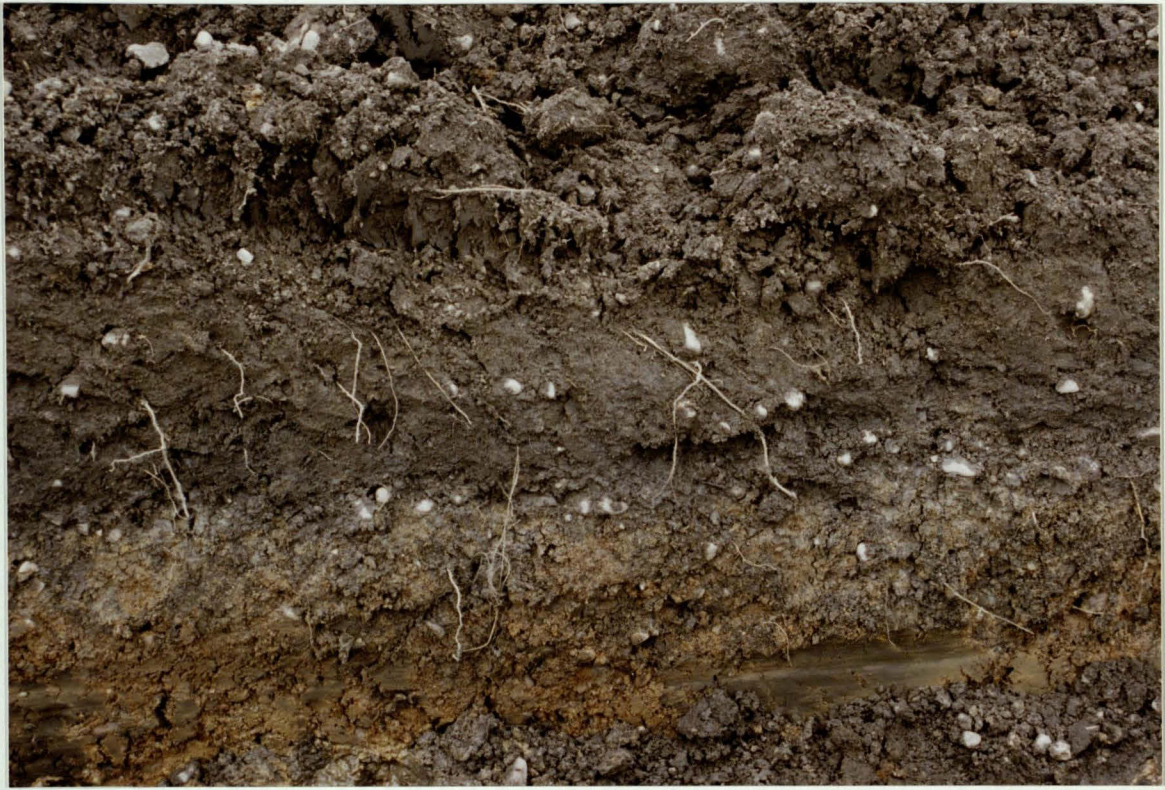
Pl. 3 Sequence of deposits at the southern end of the road trench. Topsoil overlies a thin weathered clay subsoil, above yellow clay with gravel.

At the southern end of the road trench, 2m north of the existing hedgeline, the topsoil **1** was 0.4m thick, reflecting soil build-up close to the boundary. A dark brown clay loam subsoil layer **2** beneath it was 0.2m thick above undisturbed natural of gravel and clay (Pl. 3).

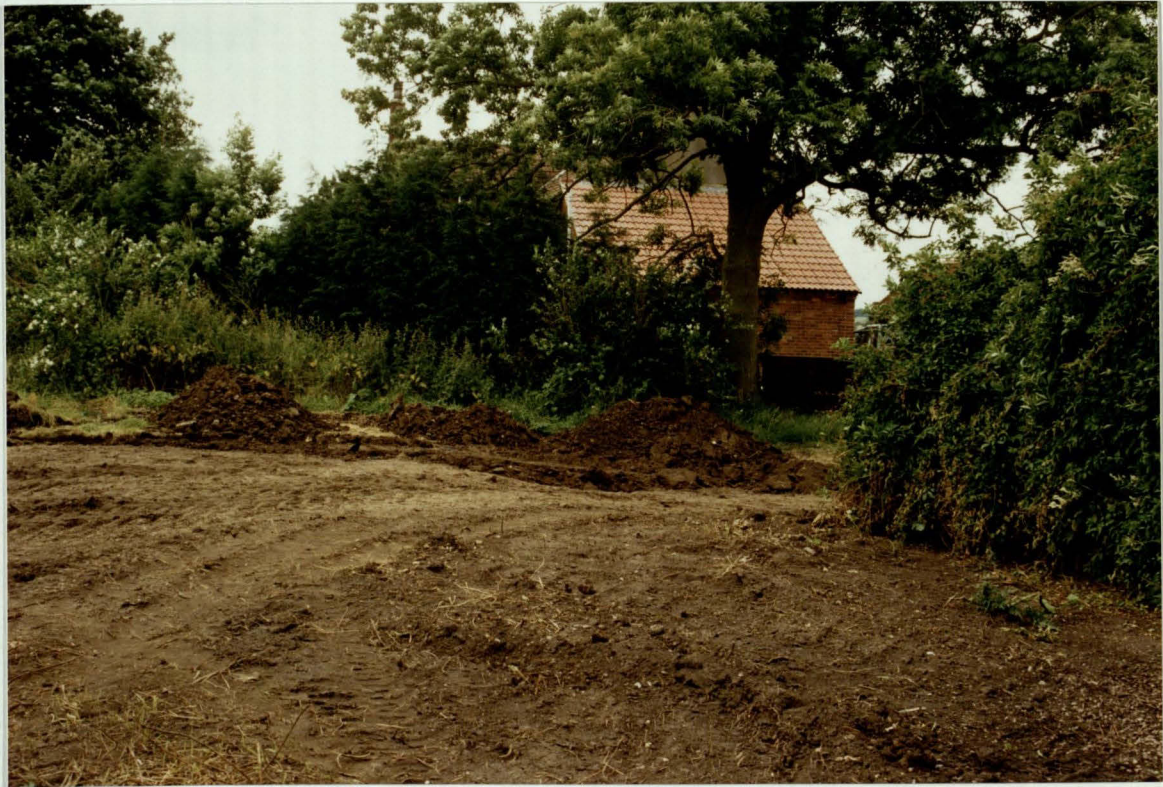
Pl. 4 The depression visible east of the lane to The Farm. The trench excavated for the new sewer is visible (looking south).

To the east of the lane leading to the farmhouse and farmyard, the new access road trench cut through a 0.7m thick topsoil layer **8** which sloped down towards the lane (Pls. 4-7). The deposit produced a single late-third or fourth century Roman sherd and two post-medieval sherds. The topsoil sealed the north-south aligned trench for a ceramic land drain **18**, presumably installed for drainage when a former roadside ditch was effectively levelled. The drain had cut through the western edge of a shallow ditch **15**, 2.8m wide and 1m deep. This was interpreted as a relatively modern recut of an earlier ditch.

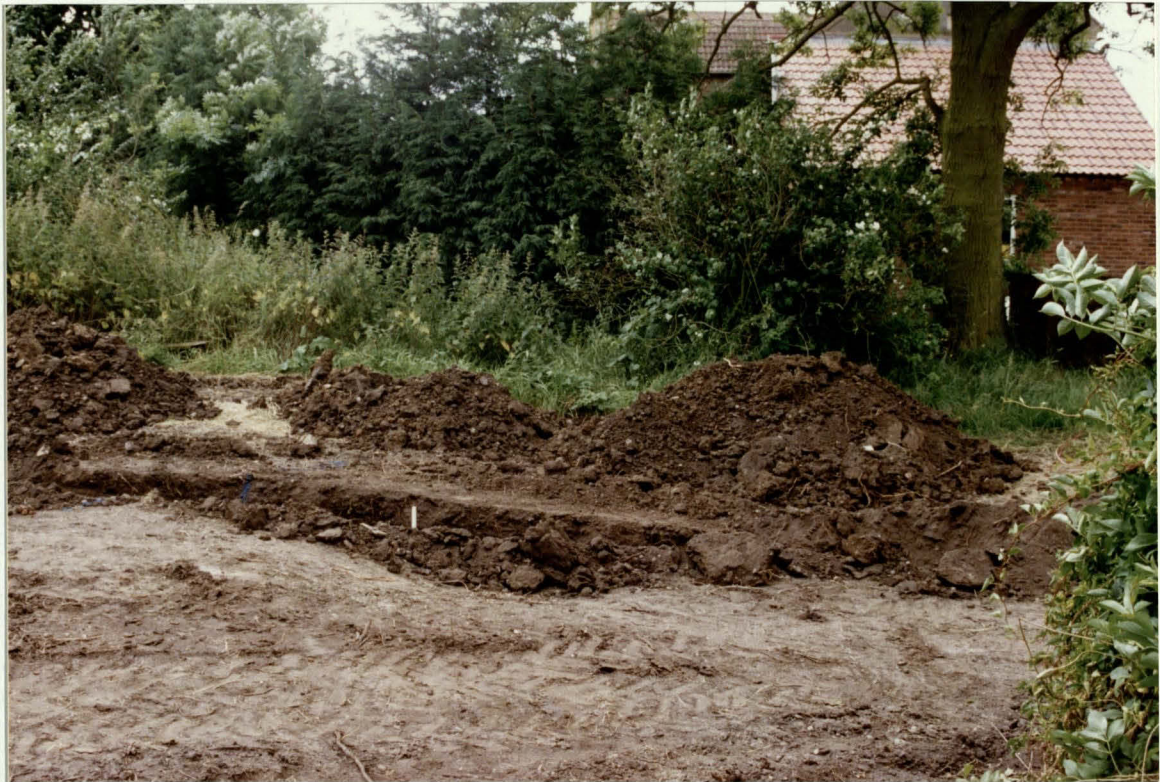
Pl. 5 The white upright marker (centre left) is at the eastern edge of the broad medieval ditch 23. Looking south.

The recut had removed part of a shallow fill **12**, a loose dark brown clay loam. This was probably produced by final silting of the earlier large ditch **23**. Beneath this fill was a compact mid-brown clay fill **11** (probably the same deposit as **13** but this could not be confirmed). A single sherd of fifteenth/sixteenth century pot was found in this deposit, the earliest identified fill of the large ditch. Its position 0.5m below the original ground level could be the result of much later levelling of a silted feature. No earlier fills were identified. Ditch **23** was at least 7m wide and over 1.5m deep, with a steeply

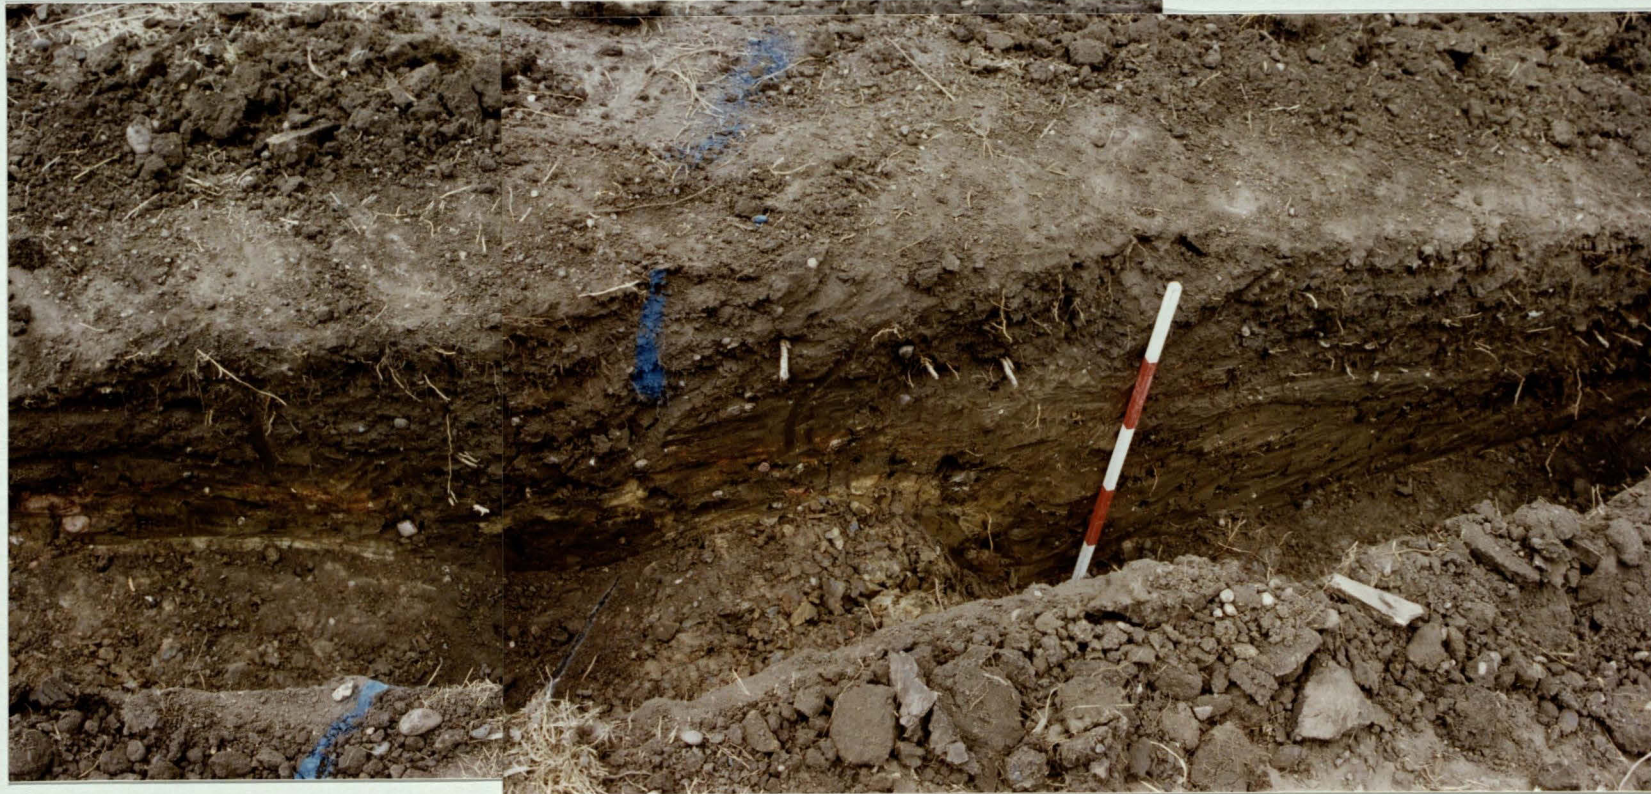
Pl. 6 Composite view of deposits visible in the trench face. The red/white 1m scale is at the eastern edge of ditch 23. Blue spray paint marks an existing service pipe trench cutting through the fired clay deposit 9. Looking south.

The ditch fill deposit **11** was apparently overlain by **9**, a small dump of fired clay on the eastern edge of the ditch (Pl. 6). The fired clay could have been redeposited from a feature of Roman or Saxon date but its position at the lip of ditch **23** indicates a more probable medieval or later date. If the clay dump seals fill **11**, then a post-medieval date is indicated. However, at this position, slumping of an exposed medieval heap on the ditch edge onto a later fill would have produced the same sequence. Clay dump **9** produced six pieces of fired clay, all are likely to be from the same object or structure. One piece is smoothed and probably formed an outer face, and another piece has a curved surface. There is no obvious temper incorporated into the clay and this indicates that it derived from an oven or hearth rather than a cob or wattle and daub building.

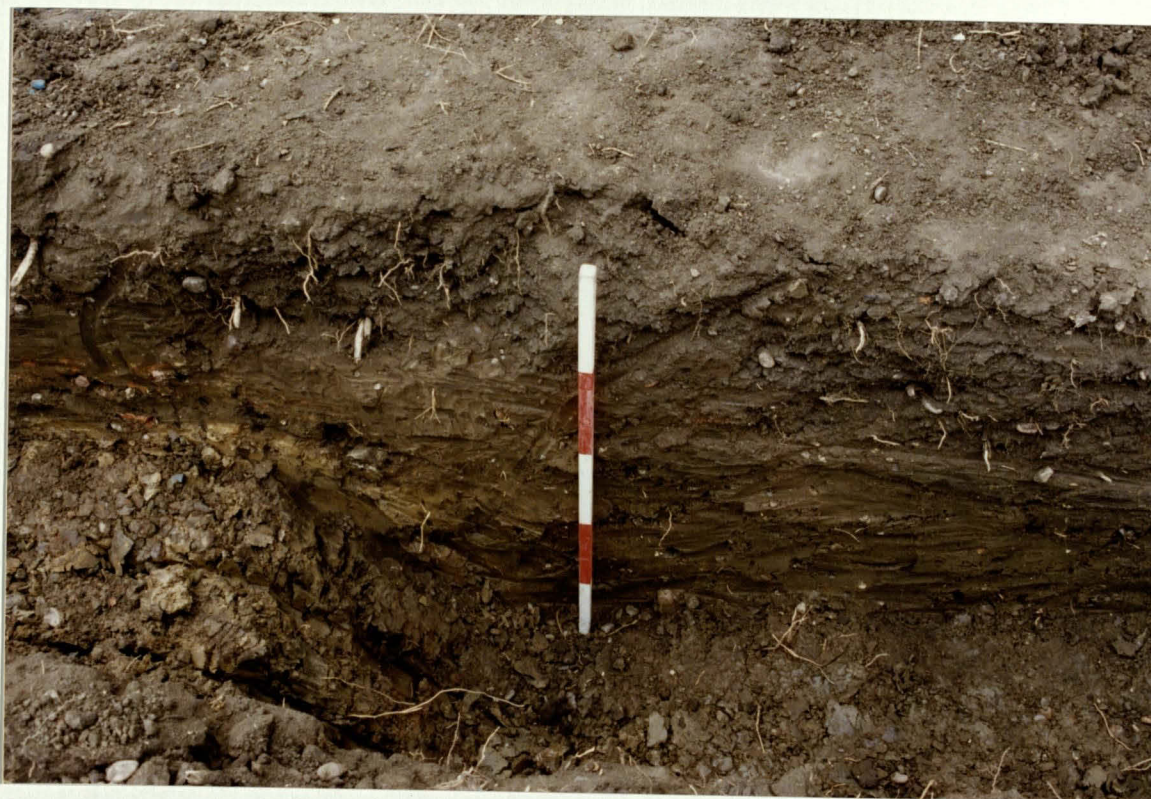
PI. 7 Detail of fill deposits at the eastern edge of ditch 23. Looking south, scale divisions 0.2m.
