© CLAU  
**BRAYFORD WHARF EAST FLATS,  
LINCOLN**  
ARCHAEOLOGICAL EVALUATION  
CLAU ARCHAEOLOGICAL REPORT NO: 358

**BRAYFORD WHARF EAST FLATS,  
LINCOLN**

**ARCHAEOLOGICAL EVALUATION**

CLAU ARCHAEOLOGICAL REPORT NO: 358

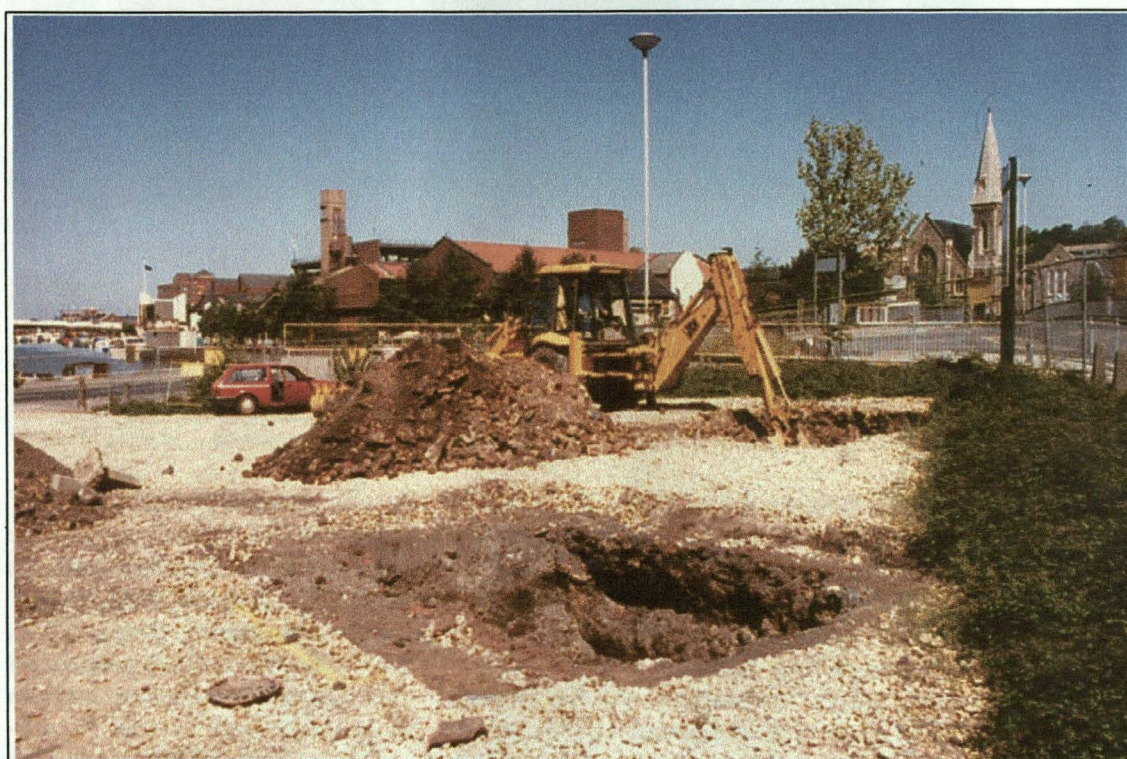
Plate 1: General view of the site looking west north-west showing the machine excavation of Trench 2 (Trench 1 can be seen in the foreground).

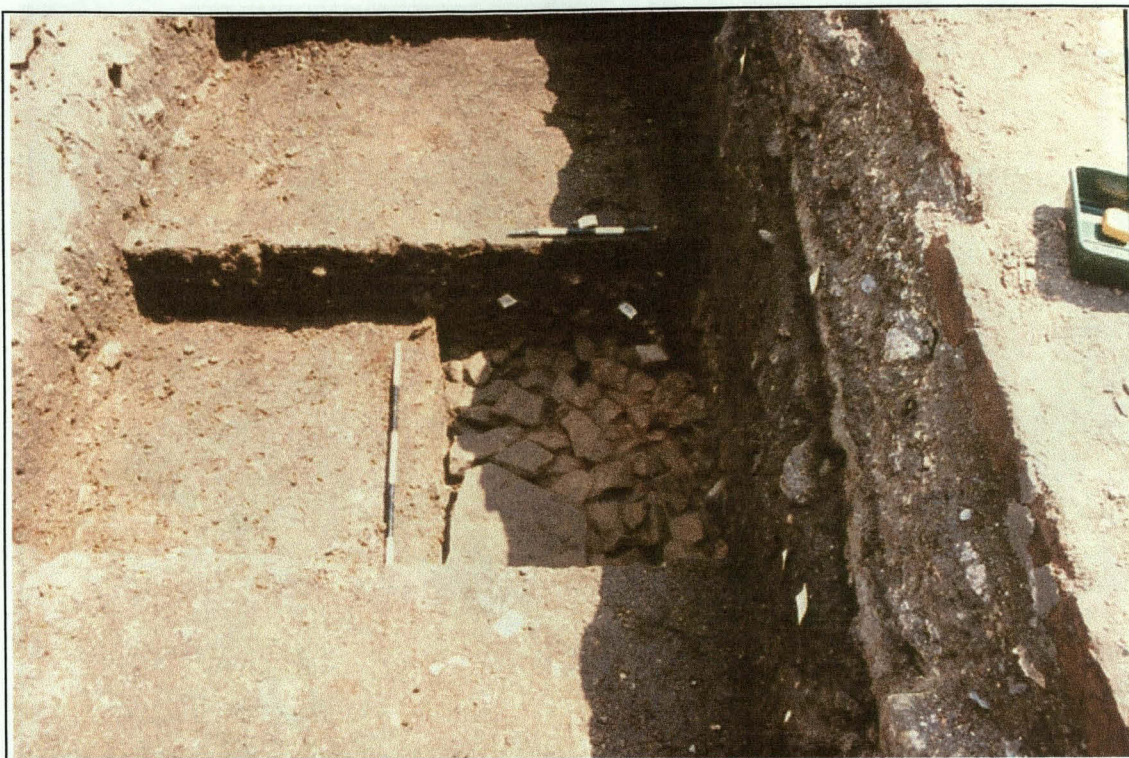
Plate II: Trench 1, looking east along the line of wall/foundation [025] (scales are 0.5m & 1.0m).

### Trench 1 (Figs. 3 & 6, Plate II)

Trench 1 lay towards the south-east corner of the site and measured c. 2m N/S x c. 4m E/W. Excavation to a depth of 1.2m was carried out by machine and thereafter continued by hand.

The earliest deposit recorded here, was [063], a mottled clayey silt layer, sloping gently down towards the north north-west (4.37m OD). A similarly sloping but dark ash/charcoal deposit, [062], overlay the aforementioned [063]. Pottery recovered from [062] indicates a 13<sup>th</sup> century date. Two further deposits, [035] and [022] (5.06m OD), appeared to raise and level the then existing ground surface (E13<sup>th</sup> century pottery and within [035] a crucible fragment and slag). East-west stone wall foundations, [025] (1m+ wide), had cut into deposit [022]. Although not fully investigated, [025] was recorded as consisting of at least three courses of unbound limestone of varying dimensions (200mm<sup>3</sup> - 1m x 0.50m x 0.30m). The plan and function of this building cannot be determined, but it probably dates to the E13<sup>th</sup> century or soon after based on pottery recovered from its fabric. No evidence for associated occupation deposits was found on the north side of the wall, suggesting that associated floors and occupation deposits may have lain to its south, outside the evaluation trench. A shallow robber trench, [061], had removed evidence for the upper elements of [025]. An extensive deposit (up to 700mm thick) of silty earth, [002] (top - 5.70m OD), sealed the robber trench and other exposed deposits (provisional dating indicates a 15<sup>th</sup>-16<sup>th</sup> century date). Deposits sealing [002] were associated with the construction and use of the area during the 1800's and later (ground level - 6.18m OD).

A stone wall, probably part of a building lay towards the south-eastern corner of the site (Trench 1). Evidence suggests that this structure was erected during the early/early-mid 13<sup>th</sup> century and was subsequently demolished sometime in the late medieval period (15<sup>th</sup> century). A number of iron blade fragments, stone hones and pottery indicating a high status ownership, were found in deposits associated with, or in close proximity too, this structure.

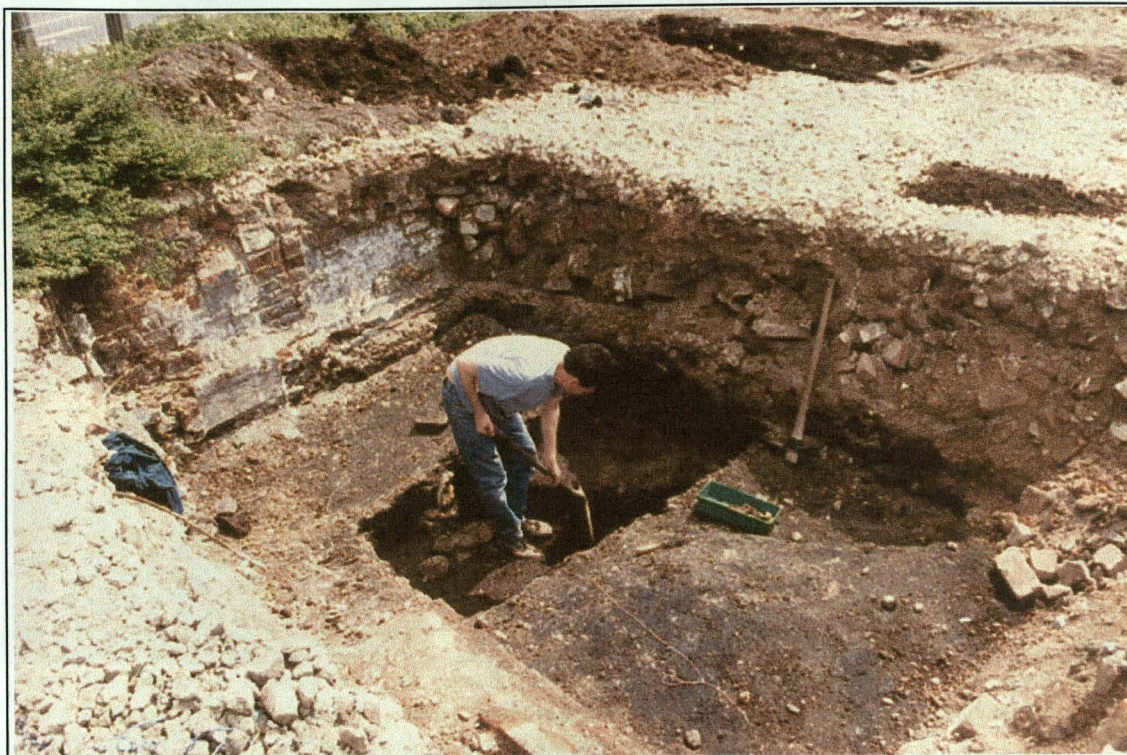
Plate III: Trench 2, general view of trench excavation looking south-east. Note the recent accumulation of demolition material visible in the trench sections (this material was derived from Hercock's Banana Warehouse).

### Trench 2 (Figs. 4 & 6, Plate III)

Trench 2 was located to the north and west of Trench 1. Measuring 4m E/W x 3m N/S, Trench 2 was initially excavated mechanically to a depth of 1.2m. The excavation of a 1.2m wide central slot in the base of the trench was then performed by hand.

Here, the earliest deposit encountered was [079], a mid-dark greyish brown silt deposit containing frequent oyster shell and charcoal flecks (this deposit was not excavated). Sealing [079] were three further silty dump deposit ([028], [031-033]), and all containing similar types of material (animal

bone, L14<sup>th</sup> century pottery and shell fragments). A north-south linear cut, [030], whose base indicated a gradual northerly descent (4.88m OD - 4.74m OD), truncated the latest of these dumps. The fill of the feature, [029] (4.97m OD), a mid-brown sandy/silt did not assist with its interpretation: pottery from the fill was also L14<sup>th</sup>-L15<sup>th</sup> century in date. Remaining deposits and features in Trench 2 were generally associated with the Hercock's warehouse use of the site (5.04m OD) and its recent demolition (existing ground level - c. 6.16m OD).

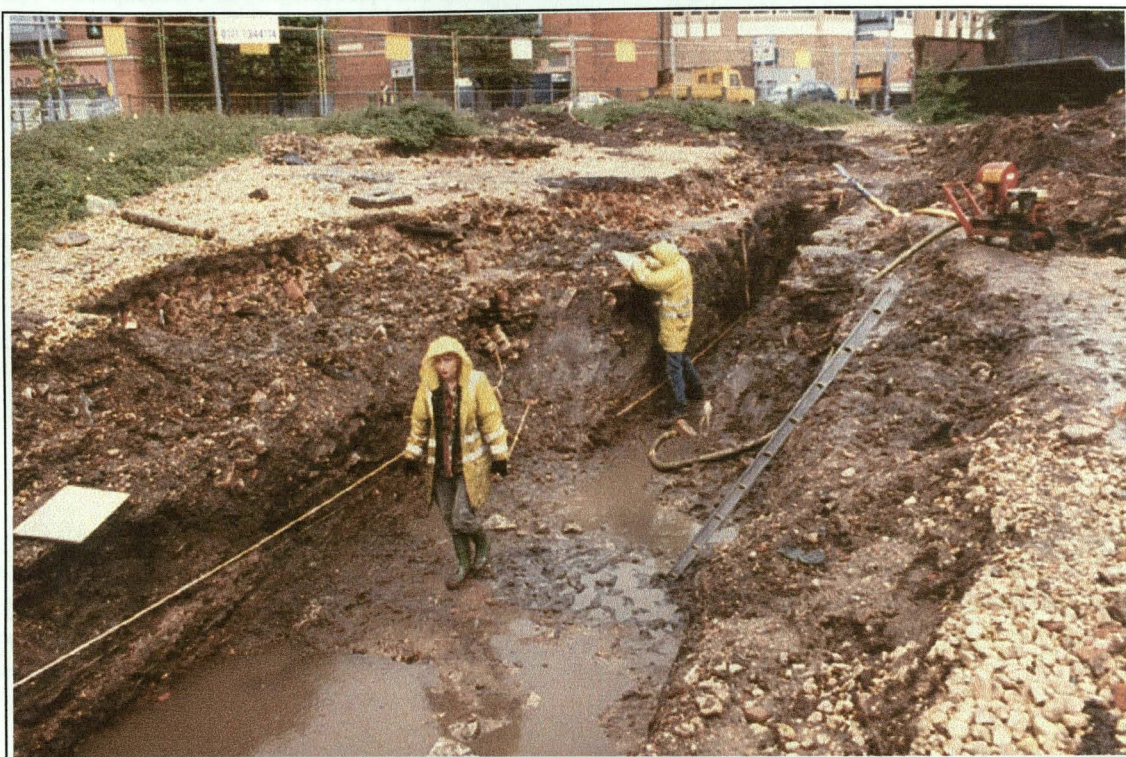
Plate IV: Trench 3, looking east south-east. As the base of the trench lay below water level, water was a constant problem (note the pump). Reclamation deposits, dipping towards Brayford Pool, can clearly be seen in the lower left-hand corner of the photograph.

#### Trench 3 (Figs. 5 & 6, Plate IV)

Trench 3, the largest of the evaluation trenches, was located towards the west side of the site. It was aligned WNW-ESE and measured 7m E/W x 3.2m N/S, being machine excavated to a depth of 1.20m. After discussions between the client, the City Archaeology Officer and the CLAU, it was decided to extend the trench further with the machine excavation of a narrow slot, eastwards, midway along its east side. This extension was c. 8m long and 800mm wide, and was excavated to a depth of approximately 1.2m. The excavation of an investigative sondage in the base of the trench (at its eastern end) was carried out by hand.

The earliest phase of reclamation occurred at c. 5.04m OD, descending towards the north-west to c. 4.40m OD. It consisted of extensive clayey/silty soil dumps, containing frequent small angular limestones, fragments of pot, bone and tile as well as shell and charcoal flecks. Interpretation of the finds suggests that it was deposited at some time during the 12<sup>th</sup>-13<sup>th</sup> centuries.

The second reclamation event lay several metres further to the south-east than the earlier, and again sloped down towards the west (4.80m OD - 4.20m OD). Their make-up consisted of alternating

deposits of dark grey/brown silty soils overlying relatively clean deposits of coarse light yellow sand - with frequent pot, bone and tile fragments within them. Pottery and tile recovered from these deposits indicate a L14<sup>th</sup>-L15<sup>th</sup> century date for their deposition.

A third period of reclamation, lying c. 3m further to the west, sealed the latter, and similarly, this event consisted of interleaved bands of sand and silt (4.80m OD - 4.40m OD). Unlike the former, this event did not appear to slope obviously towards the west and may suggest that it had a ground levelling as well as a reclamation function. Discussions with the environmental specialist concluded that in order to maintain their non-commingled nature, these deposits were probably sealed soon after their deposition. The assemblage of pottery recovered from this phase of reclamation/levelling indicates a date range between the 15<sup>th</sup> and 16<sup>th</sup> centuries.
