**Land off Meadow Lane,
North Cockerington, Lincolnshire**

Archaeological Watching Brief

LAS Report No. 322

November 1998

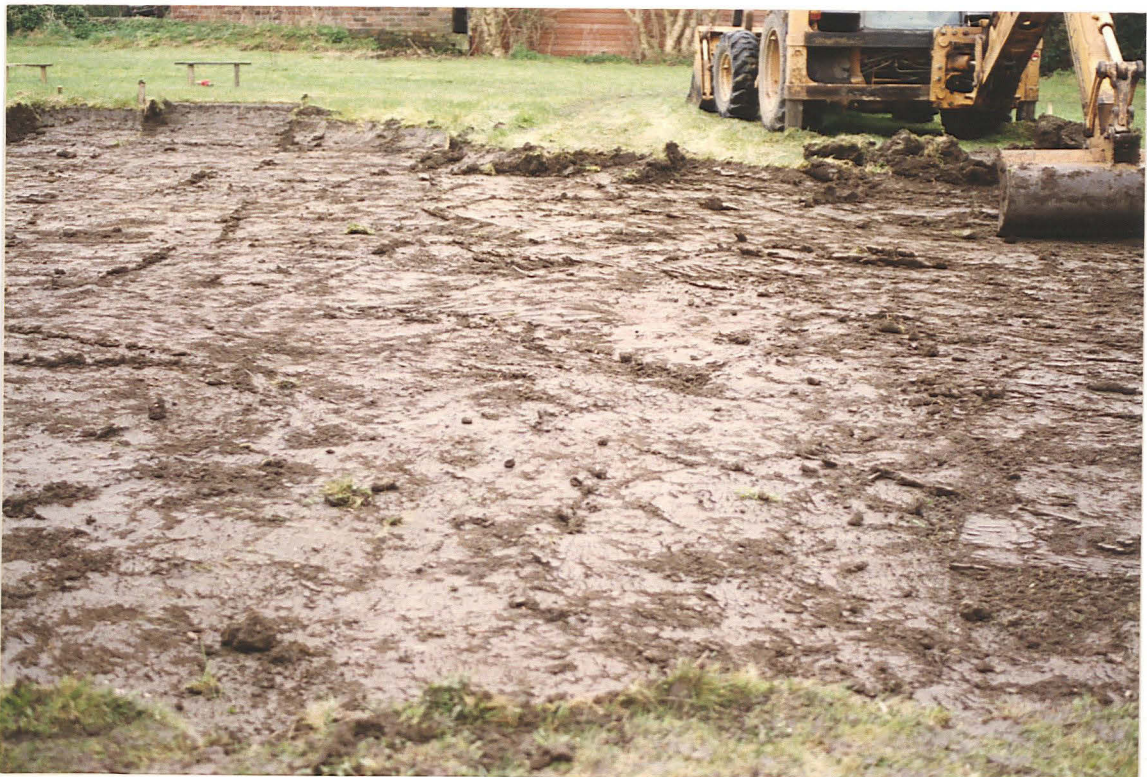
The house and the attendant garage were stripped of turf using a 1.6m toothless ditching bucket, and in most of the area the stripping did not extend below the topsoil (Pl. 2). The stripped surface was inspected but no features or artefacts were observed.

Pl. 2 Area of topsoil stripping looking north west.

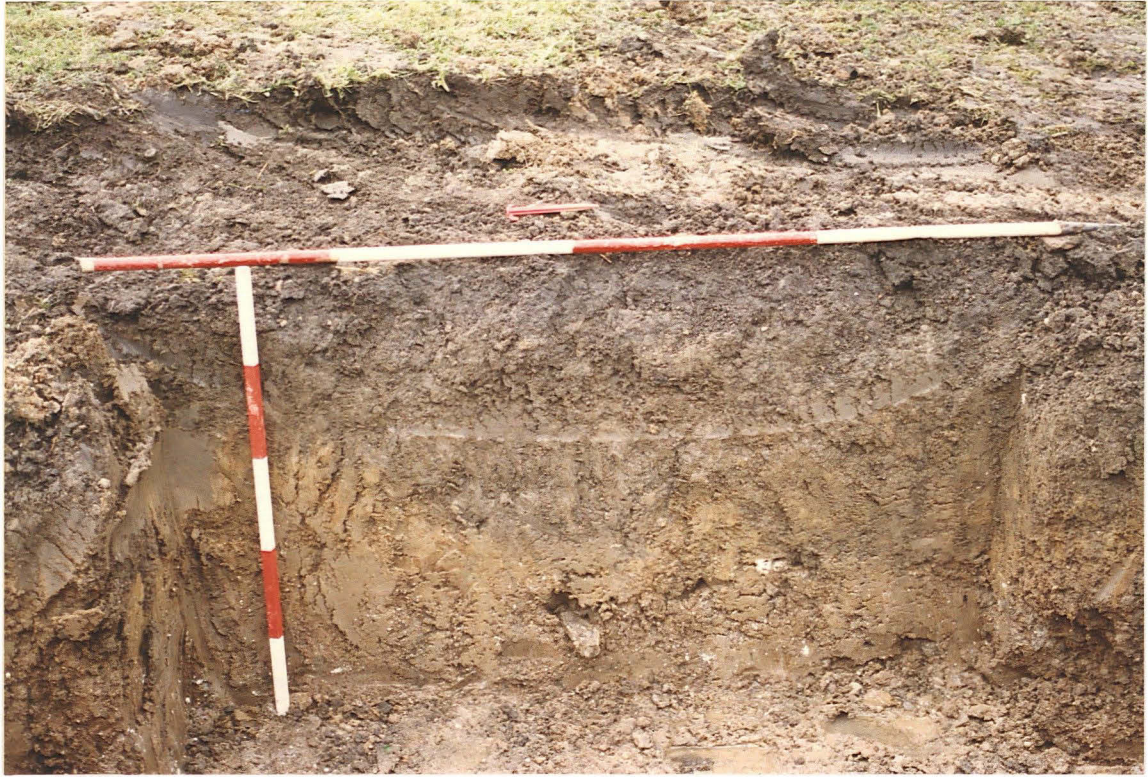
examine the spoil removed from the foundation trenches. Also due to the weather the trenches rapidly became flooded making the bases of features difficult to see (Pl. 3).

Two ditches were observed during the excavation of the foundations, the first of which, **104**, ran north-east south-west across the site (Fig.4a). It was approximately 1m wide and 0.40m, the fill was a brown grey clay **103** with flecks of charcoal present through out the fill. It ran across the site where it was truncated by the pit **102** at the eastern end (Pl. 4 and 5). **104** was truncated at the western part by a small pit **111** which contained a grey brown clay.

Pl. 3 Looking west showing ditch (104) truncated by pit (102)

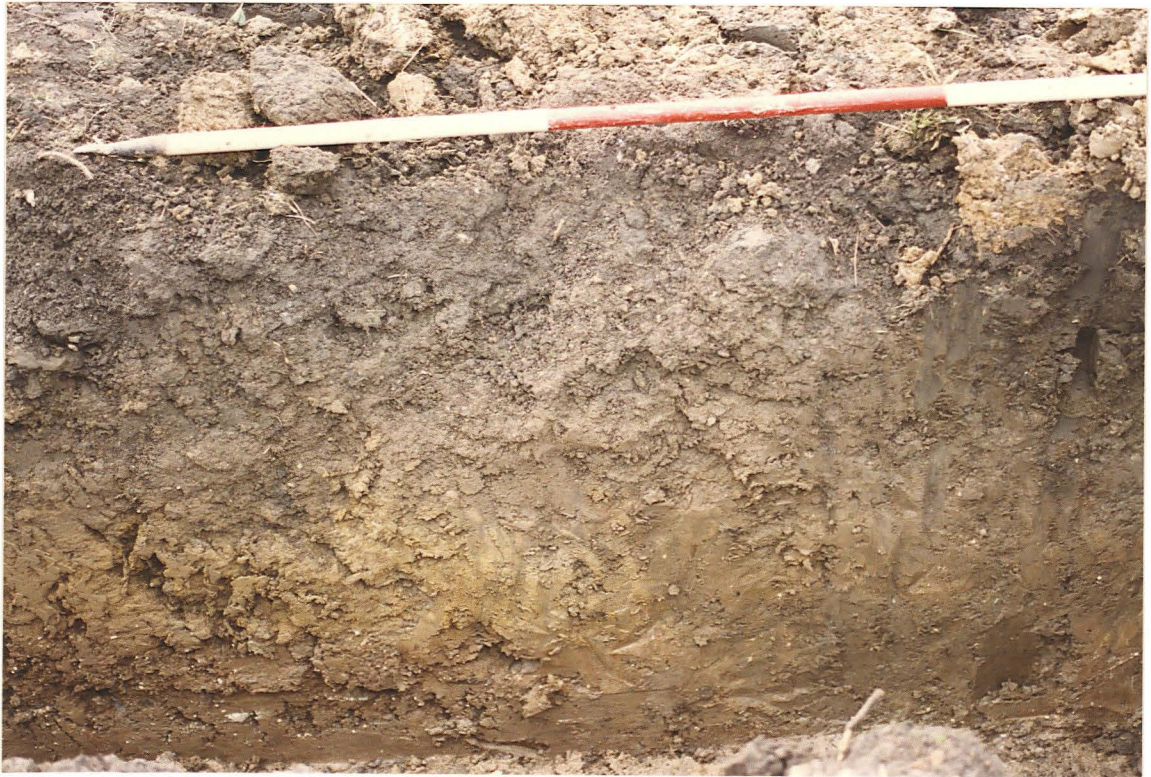
A second ditch **105** (Pl. 5) ran in a west-east direction in the western corner of the foundations (Fig. 4b). It was difficult to see the full profile of the features as it was oblique to all the sections it was observed in. The ditch contained a brown/grey clay **106** but no artefacts were found.

Pl. 4 Looking west showing ditch (105)

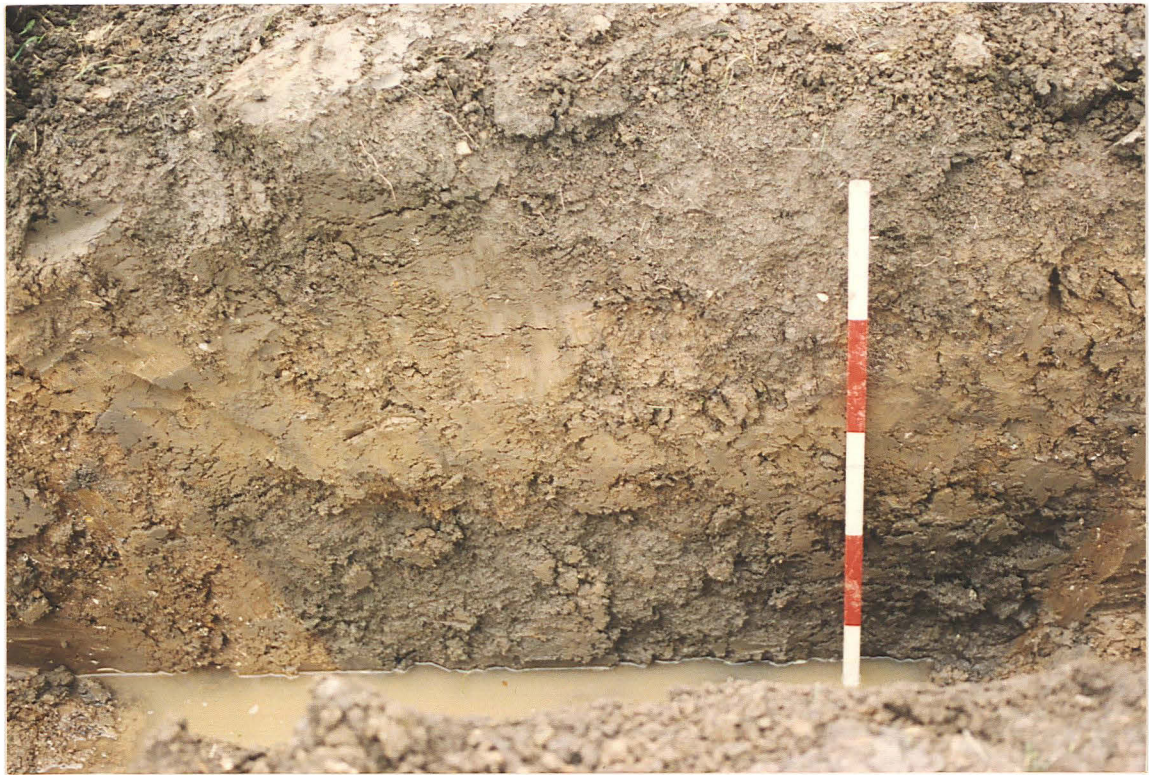
A pit **111** was discovered in south-west corner of the site. It was approximately 1.60m wide and 1.2m deep with rounded sides and contained a grey brown clay **113** overlain by a redeposit a natural orange clay **112** (Pl. 6). This pit was observed in both sides of the trench but did not extend to the foundation trenches further north.

Pl. 5 Looking south showing pit (111)

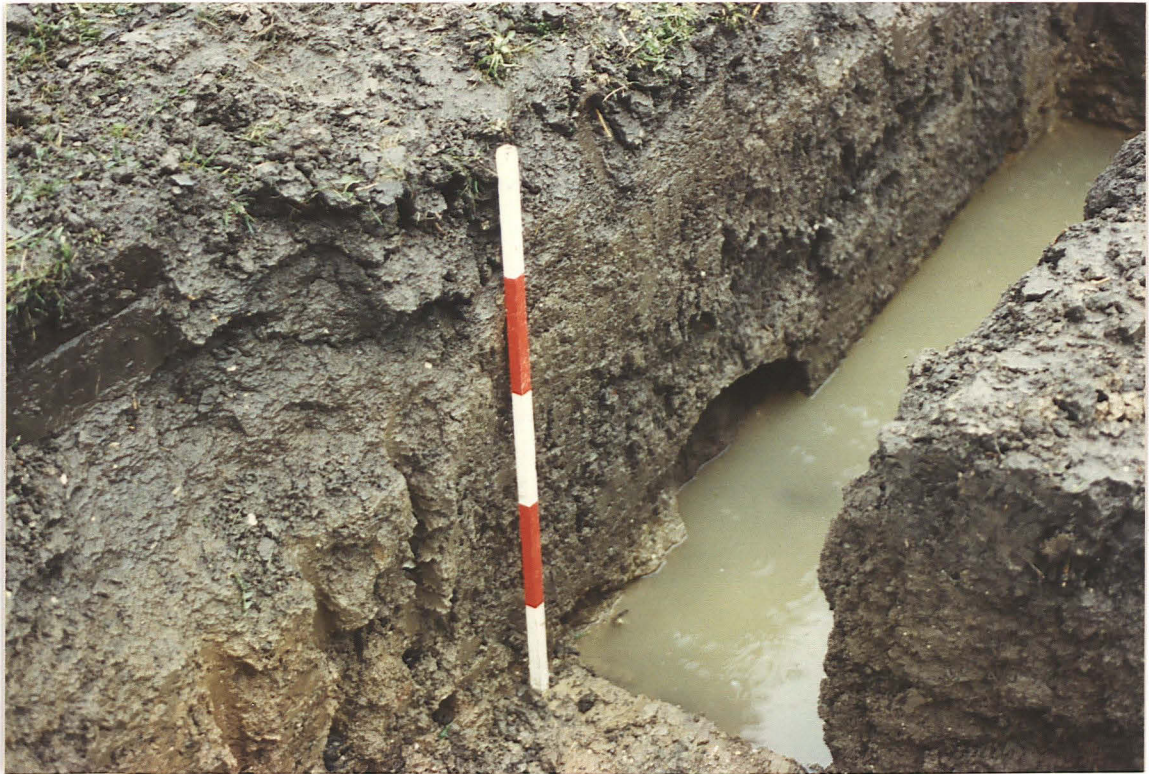
A large pit **114** or backfilled depression was located in the eastern part of the site which was at least 7 by 8m and extended to a depth of 1.20m. It was filled with a dark brown clay silt **115**, the surface of which contained some fragments of brick and may represent a levelling deposit.

Pl. 6 Looking south showing pit (114)

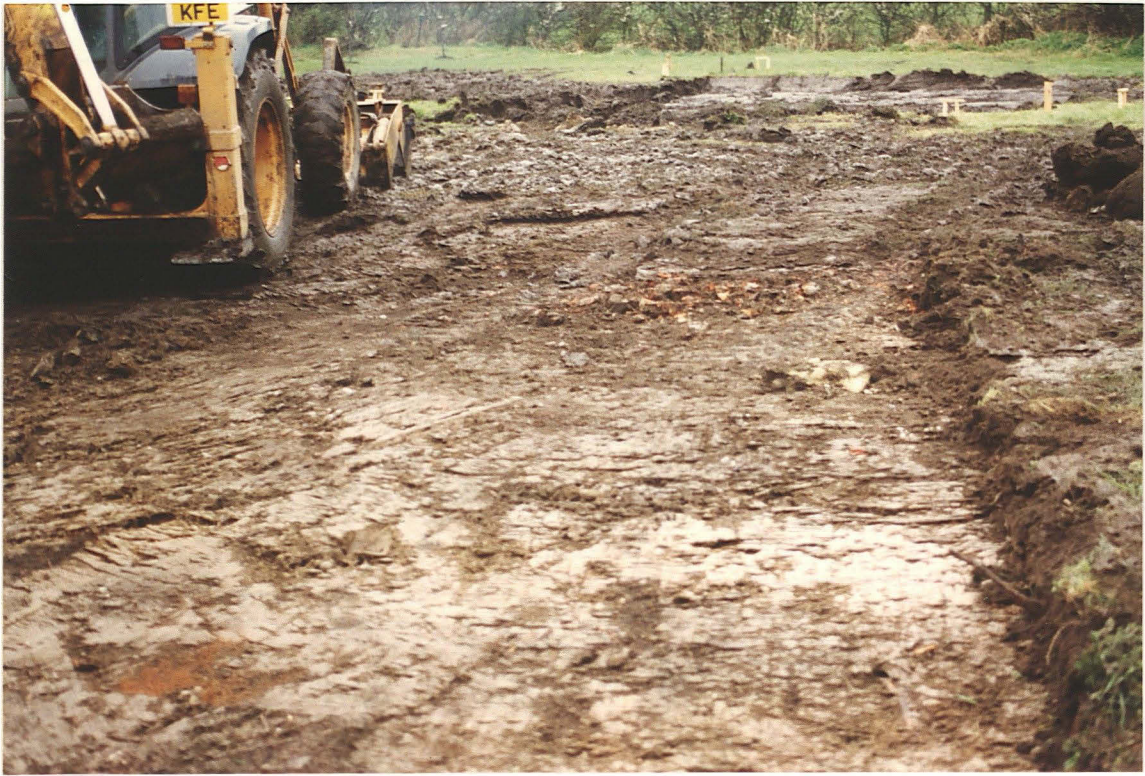
An area from the main road to the garage was stripped for the creation of an access road. Here turf was removed but over most of the area excavation did not penetrate the topsoil, and no features or artefacts were recovered from this operation.

PI. 7 Area Stripped for access road

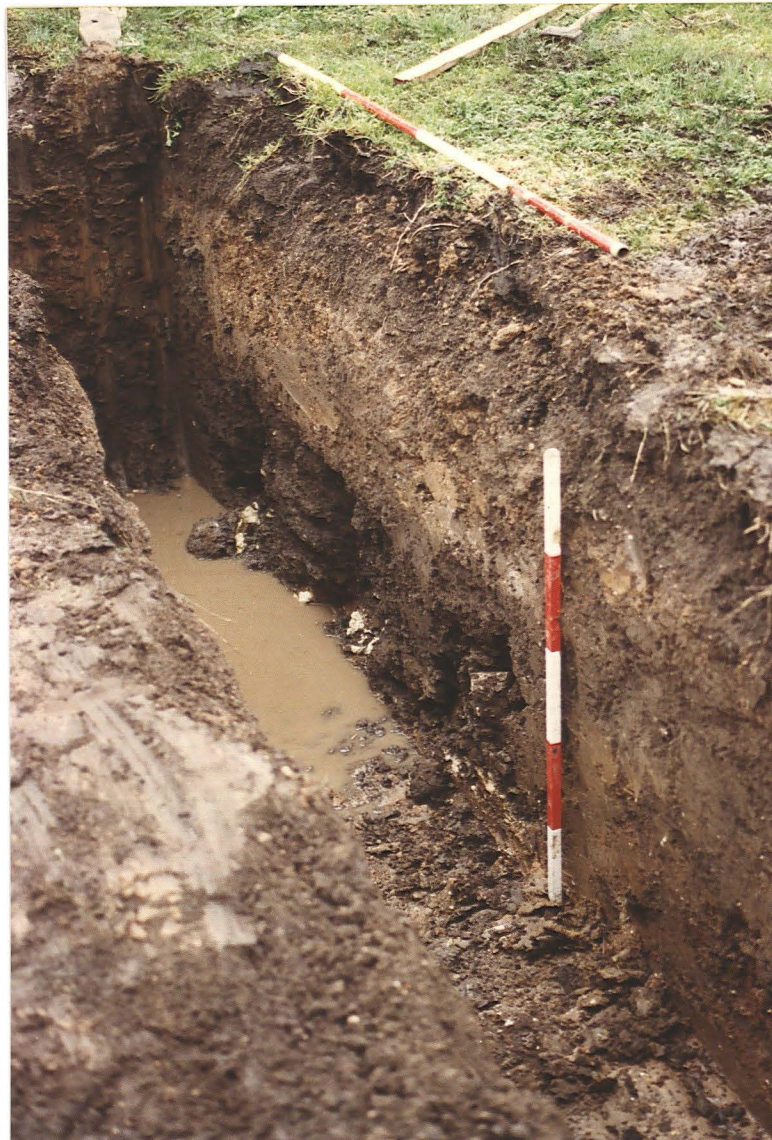
The foundations were excavated with a 0.75m toothed bucket to a depth of between 1m and 1.2m. Only one feature was revealed during this operation. This was a large pit whose visible extent was 2.5m wide and 1.2m deep. It was filled with a deposit of dark grey brown material. At its base was a layer of coarse blocks of limestone 0.10-0.20m maximum dimension.

PI. 8 Looking north showing pit (108)
