Horncastle, Banovallum Gardens:

Residential Development: Plots 54 and 55
Archaeological Watching Brief

Site Code **HBG 98**

LAS Report No. 316

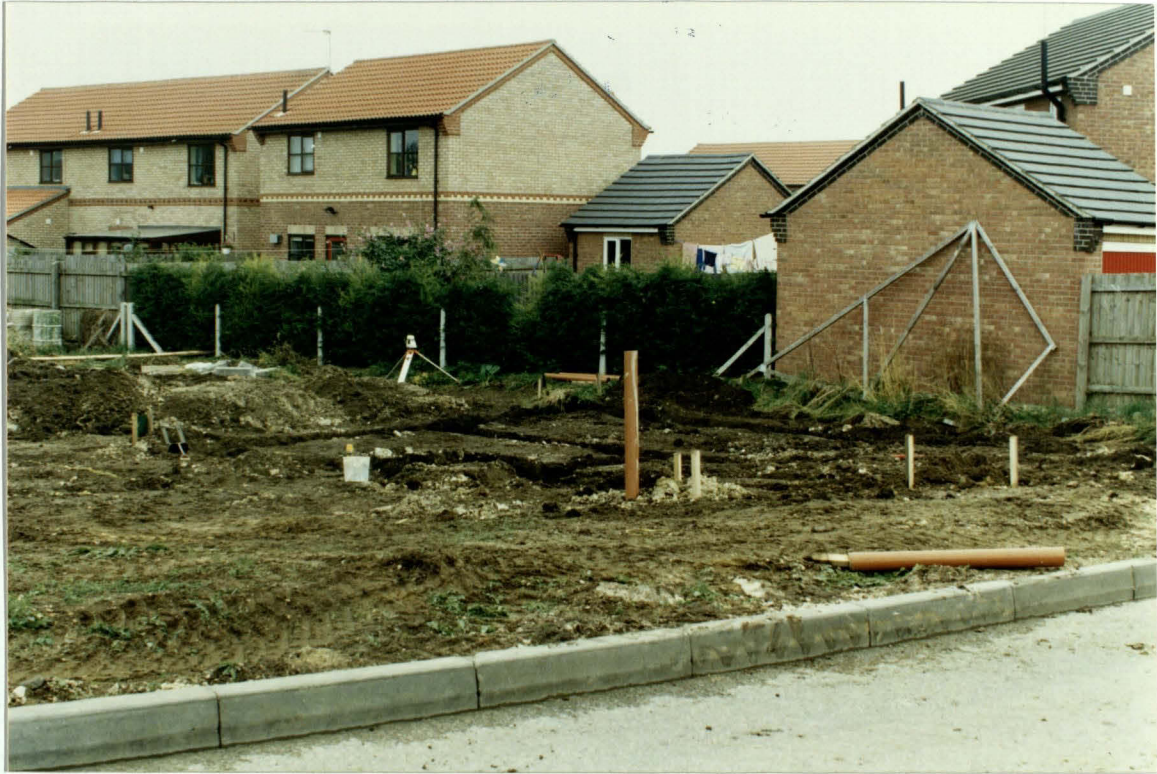
PI. 1 Position of Plot 54, Banovallum Gardens (looking east).

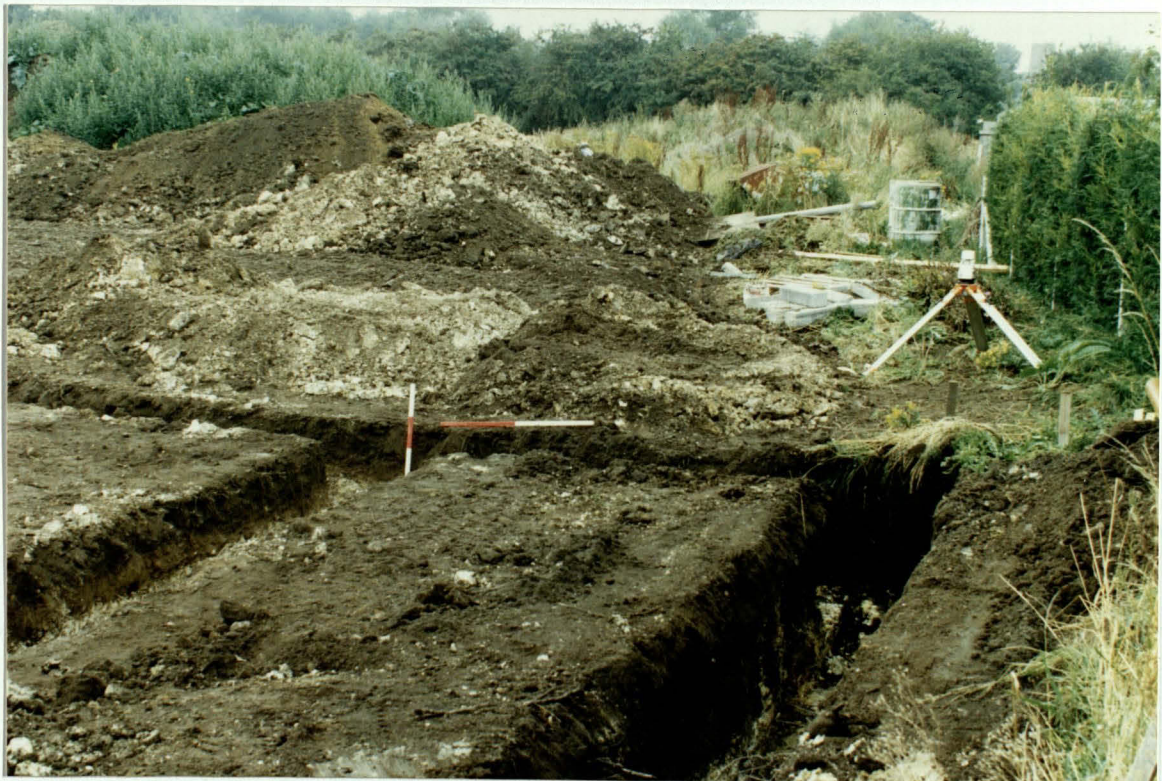
From the monitoring, a large SE-NW aligned ditch 6 was found to cross the eastern side of this plot (Pl. 2). From the sequence of fill deposits it appears that the ditch was dug to about 32.85m OD. and an original width of about 1.8m; although the edge of the feature is visible to 0.4m higher up, modern

disturbances have truncated it and the ground surface from which it was dug is not known. A light brown subsoil layer **2** sealed the ditch; Ditch **33** was also sealed by that layer. No evidence of re-cutting of this ditch was found, despite the broad width and flat base. Most of the surviving east side was filled with a chalky silt **11** which spread across half of the ditch base, and this appeared to be a natural slump of upcast material (the bank) on the eastern edge. On the western side, early silting by **12** had been succeeded by lenses of silt **7** which had entered from the west (Pl. 3). The grey coloration of most of these deposits was probably indicative of waterlogging while organic matter such as vegetation decomposed.

PI. 2 NE corner of Plot 54, looking north along the line of Ditch 6 (marked by the red/white scales) to the far hedge beside Thunker Drain.

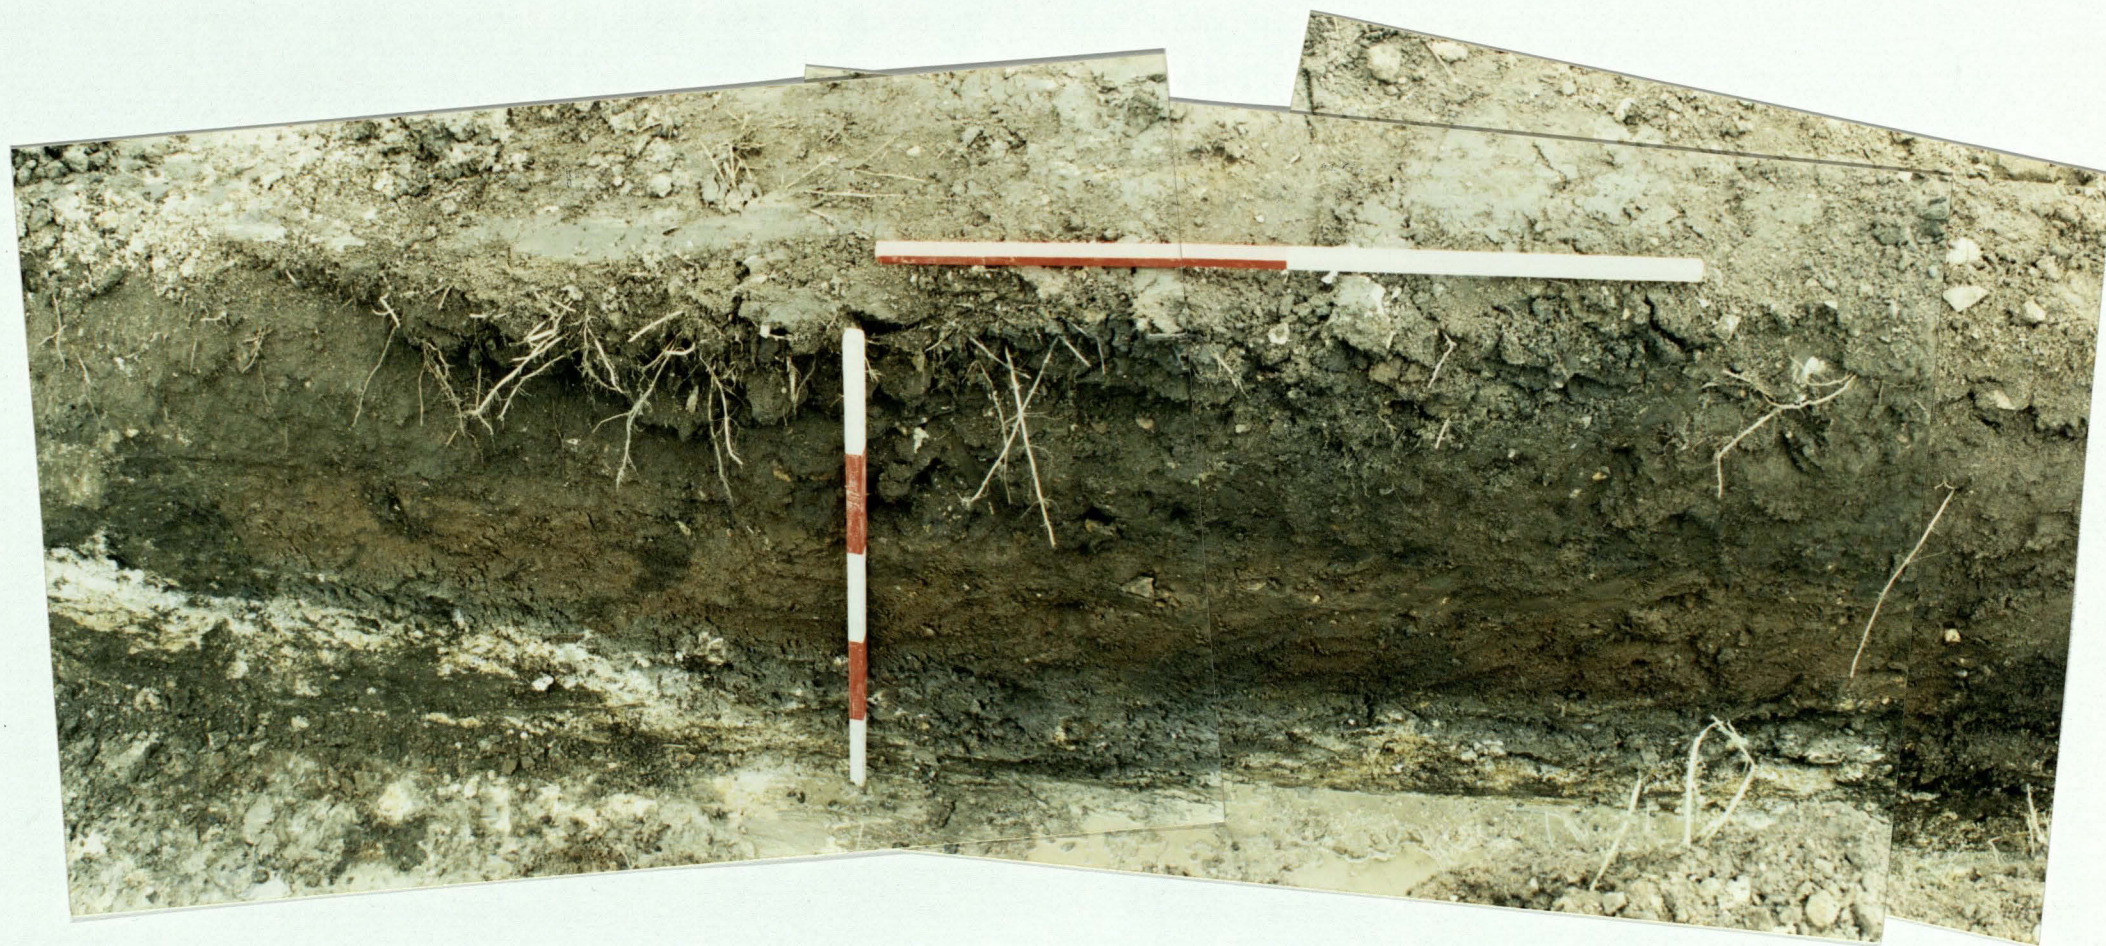
In addition to Ditch **6**, two other features were identified in the foundation trenches for Plot **54** (Pl. 4). Both of these pits were cut into the chalk bedrock, although chalk extraction seems an unlikely function. Pit **4** was the deeper, cut from above 33m OD and at least 0.3m deep. Its width was over 2m, sloping downwards to a narrow point. Pit **8** was positioned immediately to the south with its base at 32.9m OD and its highest surviving fill at 33.2m OD. The base was rounded, sloping more gently towards the south. The single fills, **5** and **9** respectively, were both grey sands.

Any relationship between pits **4** and **8** has been lost, probably during a cultivation phase responsible for producing soil layer **3** (which may equate with layer **2**). A single fragment of brick retrieved from **3** has been dated as post-medieval, probably eighteenth century.

PI. 4 Composite view of pits 4 and 8. Looking SE, scales 1m.

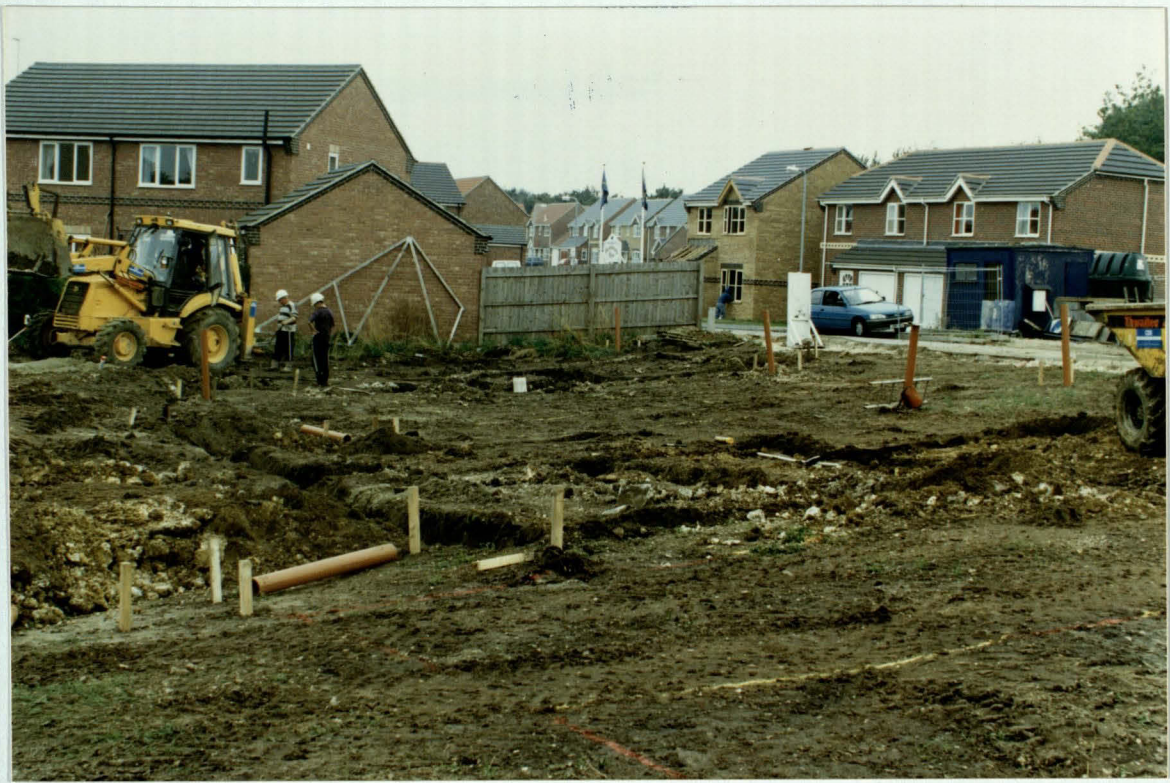
PI. 5 Foundation trenches for Plot 5^S (foreground) and Plot 54 (by machine). Looking south.

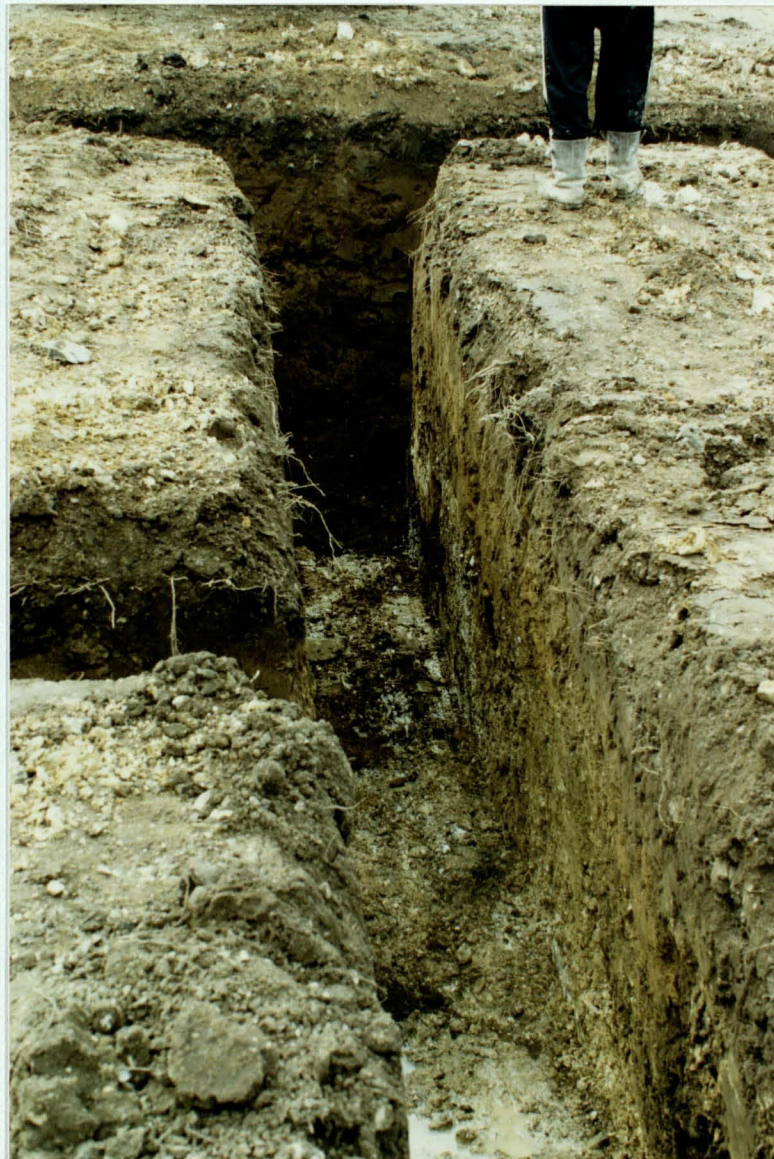
A curving channel or ditch **15** crossed the NE corner of the foundations for this house plot. The base of this 1.25m wide feature, cut into chalk bedrock, was 1.5m below existing ground level. The fill was a very mixed chalk and clay and appeared to have been naturally deposited (Pl. 6). It was overlain by

the subsoil deposit **2**. The feature was tentatively identified as a natural watercourse.

PI. 6 Mixed yellow clay fill of 15 visible in trench sides (right foreground), cutting the chalk bedrock. Looking north.

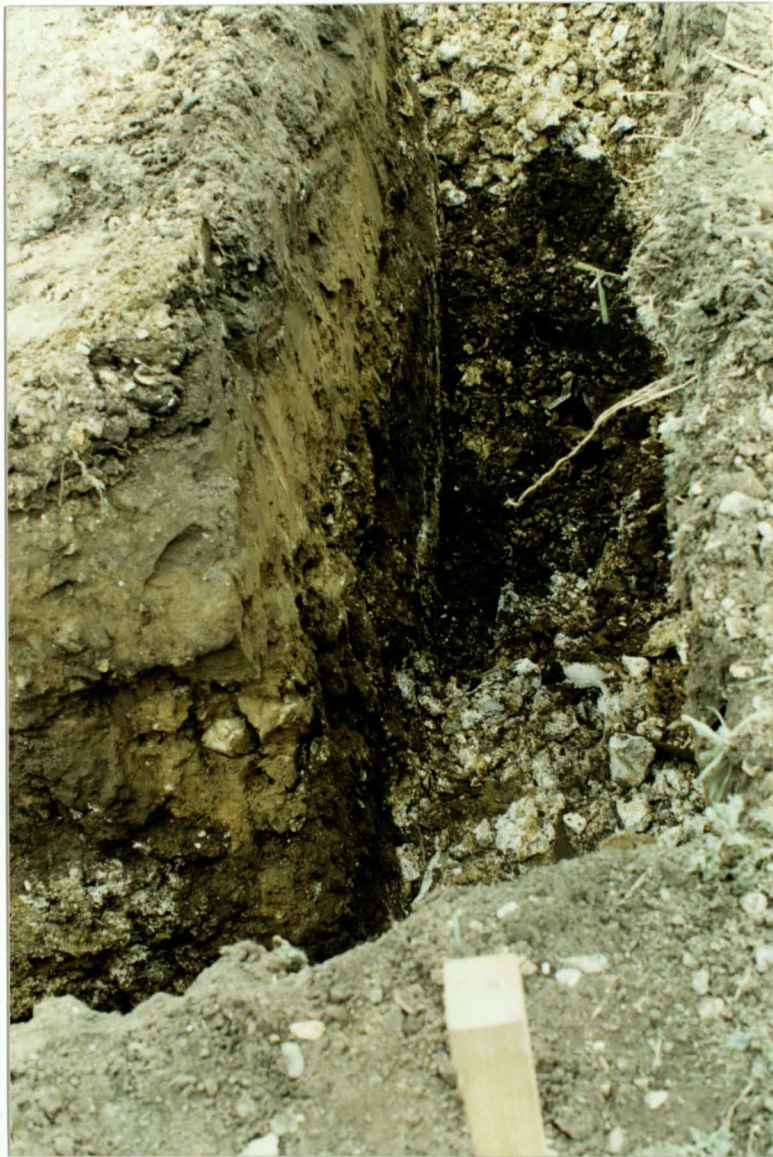
Slightly to the west of **15** was a much wider feature, apparently aligned NE-SW. Its maximum width was about 3.75m and its depth 1.35m. The upper material had been disturbed and it was difficult to determine whether this was a natural or archaeological feature (Pl. 7). The mix of chalk rubble, clay and peat suggested a natural feature such as a stream channel subsequently deliberately filled, but the straight alignment may indicate a deep boundary feature. Instability of the trench sides and the loose feature fills prevented close investigation of these features.

PI. 7 Very mixed fill of possible stream channel 17, seen in corner of foundation trenches (left). Looking north.

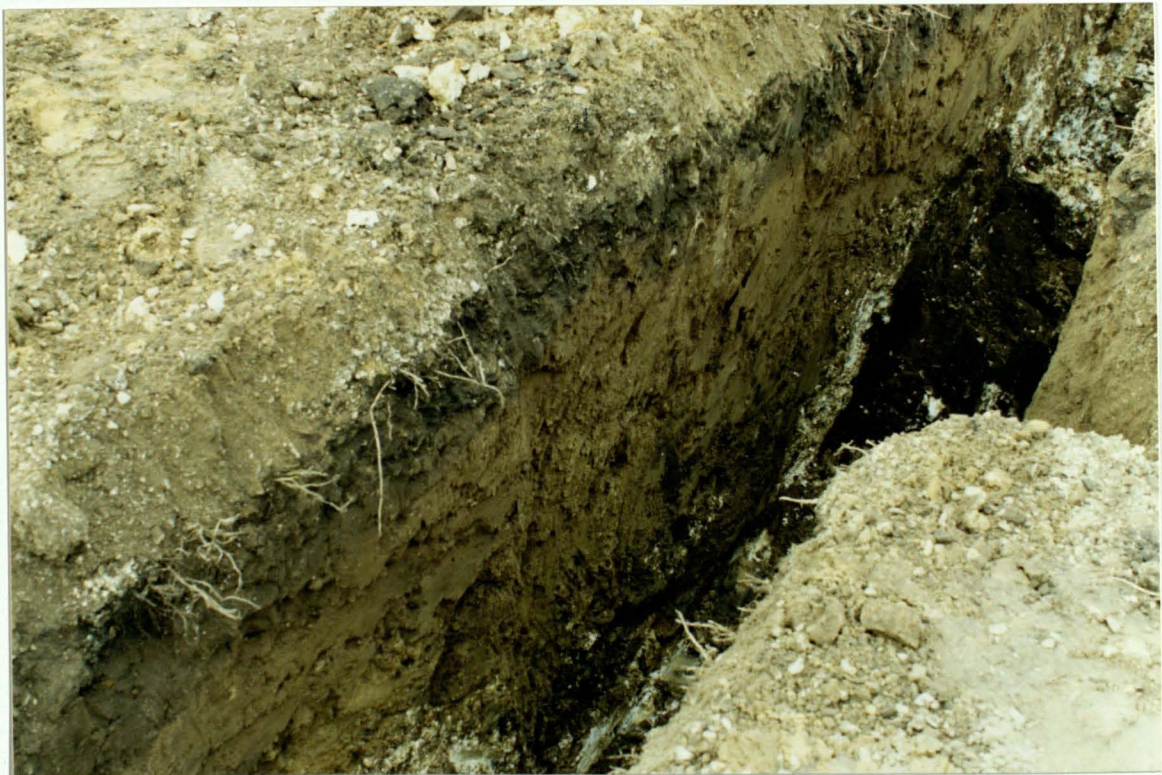
The only probable archaeological feature within these foundation trenches was **19**, seen in the western trench (Pl. 8). The base of this 1.5m wide pit was over 1.5m below the modern ground surface, and its light brown sandy loam fill was sealed by **2**. No finds were seen.

PI. 8 Pit 19 seen in west edge of foundation trenches for Plot 5^S, cut into chalk bedrock. Looking north.
