**LAND AT CHURCH VIEW, ALL SAINTS
LANE, NETTLEHAM, LINCS.**

ARCHAEOLOGICAL WATCHING BRIEF

CLAU ARCHAEOLOGICAL REPORT NO: 363

A
Report to
Wheatley Construction Ltd.

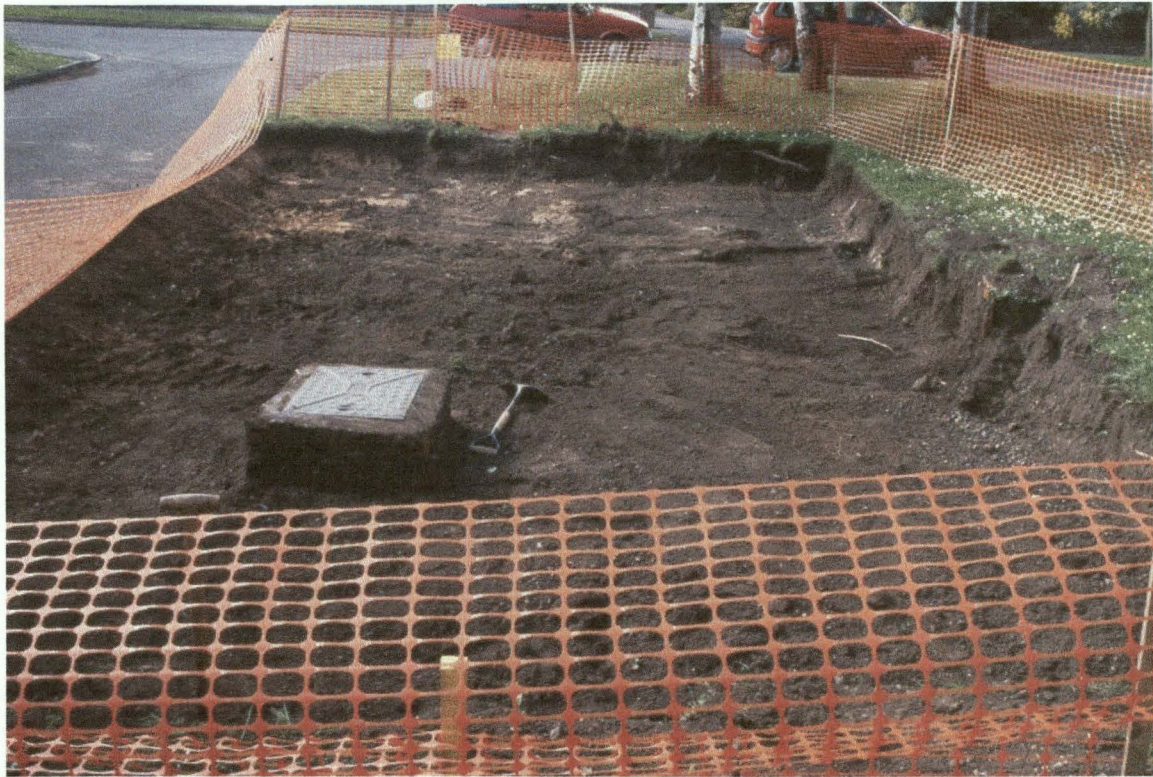
Ground reduction for the site compound extended over a 9.40m x 5.30m area and was carried out to a maximum depth of 450mm. Topsoil containing modern glass and whiteware pottery extended to the lower limit of excavation. Severe truncation, from modern services leading to a manhole within the area of excavation, was visible at the level of the trench base.

Plate 1: General view of the stripped compound area (looking south)

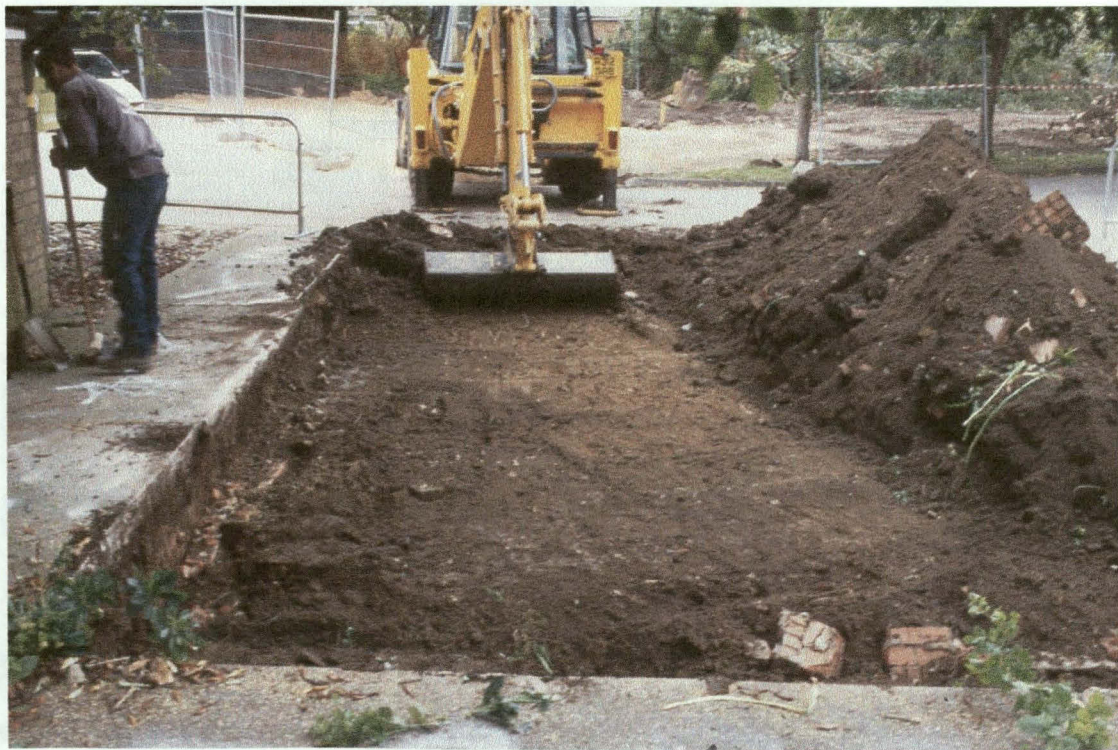
A c. 450mm depth of material was stripped in advance of the construction of the new access road which passed to the west of Church View to link with an existing small car park and access road leading to All Saints Lane.

In general, a friable, light yellowish brown silty sand containing frequent limestone fragments occupied the lower extents of the stripped areas, extending to below the lower limit of excavation. This deposit may be interpreted as a relict ploughsoil of medieval and/or post-medieval date representing an arable use of the land prior to expansion of the village. A 400mm depth of topsoil (friable, mid grey silty sand) then extended to existing ground level.

Plate 2: Excavation in progress for the access road to the west of Church View (looking north/ north-east).

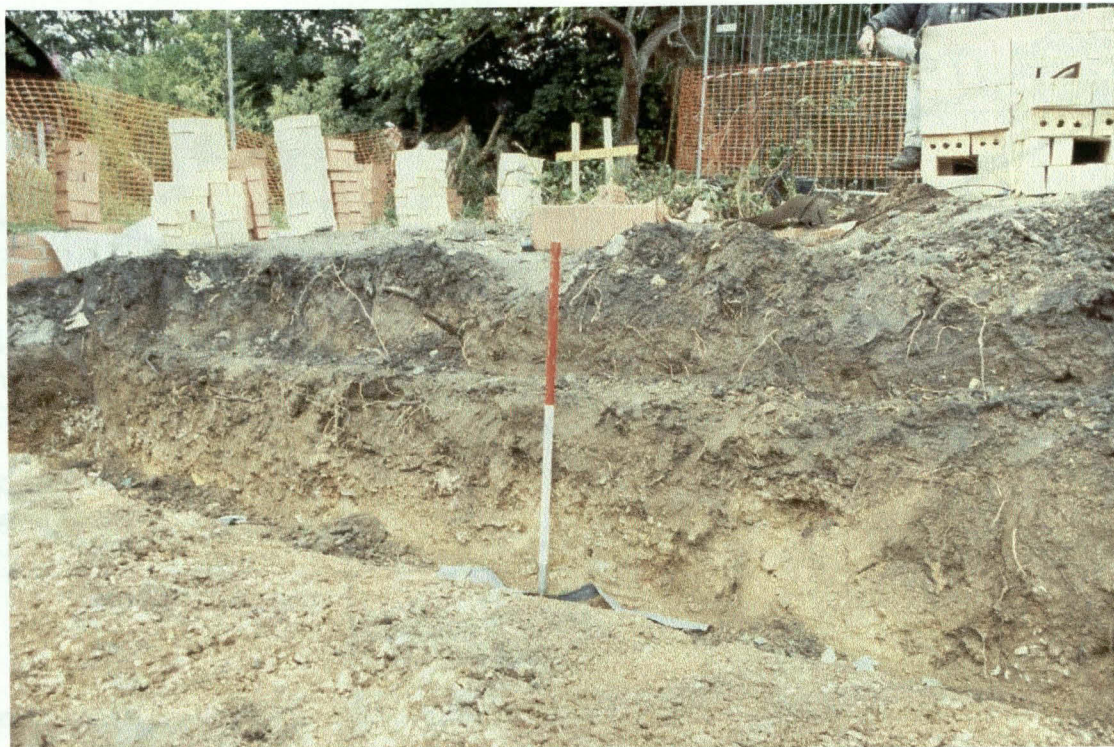
Initial ground reduction over the garden area to the north of Church View was carried out to a depth of c.200mm below the tarmac car park which lay to the west. Within the footprint of the extension (measuring c.28m N-S x c.15m E-W) a further 350mm reduction below the already stripped level was necessary to allow for the formation of the floor. Foundation trenches were generally 500mm wide. Those which lay within the eastern part of the structure were excavated to a depth of c.600mm below the stripped level, while those to the east were excavated to a depths of 1.2m - 1.7m due to the unsuitable nature of the ground in the immediate area (see below). The bungalow to the east occupied an area c.10m square and required foundation trenches with a depth of 1.10m below the access road level to the south.

Plate 3: General view of work in progress over the extension plot area (looking south-east)

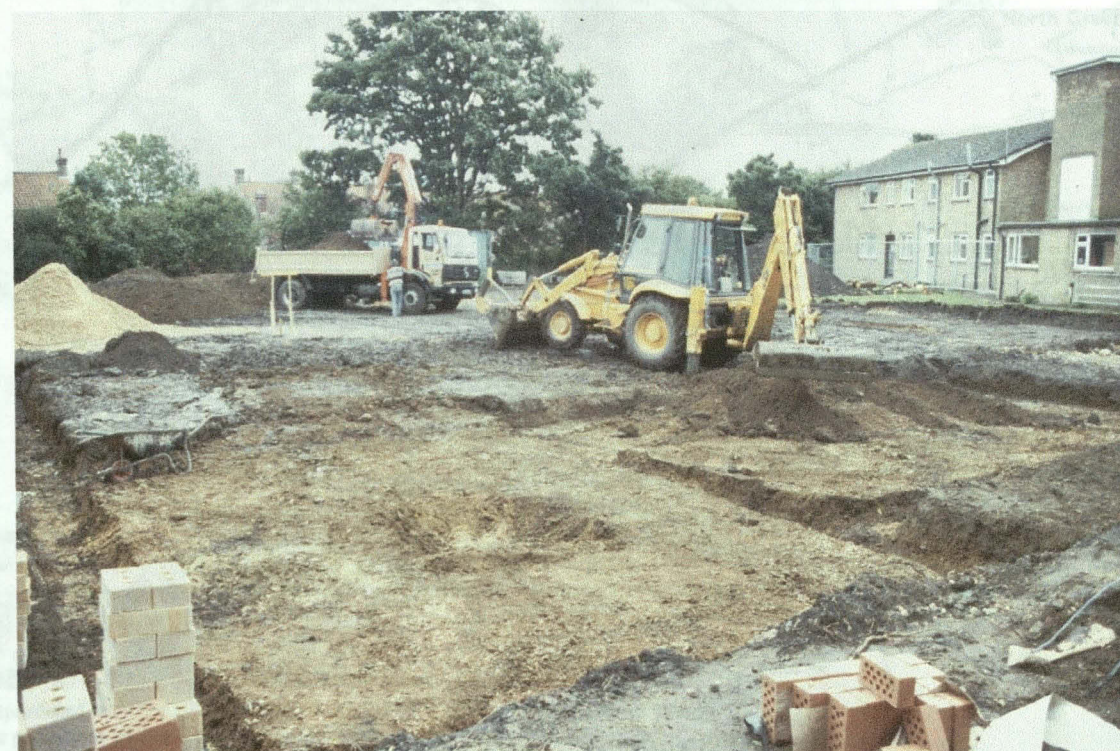
Limestone brash was encountered at c. 550mm below existing ground level over the western part of the extension (See Section 1, Fig.3), but lay at a greater depth of c.1.10m to the east, in the area of the bungalow. This material was overlain by a moderately compact, slightly sandy silt containing roots, limestone and pebbles varying in thickness between 0.40m to the west (See Fig.3) and 0.25m to the east. This deposit was itself overlain to the east by a 0.30m thick layer of moderately compact mid grey-brown silty sand containing occasional roots and occasional small stones. A loose dark grey-brown silty sand topsoil deepening to 0.50m in the area of the bungalow then extended to ground level (See Fig.3).

Plate 4: Section 1 showing stratigraphy at the north-west corner of the extension plot (looking north).

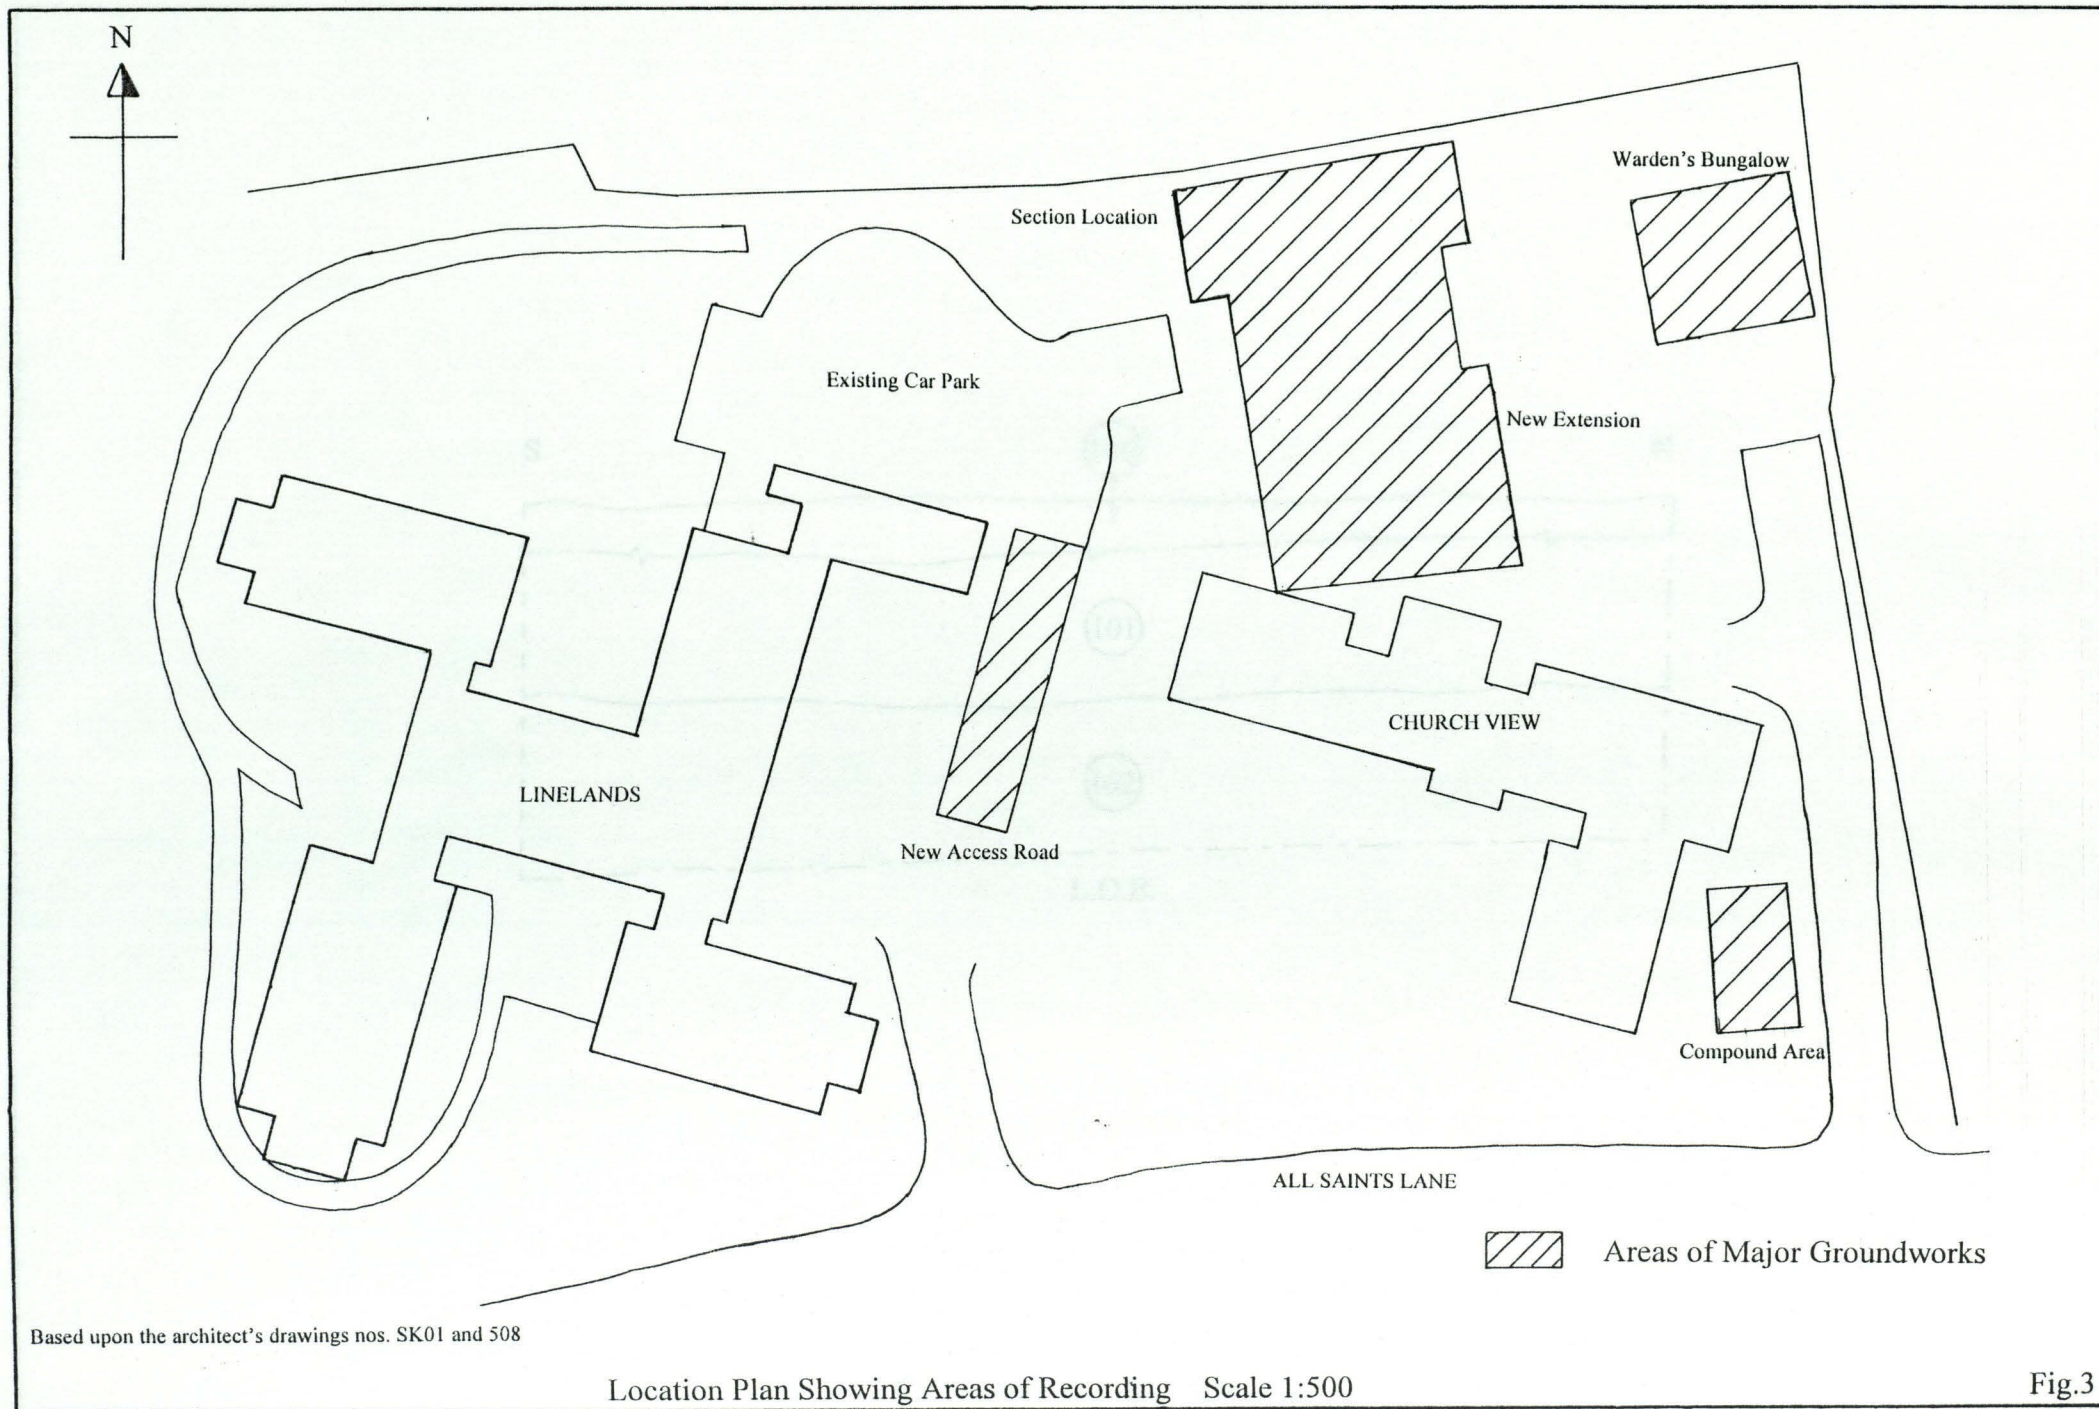
- Fig.1 Location Map - scale 1:50 000
- Fig.2 Site Location Map - scale 1:10 000
- Fig.3 Location plan showing areas of recording - scale 1:500
- Fig.4 Section 1 - scale 1:20

Several large pits, probably of comparatively recent origin, were cut from immediately below the turf horizon, truncating the aforementioned stratigraphy within the eastern part of the extension. The pits typically attained a depth of c.1.5 m below the stripped level and were filled by what appeared to be redeposited topsoil containing modern material, including corrugated iron, glass bottles, white chinaware and window glass. A similar feature measuring 2.5m across (max.) and at least 2m deep (not bottomed) was encountered at the SE corner of the bungalow plot.

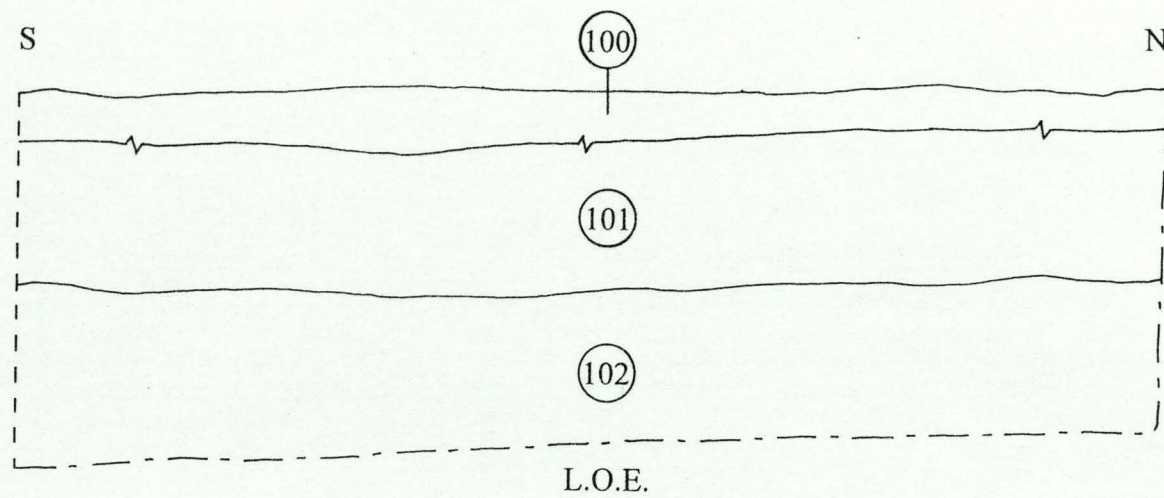
Fig.4

East-Facing Section Scale 1:20
