**Normanton Phase 1 Mains Replacement Scheme  
Archaeological Desk-Based Assessment and  
Monitoring of Groundworks between Normanton and  
Hough on the Hill, Lincs.**

NGR: SK 922 461 - SK 949 462  
Site Code: NHH 98  
LCNCC Museum Accn. No. 128.98

Report prepared for Anglian Water Services Ltd.

**LAS Report No. 337**

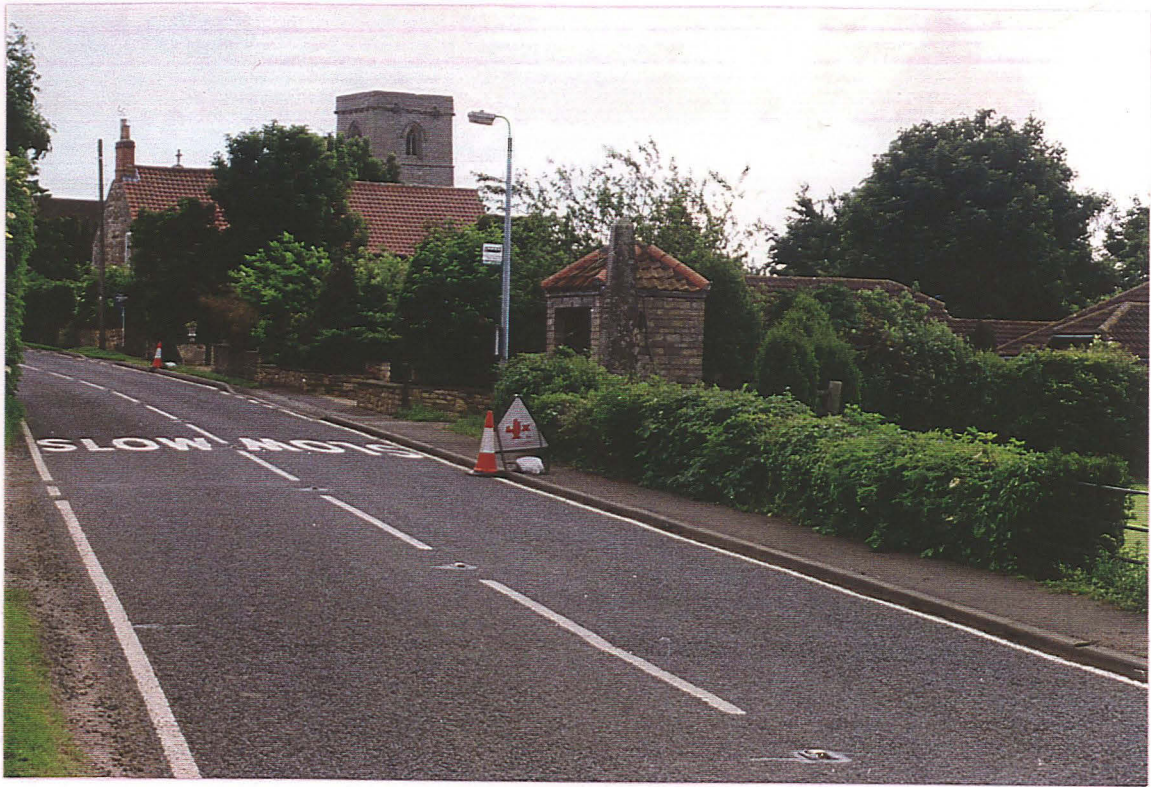
Pl. 1 Cliff Road, Normanton, showing the position of the milestone and pump (looking SW).

Pl. 2 Front view of the milestone, pump and water trough (looking west).

Within Normanton, a 0.5m wide trench was excavated beneath the modern road past a village pump, milestone and water trough **1A** now protected as a scheduled Ancient Monument (PIs. 1-3). This part was watched in order to ensure no damage to the monument; none occurred and apart from undated road metalling, no archaeological remains were seen.

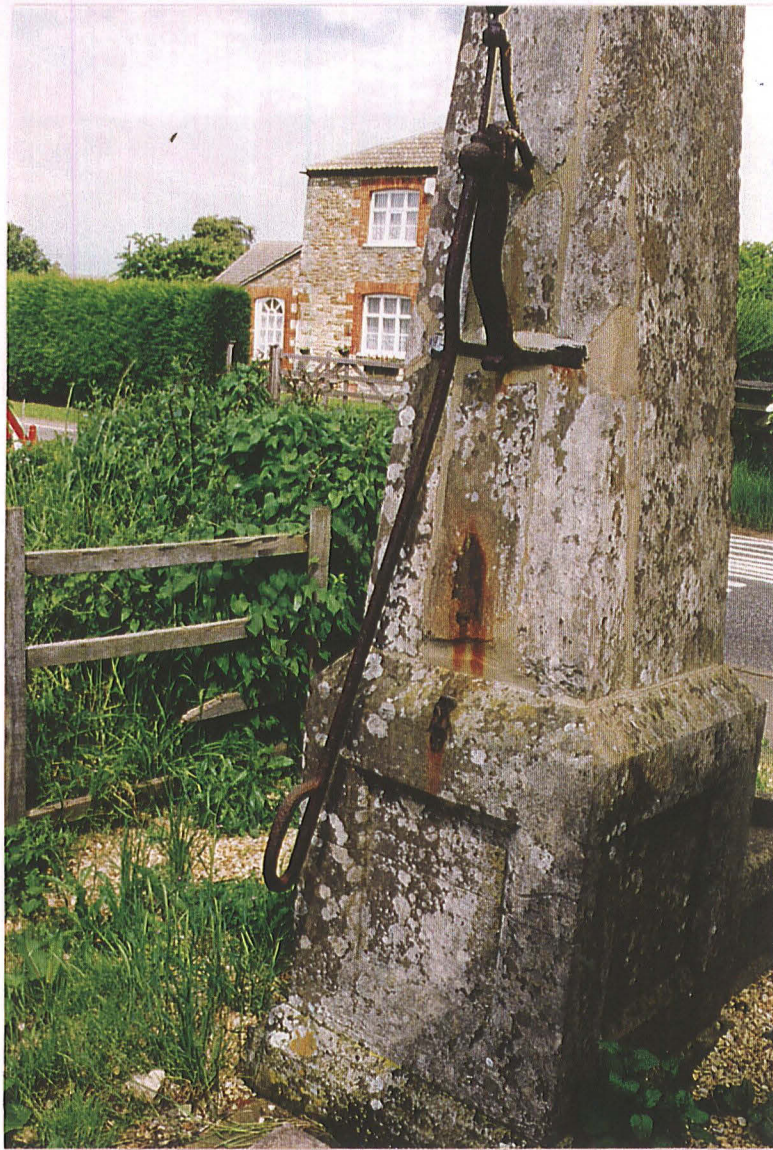
**Pl. 3** Pump handle at rear of the milestone. Looking east across Cliff Road.

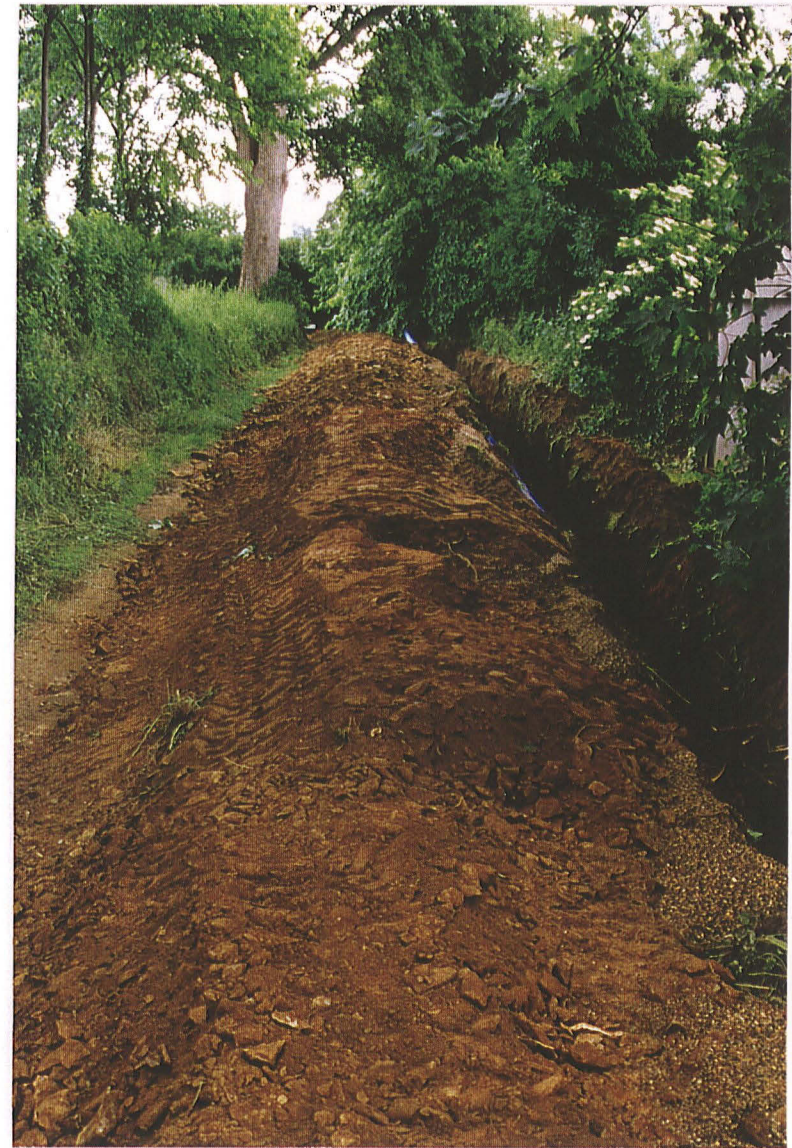
**Pl. 4** The pipe trench within the narrow track south of Normanton churchyard. Looking east to Cliff Road.

To the south of the church and graveyard, a rough metalled track leads down a slope and crosses Honington Beck by a small bridge. Alongside the graveyard the track is narrow, as if the burial ground has either been extended south across part of a medieval lane or the lane was created at a later date from part of the graveyard (PI. 4). The trench exposed no human remains, which suggested that the lane pre-dated the churchyard. Below a thin covering of soil, the trench revealed limestone brash except for a small ridge of larger stone **1C** where the lane became slightly wider. This may have

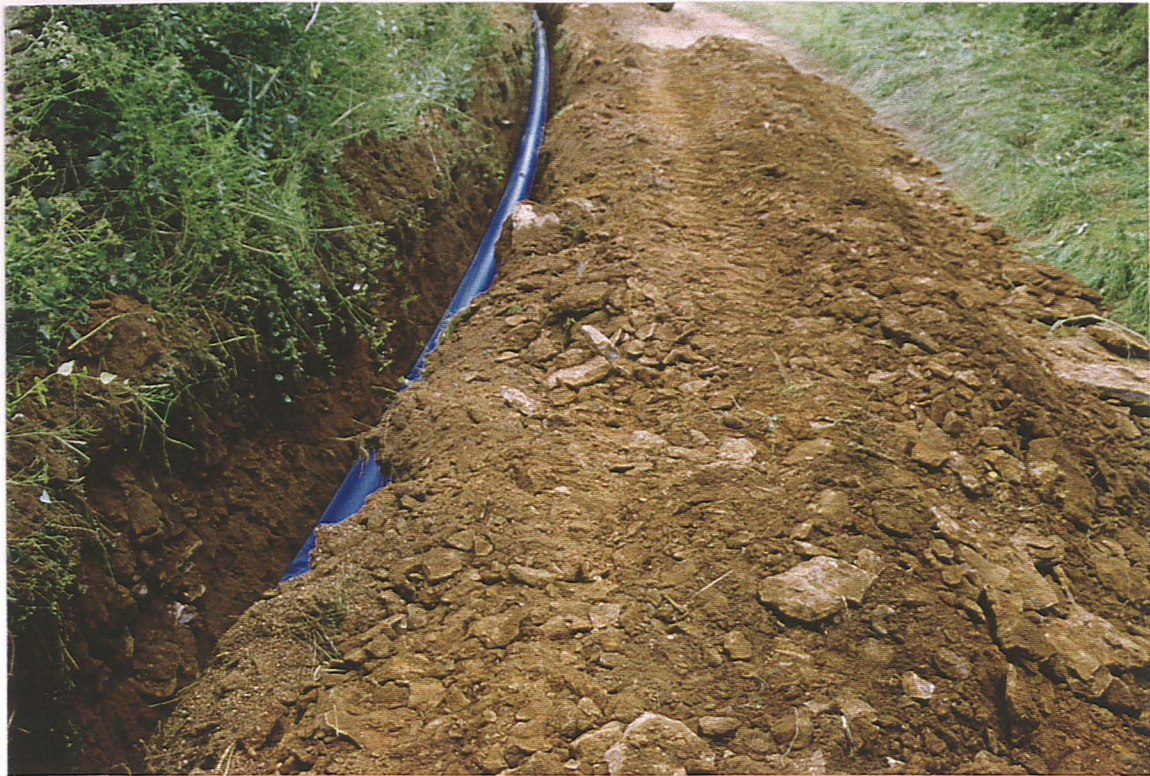
**Pl. 5** To the SW of the churchyard the track became wider with a verge. This coincided with a ridge of stone 1C in the trench face (left foreground).

been a demolished wall or an upcast mound beside an unrecognised ditch (Pls. 5 and 6).

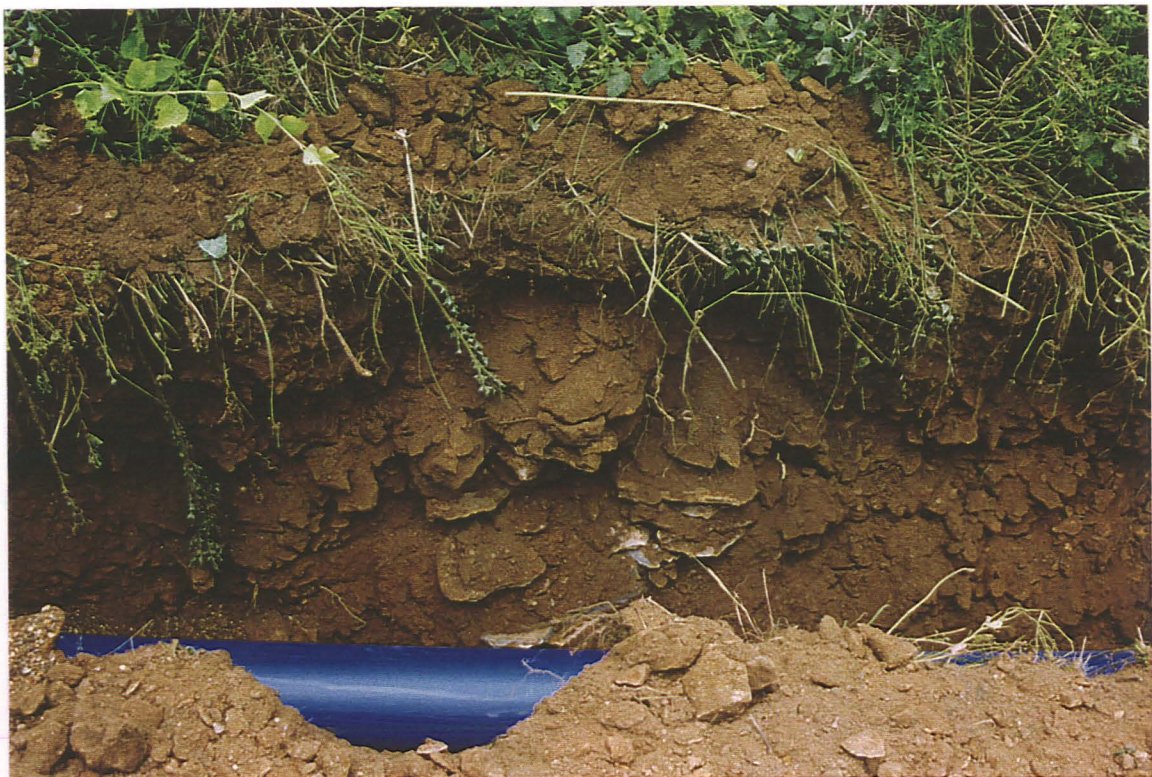
**Pl. 6** Stone ridge 1C may have been the remains of a demolished boundary wall, perhaps medieval (looking south).

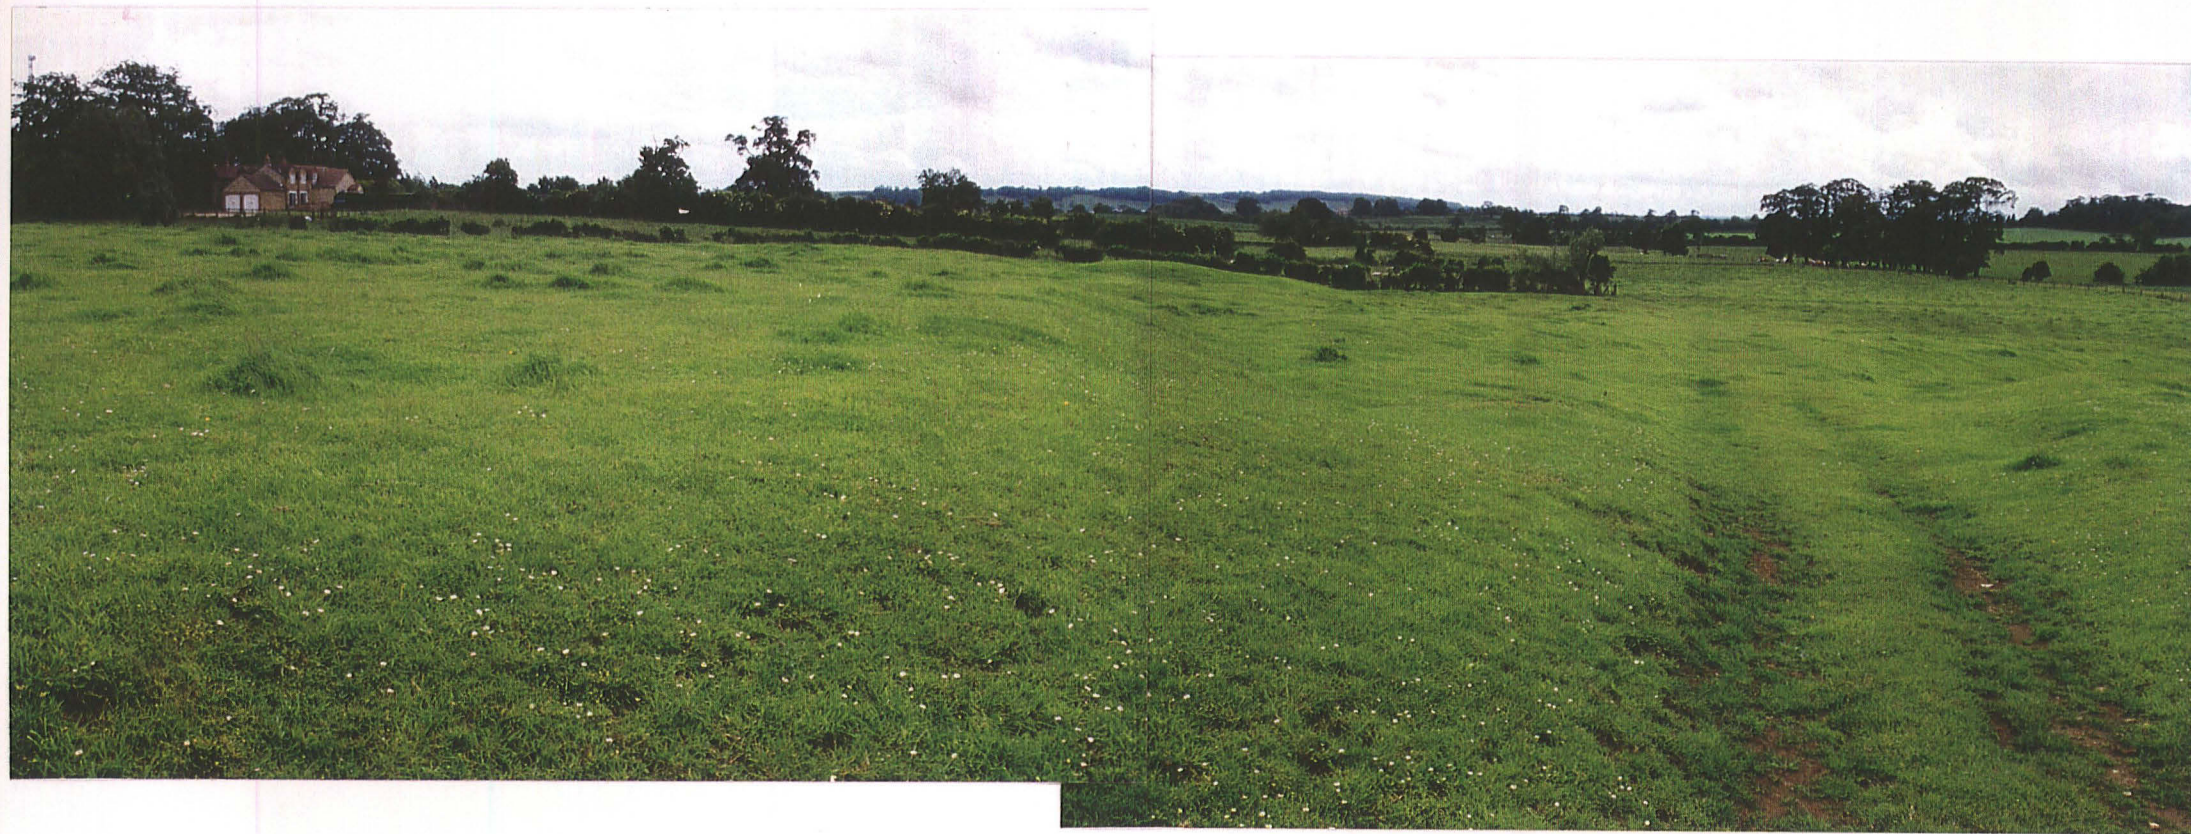
**Pl. 7** Panoramic view (with Pl. 8) showing earthworks 1D in the pasture field south of the track. (Looking south from the track edge).

The lane may instead have been a village street providing access to plots to the south of the track, now only visible as earthworks **1D** in a pasture field (Pls. 7 and 8). Although difficult to interpret from ground level, the undulations appeared to include possible house platforms, tofts and paths as well as ridge and furrow from arable cultivation. No previous record of this possible shrunken or migrated medieval village site was found.

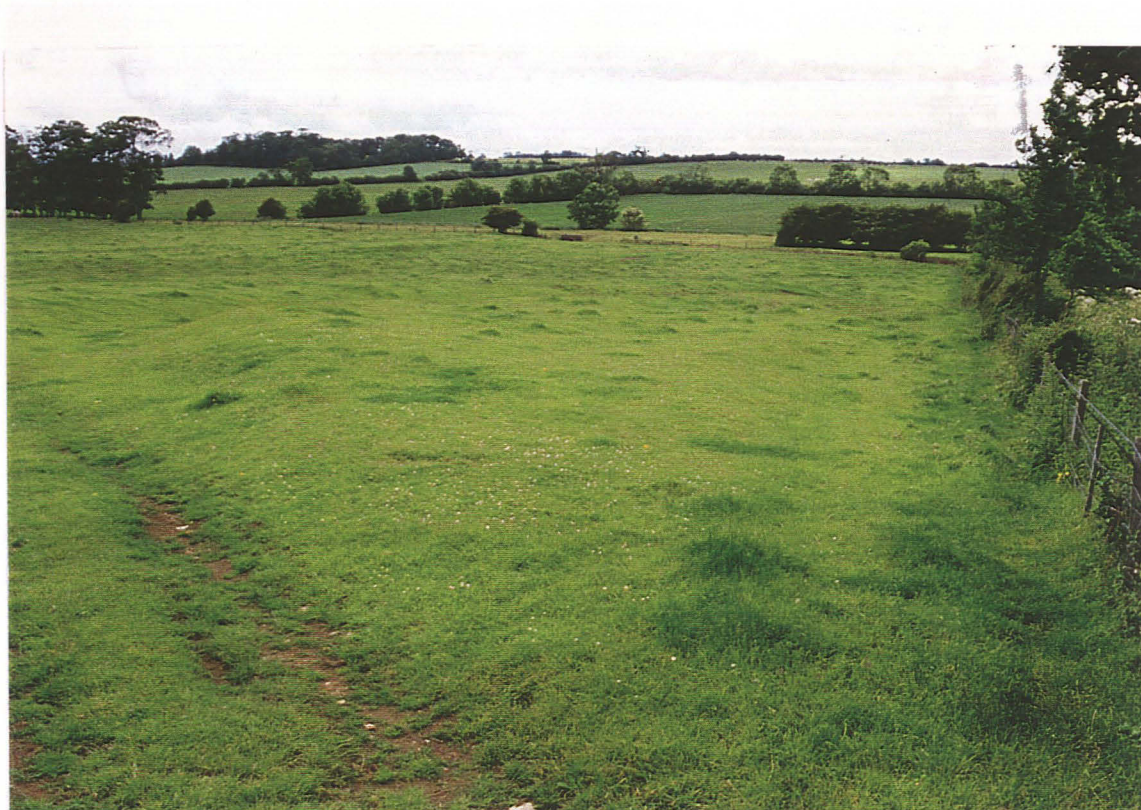
**Pl. 8** Earthworks 1D to the SW of the track (looking west).

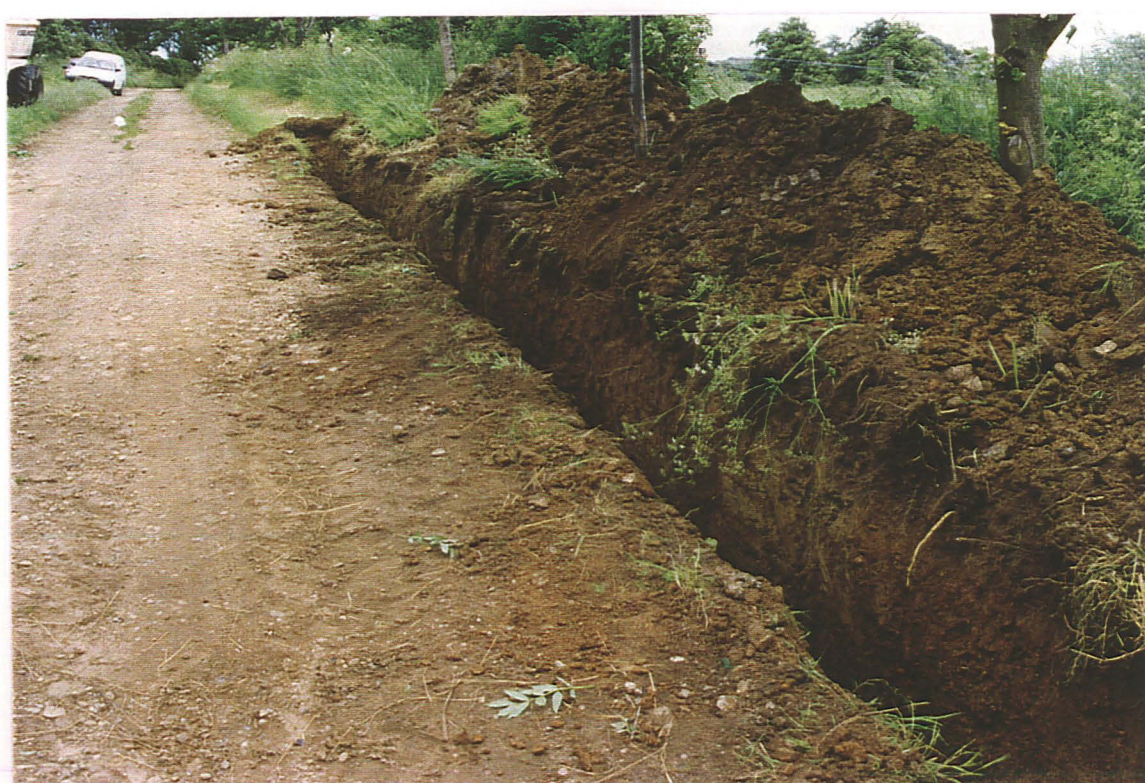
**Pl. 9** The pipe trench was sited in the southern verge of the track. A thick root (right foreground) is above ditch 1E.

Further west along the track verge, a backfilled ditch **1E** was identified in the trench face (Pls. 9 and 10). The ditch was about 0.6m deep and 1.5m wide, sealed by a 0.3m thick topsoil layer. No datable material was found in the exposed fill.

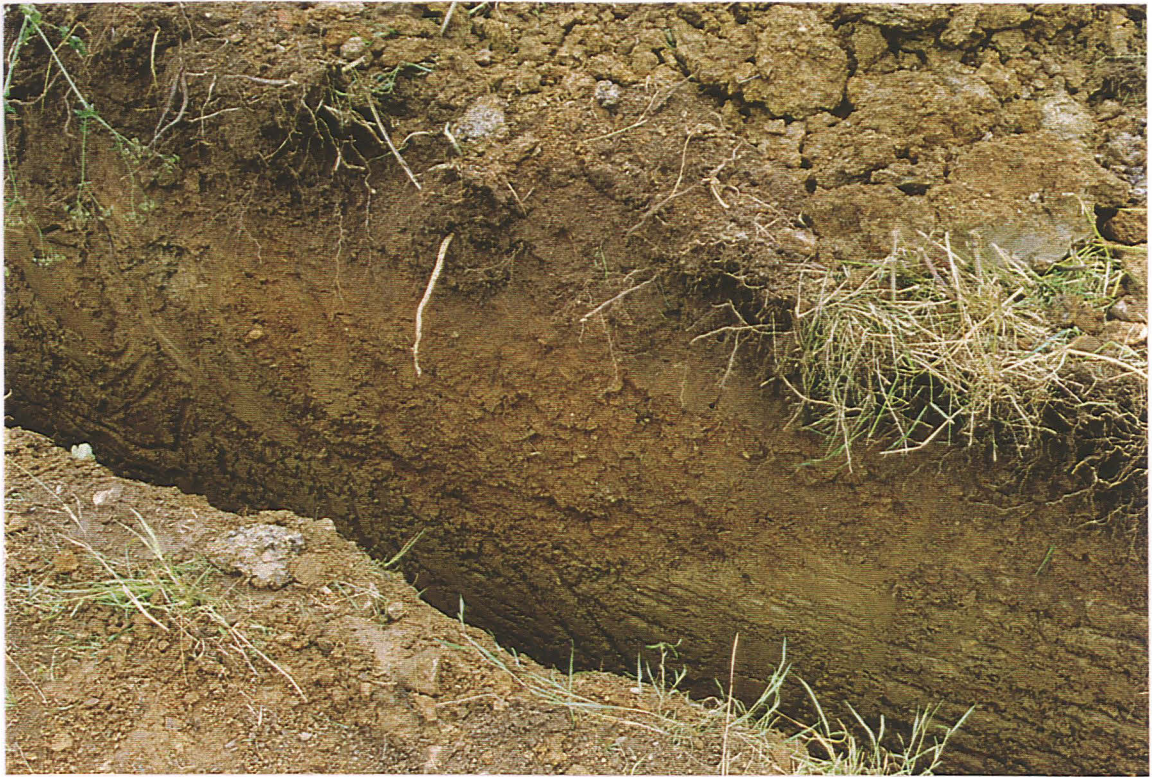
**Pl. 10 Red/brown clay fill of ditch 1E visible in the trench face. Looking south.**

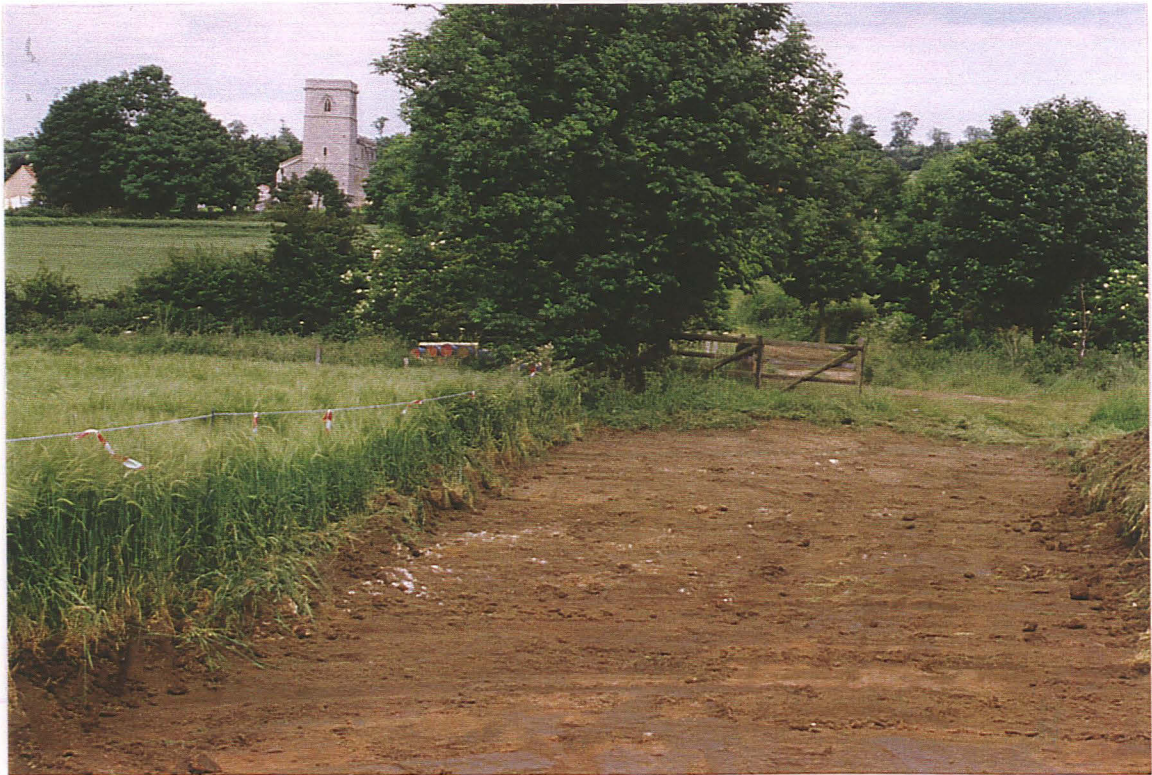
**Pl. 11 Limestone and brick rubble at 2A, perhaps associated with demolished bridge beneath former railway line. Looking east.**

Beyond Honington Beck the track ends at a broad, flat NW-SE aligned farm track where the former Lincolnshire and Honington Branch Railway has been removed. Early OS maps mark the railway as passing above the track, and a spread of brick and stone rubble at **2A** may have been the remains of a demolished bridge foundation (Pl. 11).

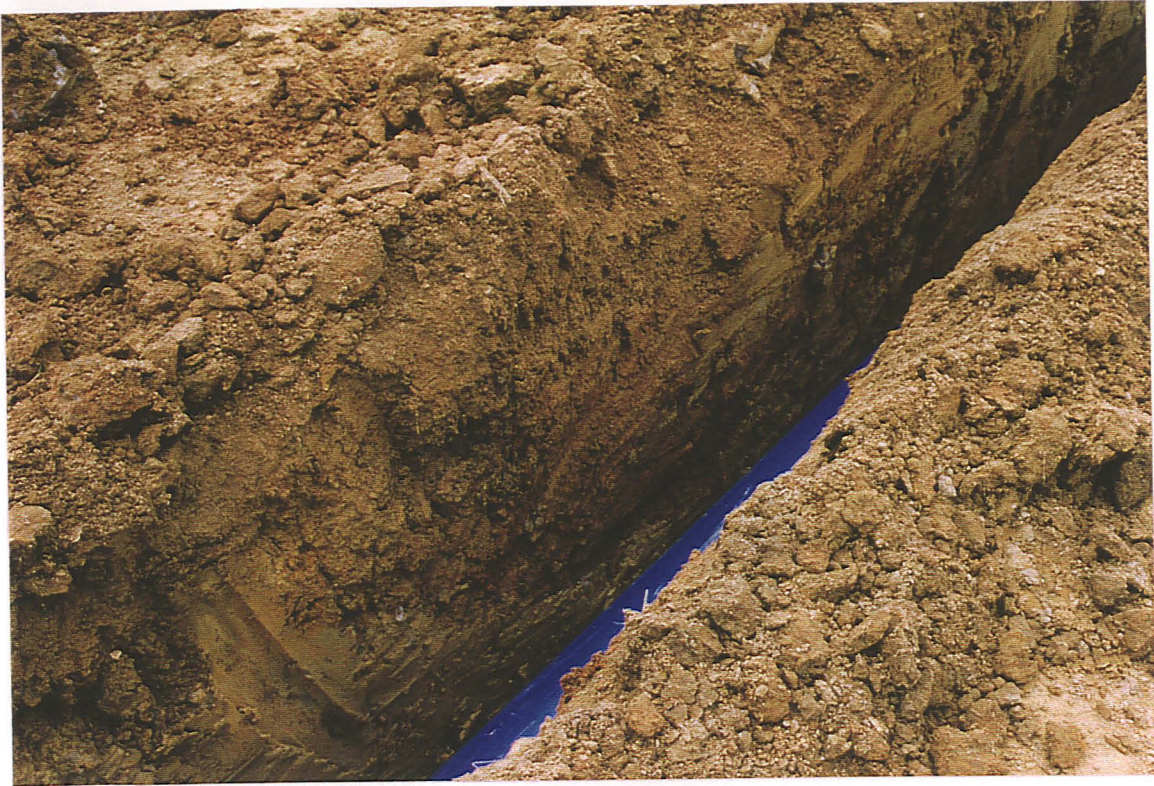
**Pl. 12 Red/brown fill of medieval plough furrow in Field 3.**

(Pls. 12-14). Investigation showed that the ditch had been cut across the ploughed field and that the ridge and furrow extended towards the green lane. The ditch upcast, piled as a bank to the south, gives a misleading impression of east-west aligned ridge and furrow (Pl. 15). The lane itself probably occupies the flatter medieval headland although this could not be confirmed. The green lane appears to originate in the mid to late eighteenth century and first appears on a map of 1756 (LAO 2CC 70/7). The ditch seems to have been dug to define the lane and probably dates from the change from arable to pastoral land use.

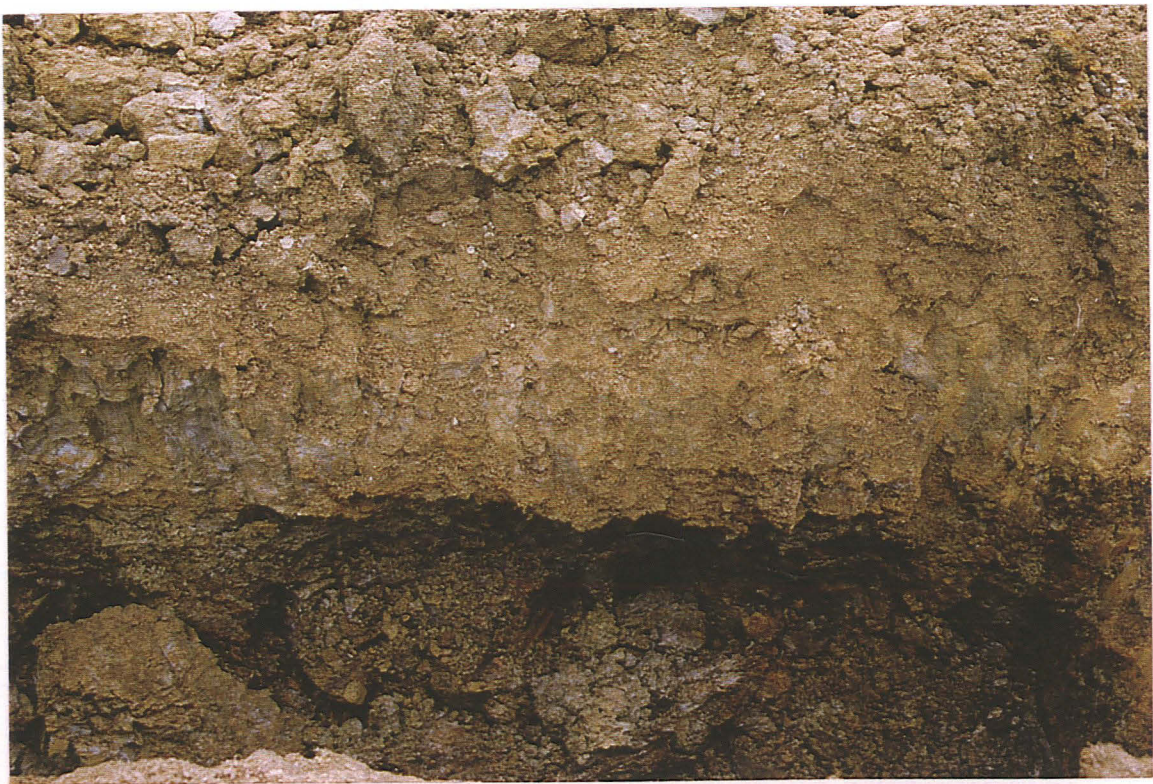
**Pl. 13 Within Field 3, the subsoil covered patches of dense ironstone.**

In Field 3, the easement was aligned across a pasture field south of an almost backfilled ditch **3E** defining the side of a tree-lined green lane. The pasture undulated across north-south aligned ridge and furrow which in places was still pronounced; the pipe trench showed that some furrows had cut over 1m into the subsoil despite the ironstone boulders present in places

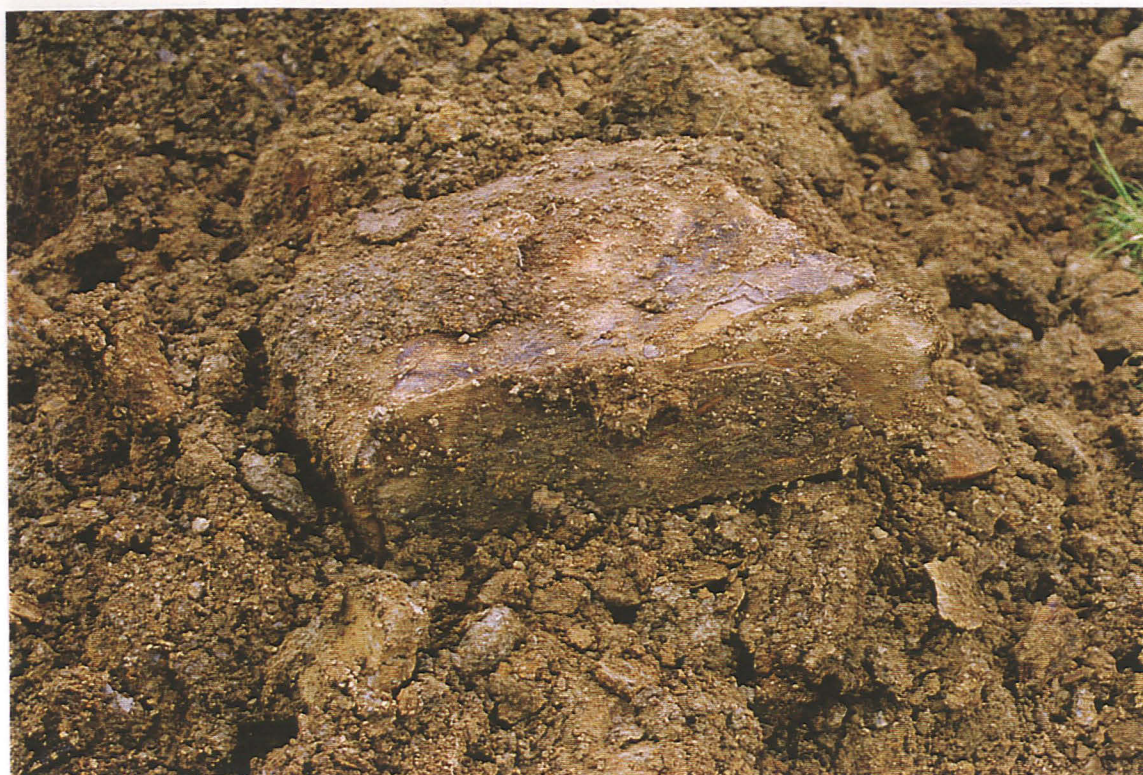
**Pl. 14** Ironstone block from the natural deposit in Field 3.

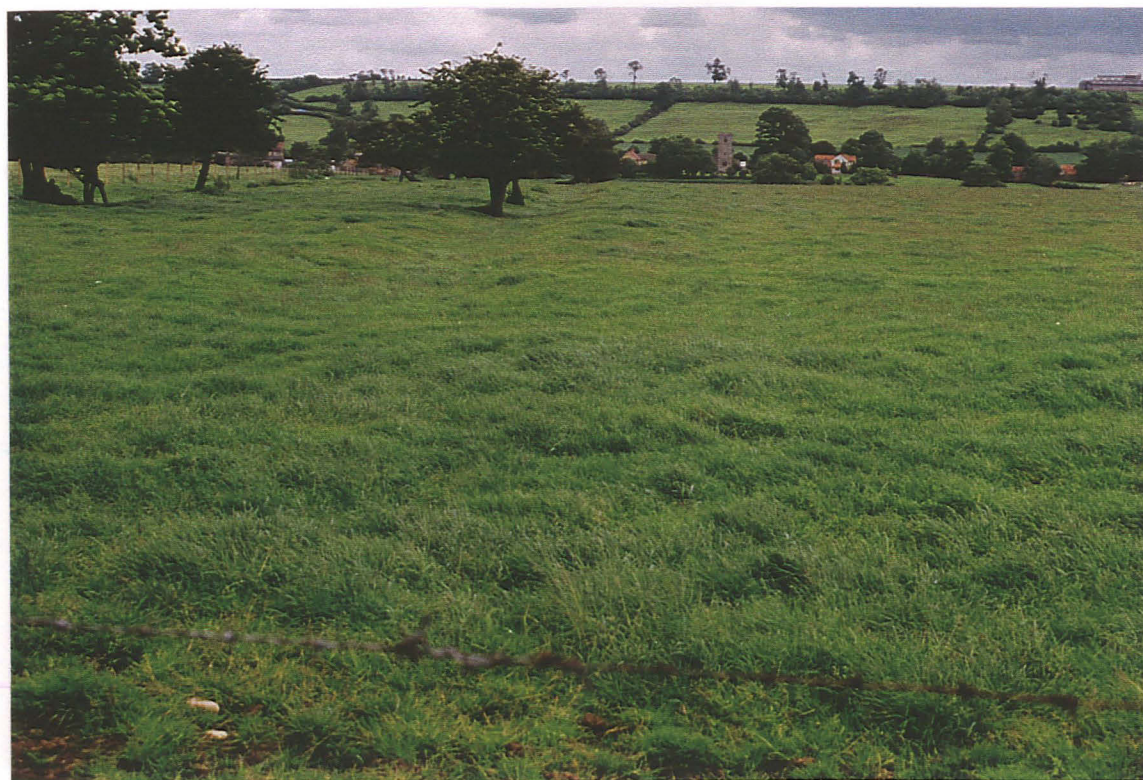
**Pl. 15** The post-medieval tree-lined green lane at the edge of Field 3, showing the adjacent ditch 3E and bank. Plough furrows in the field to the right are not visible from this angle (looking east to Normanton village).

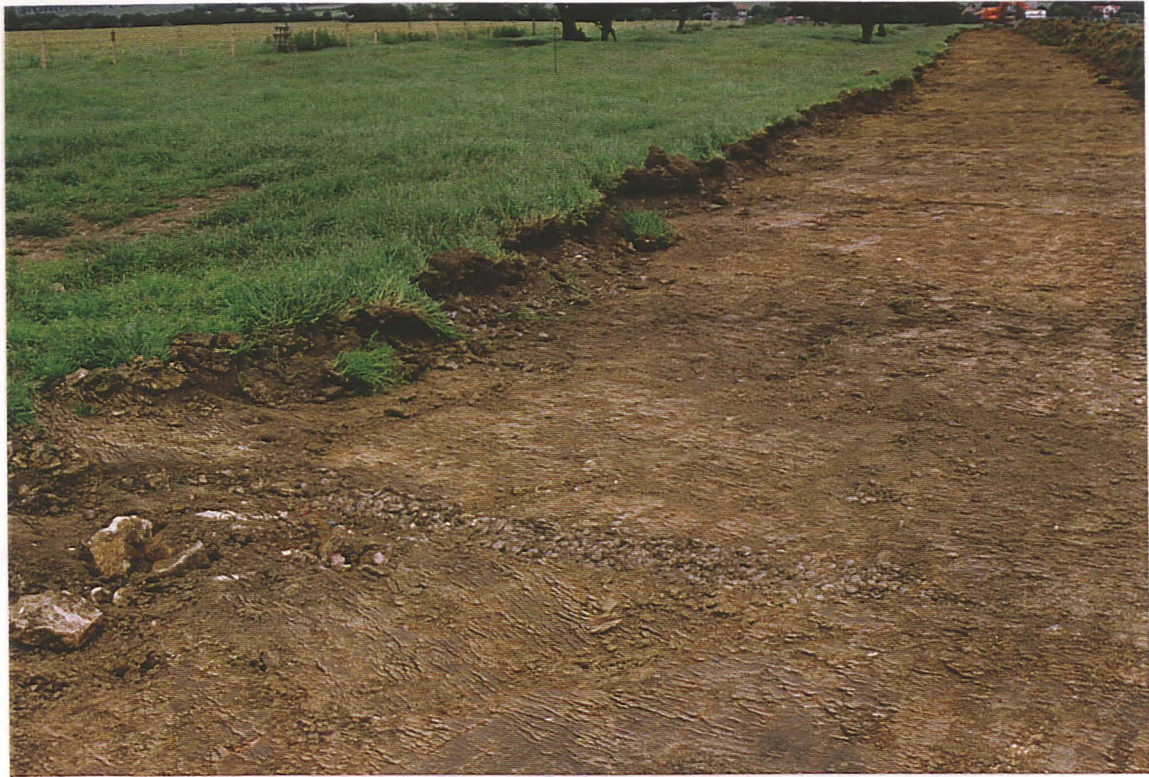
**Pl. 16** Topsoil removal in Field 3 revealed the darker soil filling plough furrows, with lighter intervening ridges (looking east).

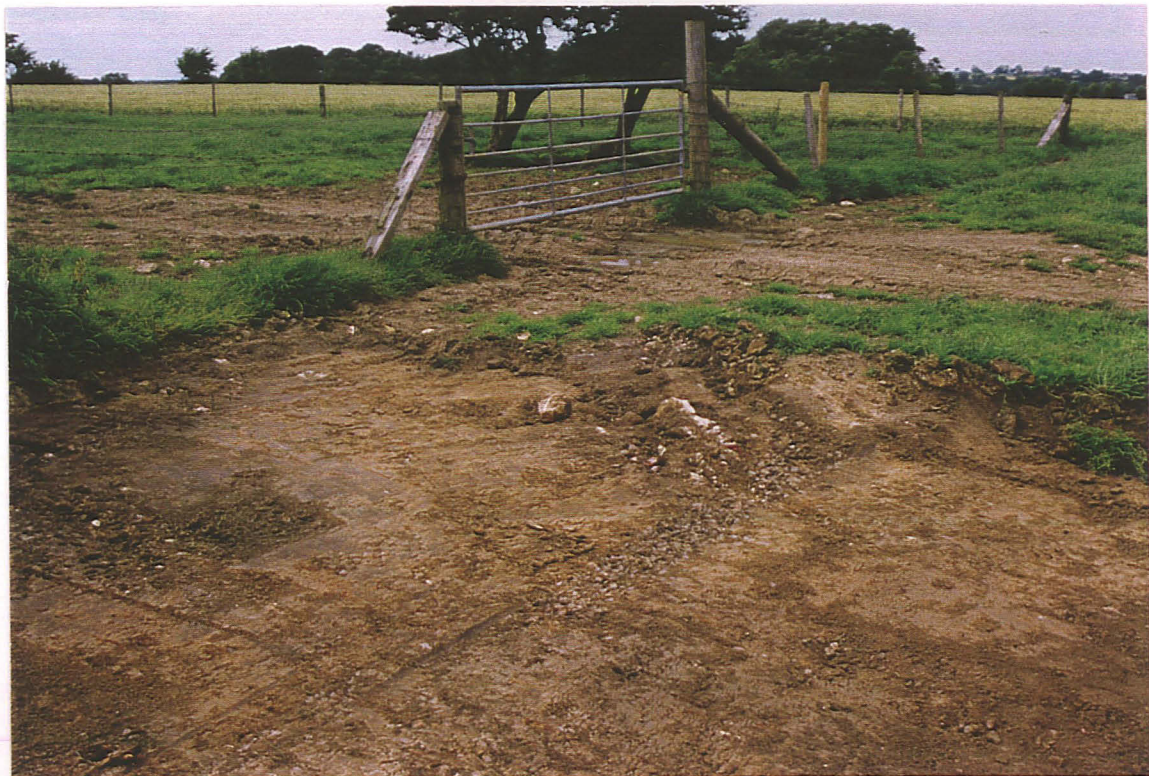
**Pl. 17** Limestone rubble in a post-hole at the western side of Field 3, probably re-used from the Roman stone building as support for a post-medieval or modern fenceline or gatepost (looking north).

Despite the proximity of the recorded Roman site to the western end of Field 3, no Roman pottery was found during topsoil stripping or later trenching. A cluster of limestone lumps at **3A** was interpreted as stone packing for a field boundary fence- or gate- post, very close to the existing fence line and probably not of any antiquity (Pls. 16 and 17). The stone may have been re-used from material disturbed at the site of the Roman building. A medieval sherd was found close to **3A**, two at **3B**, and another at **3C**.

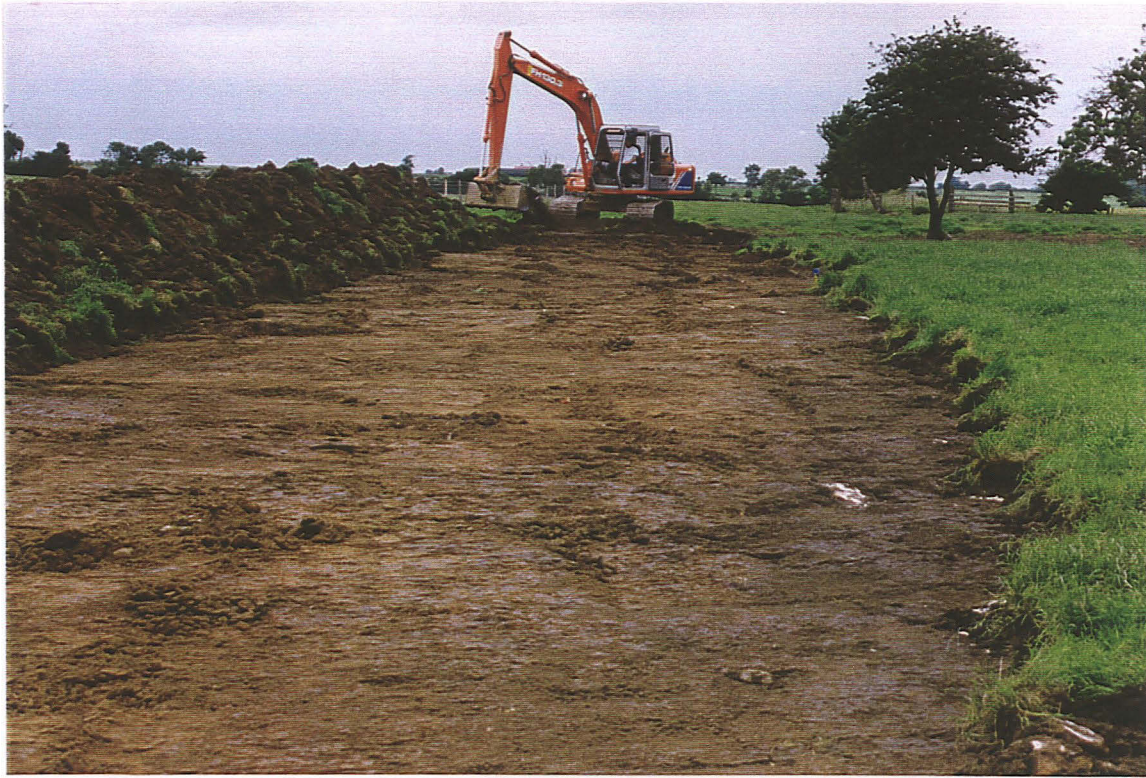
**Pl. 18** Archaeological remains from an Anglo-Saxon cemetery were revealed at this level after topsoil removal in Field 4 (looking west). The backfilled ditch flanking the post-medieval green lane is visible, right foreground.

Topsoil removal at the eastern side of Field 4 was monitored very closely to try to avoid damage to any surviving structural remains. At the northern edge of the stripped easement a linear feature filled with darker soil was visible, containing limestone lumps. This proved to be a continuation of the ditch defining the green lane and was probably eighteenth century in origin (Pl. 18).

Bone fragments were found at a depth of about 0.25-0.3m below the surface and these were identified as human skeletal remains, although few bones remained. Home Office Licence No. 1190 (dated 24th June 1998) was obtained prior to their removal by LAS. Machining continued at this level but with no further results; the blank zone was then machined slightly deeper. Stone rubble, apparently forming a surface, was clipped at intervals and the decision was made to cease machining at that level despite the few visible features. The soil appeared homogenous, unlike Field 3 where the furrow fills were much darker than the intervening ridges, and it was unclear whether medieval cultivation had affected the site. As no definite furrows were evident,

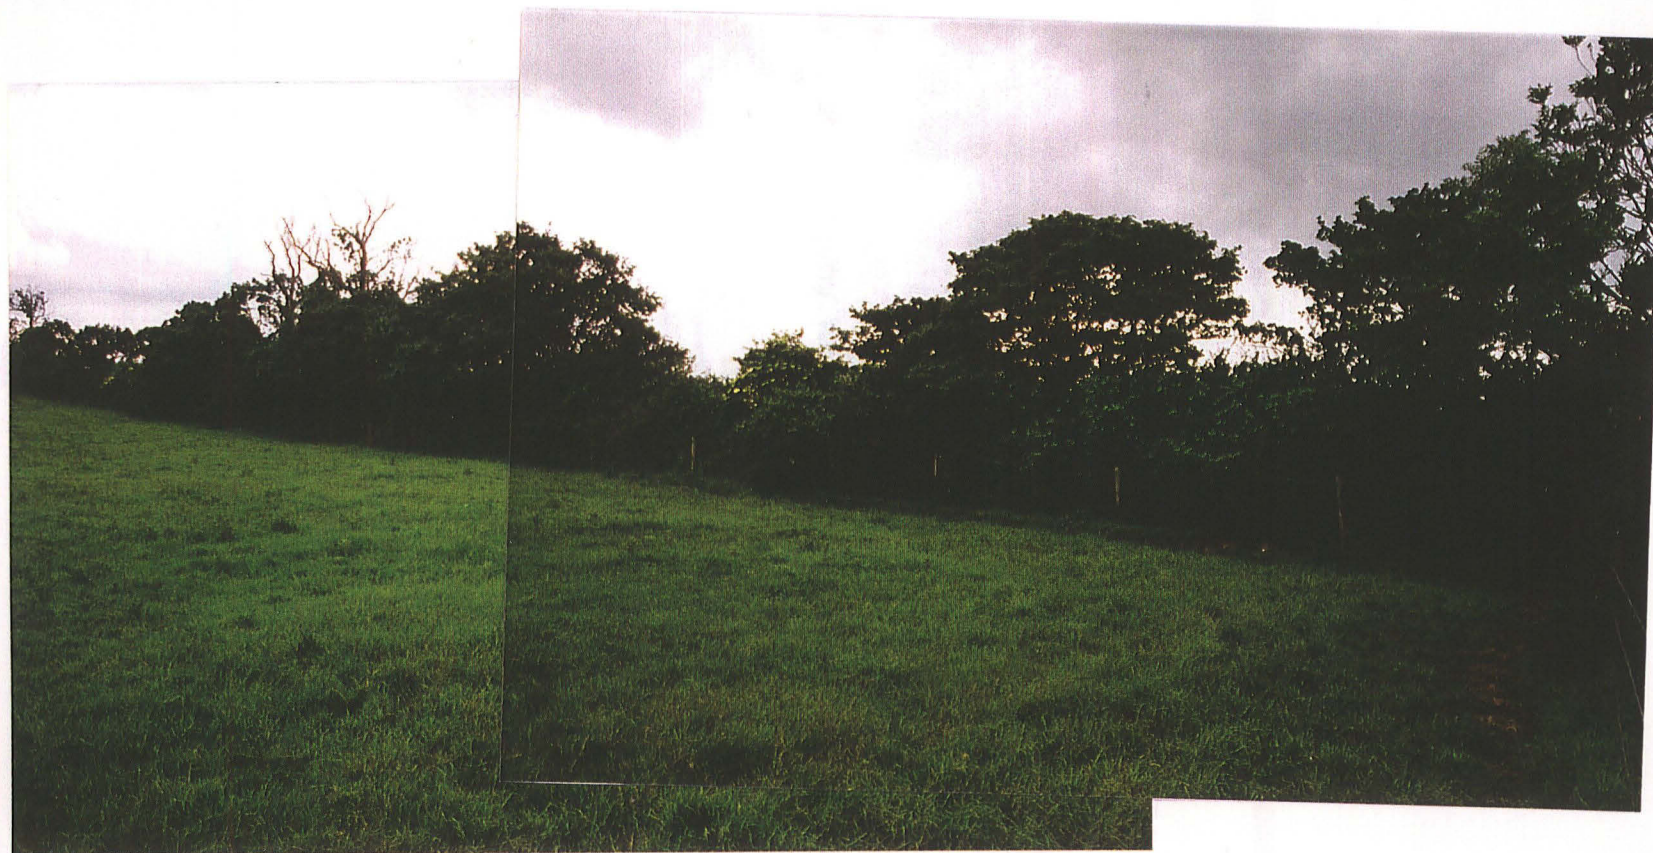
**Pl. 19** Part of the multi-species hedge along the Normanton parish boundary. Looking west.

The western edge of Field 4 was bounded by a thick hedge growing along the parish boundary. In order to avoid damage to the hedgerow, the pipe was moled beneath it, and no information about the boundary's origin was revealed.

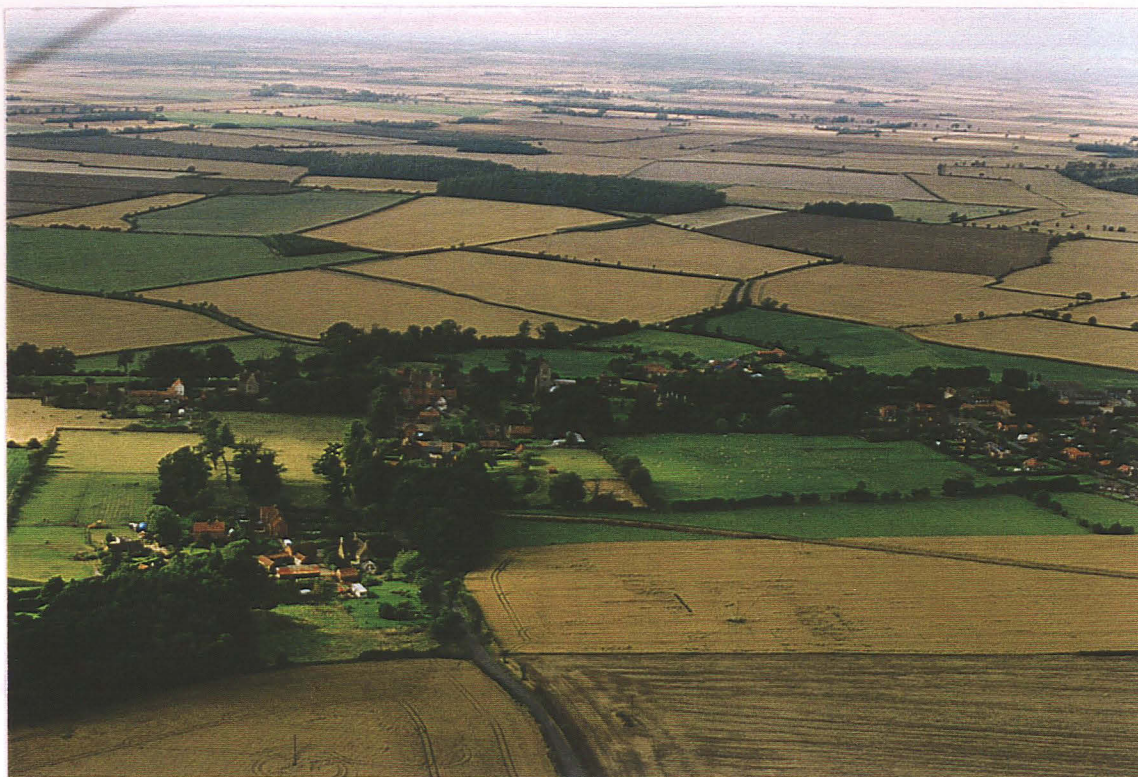
**Pl. 20** Aerial view of Hough on the Hill village showing the pipeline easement crossing fields 6 and 7. Earthworks are recorded in the field with sheep (centre right). (Looking north, photograph: N. Field).

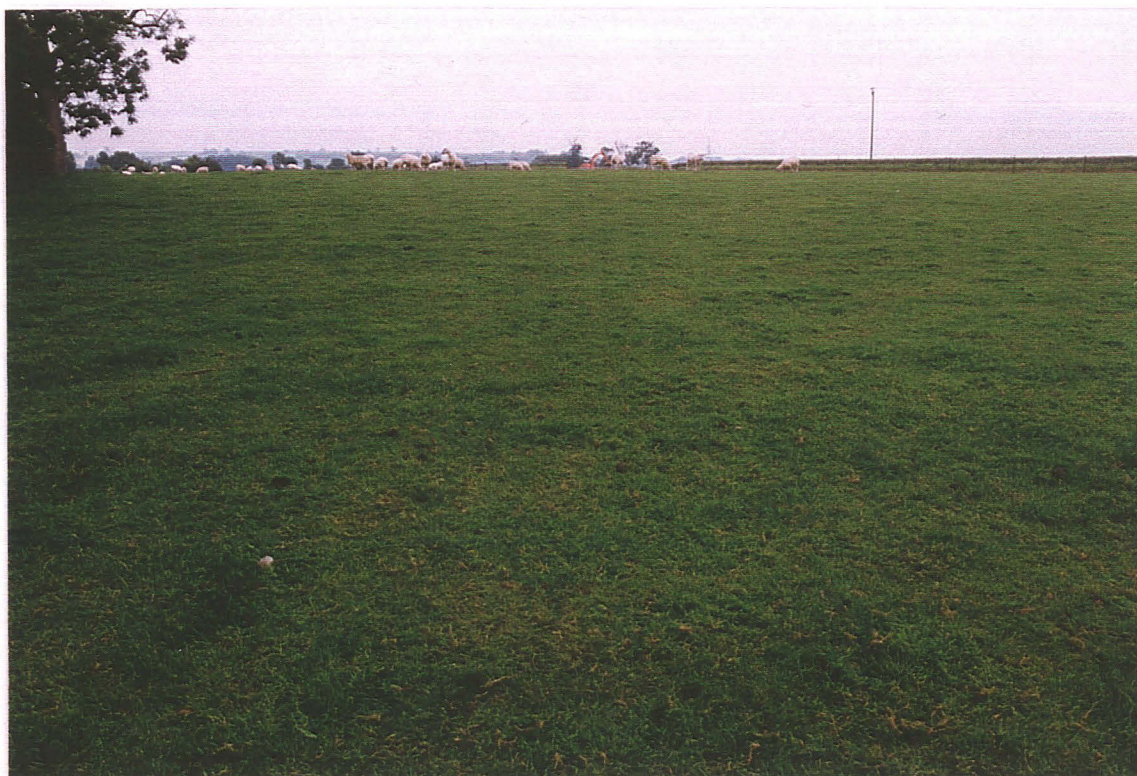
**Pl. 21** View to east across route of pipeline in pasture field 7 in advance of topsoil stripping. No earthworks were visible in this field.

This pasture field could not be topsoil stripped with the rest of the route, and topsoil removal and trench excavation was not monitored. Earthworks of medieval settlement features have been recorded in adjacent fields but there was no evidence that they extended into this field (Pls. 20 and 21). A search of exposed soil failed to locate any pottery scatters that might have indicated occupation features.
