Snarford, Hall Farm

**Archaeological Watching Brief
during Groundworks for an Extension to the
Farmhouse**

Site Code **SHE 99**
LCNCC Museum Accn. No. **9.99**
WLDC Planning Application No. **98/P/0824**

LAS Report No. 342

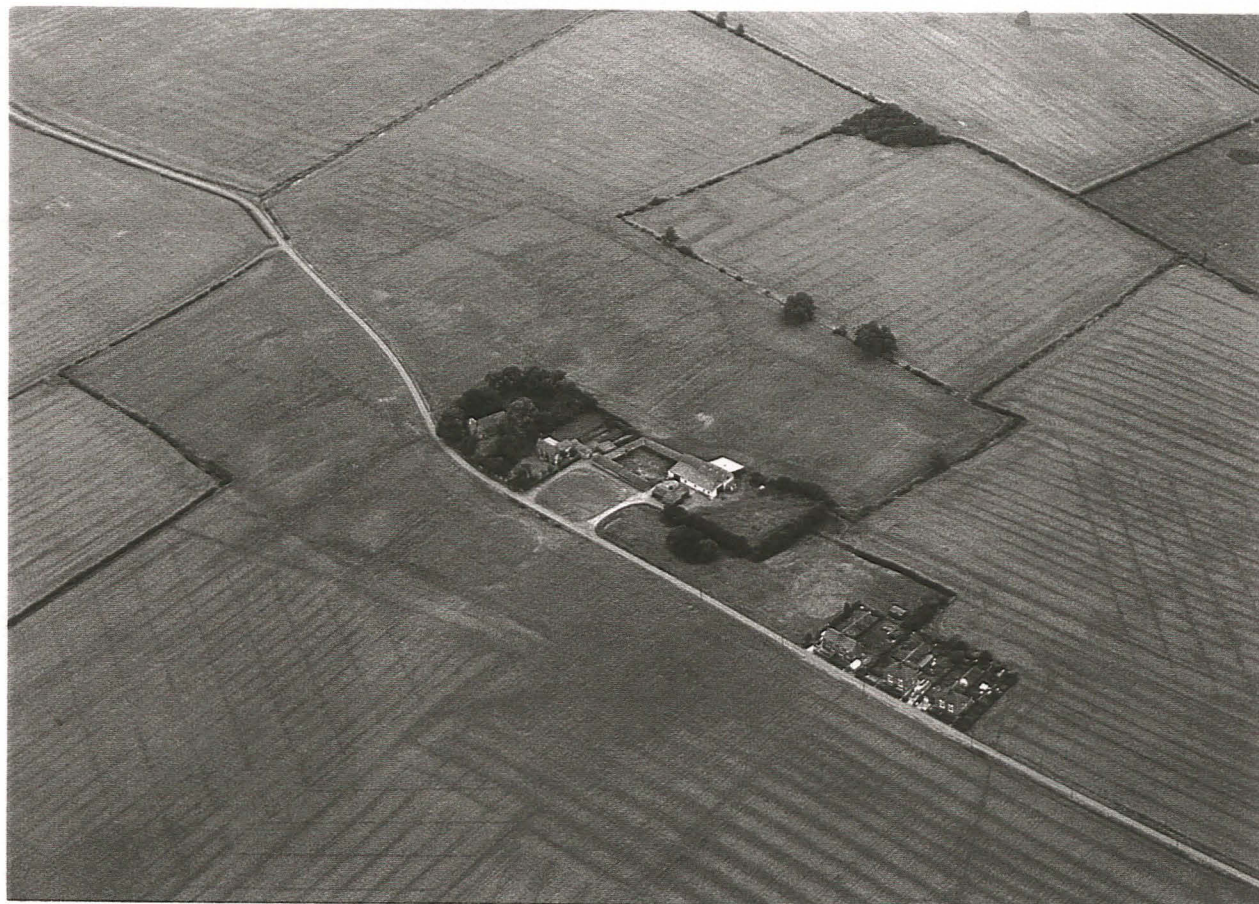
Pl. 1 Air photograph showing Hall Farm, Snarford in the centre of levelled medieval settlement earthworks. Looking NE. (Ref. 2963/31, 29.7.1979 PE. Copyright Reserved).

The church, Hall Farm House and the farm buildings are the only buildings within the area of the medieval settlement (Pl. 1). The church has twelfth century fabric at the base of the tower and later building elsewhere, but the farmhouse and farm buildings are probably of seventeenth century origin; the site of successive medieval hall buildings is thought to lie west of the modern road (Pevsner and Harris 1964, 363-4).

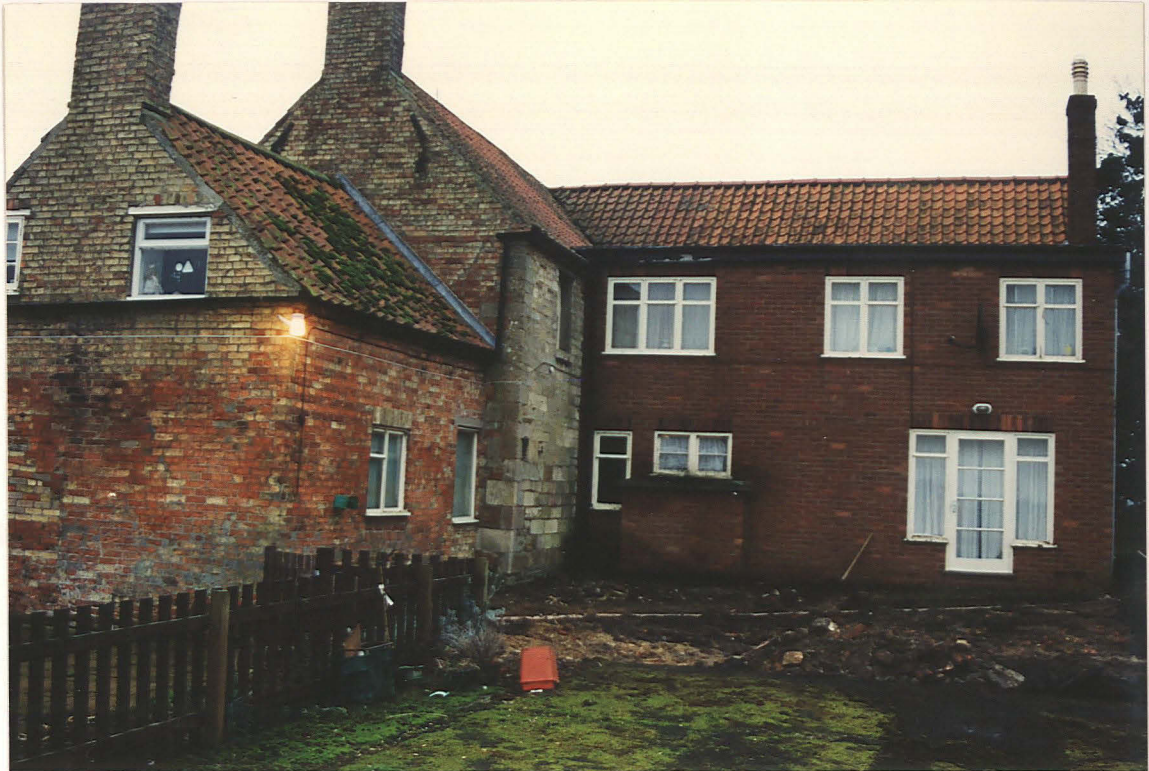
Pl. 2 Position of the new extension, after removal of the tennis court surface. Looking SW.

The new extension is positioned in the angle between the brick kitchen, the stone heart and a 25-30 year old brick extension to the north (Pl. 2). It replaces part of a surfaced tennis court.

By arrangement with LAS, the contractor had removed the tarmac surface of the tennis court from the area of the new extension before the first monitoring visit. Inspection confirmed that this operation had not affected any archaeologically significant deposits, and that the court had been levelled on a brick rubble foundation.

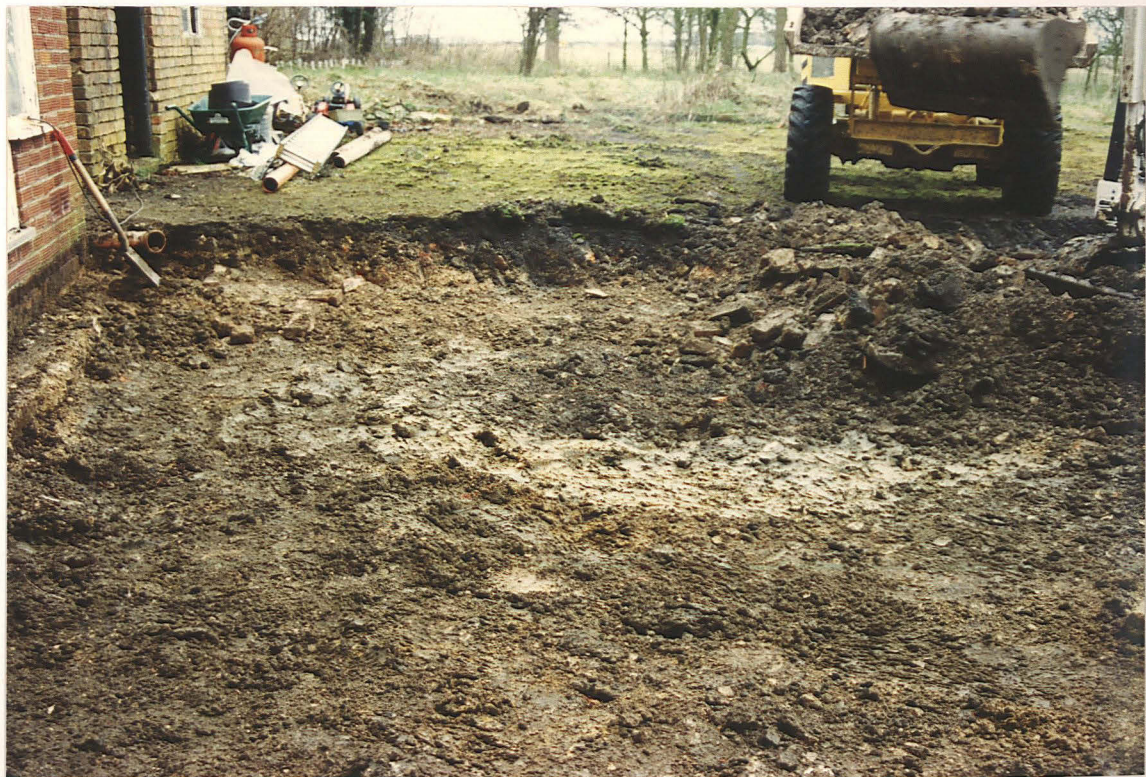
Pl. 3 Yellow clay and ash above ditch or pit 6. Looking NW.

After removal of the levelling material for the tennis court, three features were evident within the cleared area of the new extension. To the SW was an extensive area of yellow clay which formed the rectangular end of a 3m wide feature extending northwards beyond the site. Within the centre of this clay was an area of ash and clinker (Pl. 3). After excavation of Trench 1 along the northern side of the extension, it was apparent that the yellow clay was redeposited material surrounding a deeper central feature 6 which incorporated topsoil with brick and stone rubble. The deepest element seemed to be a 1m wide north-south aligned ditch, cut into the undisturbed orange sandy clay. The ditch appeared to have been backfilled this century, although there was no clue as to its original date.

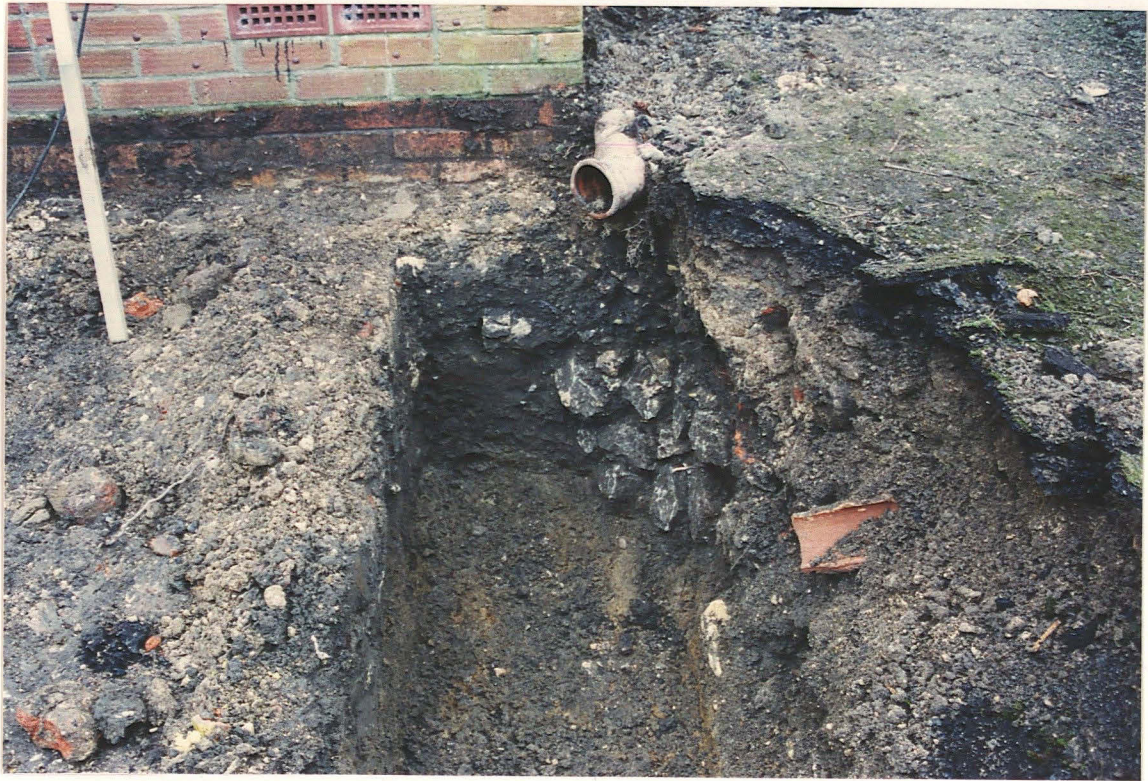
Pl. 4 Stone rubble foundation 7 in side of Trench 1. Looking west.

Trench 1 was excavated to a depth of about 1m below the external ground level. At the NW end of the trench, and almost certainly cut by the foundations of the brick wing, was a feature 7 filled with limestone rubble (Pl. 4). The feature had virtually vertical sides and may have been a wall foundation trench or a stone-packed post-hole. Insufficient was exposed to allow the shape or extent of this to be obtained.

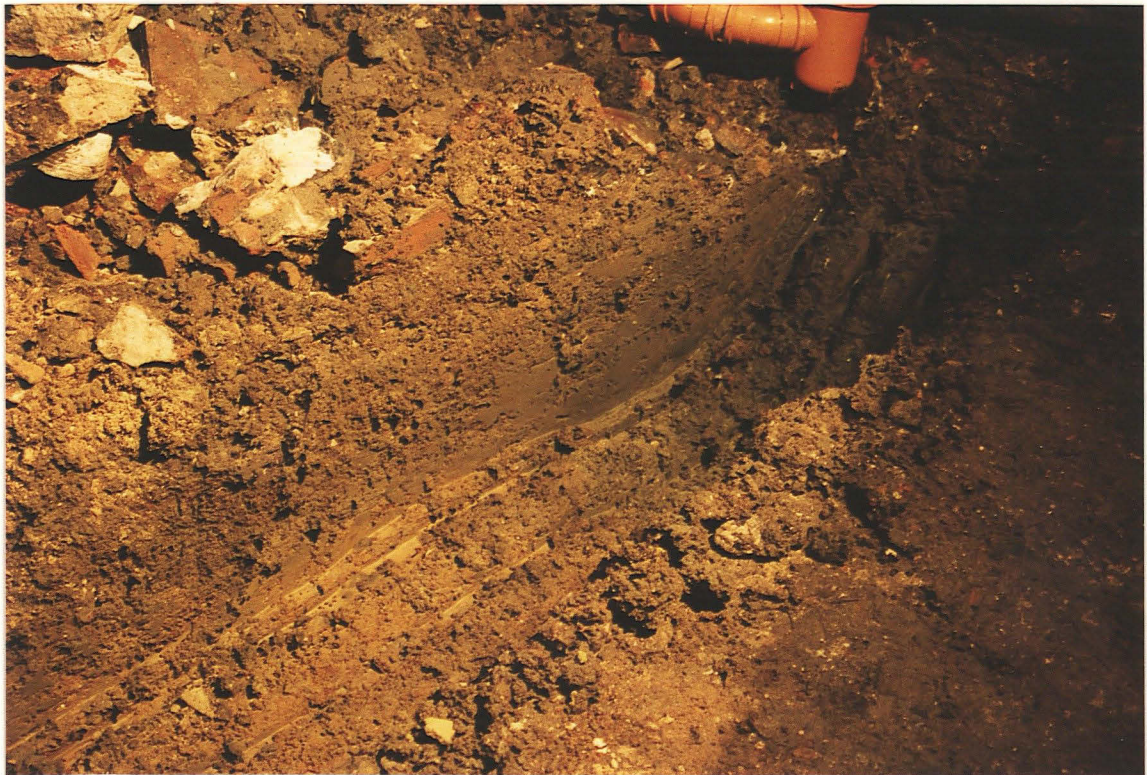
Pl. 5 Dark brown upper fill of ditch 2 below modern drain. Looking south.

An active domestic drain, outside the kitchen window, was found to overlie a much older backfilled west-east aligned ditch **2** (Pl. 5). The ditch was about 1.8m wide at ground level, sloping to about 0.8m wide close to its base 0.8m below the stripped surface. To the north, the 'natural' at the trench base was dirtier than elsewhere and may possibly have been fill of an even earlier adjacent ditch **5**, on a similar alignment. Two fills were recognised: the upper was a dark brown mixed clay loam, with an underlying grey/green silty clay. From the evidence of Trench 3, it seems that these represent two successive cuts of the same ditch.

The southern side of the deeper part of ditch **2** coincided with the position of the stone wall of the farmhouse. Its position suggested that the house had been built up to a traditional west-east boundary ditch which had already become backfilled.
