ARCHAEOLOGICAL WATCHING BRIEF OF DEVELOPMENT ON LAND AT BAYFIELD FARM, (PLOT 24), TIMBERLAND, LINCOLNSHIRE (TBF97)

Work Undertaken For S. Fenwick Building Contractors Ltd

January 1999

A.P.S. Report No. 12/99

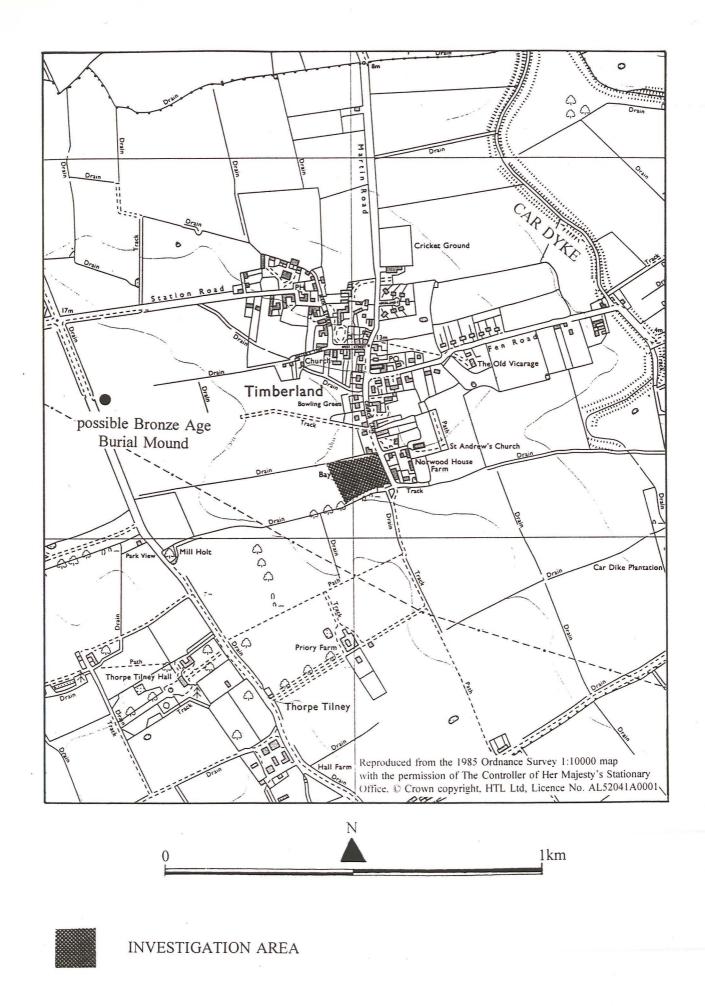
Figure 2: Site Location Plan, showing archaeological remains in area

The site is in an area of archaeological remains dating from the prehistoric period onwards (Fig. 2). Approximately 0.5km west of the site is a possible burial mound of Bronze Age date. Additionally, a Bronze Age stone axe is recorded as having been found near the Car Dyke in Timberland.

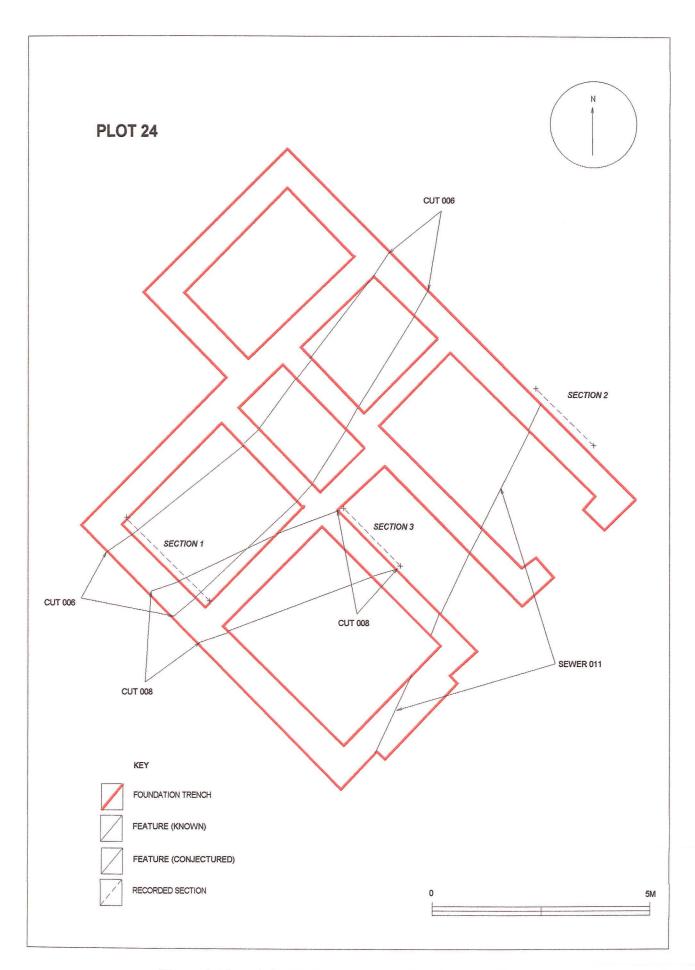
Figure 4: Plan of plot 24 showing recorded sections and features

Excavation of the foundation trenches was completed by machine (Fig. 4). Following excavation, the sides and bases of the trenches were manually cleaned and inspected for archaeological features.

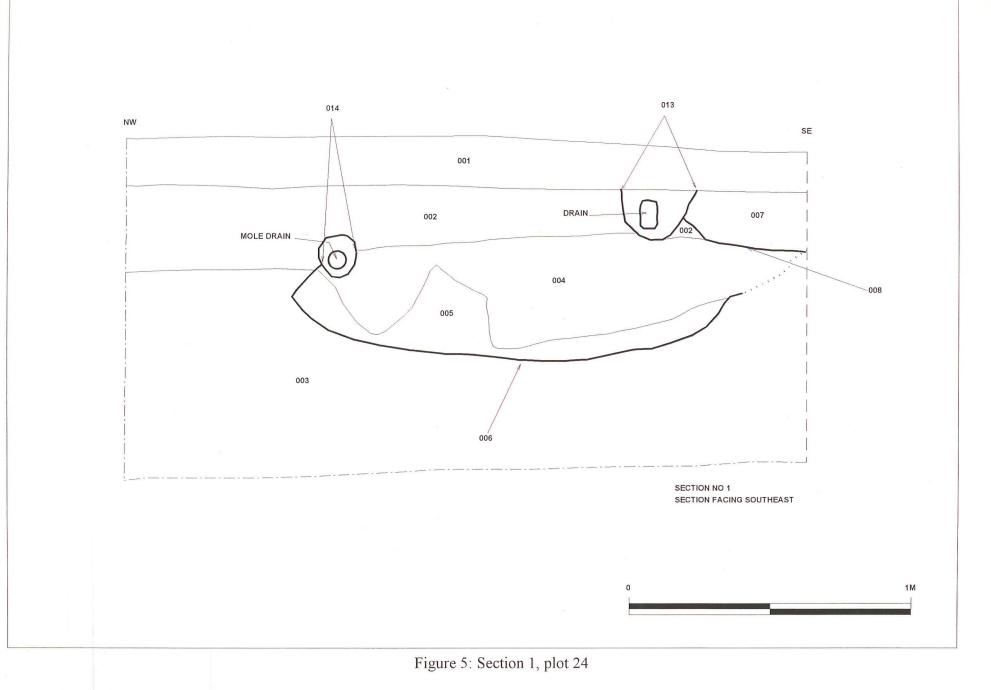
Cutting into the natural clay on the west side of the plot was a north-south linear feature [006], approximately 0.7m deep and 1.8m wide (Fig. 5, Section 1; Plate 2). Interpreted as a ditch, this was filled with deposits of brown-grey silty clay [004] and light grey clayey chalk fragments [005].

Truncating the eastern edge of ditch [006], and also cutting the subsoil in the centre of the plot was a northeast-southwest aligned linear feature [008]. Approximately 0.25m deep, 1.5m wide and filled with light brown silty clay [007], this is interpreted as gully or furrow (Fig. 5, Section 1; Fig. 6, Section 3).

Cutting the subsoil [002] were two field drains [013 and 014]. One of these [013] cut down from the surface of the subsoil but the other [014] was in the body of the deposit and is explained as a mole drain (Fig. 5, Section 1).

Cutting into the natural was a ditch and gully or furrow (Phase 2). The ditch is probably a former field boundary and it is likely that the shallower feature is a remnant of ridge and furrow ploughing. Both the ditch and furrow were part filled with chalk fragments which is probably material deliberately dumped into the features to backfill them. Moreover, the similarity of these materials in the two features may indicate that the backfilling of both occurred at the same time. Above the ditch and furrow was a subsoil that was probably of agricultural origin, formed by ploughing. It is likely that the ditch and furrow were originally cut through this layer but ploughing erased the upper parts of the features. Cutting into this subsoil was a further furrow which may also be a remnant of ridge and furrow ploughing.

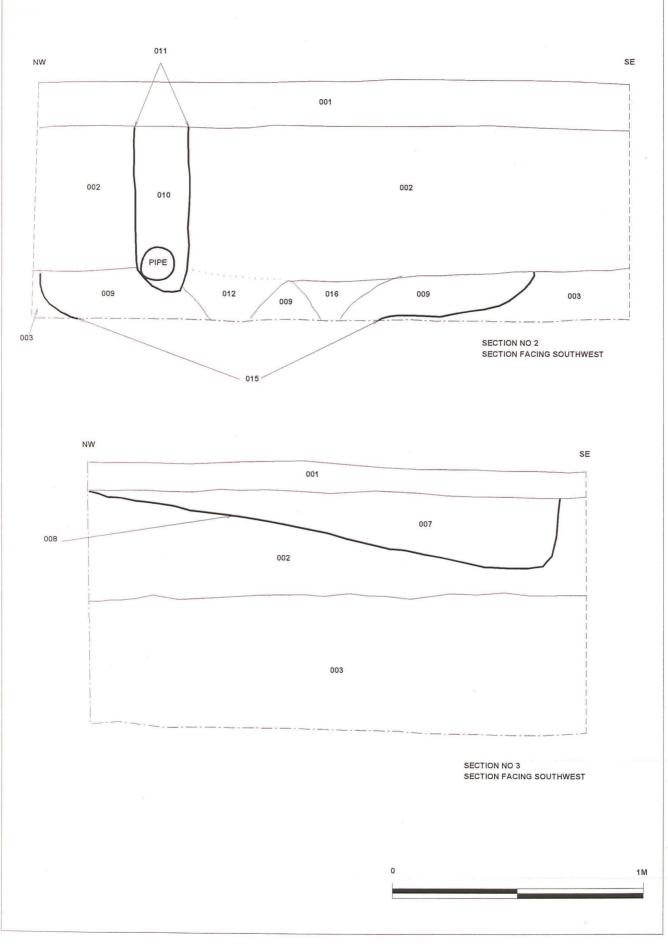
Figure 6: Sections 2 and 3, plot 24

Near the northeast corner of the plot, and also cutting the natural clay, was a shallow, possibly flat-based feature [015], interpreted as a possible gully or furrow (Fig. 6, Section 2). This was filled with brown silty clays [012] and [016] and light grey clayey chalk fragments [009].

Also cutting the subsoil on the east side of the plot was a north-south sewer trench [011] containing a circular sewer pipe and stone backfill [010], (Fig. 4; Fig. 6, Section 2).
