**Doughty's Mill, Lincoln,
Phase 3**

ARCHAEOLOGICAL WATCHING BRIEF

CLAU ARCHAEOLOGICAL REPORT NO: 373

A
Report to
Longhurst Housing Association

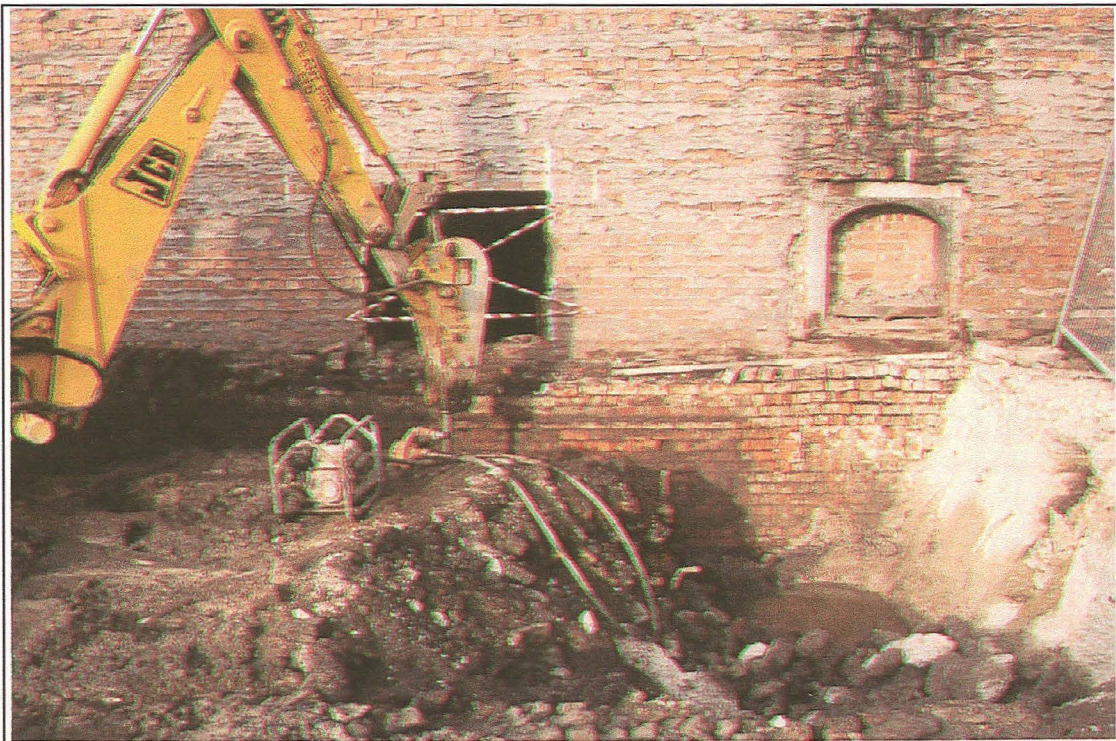
Plate I: View looking north, showing the excavation for the removal of buried obstructions (in this area concrete up to 1.80m thick was encountered) to the south of Building One. Previous remodelling to the mill buildings had severely disturbed archaeological deposits across much of the site.

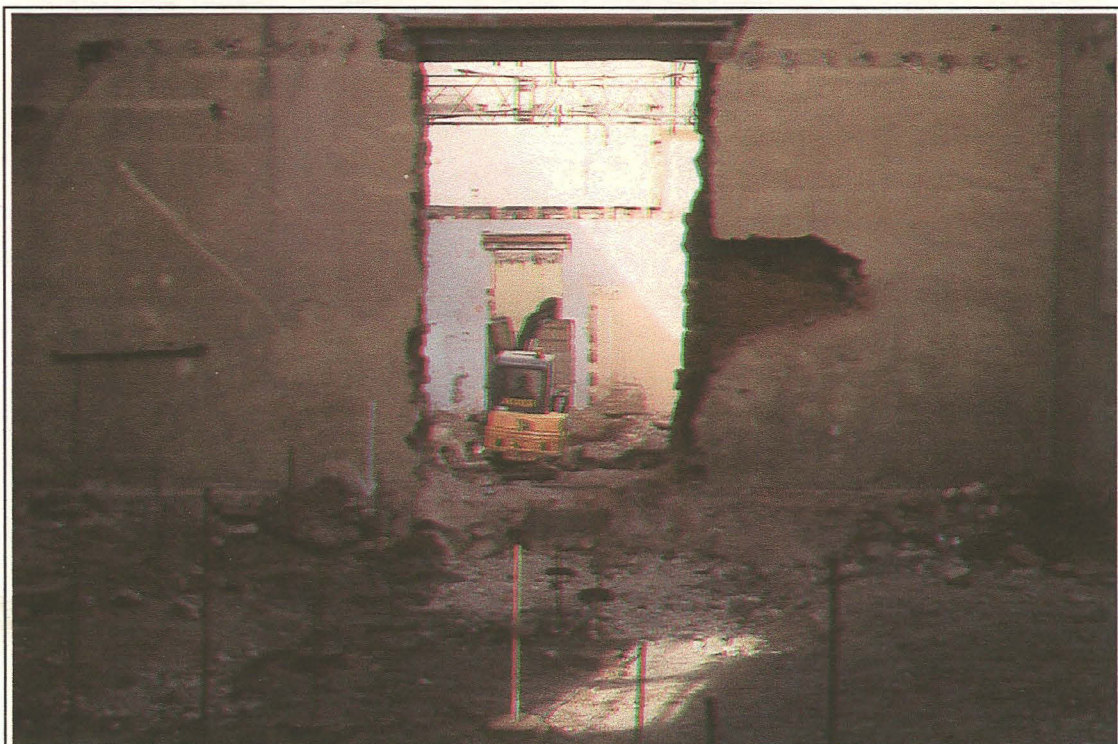
Plate II: View showing excavation of pile caps within building 2 (looking south).

An extensive piling programme was implemented within the mill buildings themselves. Excavation by the main site contractor of the existing internal ground floors to both mill buildings failed to reveal identifiable archaeological deposits. Much of the upper 1m of the footprint of the mill buildings had been extensively remodelled during the mill's existence. Piling in external areas of the site, for extensions to the existing buildings and for the stabilisation of the brick facade lying between mill buildings 1 and 2, was also monitored.
