## Dunston Heath, Phase 2

### Archaeological Monitoring on Metheringham Heath Lane

Report prepared for  
Anglian Water Services Ltd

LAS Report No. 349

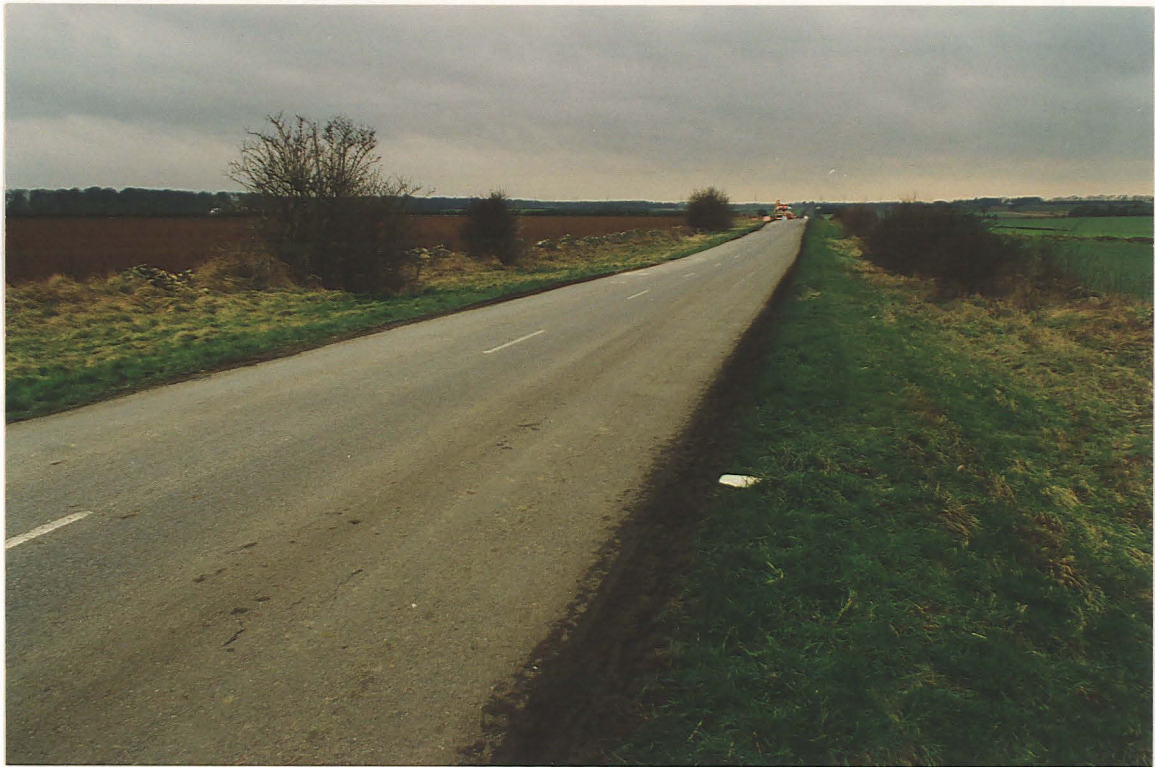
**Pl. 1** Metheringham Heath Lane, looking west along the specified area of archaeological interest. The works in progress are at Trench 4.

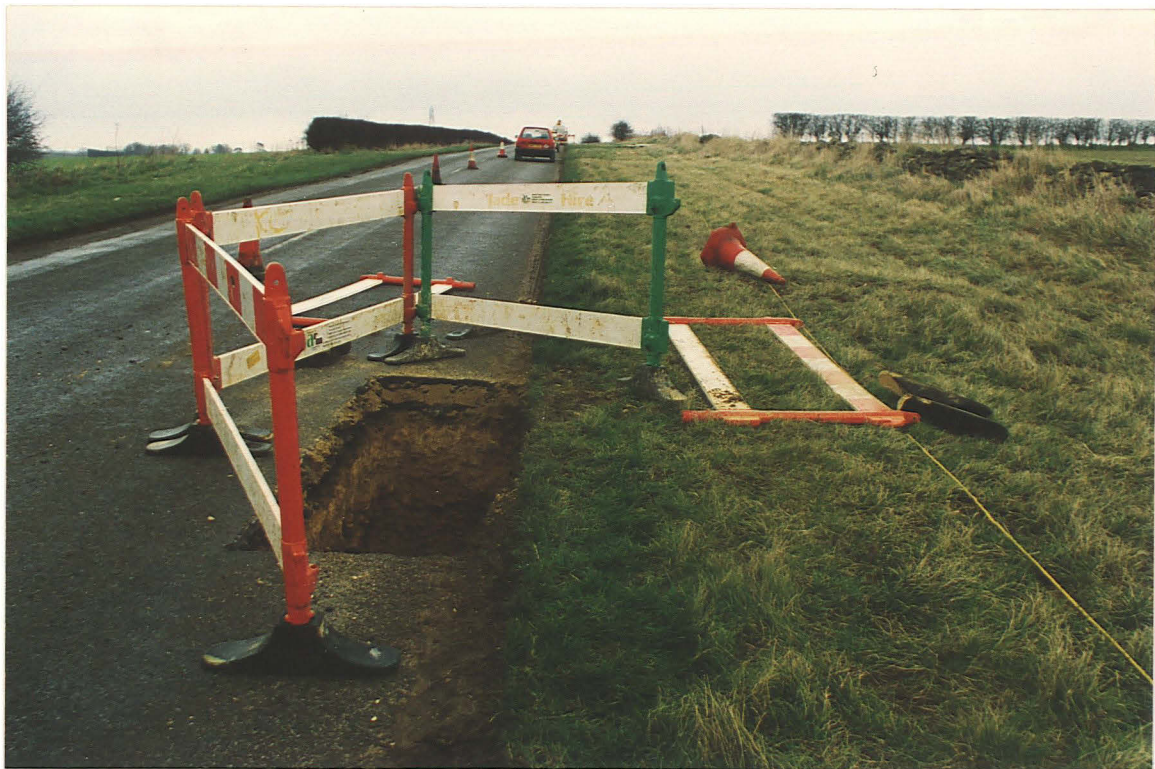
**Pl. 2** Metheringham Heath Lane, looking east past Trench 6.

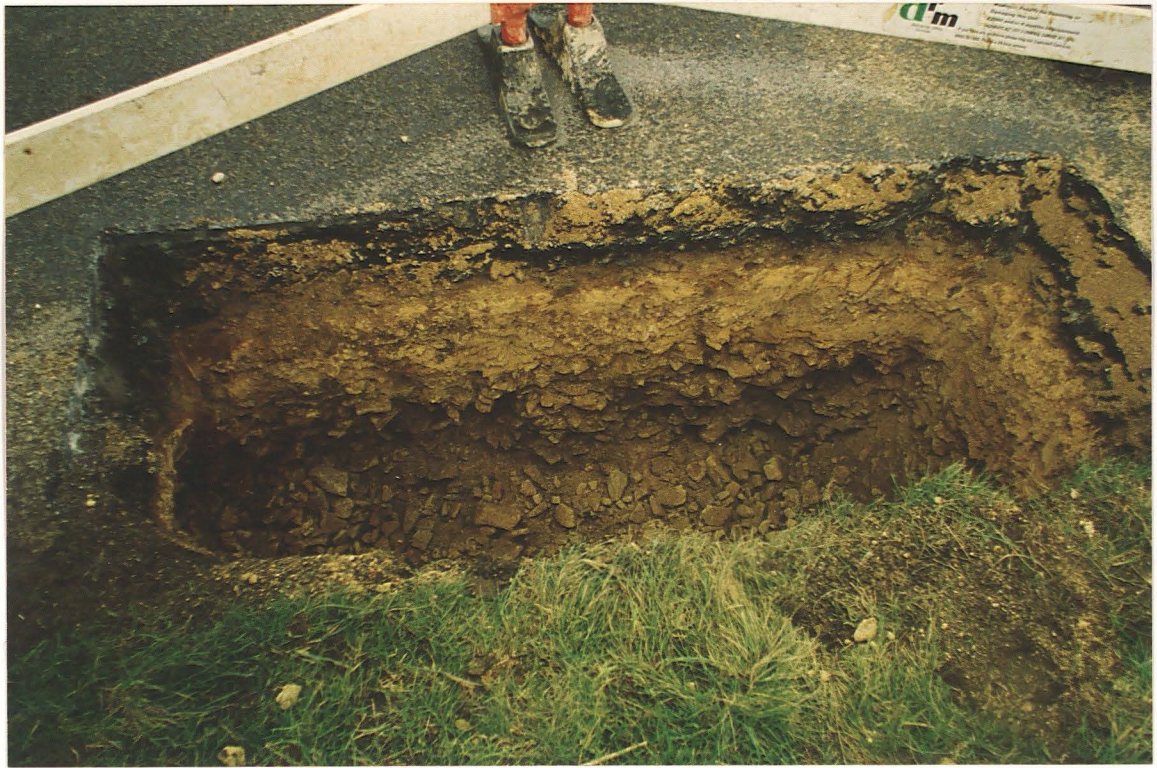
Trenches 3, 4 and 6 revealed nothing other than limestone bedrock beneath the road foundation (Pl. 3). The northern side of Trench 5 revealed two narrow disturbances in the limestone, filled with red/brown clay loam (Pl. 4). These were almost non-existent in the southern trench side and were interpreted as naturally caused cracks or watercourses (Pl. 5).

Pl. 3 Limestone bedrock in side of Trench 6, beneath foundation of modern road.

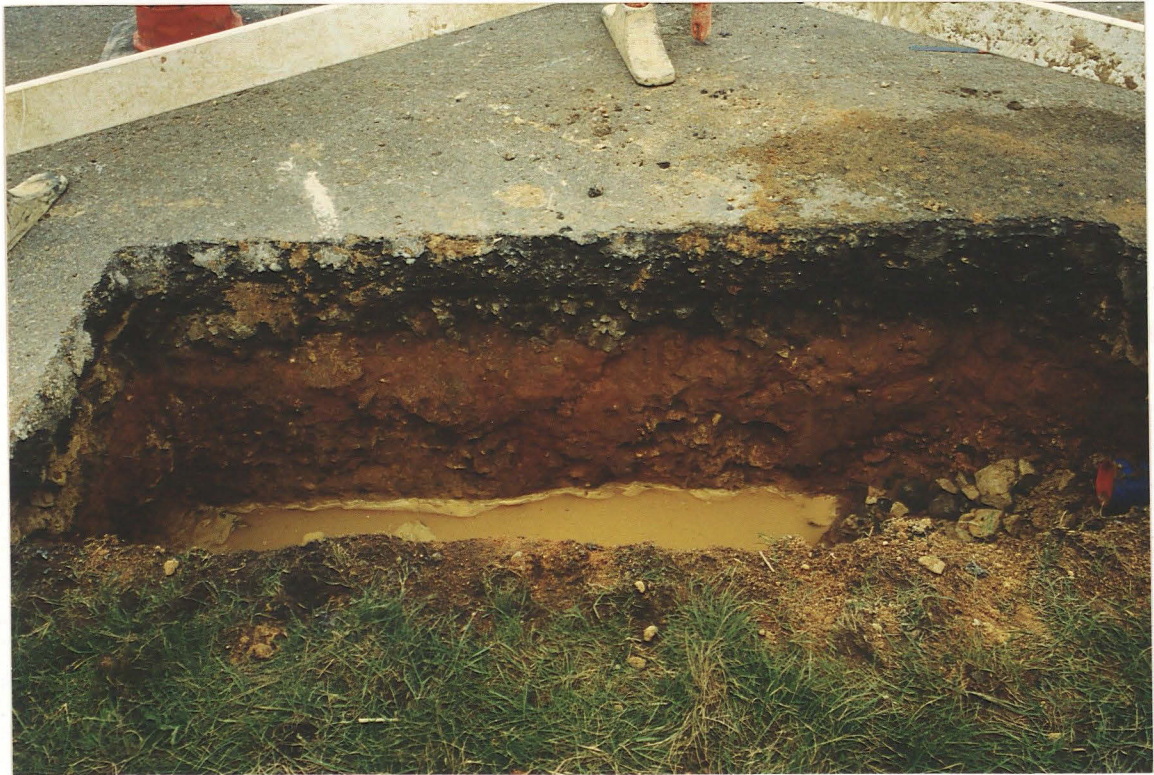
Pl. 4 Red/brown clay loam filling natural features within the limestone bedrock, northern face of Trench 5.

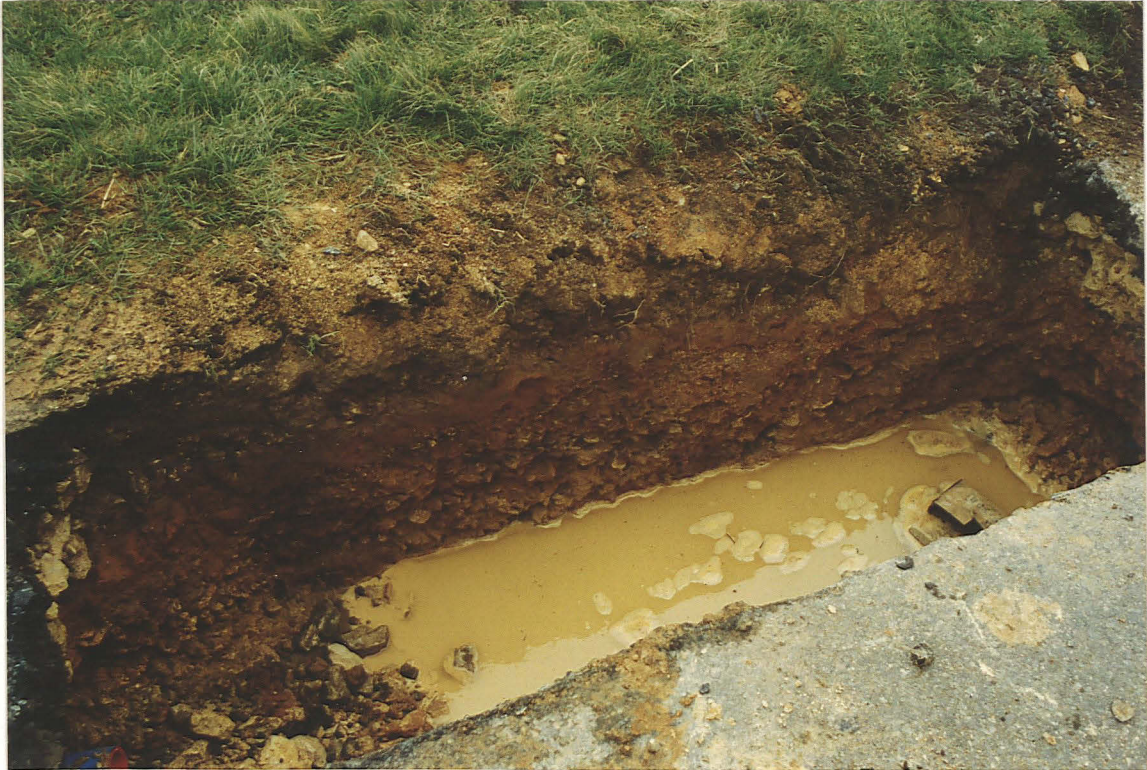
**Pl. 5** The southern face of Trench 5 showed that the natural features (filled with red/brown material) were not extensive.

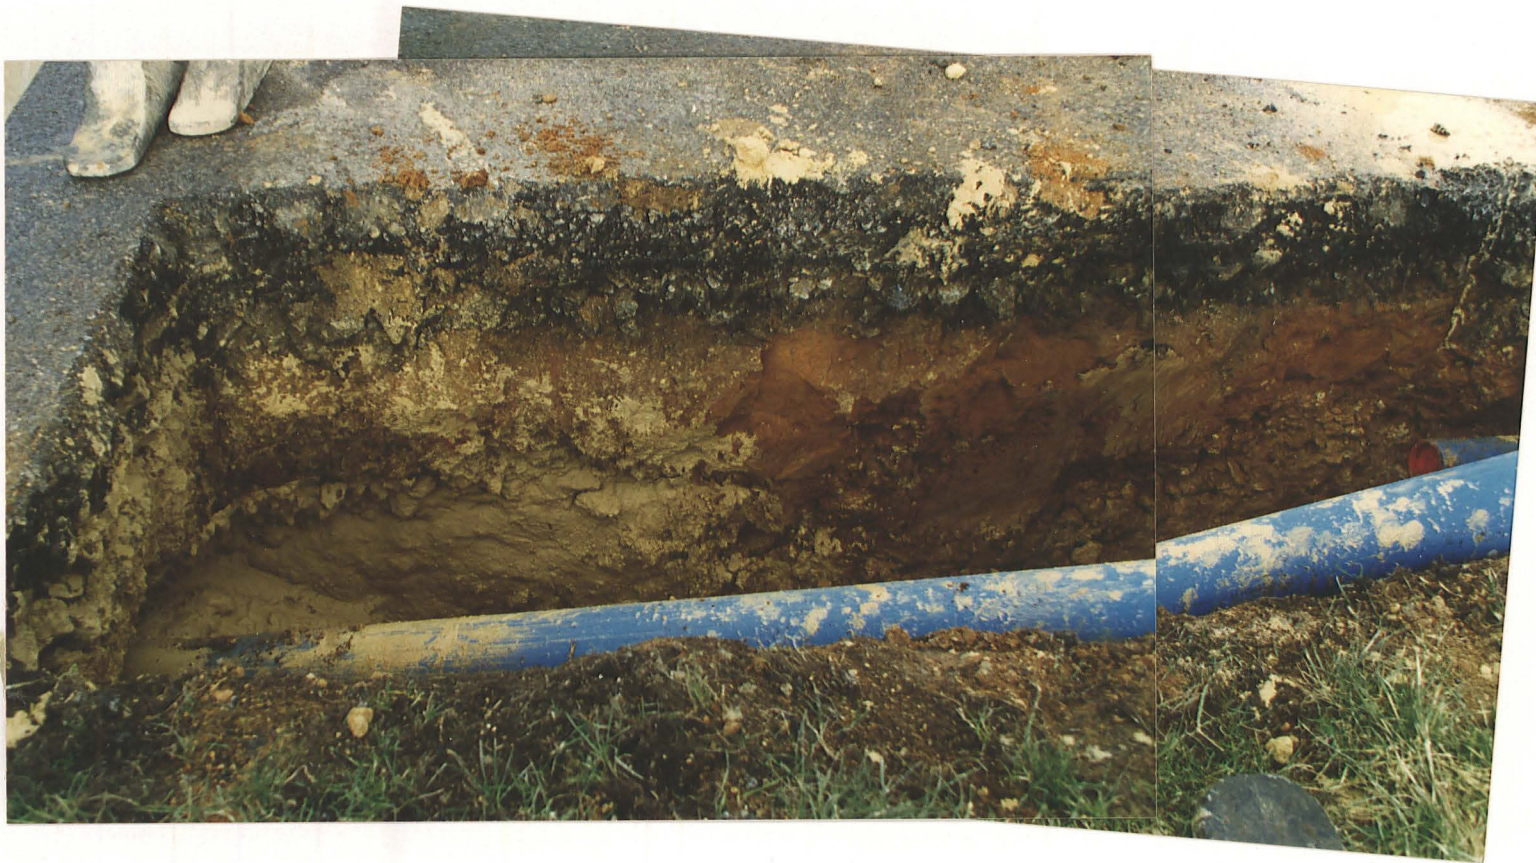
Trench 7 contained a red/brown loam filling a feature cutting the bedrock, but it was impossible to determine whether it was a natural feature or the base of a truncated or shallow artificial ditch or pit (Pl. 6).

PI. 6 Red/brown clay loam in Trench 7 was interpreted as the fill of a naturally formed feature within the limestone, but might have been fill of an undated ditch (looking north).

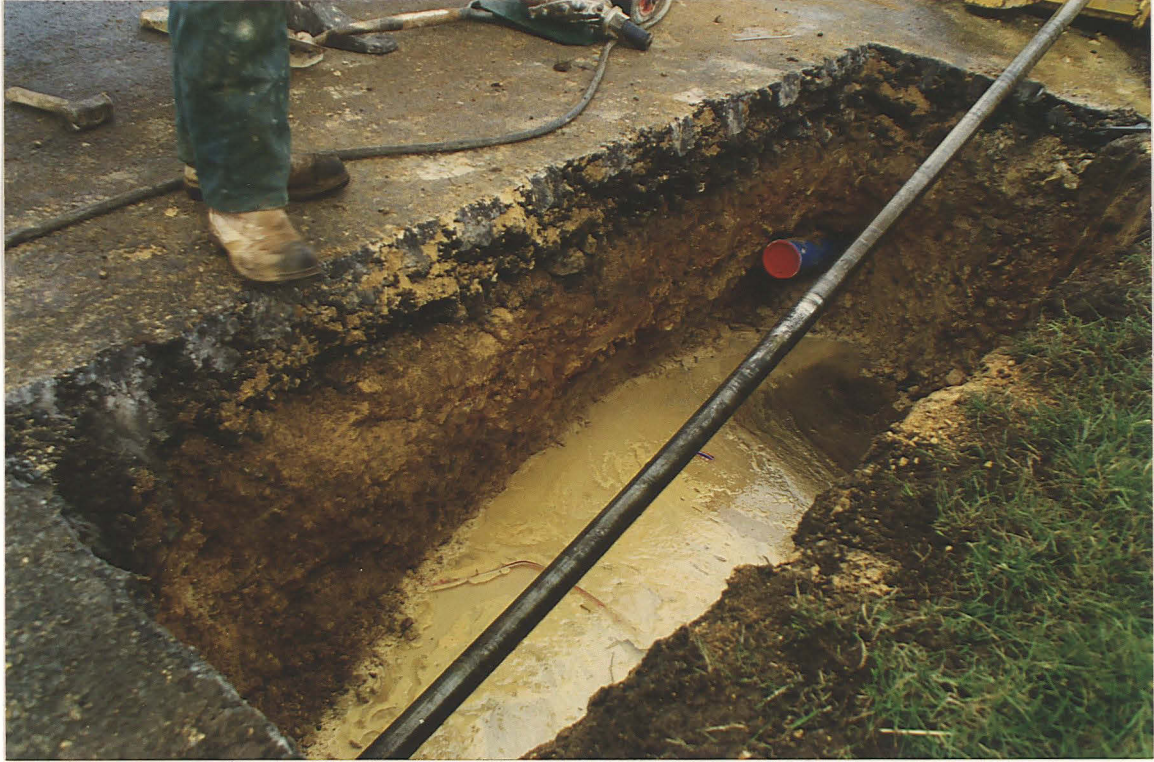
In Trench 8, the road sealed a mixed series of deposits, with limestone brash within a clay loam matrix (Pl. 7). This was thought to be naturally formed although it could conceivably represent backfill within a very wide feature.

**Pl. 7** Mixed limestone brash and clay loam in Trench 8 was thought to be a natural deposit, although it could possibly have been fill of a large artificial feature.

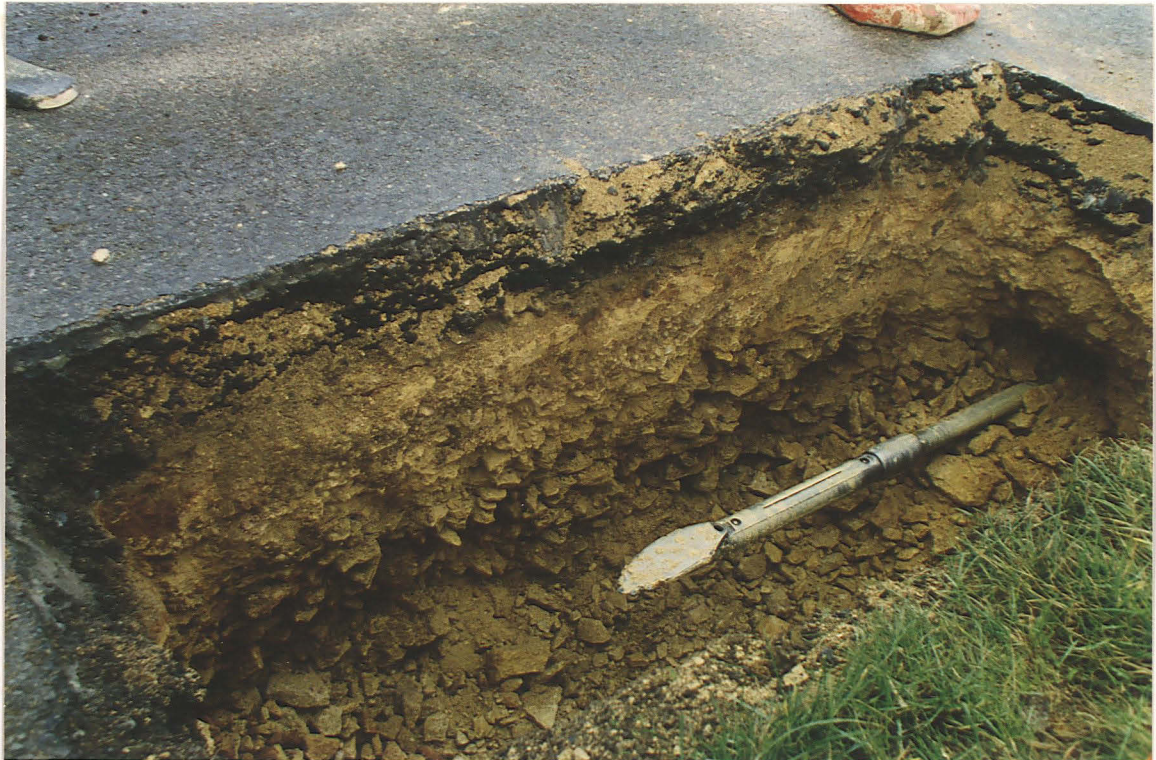
Trench 9 was cut through dense limestone bedrock (Pl. 8). Trenches 10 and 11 cut through make-up deposits used to carry the road across a broad natural depression.

**Pl. 8** Dense limestone bedrock in Trench 9.
