No.10, CORNMARKET, LOUTH, LINCOLNSHIRE

PHOTOGRAPHIC BUILDING SURVEY

Report prepared for John Stainton (Architect)
by

September 2008

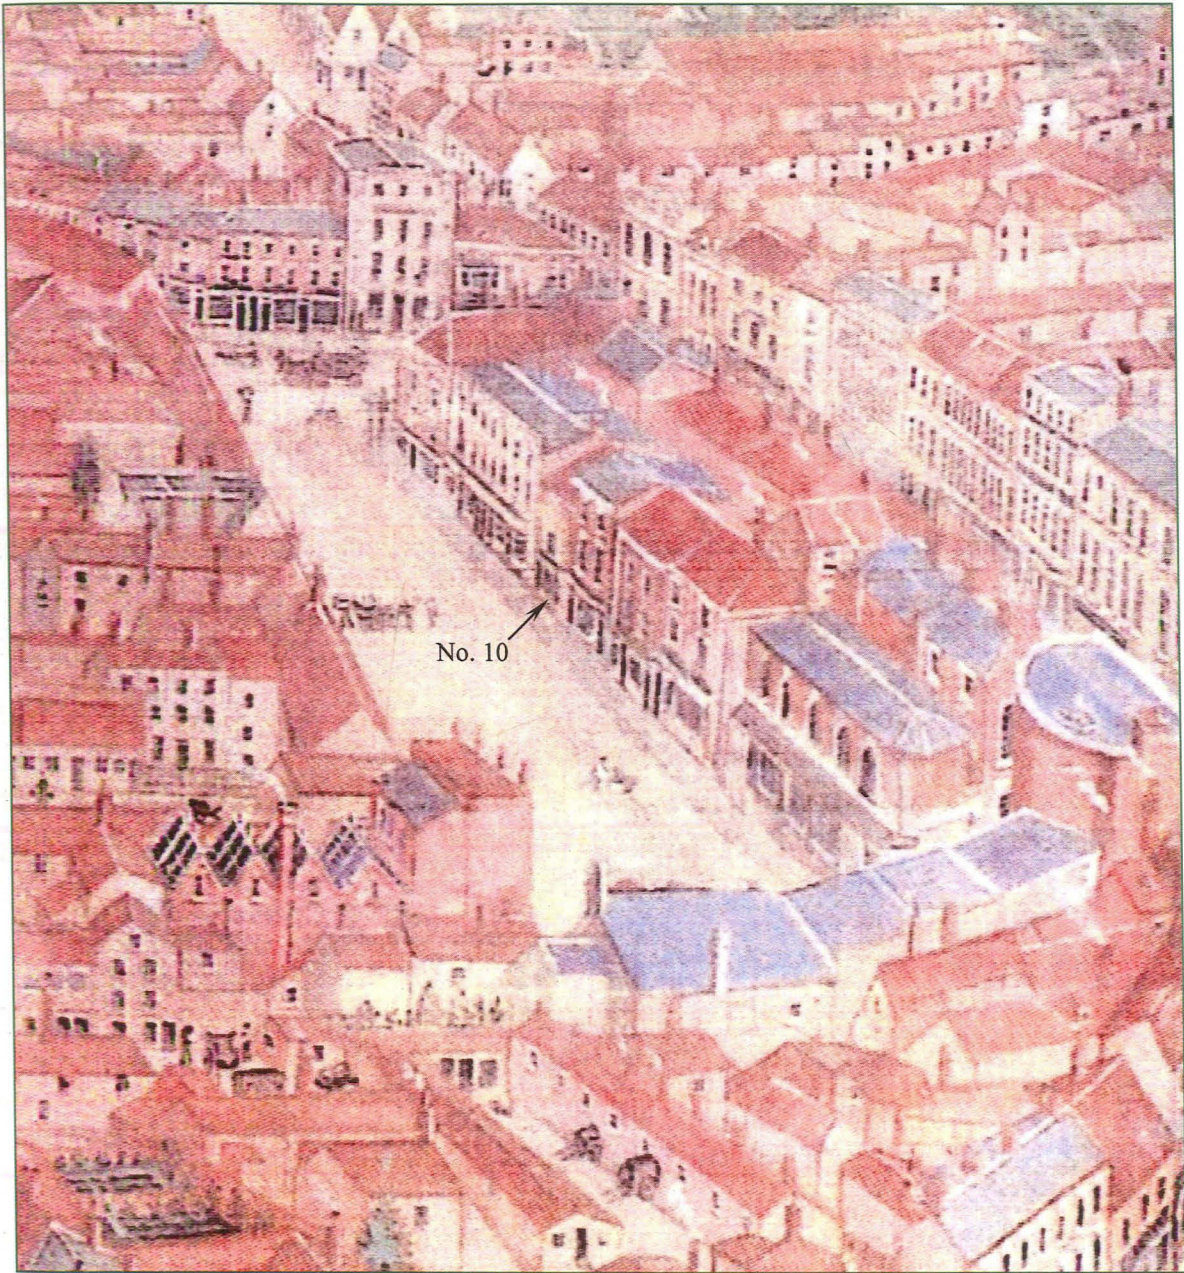
Figure 5: Enlarged extract from the Louth Panorama, showing the Corn Market in detail. The building in the foreground, with the elaborate frontage and multiply pitched glass roof, is the converted theatre that became the new Guildhall, and was shortly to be demolished and replaced by the Cornmarket.

The discrete groups of buildings along the south side of the Corn Market can be identified from their DoE listings: nos. 2-8 a single stucco-fronted building; no. 10 slightly lower than the surrounding buildings, with a red pantile roof and large oriel window; nos. 12, 14-16 and 18-20 as three narrow structures side by side, and the long, two-storey frontage of nos. 24, 26 and 26a at the near end of the row.

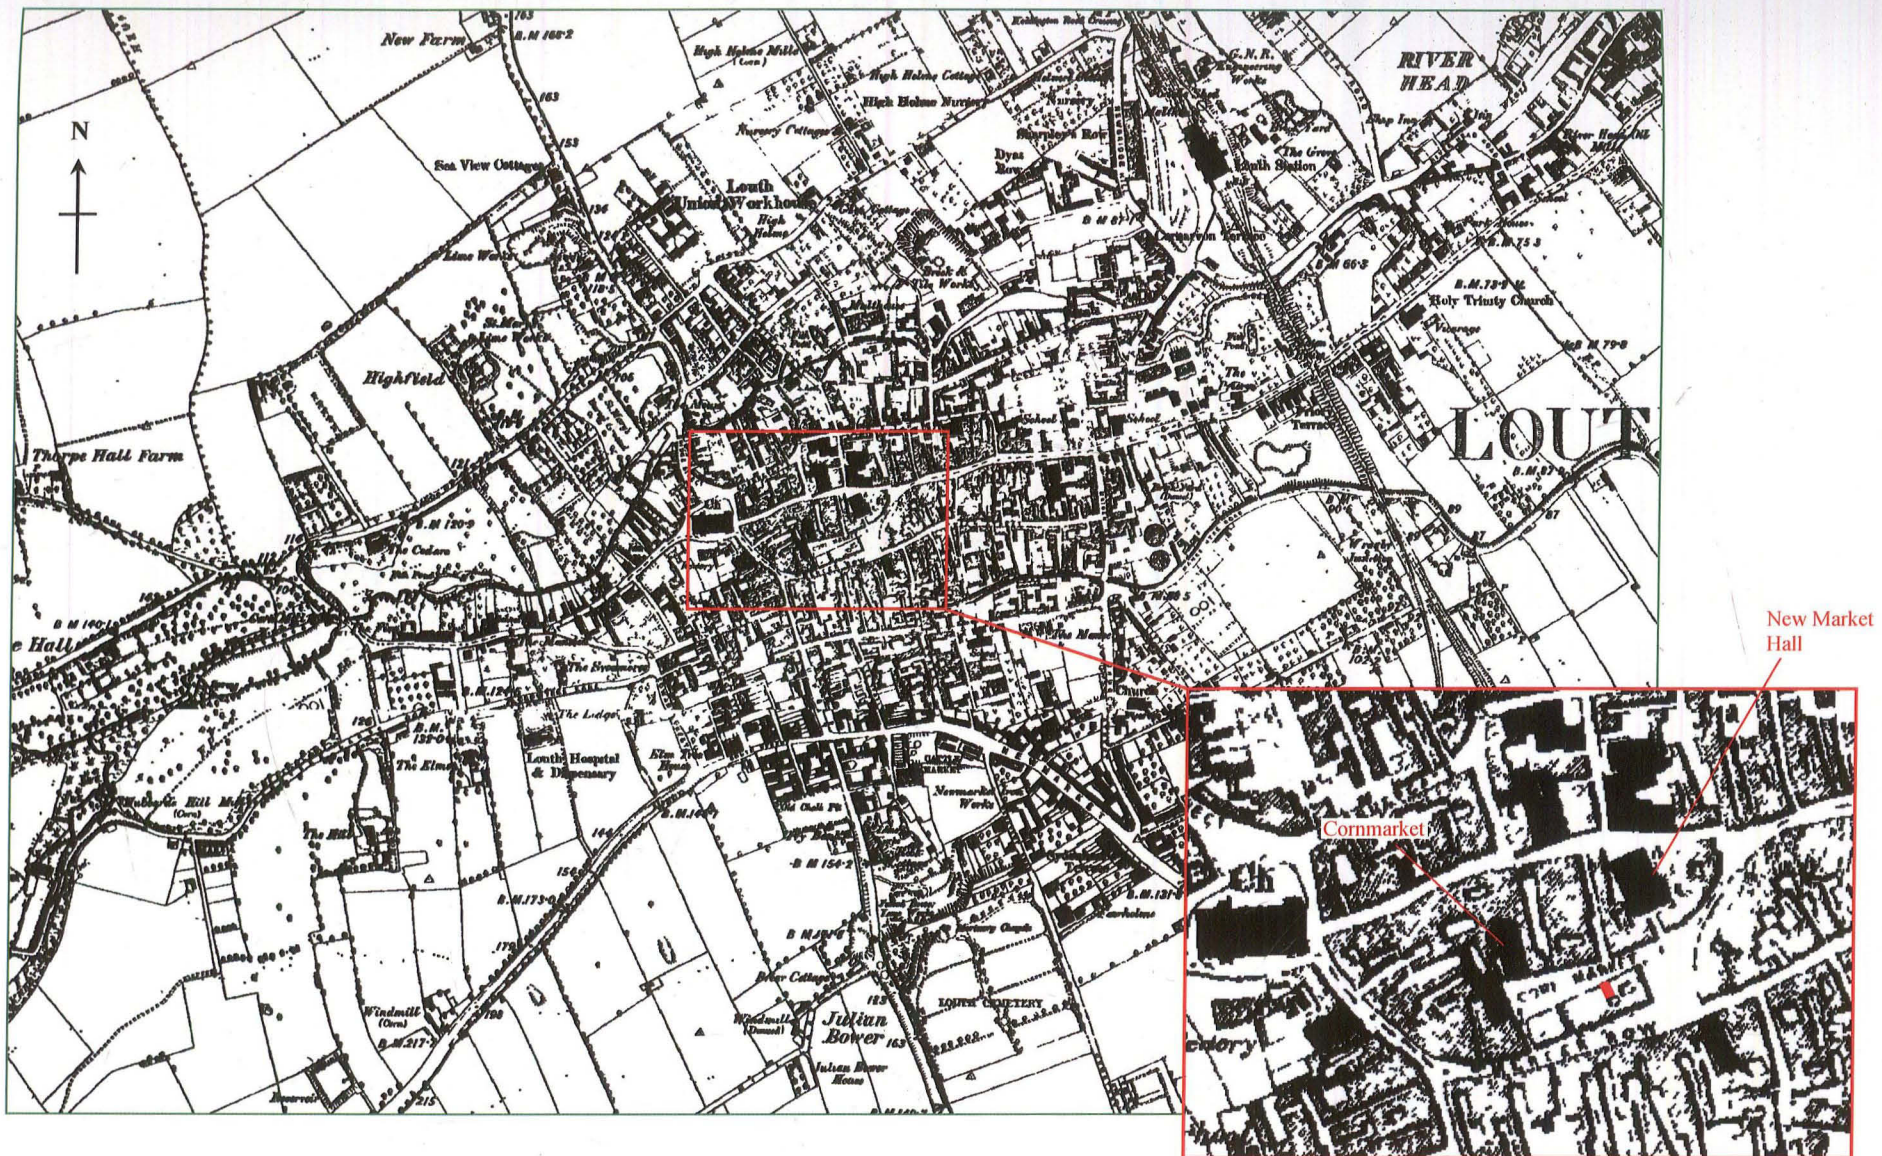
Figure 6: The 1st edition 6" Ordnance Survey map of 1890, with an enlarged extract (not to scale) showing the Corn Market. The probable position of no. 10 is shown in red.

The 6" 1st edition Ordnance Survey map of 1890 shows the south side of the Corn Market in a very similar pattern to its present form, with a large block of buildings, enclosing small yards or open spaces, to the east and a smaller, solid block to the west, separated by a narrow thoroughfare (fig. 6). However, the position of no. 10 can still only be conjectured. The 25" 2nd edition Ordnance Survey map of 1906 is detailed enough to show individual buildings, and no. 10, Corn Market can confidently be identified: the area is now very close to its modern appearance (fig. 7).

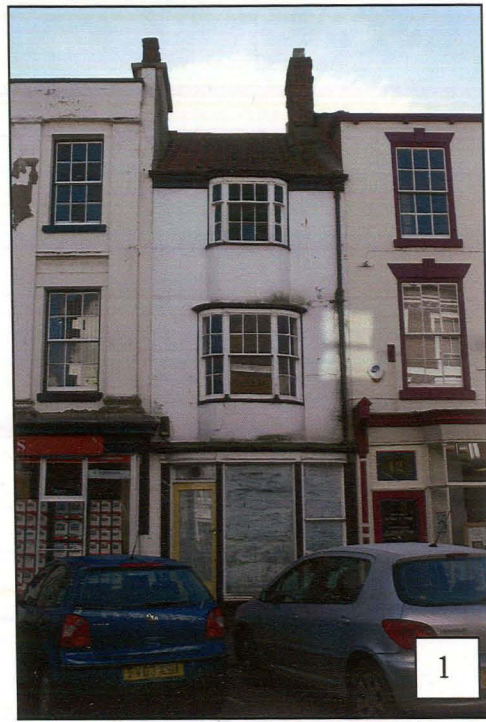
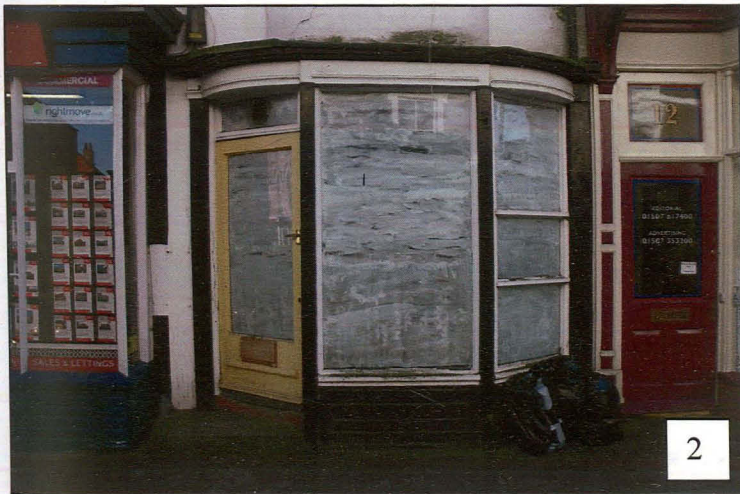
The building was of three storeys, with a pitched pantile roof, and was constructed of brick (the street front is rendered). It had a double-flue chimney stack at the ridge, with a single flue stack to the south, both stacks on the west wall of the property. The street frontage was characterised by the 2-storey, 3-light curved oriel to both first and second floors, reducing in size and retaining hung sashes with glazing bars and plain pilasters.

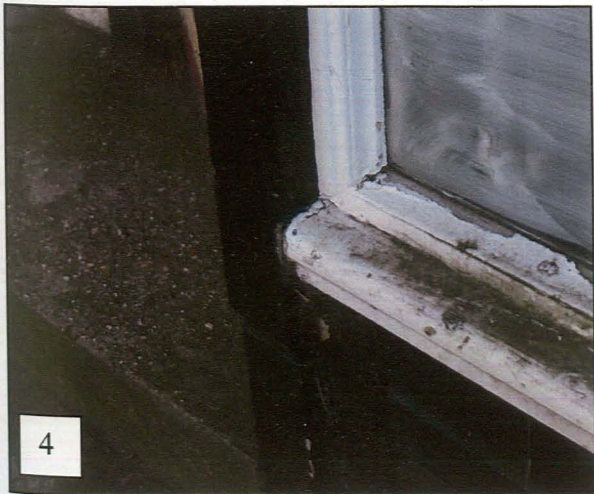
The ground floor had a modern shop frontage, probably constructed in place of an earlier one, with plain pilasters and entablature, plate glass windows (the western window divided as a service hatch, now reglazed) with a modern door with fanlight on the east side.

The first floor oriel window was of three lights, with a central double hung sash flanked by two curved sashes. These were separated by plain pilasters with simple capitals. These windows had no sill, the base of the capitals being chamfered, but the bay had a simple ovolo cornice.

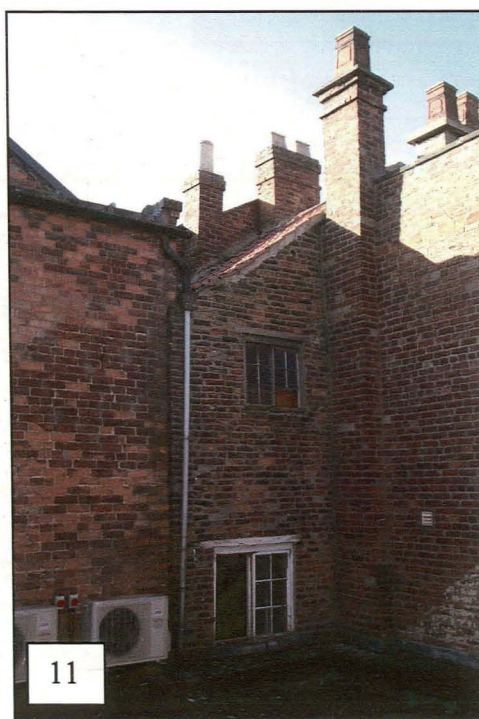
The only exposed exterior brickwork was at the rear of the property above ground floor level. This was 4" in thickness, and of a mixture of bricks, whose size varied considerably (average brick size: $9\frac{1}{2}" \times 4\frac{1}{2}" \times 2"$, 3 courses = $8\frac{1}{4}"$), in stretcher bond.

Two horizontally sliding sash windows were present in this elevation, one on the first floor and one on the second.

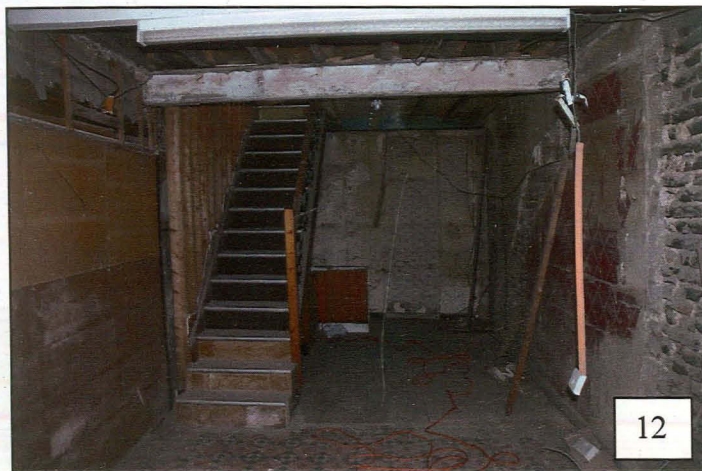
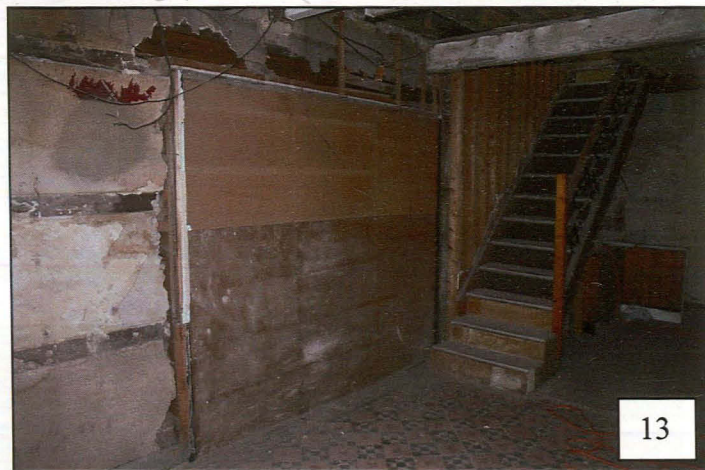
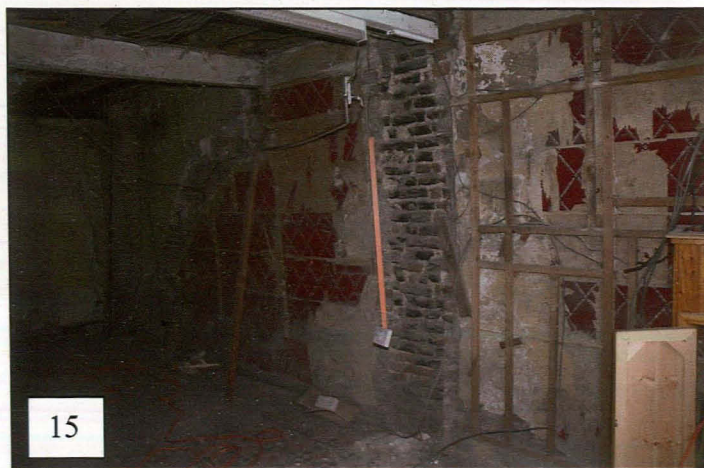
The room was dominated by a modern staircase, which led to the first floor. This was re-used, falling onto a 2-step custom-made plywood block at its base, with a 3" x 2" carcass. The staircase had 12 stairs (of 8" treads and 7½" rise) with a modern wrought-iron baluster panel and handrail.

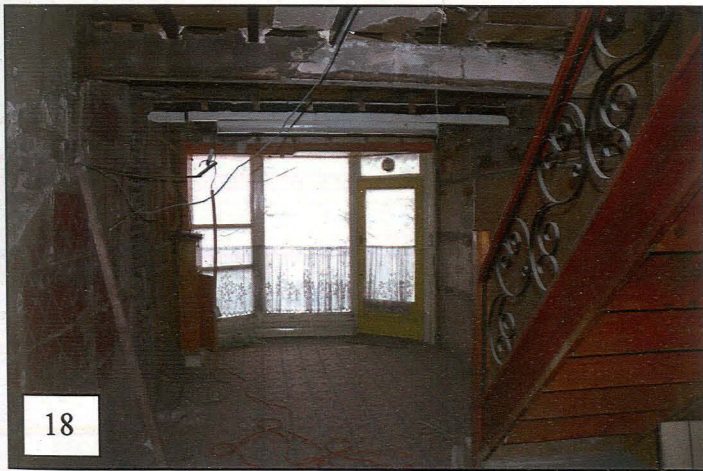
18

In the south west corner, a blocked doorway in the west wall showed that there was an opening into the adjacent property to the west (no.12); this had been bricked-up and plastered.

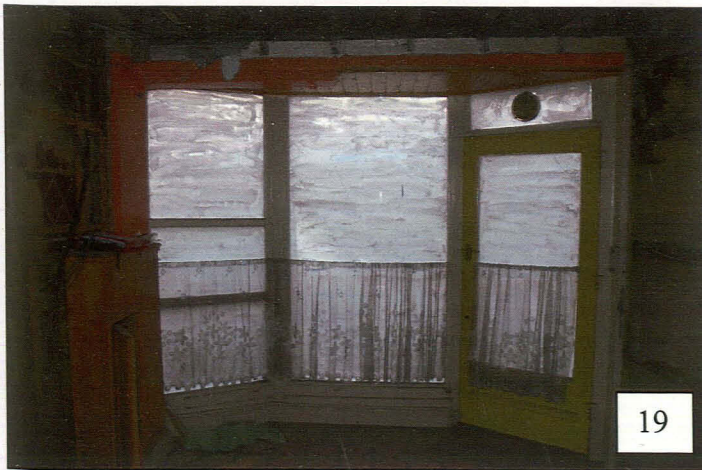
19

The wall above the opening for the shopfront was supported on two differently sized steel box girders, joined with a riveted plate. The soffit of the bay to the north of this had been infilled with tongue and groove pine boards and varnished.

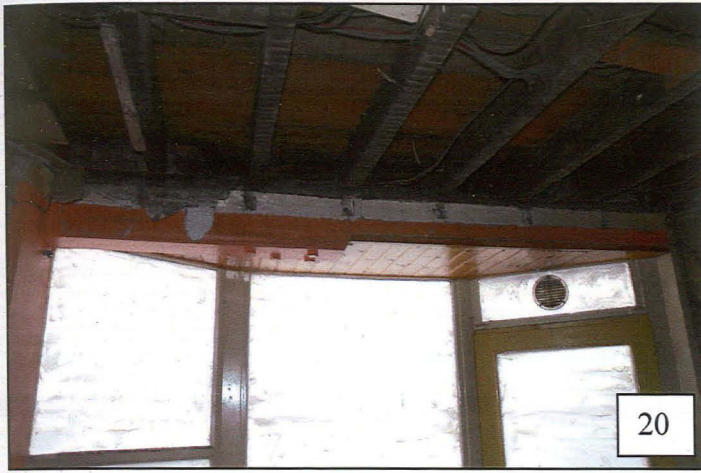
In the northern half of the room, the plasterboard ceiling has been removed, revealing the joists and floorboards of the first floor. These are supported on several larger east-west beams, the central one of which (probably in the position of an original partition) has a beaded stop-chamfer on its lower edges. In the southern part of the room, the plasterboard ceiling survives at the level of the upper face of the supporting beams and has been covered with textured wallpaper. A mild-steel extraction hood also survives on the west wall and would have vented into the southern chimney stack (which is only present above this level).

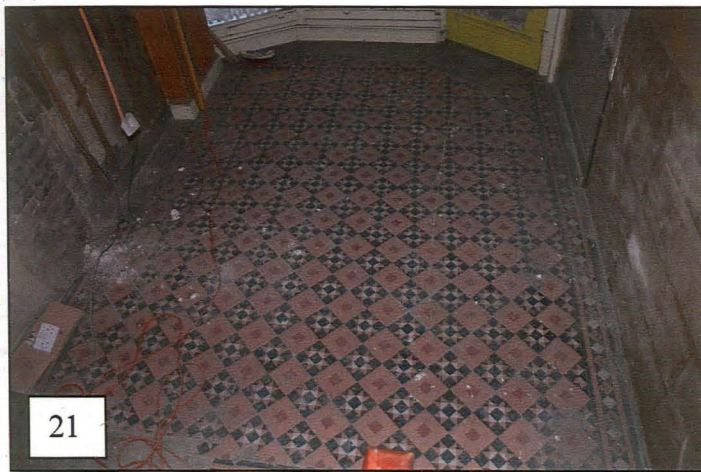
The floor in the northern half of this area is of patterned mosaic tiles, while that of the southern half is of hardboard over the original floorboards.

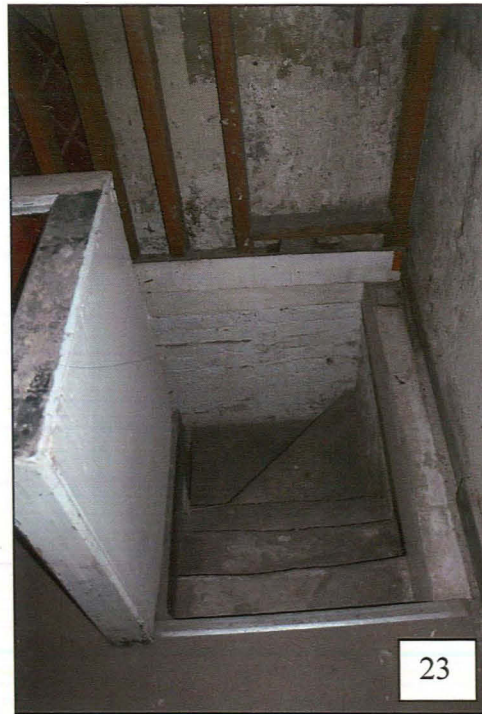
In the rear of the property, in the south east corner, a flight of stone steps leads down to the cellars. The banister here has been boxed in with plywood.

Ten steps afforded access to the cellars. They were 28" wide, with stone treads 2" - 2 ½" in thickness, with treads of 9" and a rise of between 7 ¾" - 8". As infill between the treads, a row of edge-set stretchers was present, with the exception of the lowest step, which was set on a row of edge-set headers.

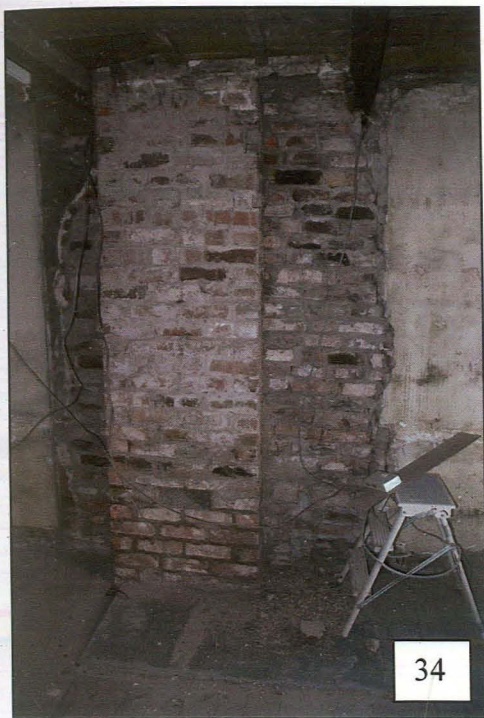
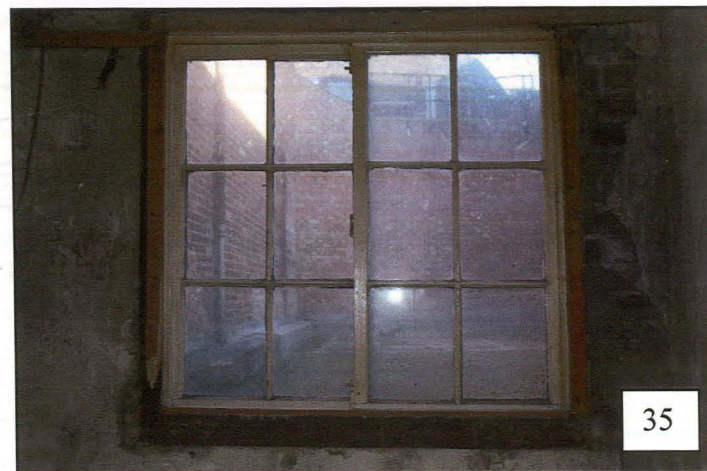
A window was present at the southern side of the eastern wall. This was of two six-light sashes of the horizontally sliding 'Yorkshire' type; its sill was 4' from the floor, and it provided access onto the flat roof of the neighbouring property.

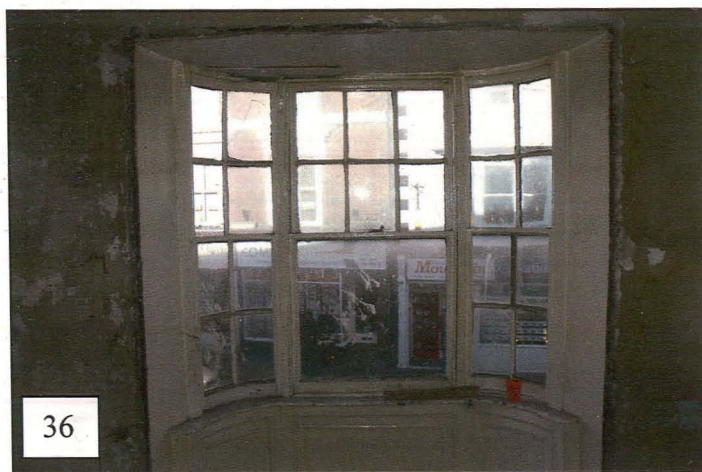
The bay window in the north wall comprised a central 12-light double-hung sash (the lower sash having a modern single pane), flanked by curved 8-light sashes. The area below the windows was of decorative timber panelling, of fielded panels with a bolection moulding. The windows and panelling have been successively repainted, obscuring the detail of the original mouldings.

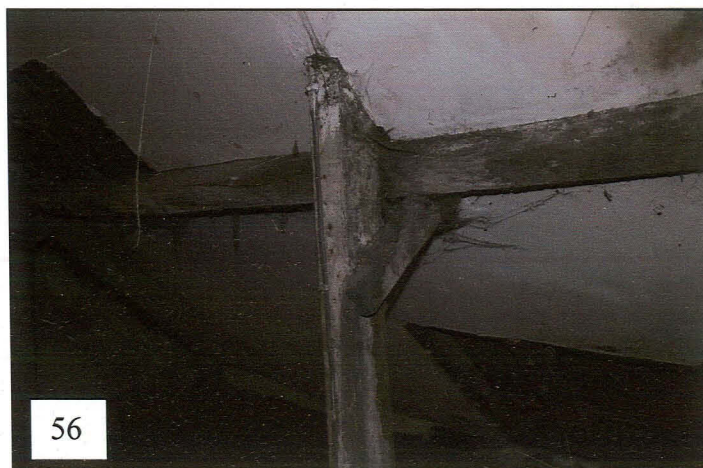
56

Some strategic holes in the plasterboard have allowed for a partial description of the construction of the roof. The roof appeared to be of collar-rafter construction, the lower purlins exposed below the plasterboard and clasped to four vertical posts (two posts per purlin) with short diagonal planks. The exposed rafters measured 3" x 2", while the lower purlins were of 3" x 2½" timber, and the vertical posts were 3½" x 2"; the layout of these posts in plan clearly demonstrated that they were placed arbitrarily rather than being members of a 'truss' arrangement.
