**ARCHAEOLOGICAL WATCHING BRIEF  
AT  
ST. ANDREWS CHURCH,  
STEWTON,  
LINCOLNSHIRE  
(SSA98)**

Work Undertaken For  
The Incumbent and Churchwardens  
of the Parish Church

March 1999

A.P.S. Report No. 26/99

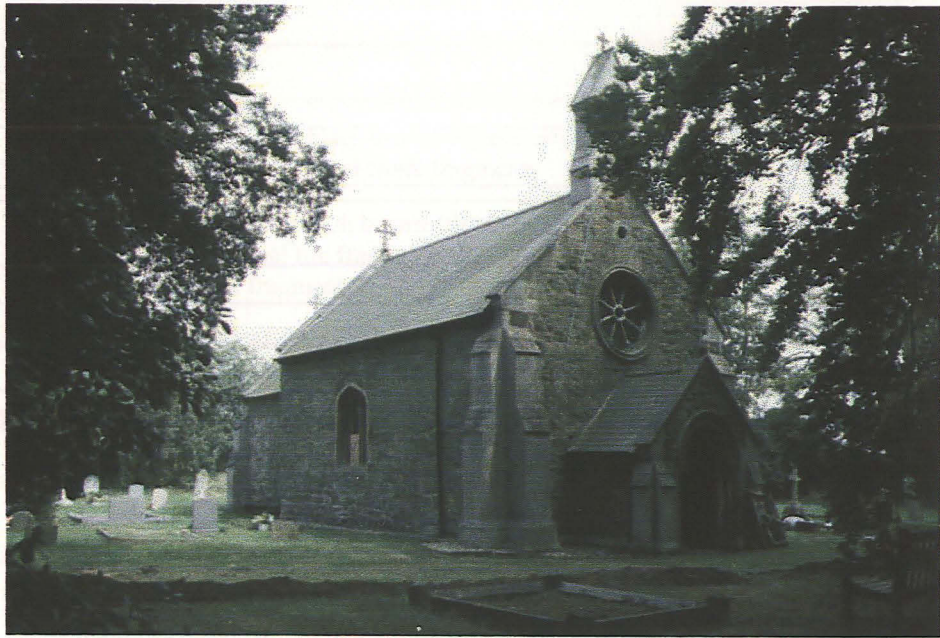
Plate 1 - St. Andrew's Church, with the pipeline trench  
in the foreground, looking southeast

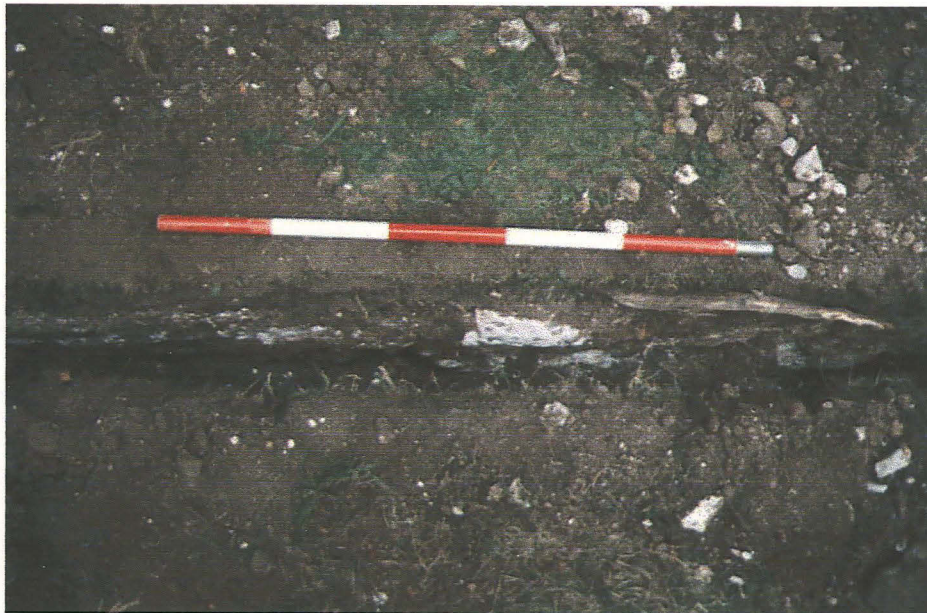
Plate 2 - Section 1, looking northwest
