**ARCHAEOLOGICAL WATCHING BRIEF REPORT
PLOT 3, CHURCH LANE, GRAYINGHAM, LINCOLNSHIRE**

Site Code: CLG99
LCNCC Acc No. 23.99
NGR SK 9356 9621
Reference 97/P/0591

Report prepared for Mr D Goodhand
by CPH Palmer-Brown
March 1999

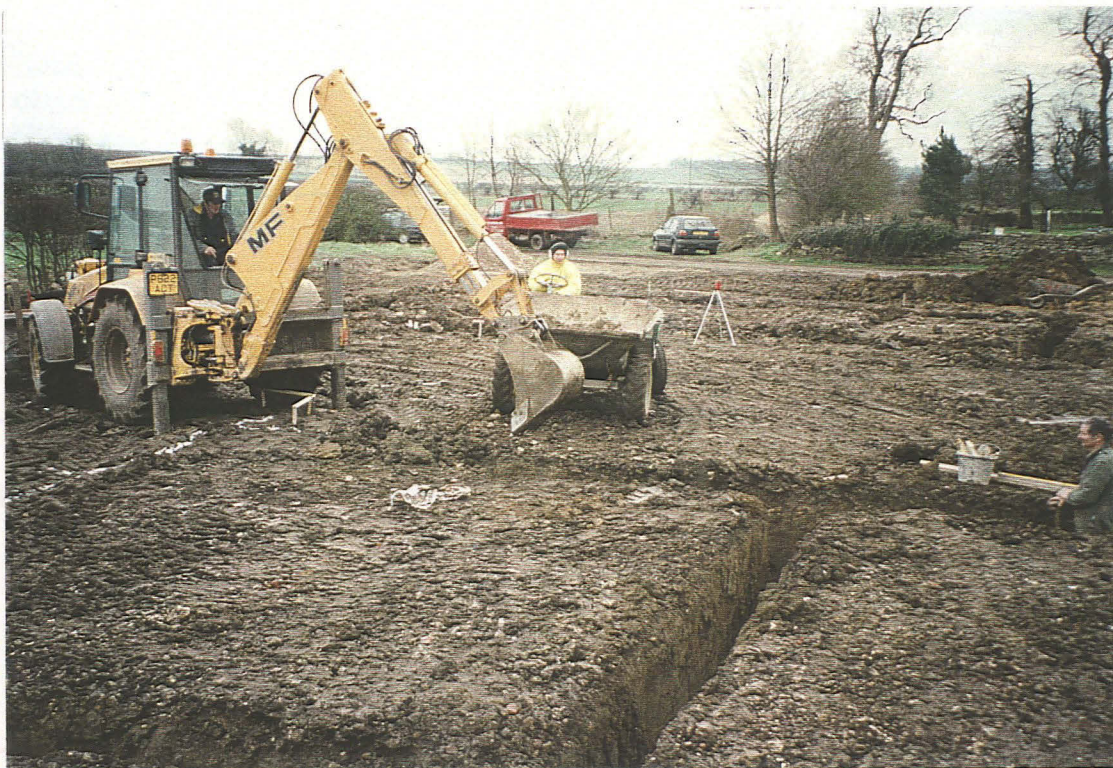
P.1 General view of the foundation trenching in progress, looking south.

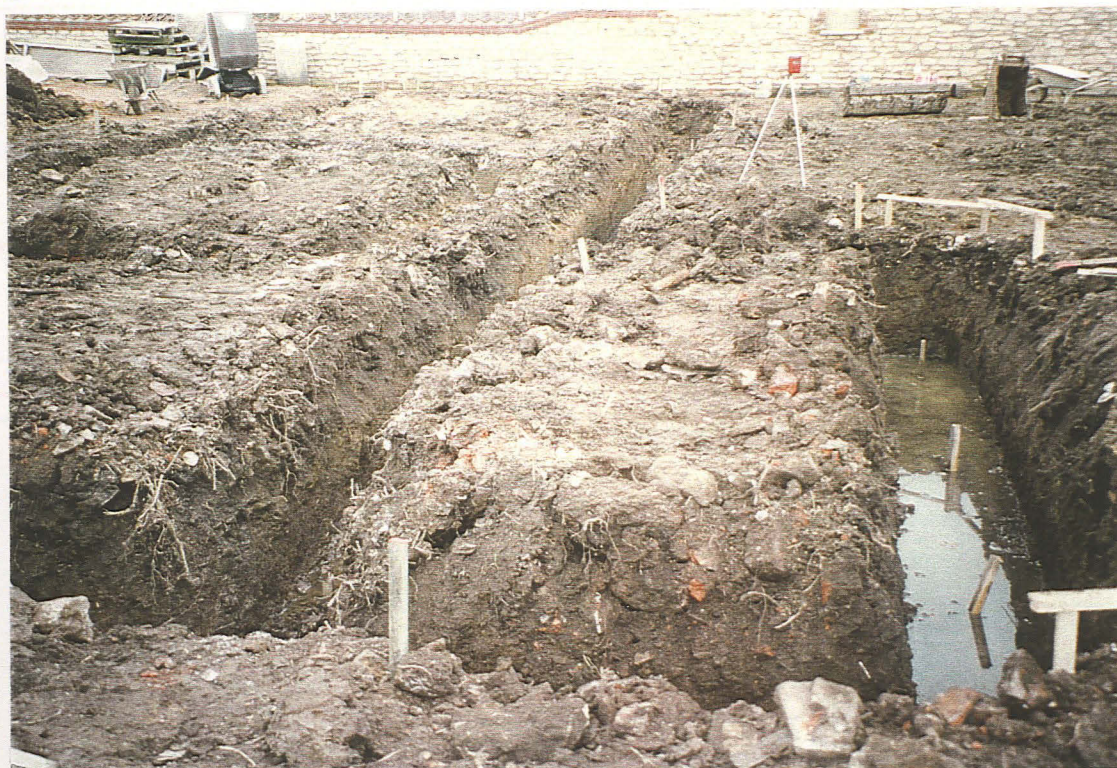
As noted above, much of the area was characterised by overlying rubble and relatively modern intrusive features (pits) filled with black soil and brick fragments. In addition, there was a substantial amount of ground water present, making the work difficult and messy.

P.2 General view of house foundation trenches looking west, showing rubble from demolished agricultural buildings.
