**Leadenham to Welbourn Water Main Replacement
Pottergate Road, Welbourn**

Archaeological Watching Brief

Site Code: WLM 99

LAS Report No. 350

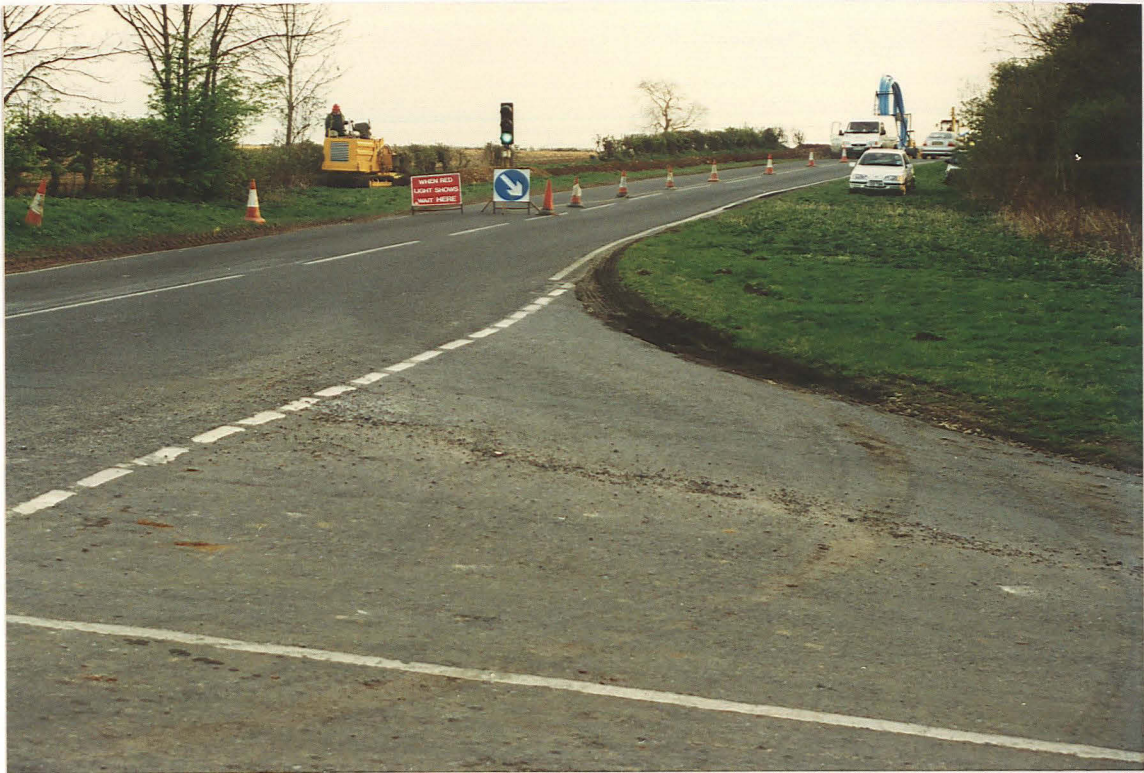
Pl. 1 Trenching for the replacement main, south of the Pottergate Road junction near The Mill Farm (looking south).

The trench was excavated within the eastern roadside verge, using a trenching machine or a JCB with narrow toothed bucket (Pl. 1). The trench was positioned to the east of the existing mains trench.

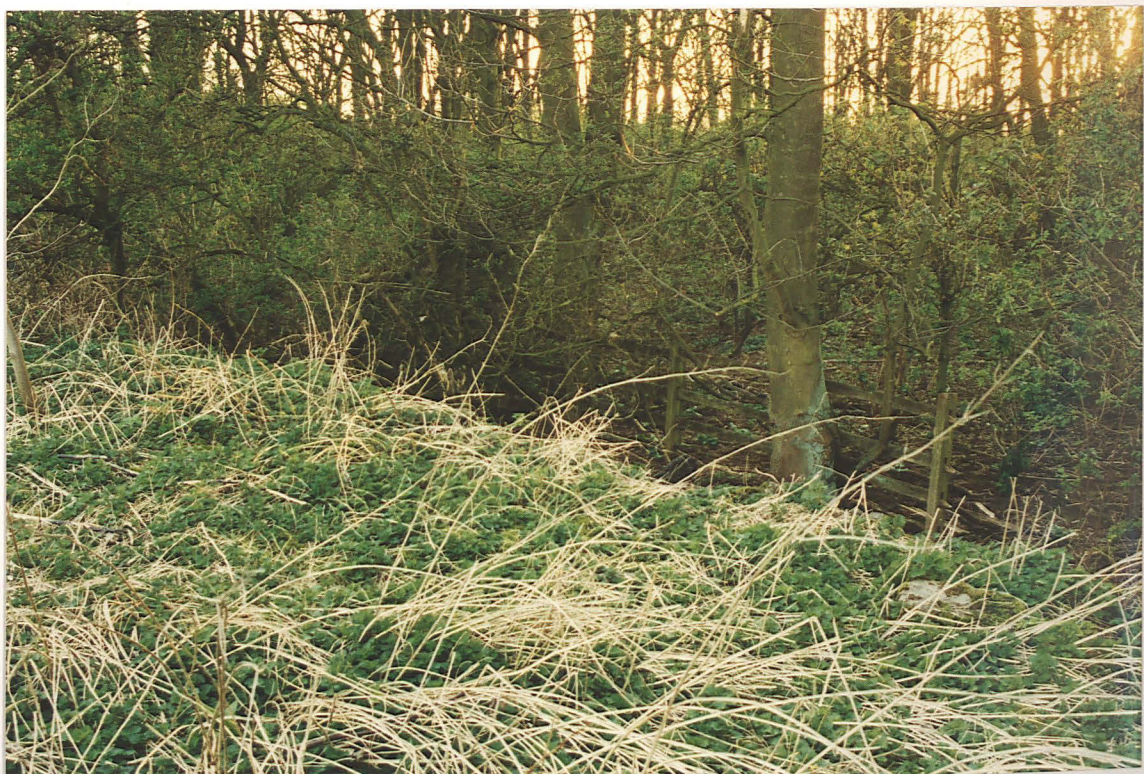
Pl. 2 Windmill Plantation, growing in a former limestone quarry beside Pottergate Road.

Mill Farm Plantation lies within a former quarry site, which has been partly backfilled close to the roadside verge (Pl. 2). On the opposite site of Pottergate Road, the trench revealed a large soil-filled disturbance which produced infrequent and unstratified fragments of nineteenth century material 1. It is likely that this was the edge of a small limestone quarry, cutting into a limestone outcrop where it is exposed on the edge of a natural depression (Pl. 3).

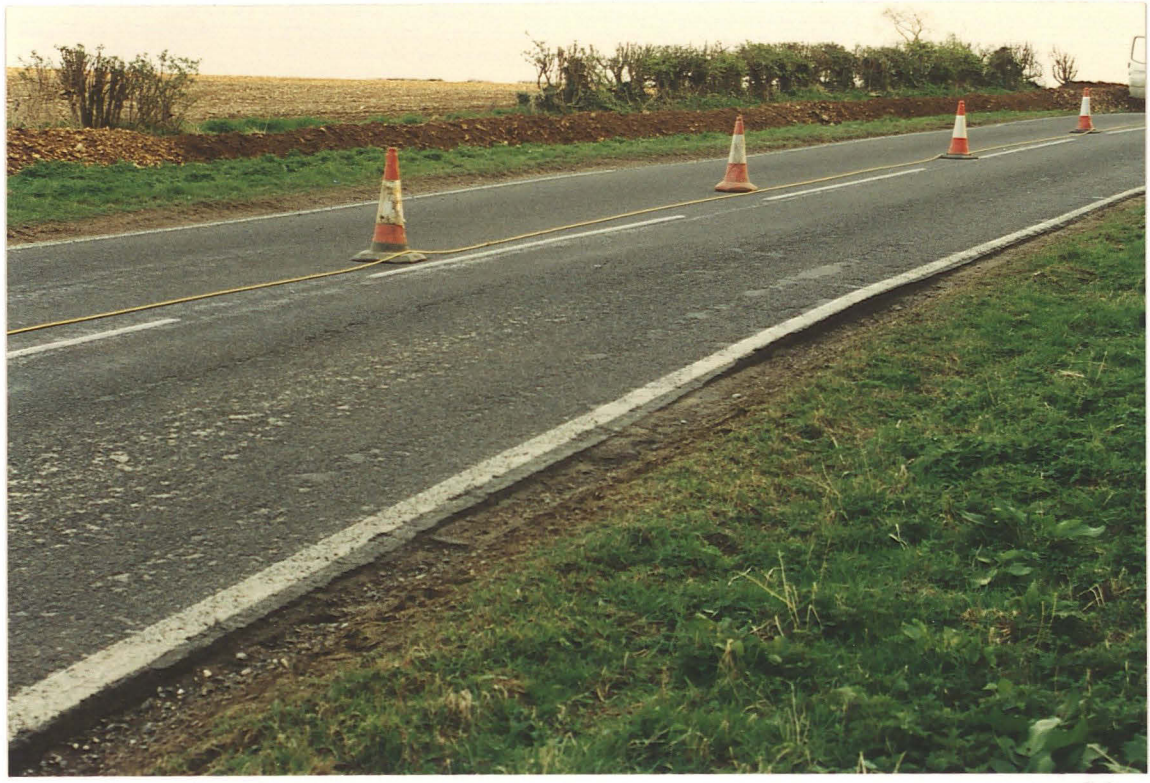
Pl. 3 Trench spoil showing areas with differing densities of limestone at 1. This was interpreted as a natural feature, possibly an ancient stream course, perhaps affected by post-medieval stone quarrying and later soil tipping (looking south).
