**Brauncewell Water Main Replacement
Nipton Lane, Brauncewell**

Archaeological Watching Brief

LAS Report No. 354

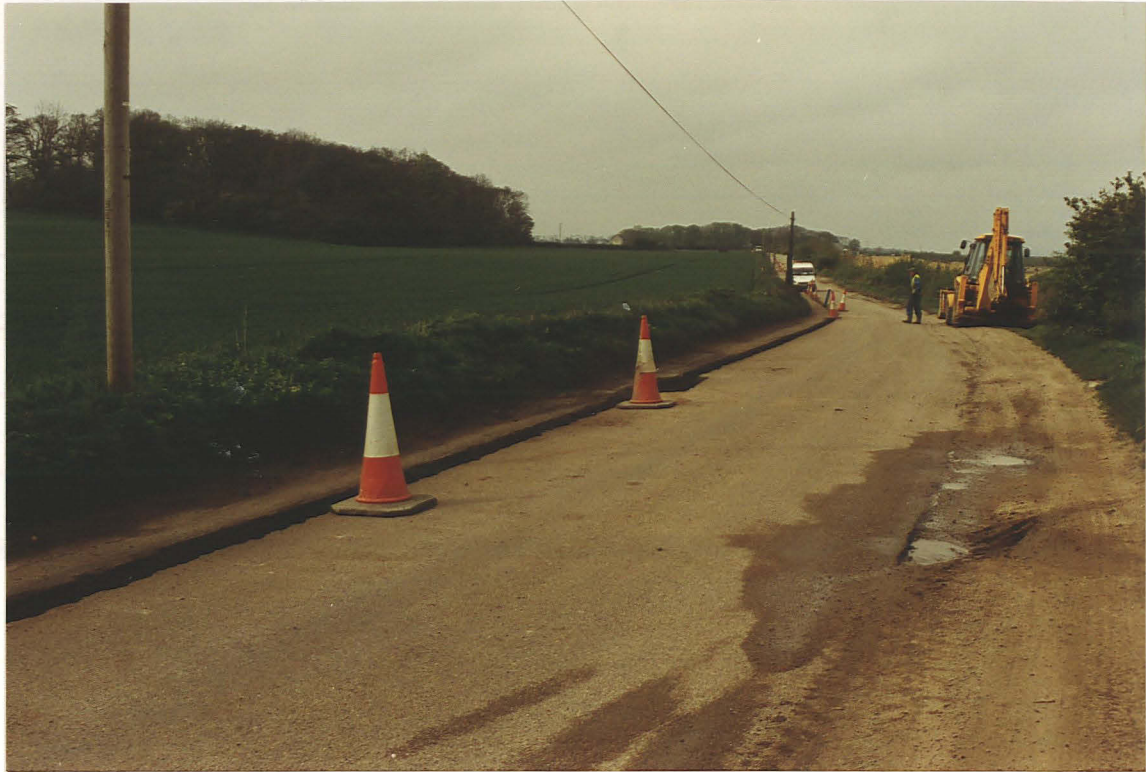
1. Although no trace of a ditch was seen at the western of the two anticipated locations, a 7m wide feature was visible between 110m and 117m west of the farm track (Pls. 1 and 2). The road at this location consists of a 0.1m thick layer of tarmac over a bedding layer of limestone rubble and soil 0.3m thick (Pl. 3). Beneath this was red/brown clay subsoil, above undisturbed limestone.

The feature was interpreted as a ditch, cut into the dense limestone bedrock and backfilled with small fragments of limestone within a red/brown clay matrix. It coincided with a ridge in the road: either the ditch was using the natural topographic feature as an additional obstacle, or the ditch had been recut to the east, producing an upcast bank on the western side over which the road rises. It was not possible to distinguish a recut or an upcast bank in the trench face.

Pl. 1 Position of Ditch 1 (between two cones in foreground; looking SW along Nipton Lane, with Brauncewell Quarry to the right).

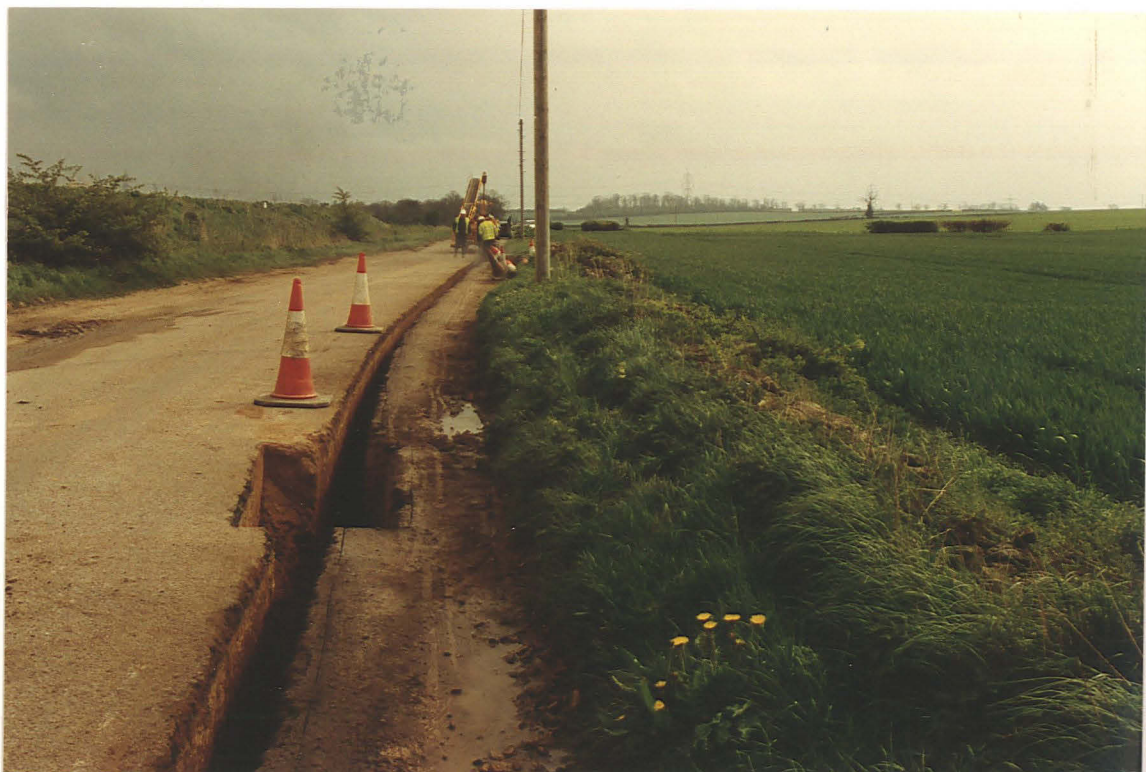
Pl. 2 Position of Ditch 1 (between two cones in foreground; looking east along Nipton Lane).

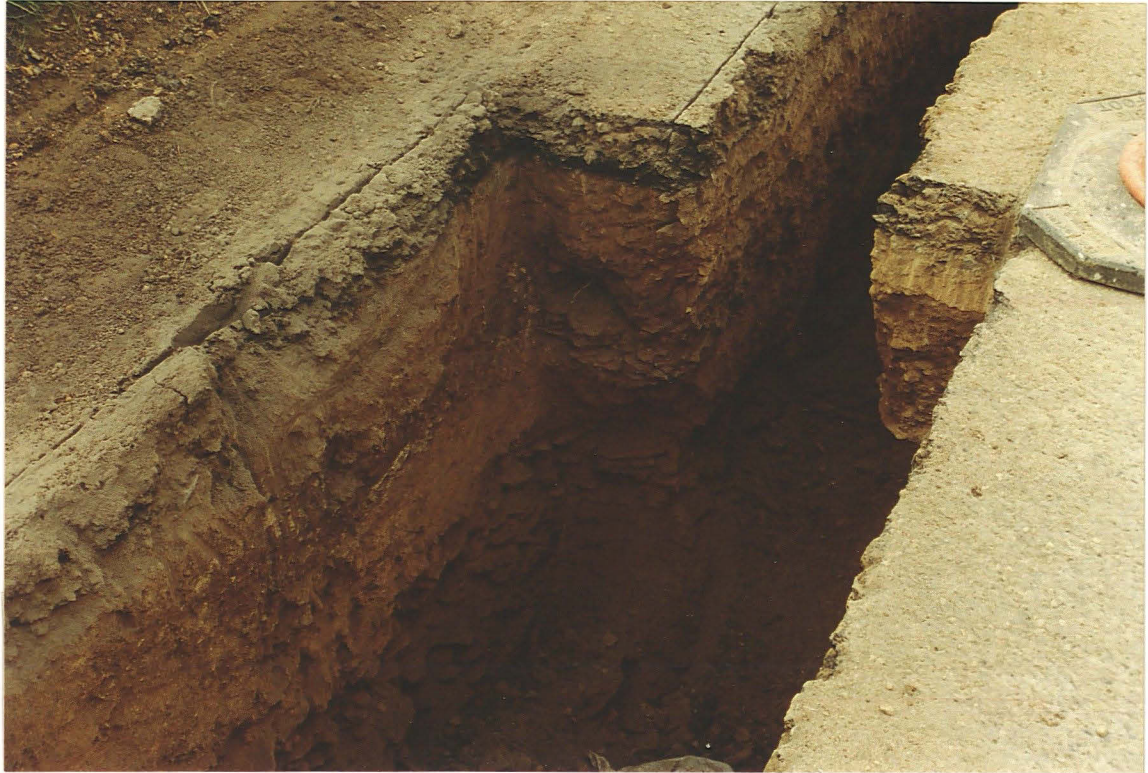
Pl. 3 Sequence of deposits visible in the pipe trench to the west of Ditch 1. Trench depth 1m.
