**Bassingthorpe Reservoir to Ingoldsby, Lincs.
Mains Replacement Scheme
Archaeological Monitoring in Lower Bitchfield**

NGR: SK 983 284
Site Code: IMR 98
LCNCC Museum Accn. No. 208.98

Report prepared for
Anglian Water Services Ltd

LAS Report No. 356

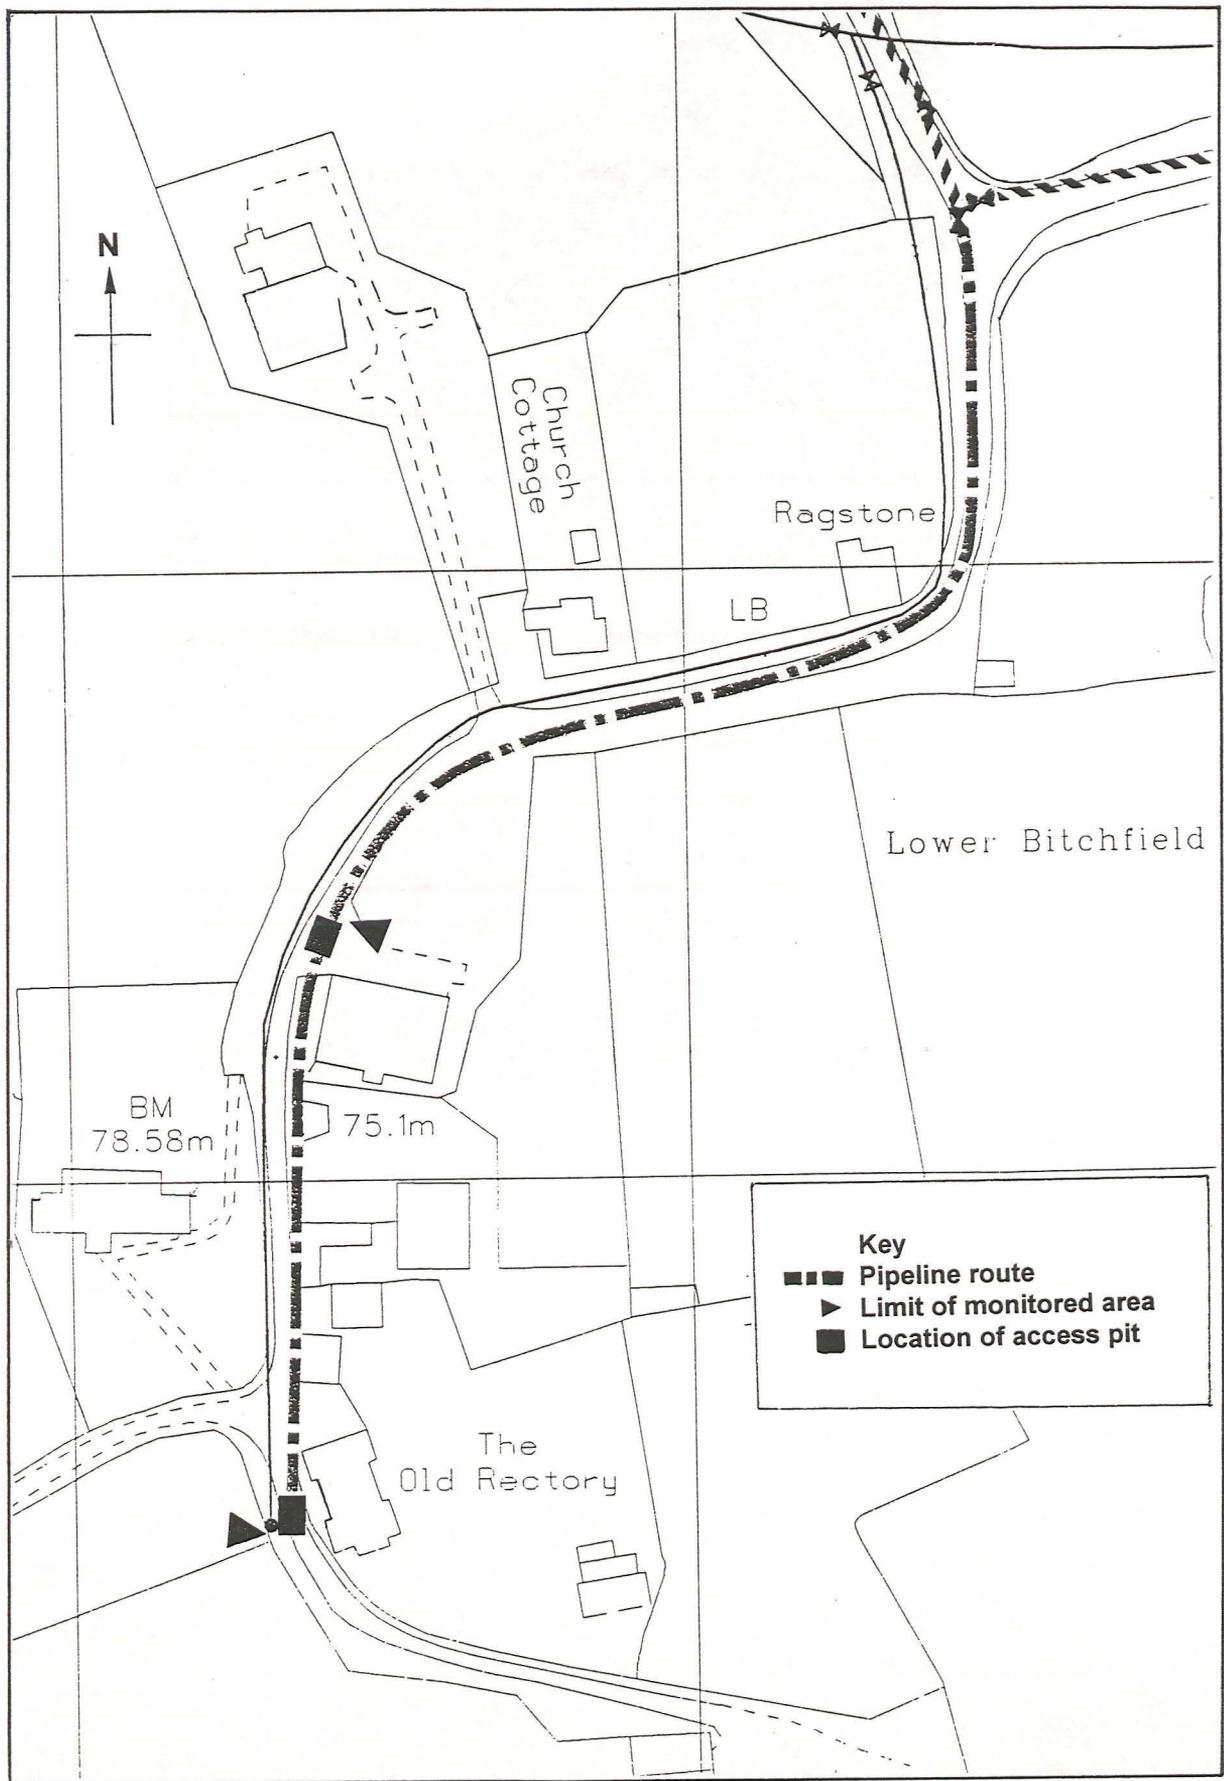
Fig. 2 Location of the two monitored trenches (based on the Anglian Water Services plan 9721905/1, reproduced at 1:2500 scale).

Two access pits were machine-excavated, one at each end of the specified length of replacement main, with the remainder of the section successfully flow-moled.

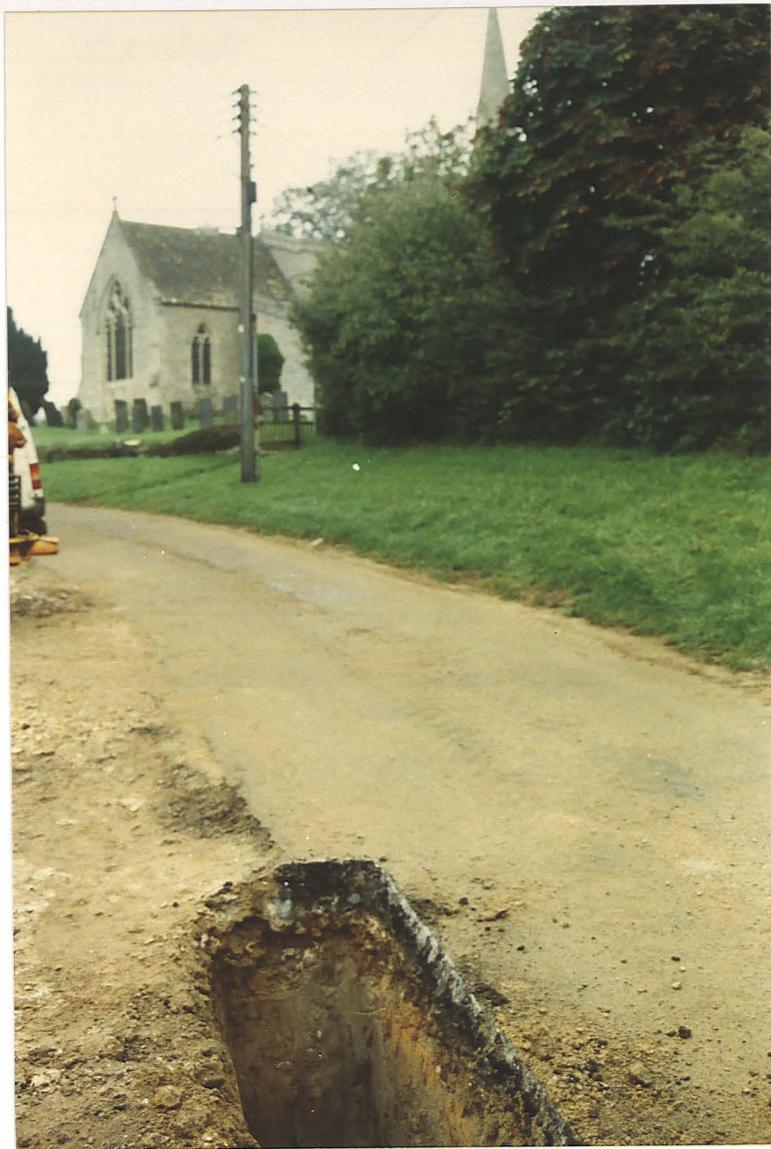
Pl. 1 Position of Trench 1 (looking SW to St. Mary Magdalen's Church).

The first trench excavated was at the northern end of the area, at the eastern edge of the road beside the vehicular access to the new house (Pl. 1). The trench was 1.8m north-south and 0.6m west-east, and 1.05m deep.

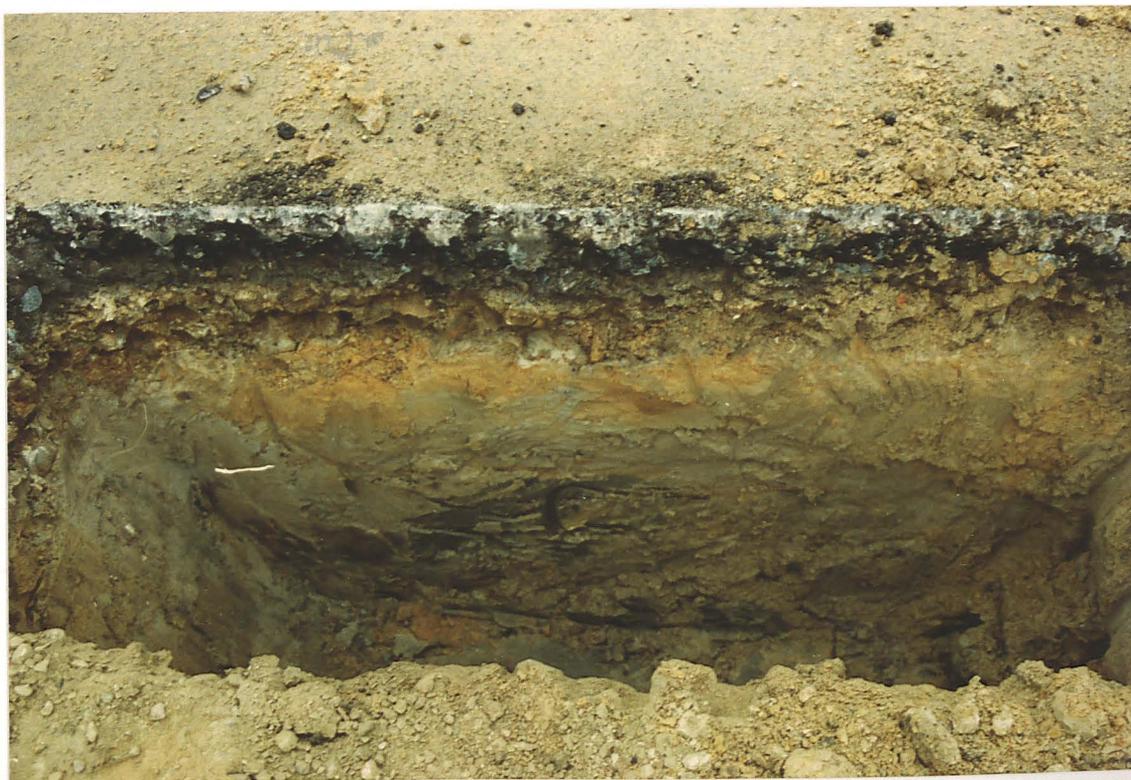
Pl. 2 Post-medieval gravel road metalling beneath the modern tarmac, Trench 1.

The tarmac road surface was 0.12m thick and overlaid a thin band of fine grey material, probably a bedding layer or dust accumulation on the underlying surface. A 0.32m thick compacted layer of medium gravel in a dirty sand matrix beneath this almost certainly represented a post-medieval metalled road surface (Pl. 2). This layer on a 0.45m thick layer of yellow sand with the lowest exposed deposit being a grey sand. This sand probably is naturally deposited and associated with previous courses of the River Glen.
