A Report to GELDER CONSTRUCTION Ltd

STUDENT ACCOMODATION,
CARHOLME ROAD,
LINCOLN

ARCHAEOLOGICAL WATCHING BRIEF

CLAU ARCHAEOLOGICAL REPORT NO: 387

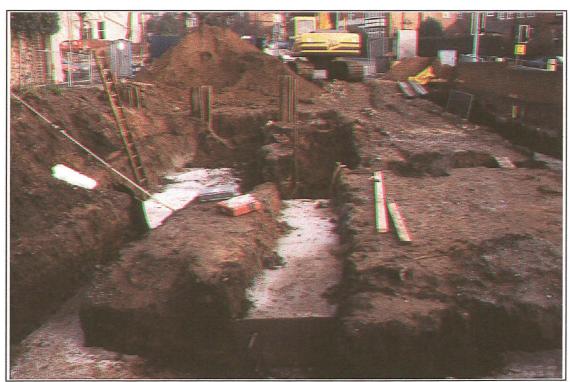
Plate I: General view looking north-east across the site during the excavation of the foundation trenches. Although extensive, the foundation trenches were thought to have disturbed no important archaeological remains.

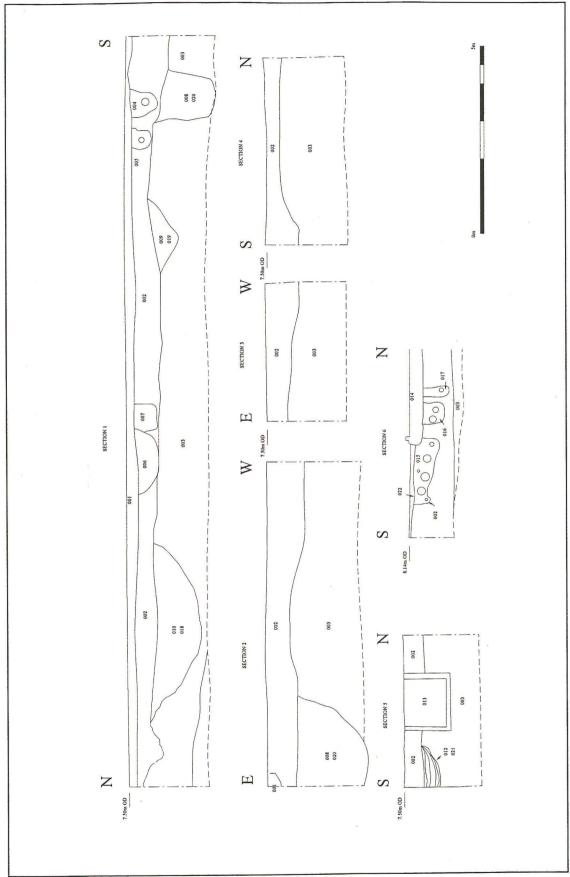
Fig. 3: Sections 1-6 (Scale 1:100).

The excavation of the foundation trench revealed four pit features cutting in to the underlying natural sand. Pit [020] lay in the south-east corner of the site and was revealed to be over 2.5m wide and 2m deep with a 'U' profile (base of pit - c. 5.00m OD). The fill of the pit, [008], a loosely compacted, middark brown sandy soil, contained only occasional small limestone chippings. A second, smaller pit, [019] lay 2m to the north of [020]. Its fill [009] was very similar to [008] and contained a small assemblage of L12th-M13th century pot and some animal bone. The third pit, [021], lay in the approximate centre of the new building plot and was revealed to be circular in plan and 1.5m wide with a gently curving 'U' profile. The fill of the pit, [012], consisted of laminated bands of a very loosely compact, mottled yellow/brown cessy sandy soil, containing a few medieval pot sherds (13th century) and some animal bone. A large pit ([018] - 5m in diameter and 1.5m deep) was found to lie in the north-east corner of the site. Its fill, [010], was very similar to the fill of pits [019] and [020].

Prior to the excavation of the new building's foundations, the site ground level was reduced by up to 1m to approximately 7.50m OD. The excavation of the foundation trenches for the new building was carried out by mechanical excavator. Trench depth was nominally 2.00-2.50m deep. Terrace sands ([013]) were encountered approximately 1.00m below existing ground level, rising to within 200mm of ground level towards the northern end of the site (6.30m OD - 8.00m OD). A large fragment of Roman Samian pottery (base sherd (stamped) - see appendix 4) was recovered from the natural sand.

Overlying the aforementioned activity was extensive (up to 1m thick) dump deposit [002], a clean, loose compaction, mid-dark brown sandy soil with a few limestone inclusions (7.30m - 7.50m OD). Two small pit features, [006] and [007], filled with recent (19th/20th century) demolition material, were recorded cutting into [002] mid-way along the eastern boundary to the site. Brick features were revealed towards the northern end of the site. Here, two brick wells were recorded, [023] and [024]. Both were revealed to be c.1m in diameter. Their depth was not established as they were infilled with demolition debris (not removed). An infilled cellar, [003], associated with the terrace buildings that once stood on the site, lay centrally on the site. Several pipe trenches were also recorded crossing the site during the excavation of the sewer connection made in Newland Street West.
