# LINDSEY ARCHAEOLOGICAL SERVICES

HARMSTON AND COLEBY REPLACEMENT WATER MAINS:

ARCHAEOLOGICAL MONITORING PROJECT

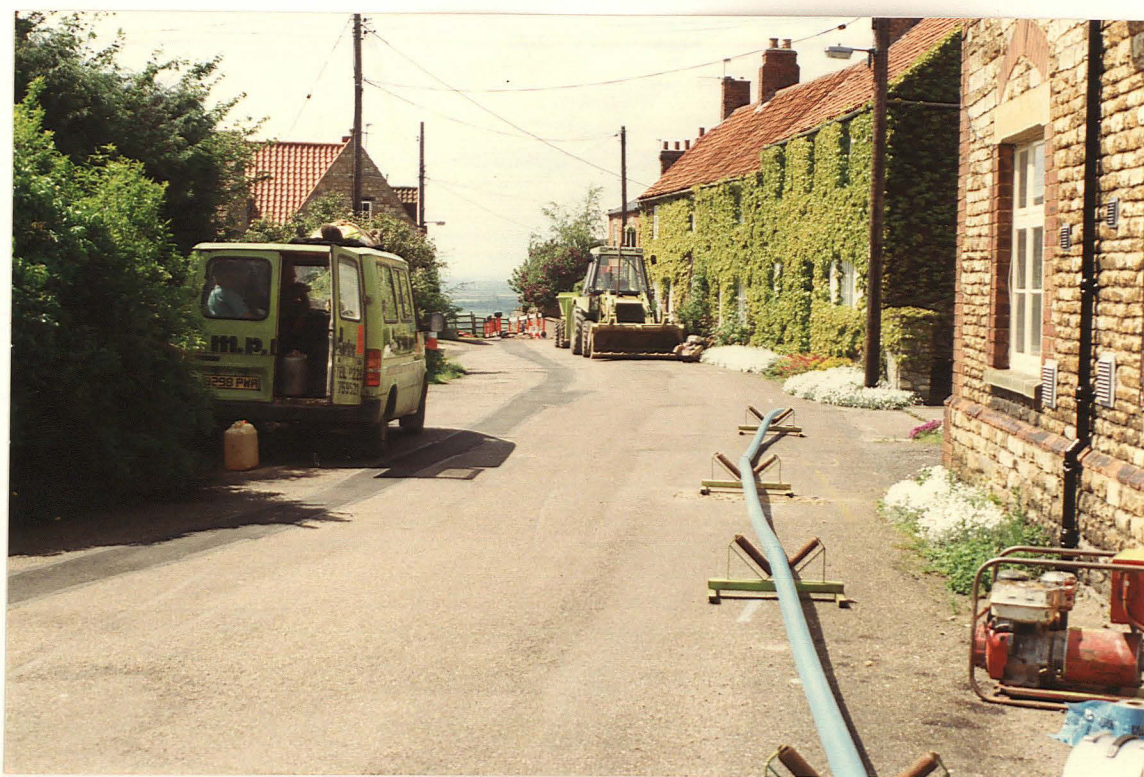
Pl.2 Coleby, Church Lane. Contractor's cones mark the hilltop edge

Coleby and Harmston are both settlements sited on the edge of a pronounced scarp, with the land falling away abruptly to the west (Pl.1). The edge of the hilltop has restricted the spread of settlement (Pl.2); each village consists of several narrow village streets with a single road leading down the hill. A minor communication route along the edge of the scarp may have linked Coleby with Harmston (and perhaps Waddington) in the medieval period but only short stretches of this are metalled, including Hill Top Road in Harmston.

The street surfaces of tarmac had been laid onto natural limestone with virtually no intervening rubble foundations of earlier metalling, even close to long established buildings (Pls.2 and 12). A restricted area of disturbance was noted in the trench section close to the west end of Church Lane (Pit 12) but no datable material was seen (Pl.13). The road had previously been excavated for other services and this might have represented part of the fill of an adjacent trench viewed at an angle.
