99/13
**ALL SAINTS CHURCH,
SALTFLEETBY, LINCOLNSHIRE**

ARCHAEOLOGICAL WATCHING BRIEF

CLAU ARCHAEOLOGICAL REPORT NO: 392

A
Report to
The Churches Conservation Trust

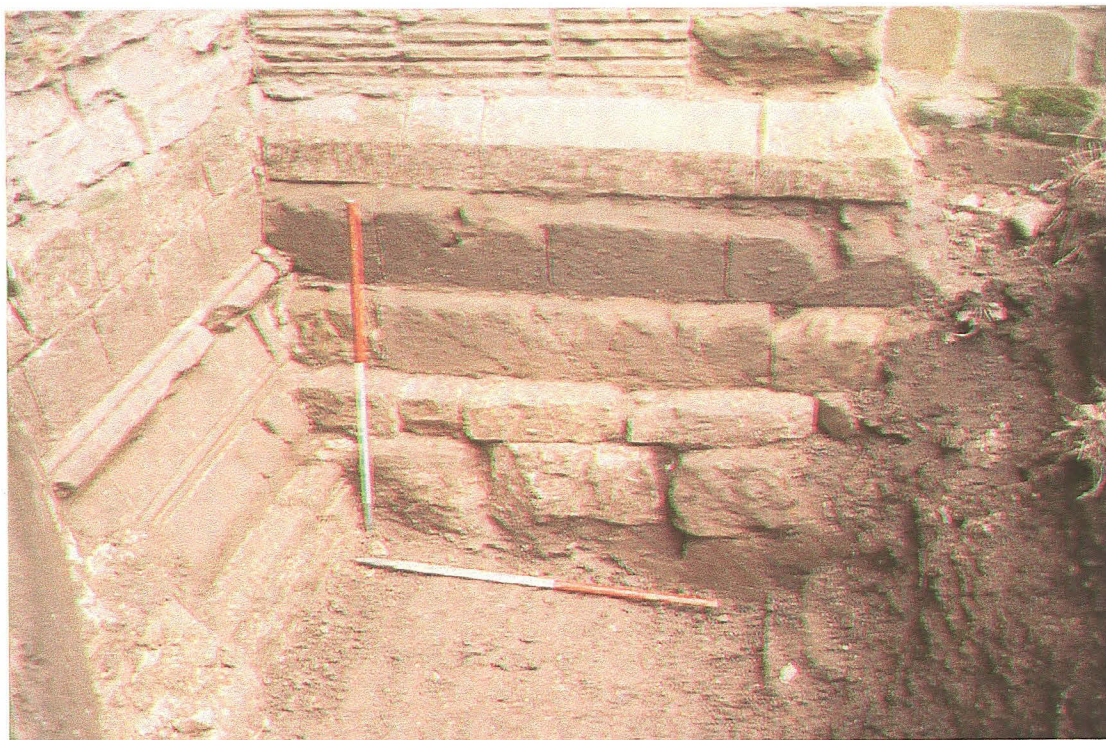
Plate 1: View of exposed foundations of 15th century buttress (west end of aisle/south side of tower) - looking east

The masonry of the tower, [135], was founded on a rough bedding of chalk & limestone pieces (c.200mm thick to L.O.E.). The buried elements comprised six courses of stonework, as follows (from base upwards, see also *Plates 1-3*): a 100mm thick course of roughly worked limestone blocks (each measuring between 200mm and 400mm in length), stepped out from the face of the remaining wall; a 200mm thick course of chamfered and faced blocks, which probably originally formed the base of the exposed wall; a 200mm thick course of faced limestone blocks with a half-round carved moulding along the lower edge; a moulded string-course, approximately 150mm thick (see Fig.3); and finally two courses of plain faced limestone blocks (identical to those present in lower parts of the exposed tower walls) (see *Plates 1-3*).

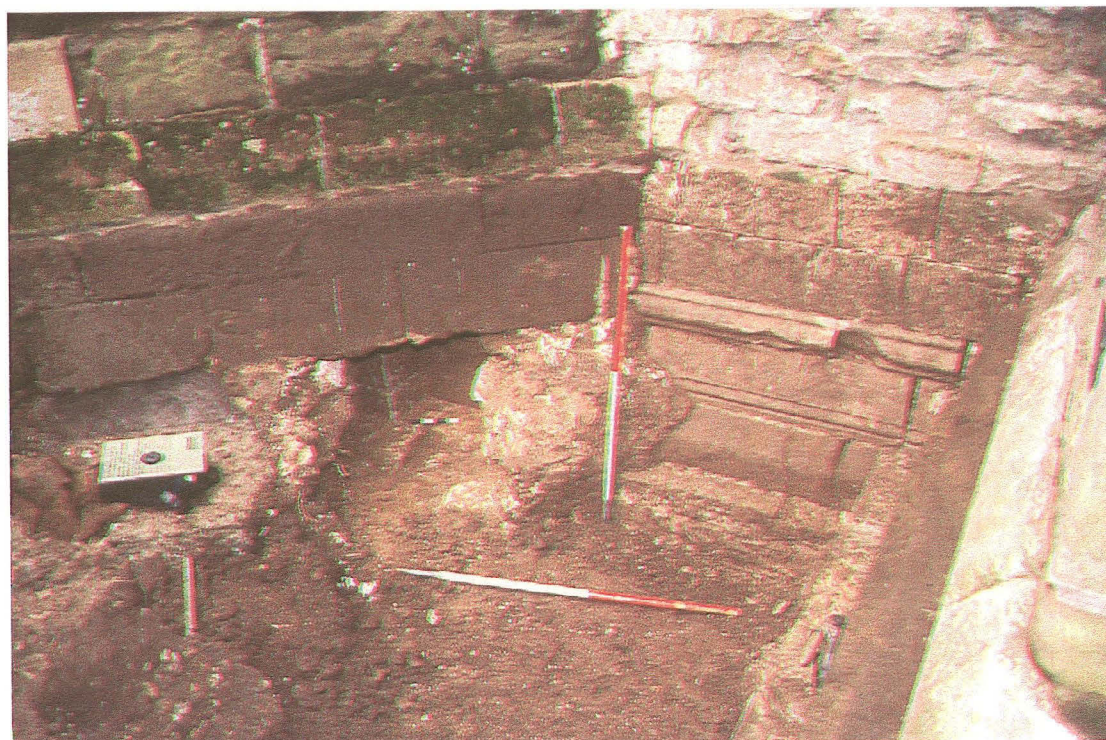
Plate 3: View of original tower corner (and small buttress) exposed beneath existing 1886 buttressing - looking north-west

The stonework revealed beneath the existing tower buttresses during the 'needle-beam' insertion appears to represent elements of the original Norman structure (see Fig.3, and *Plate 3*).

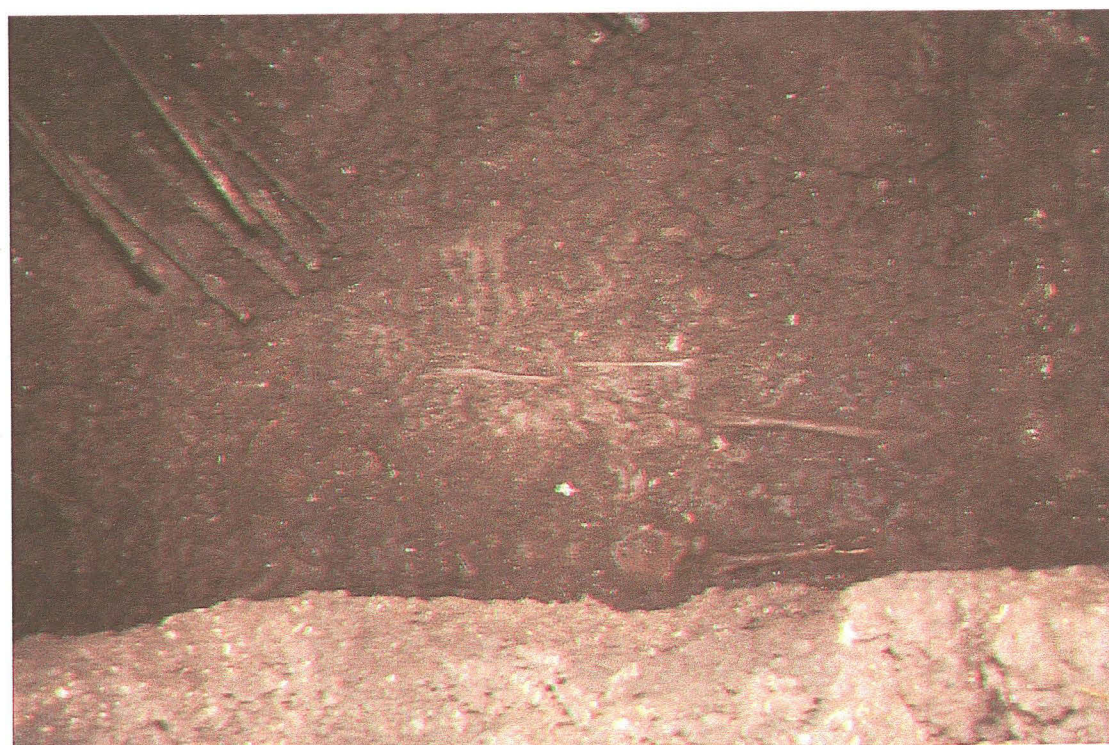
Plate 4: Overhead view of skeleton [112] (Burial 3), uncovered in south-east corner of excavated area - looking north

pelvis and left arm; and Burial 3 (fill [111], skeleton [112], cut [113]; see *Plate 4*), complete except for the lower legs. Each of the skeletons was between 900mm and 1.1m below the existing ground level, and each appeared to be an adult individual. The truncation of the skeletons was caused by the existing buttress [136] at the west end of the aisle, a feature apparently dating to the 15th century.

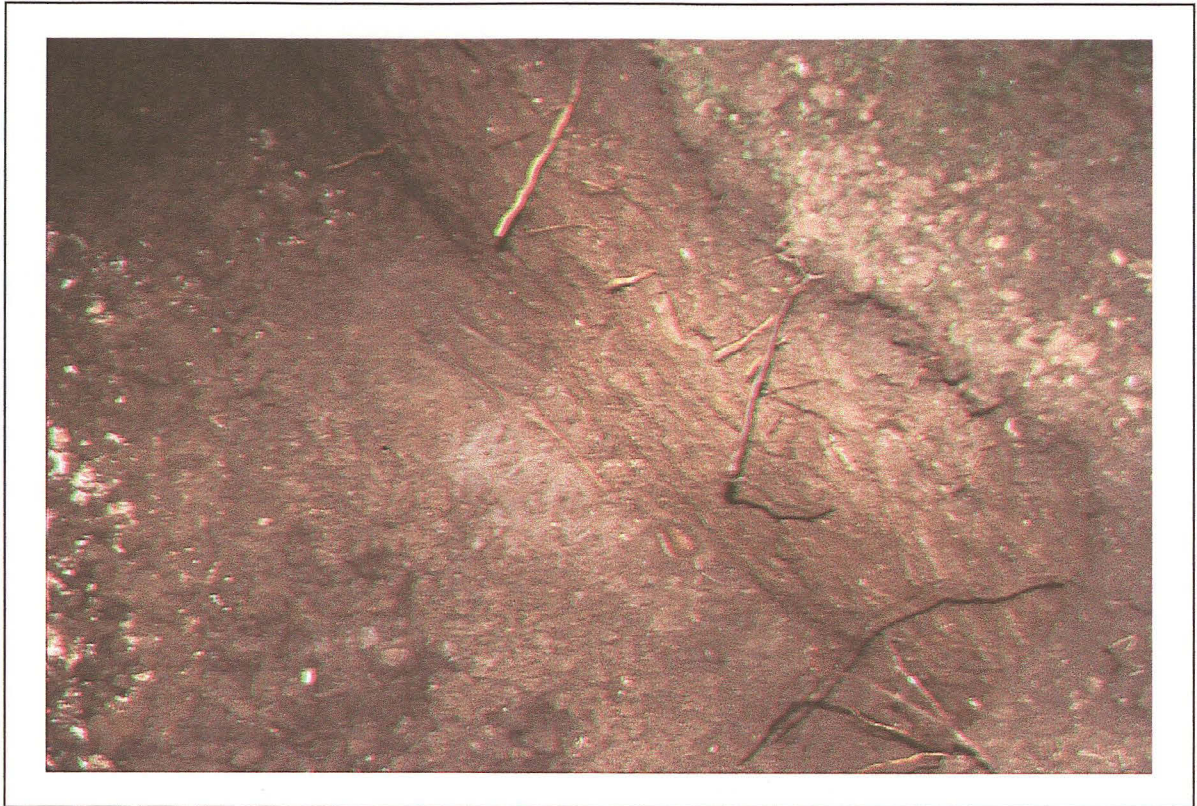
Plate 5: Overhead view of Skeleton [115] (Burial 4), revealed at southern edge of excavated area - looking south-east

Burial 4 was present directly above Burial 6, and comprised fill [114], skeleton [115] and cut [116]. The skeleton was again that of an adult and appeared complete, although only the skull, the left hand side of the torso and pelvis, and the legs were within the trench (see *Plate 5*). No dating evidence was recovered from these graves.

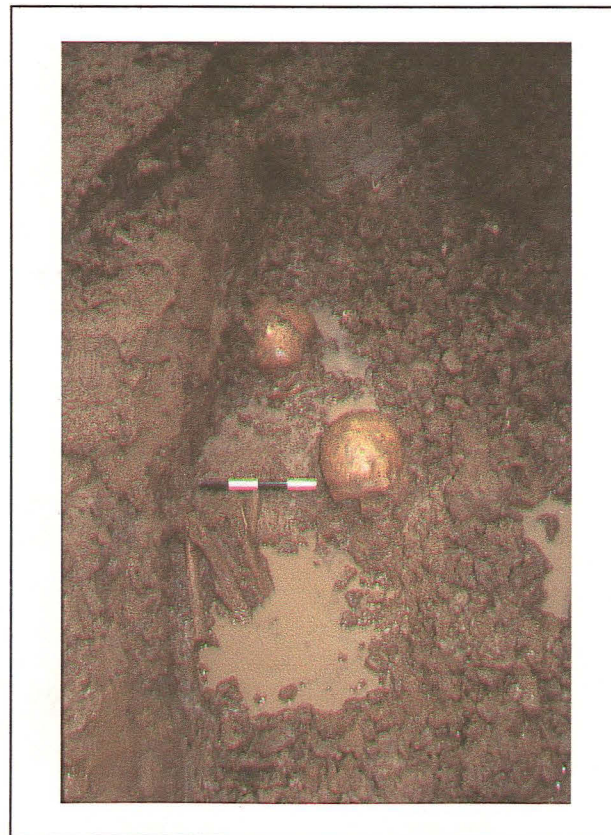
Plate 6: View of Burial 7, a charnel pit containing the (partial) remains of at least two individuals - looking west

All of the graves, with the exception of Burial 7, were oriented east-west (with the head to the west) and contained supine articulated human remains (to a greater or lesser extent). The exception (fill [123], human remains [124], cut [125]) appeared to represent a small charnel pit. This contained two skulls, two displaced jawbones and four miscellaneous long bones, and possibly represents material disturbed during a previous phase of extension or renovation (see *Plate 6*).

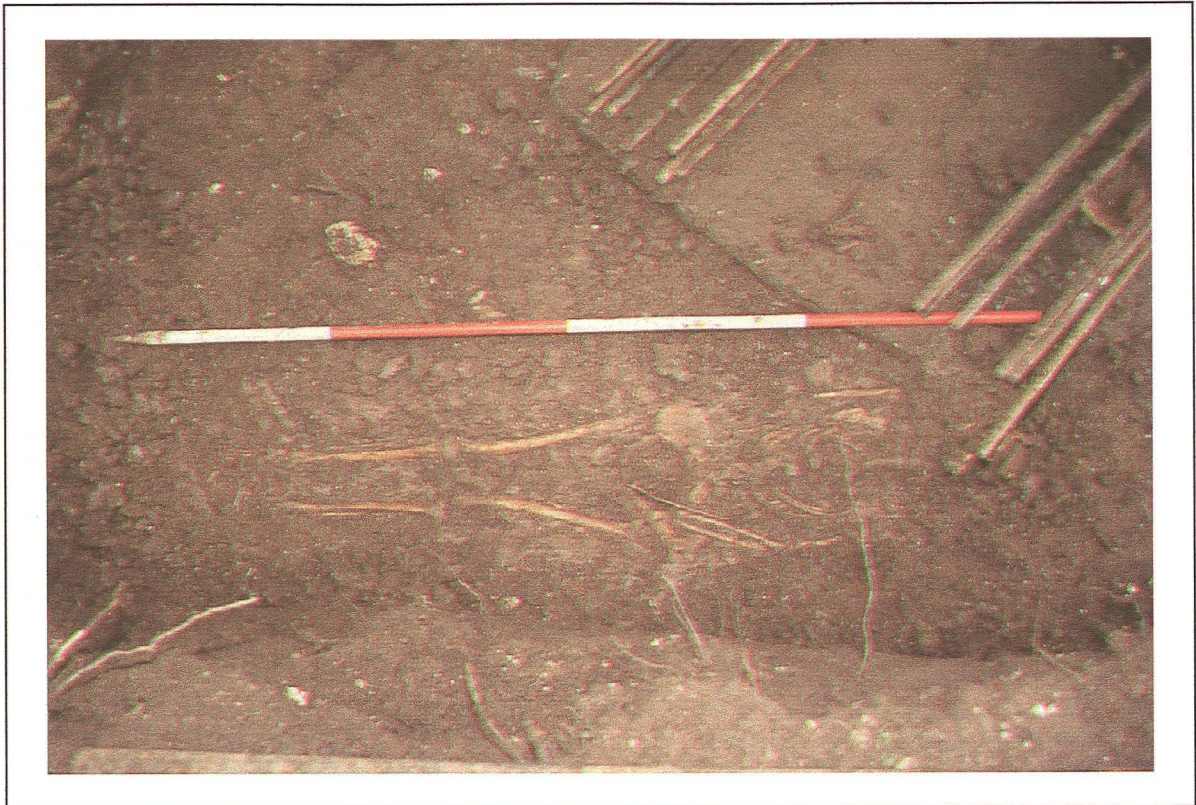
Plate 7: Overhead view of skeleton [130] (Burial 8) on north side of tower - looking south

The final two graves were located along the northern side of the site area, and provided the only complete skeletons uncovered during this project (see *Plates 7 & 8*).

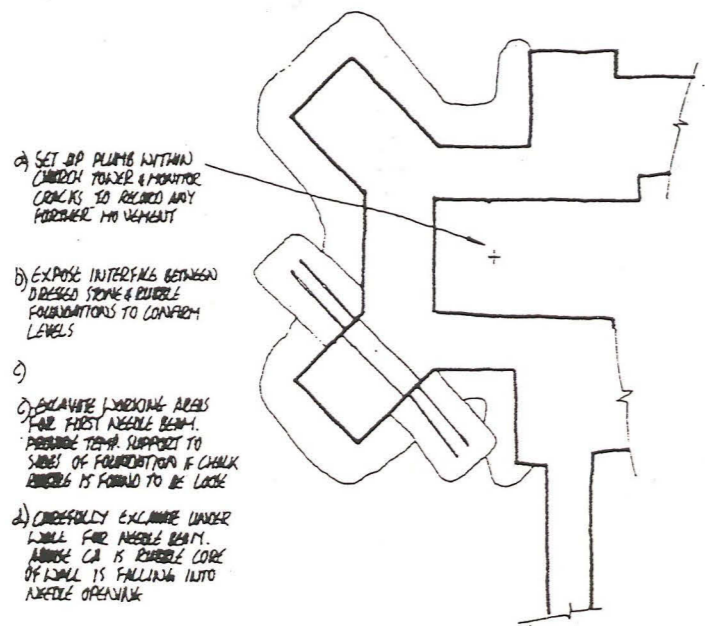
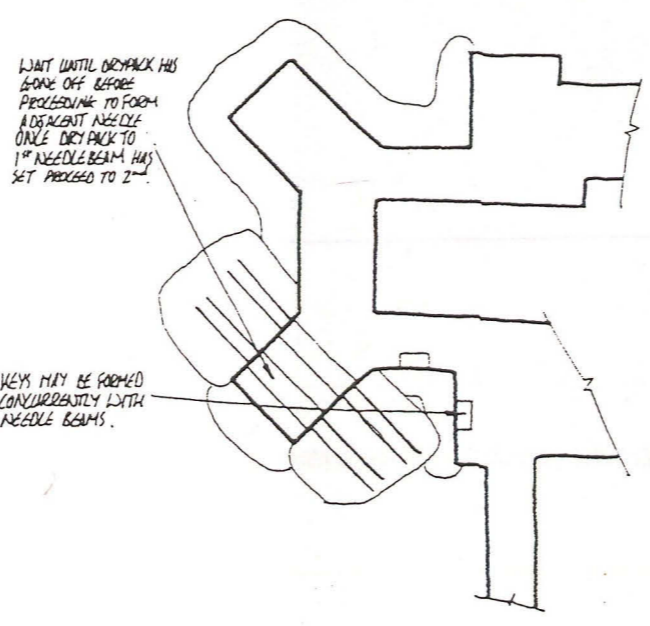
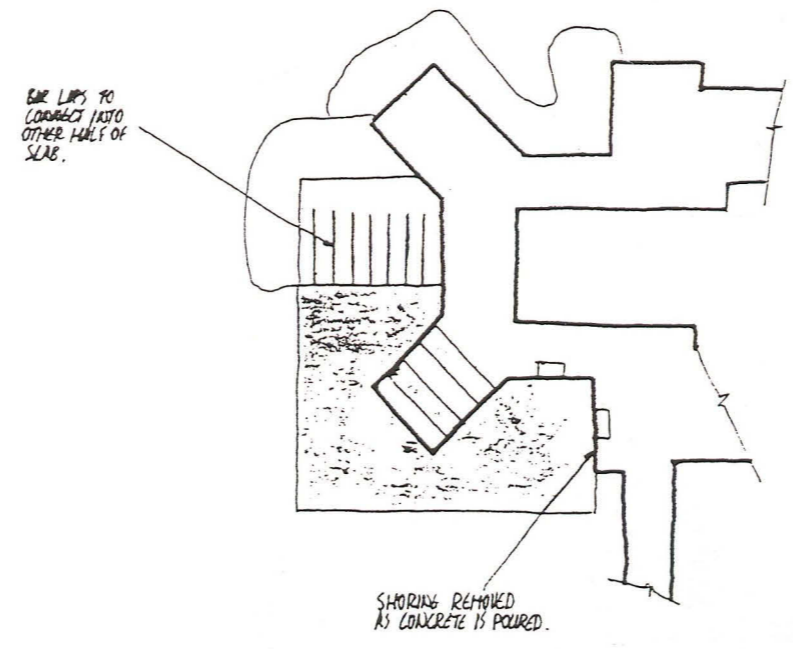
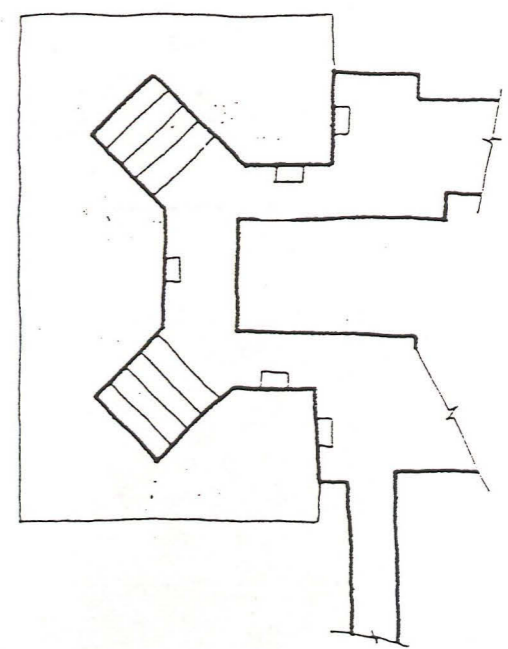
Fig.2

1. FORM FIRST NEEDLE BEAM

- a) SET UP PLUMBS WITHIN CHURCH YARD & MONITOR CRACKS TO RECORD ANY FURTHER MOVEMENT
- b) EXPOSE INTERFALS BETWEEN DRESSED STONE & RUBBLE FOUNDATIONS TO CONFIRM LEVELS
- c) EXCAVATE WORKING AREAS FOR FIRST NEEDLE BEAM. PROVIDE TEMP. SUPPORT TO SLOPE OF FOUNDATION IF CHALK RUBBLE IS FOUND TO BE LOOSE
- d) CAREFULLY EXCAVATE UNDER WALL FOR NEEDLE BEAM. WHERE CA IS RUBBLE CORE OF WALL IS FALLING INTO NEEDLE OPENING

2. FORM SECOND NEEDLE BEAM AND KEYS

WAIT UNTIL DRYPACK HAS GONE OFF BEFORE PROCEEDING TO FORM ADJACENT NEEDLE. ONCE DRYPACK TO 1st NEEDLE BEAM HAS SET PROCEED TO 2nd.

KEYS MAY BE FORMED CONCURRENTLY WITH NEEDLE BEAMS.

3. EXCAVATE FOR FIRST HALF OF CONCRETE APRON

ONLY HALF OF APRON IS FORMED AT A TIME. THIS IS TO REDUCE:-

- EFFECTS DUE TO REMOVAL OF OVERBURDEN
- EXPOSURE OF CLAY TO DRAINAGE
- EFFECT OF POTENTIAL MOVEMENT OF RUBBLE FOUNDATIONS
- WITH WORKING ON BOTH PACE SIMULTANEOUSLY.

TEMPORARY WORKS TO PREVENT EXPOSED RUBBLE FOUNDATIONS FALLING OUT. (PRECAUTIONARY MEASURE)

TEMPORARY SHORING TO BE REMOVED AS CONCRETE IS POURED.

4. FORM FIRST HALF OF APRON

BAR LIPS TO CORRECT INTO OTHER HALF OF SLAB.

SHORING REMOVED AS CONCRETE IS POURED.

5. REPEAT FOR SECOND HALF.

In order to attempt to arrest this movement, the Trust decided to underpin the tower with a concrete 'apron', as designed by the Trust's structural engineers, Alan Baxter & Associates (see Fig.2).

Owing to concerns regarding the structural stability of the tower it was proposed to undertake the underpinning groundworks in several phases, thereby limiting the disturbance (see Fig.2).

The basic approach involved dividing the area into two parts along an east-west axis. The southern half would then be attempted, with the northern half only proceeding after the underpinning was in place to the south.

The first element of the groundworks involved hand-excavation to expose the existing foundations and delineate the position of one of the two 'needle-beams'. This beam would then be completed before excavation was carried out for the second of the pair. Only after both beams were complete would excavation for the larger reinforced concrete apron take place (this time using a mechanical mini-excavator). The process would then be repeated for the northern half of the area.

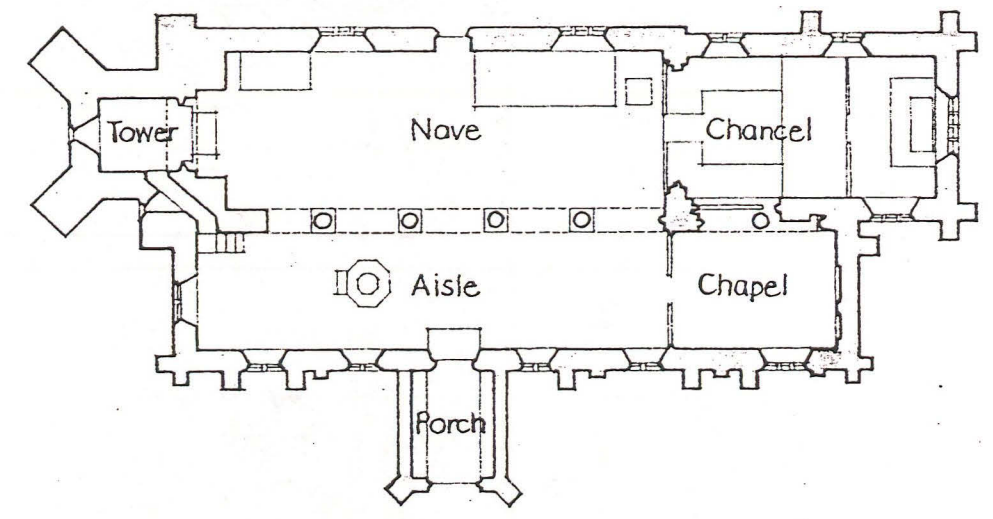
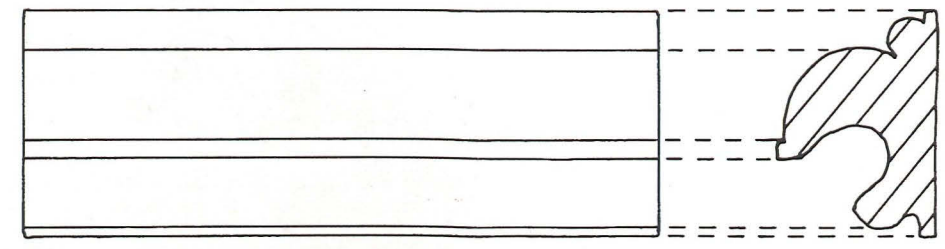
Original Masonry Revealed by Excavation for 'Needle-Beams'

General layout plan of church

West-Facing Elevation

Cross-Section

Detail of Moulded String Course 1:5

Graves were found in various locations across the excavated area, although most were concentrated in the southern half (see Fig.3).

This stonework exhibits a high quality stonemasonry and incorporates several mouldings, including a string-course (see Fig.3) which can be seen to continue along part of the north wall of the Norman nave.

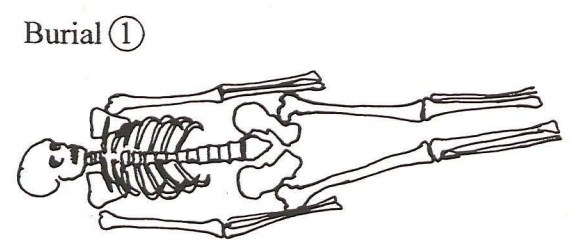
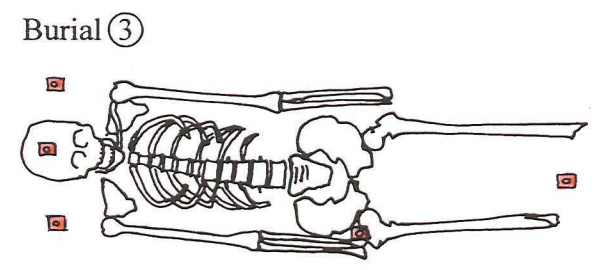
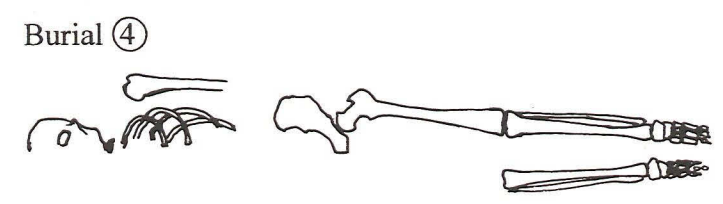
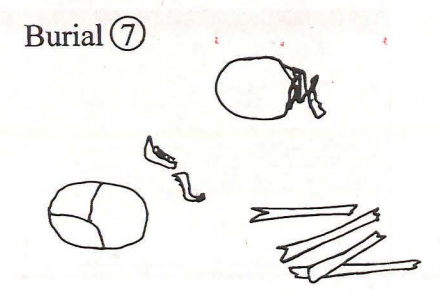
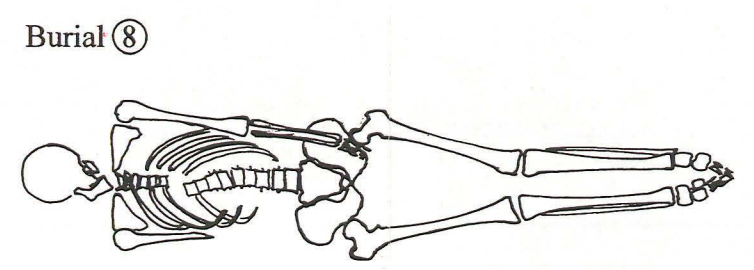
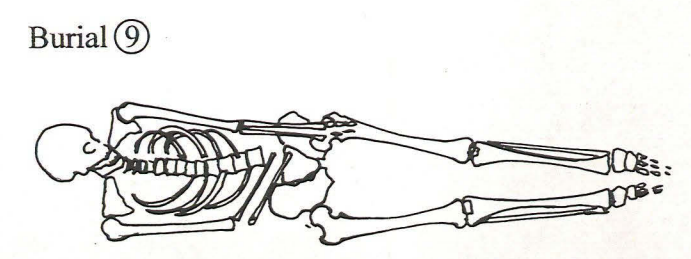
Fig.4

Position of Iron Coffin Studs/Clench Nails

Burial ⑥ Not Excavated

The first three 'proper' graves were revealed immediately to the south of the tower and comprised: Burial 1 (fill [105], skeleton [106], cut [107]), almost complete except for the feet; Burial 2 (fill [108], skeleton [109], cut [110]), an articulated torso, right arm and skull, partial

Immediately to the west of this group of graves were Burials 4 and 6. The first of these, Burial 6 (fill [120], skeleton [121], cut [122]), was only revealed at a depth of c.1.35m. As it was not in danger of disturbance it was left in situ. While it was not fully cleaned, it did appear to represent a further adult.

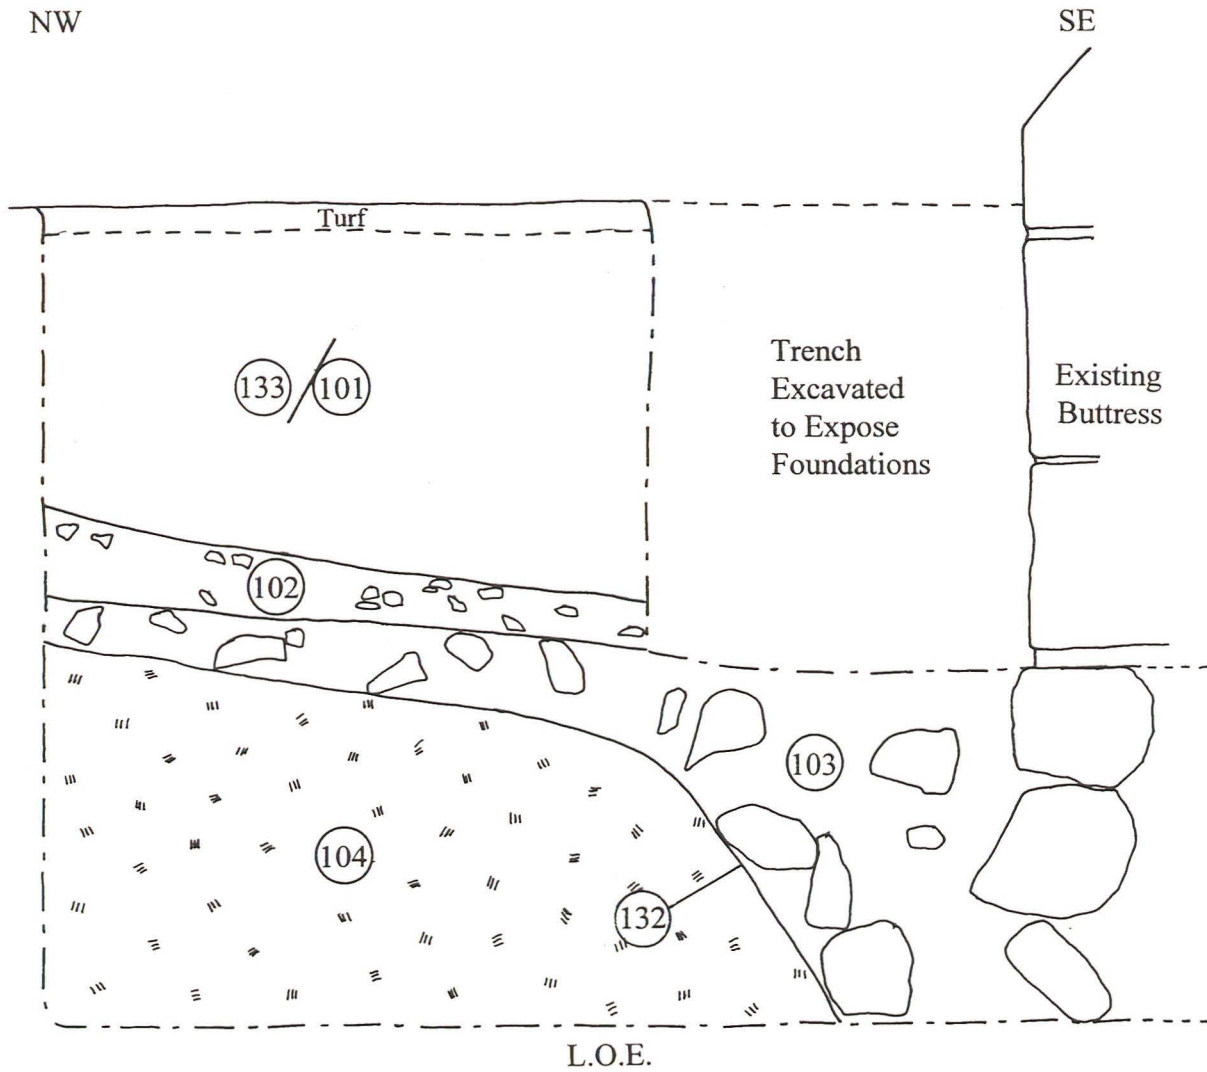
Fig.5

CITY OF LINCOLN ARCHAEOLOGY UNIT		
SITE CODE: ASS98	PLANE/ELEV/SECTION NO:	
CLIENT: The Churches Conservation Trust		
DESCRIPTION: South West-Facing Section		
SCALE: 1:10	ARCHIVE NO:	
DRAWN BY: K.W.	CHECKED:	DATE: 20/11/98
MUSEUM ACCESSION NO: 254.98

Limestone

In the vicinity of the two 1886 buttresses, this layer was cut by the construction trench for the buttresses, [134] (see Fig.5), which was at least 500mm deep to L.O.E. It was filled by [103], a mixed mid-brown silty clay containing small-medium sized limestone and chalk pieces. Layer [103] appeared to form the (limited) foundations for the existing buttresses, [134].
