**BRAYFORD WHARF EAST FLATS,
LINCOLN**

ARCHAEOLOGICAL WATCHING BRIEF

CLAU ARCHAEOLOGICAL REPORT NO: 389

A
Report to
The
Kingswater (Lincoln) Ltd
and
Lindum Group
Partnership

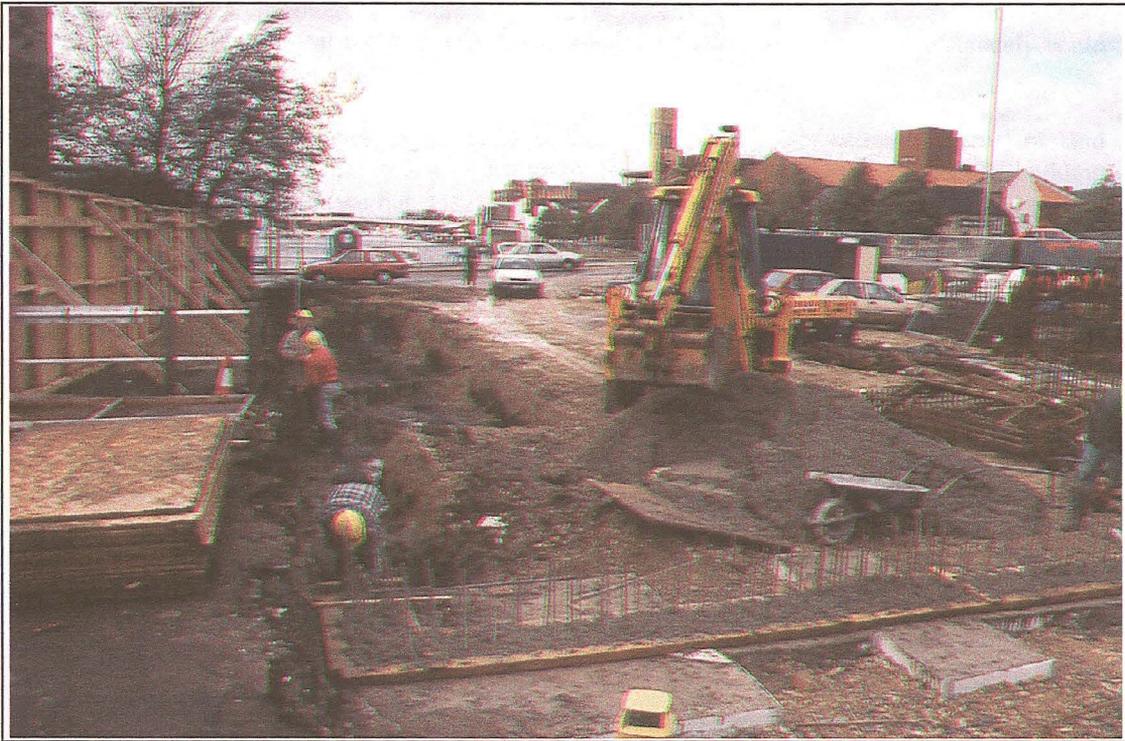
Plate 1: General view of the site, looking west as the development's groundwork progresses. Although apparently destructive, mitigation measures have ensured that much of the buried archaeological resource has been preserved in situ.

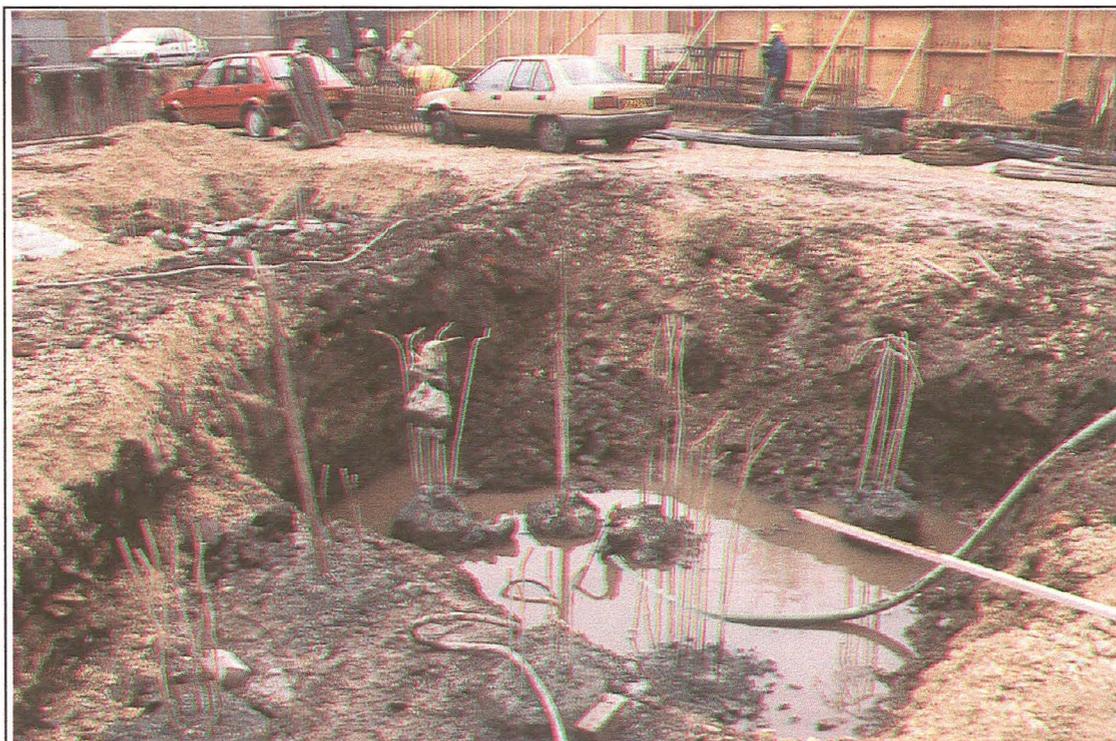
Plate II: General view of the lift pit trench looking south-east.

Although the excavation for the lift pit was the most intrusive of all the groundworks monitored during the watching brief (maximum depth - 3.78m OD), little new information regarding the site's archaeological content was revealed. The earliest deposit encountered was [010], an extensive (600mm+ thick) deposit of dark brown silty sand with interleaved lenses of organic material (4.35m OD). This deposit probably related to the reclamation events dated to the 13th century and revealed during the 1998 evaluation of the site. Overlying [010] were several narrow bands of north-sloping silty soil forming a second reclamation event ([004]-[009] - 4.98m OD). As with [010], this event can be placed within the sequence recorded during the evaluation as late/post medieval in date. Deposits and features associated with Hercock's warehouse ([002] & [003] - 5.18m OD), sealed the previously described event. A 200mm - 500mm thick deposit of limestone fragments laid down by the contractor

to form a level platform for the piling machine ([001]) constituted the latest deposit present. No further features and/or deposits were recorded in the area of the lift pit.

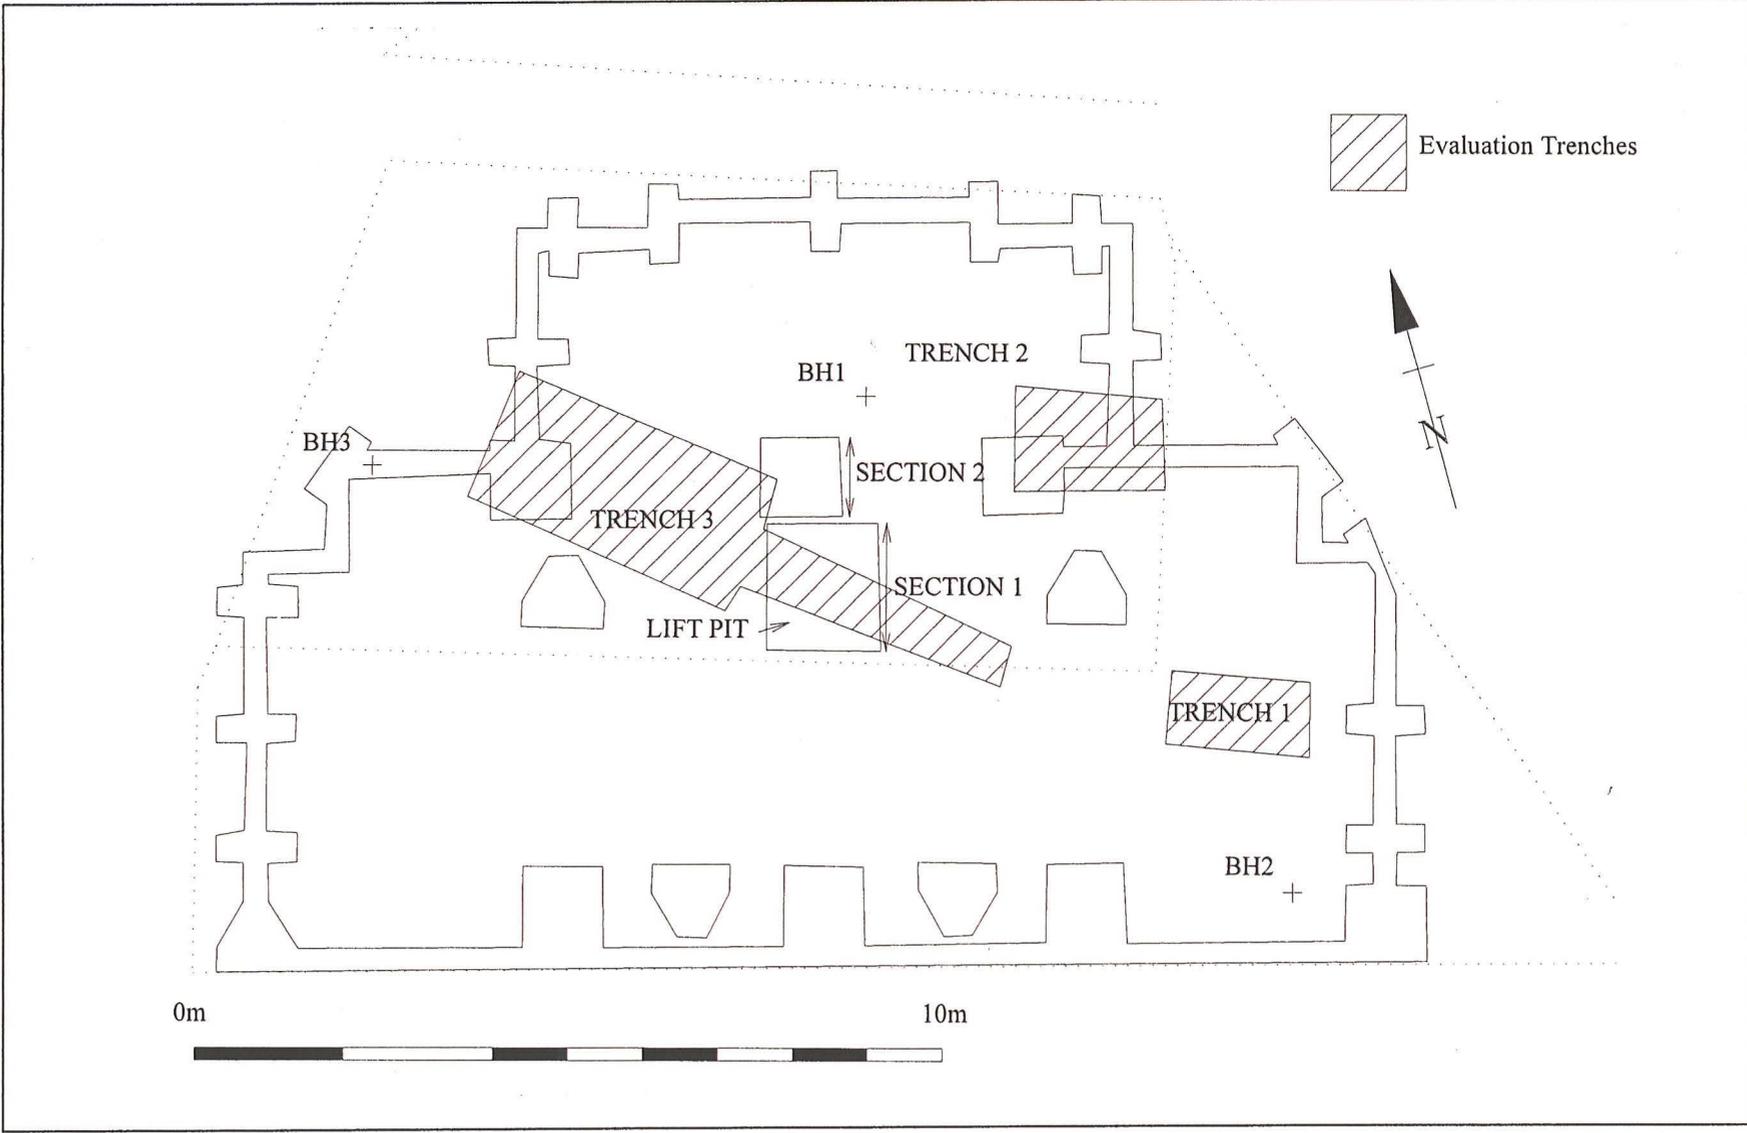
Fig. 2: Section location plan, also showing position of Evaluation trenches and boreholes.

Groundbeam & Pile-cap excavation (Figs. 2 & 3 and Plate I)

Lift Pit (Figs. 2 & 3 and Plate II)

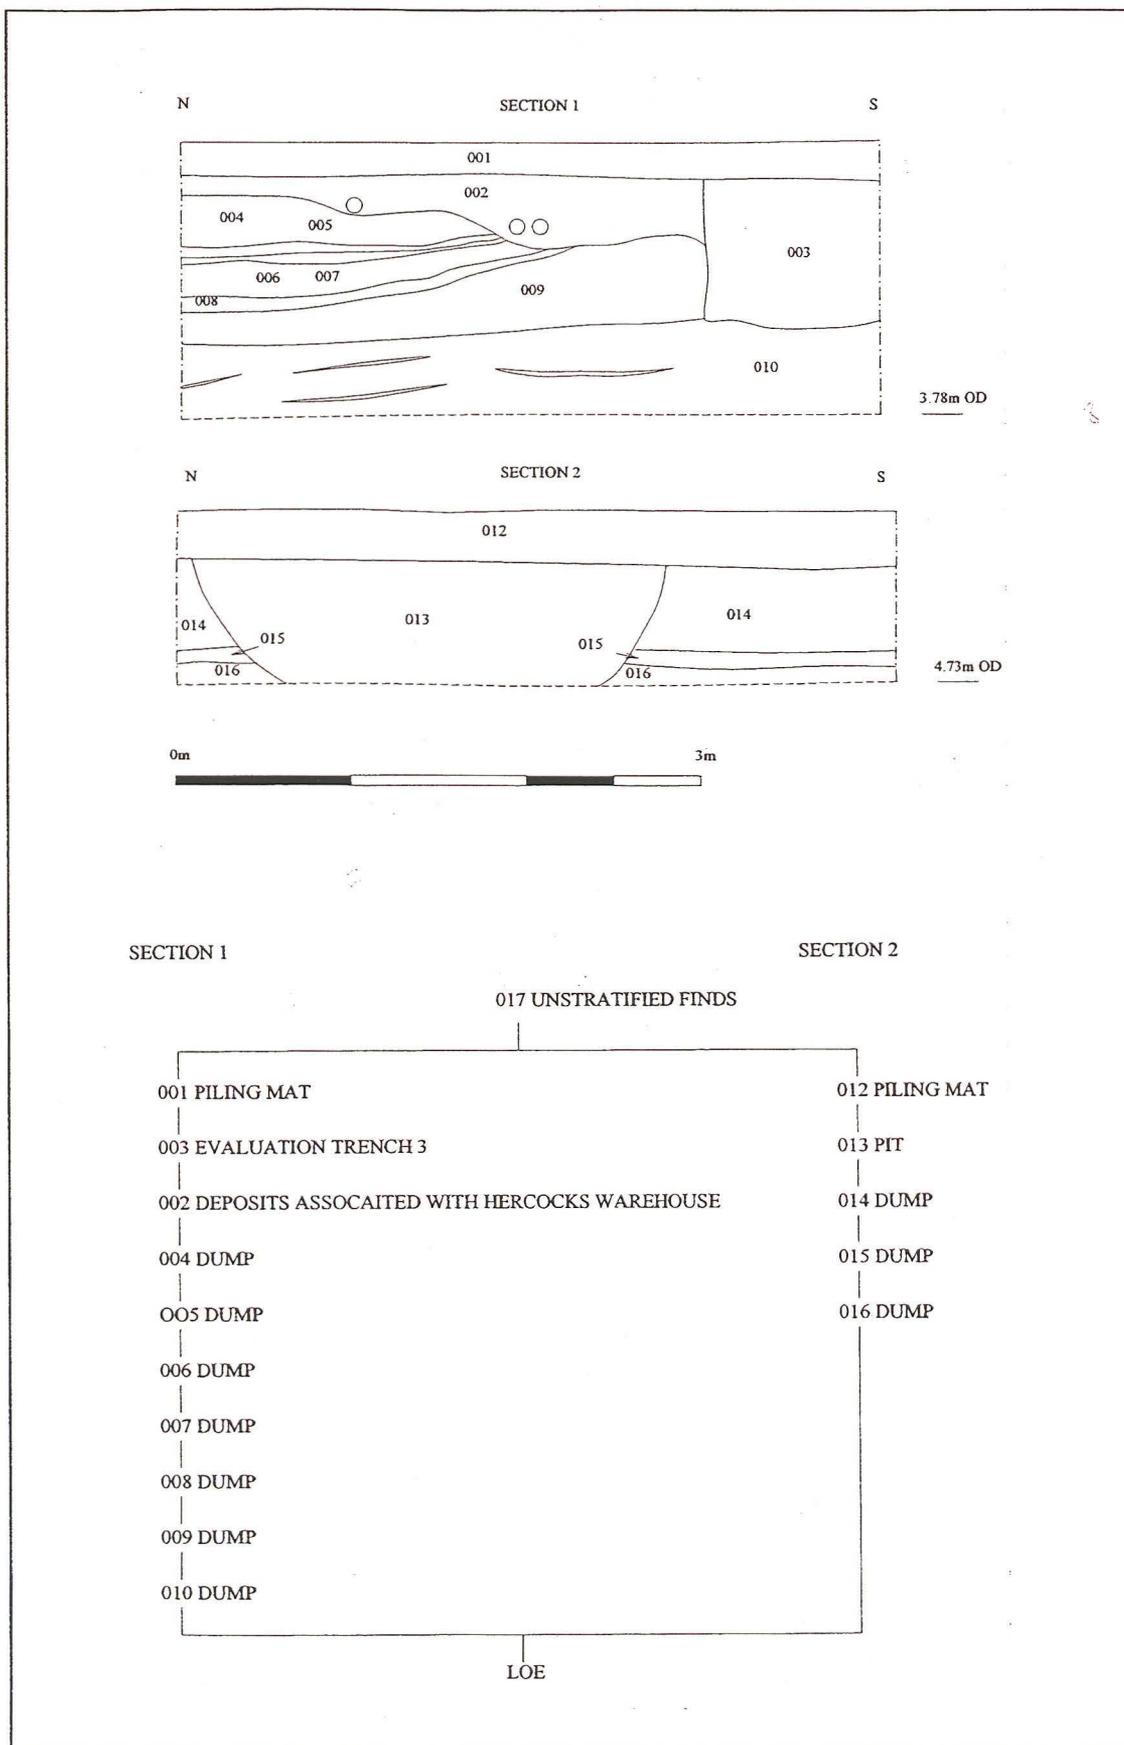
Fig. 3: Sections 1 & 2 and Stratigraphic matrices.
