**ARCHAEOLOGICAL WATCHING BRIEF
AT ST. ANDREW'S CHURCH**

Culverthorpe & **KELBY,
LINCOLNSHIRE
(KSA98)**

August 1999

A.P.S. Report No. 4/99

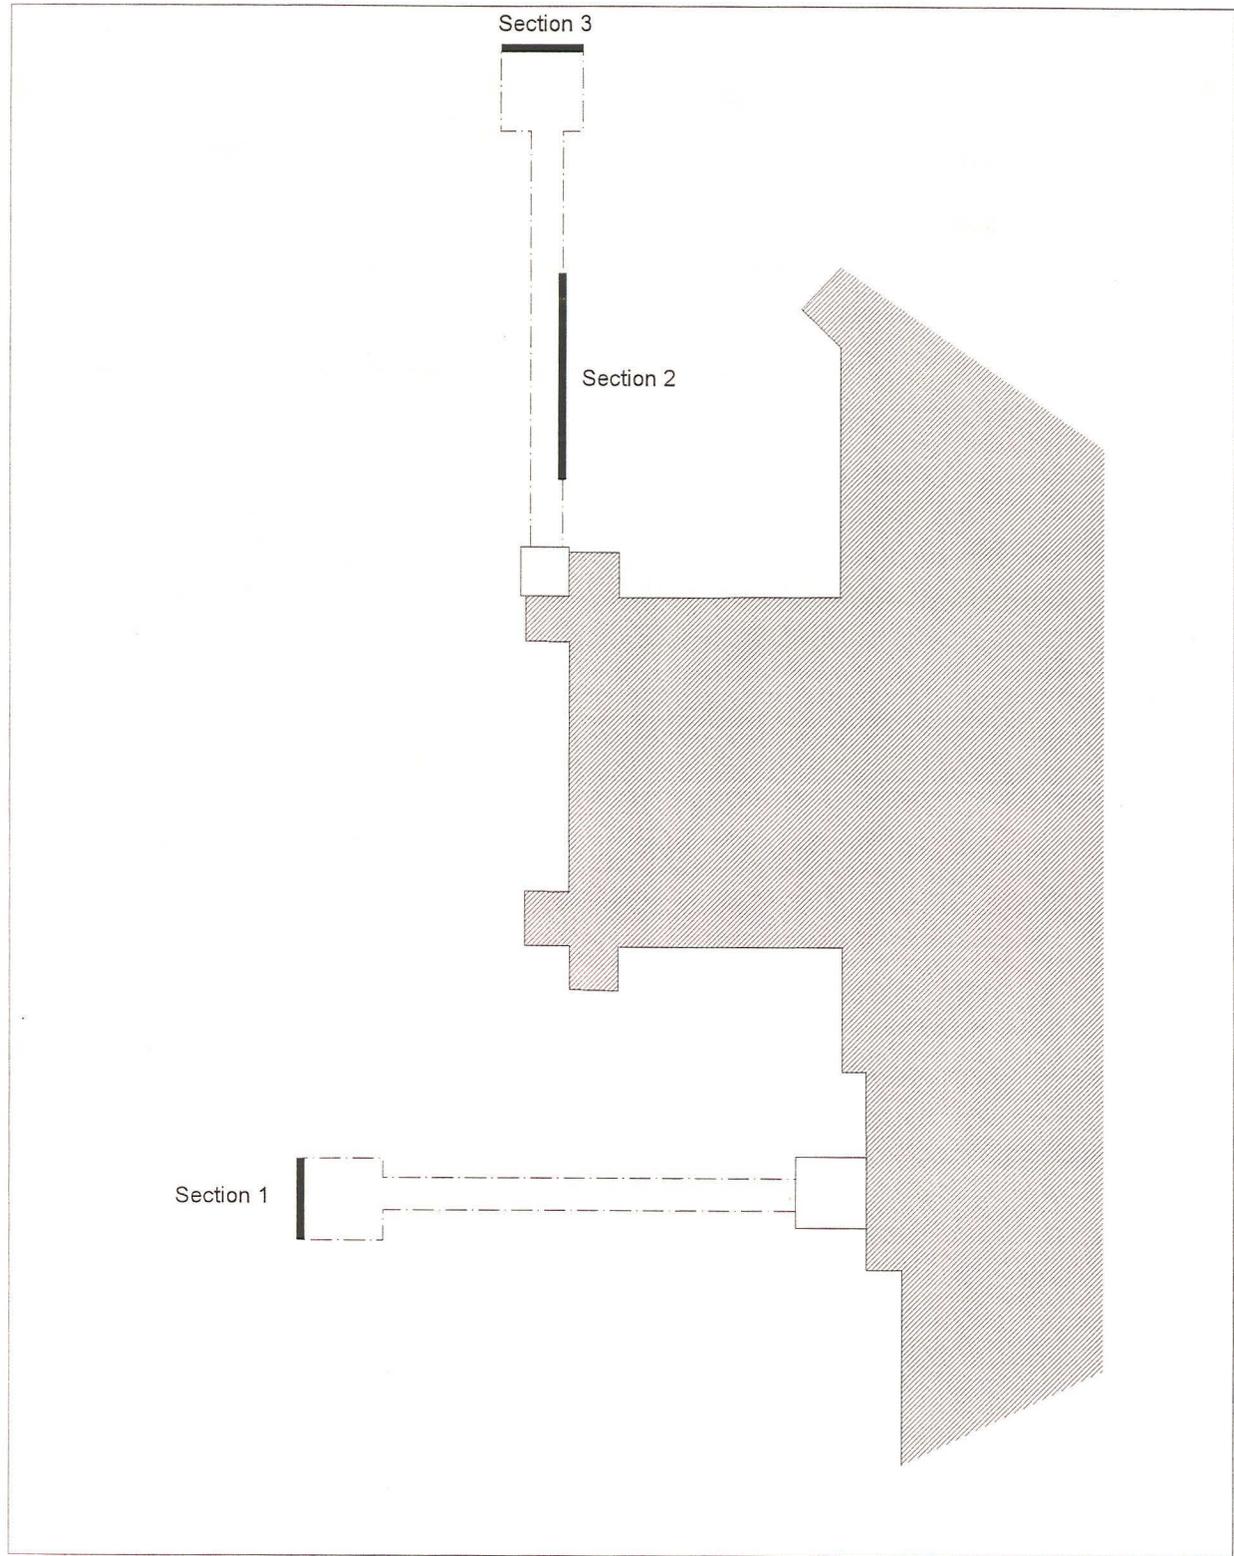
Figure 3 - Drainage Plan, showing section locations

Two drains, each with a soak away, aligned east-west and north-south was excavated adjacent to the west and north sides respectively of the tower of St. Andrew's parish church. The trenches measured *c.* 5m long by 1m deep (Fig. 3).

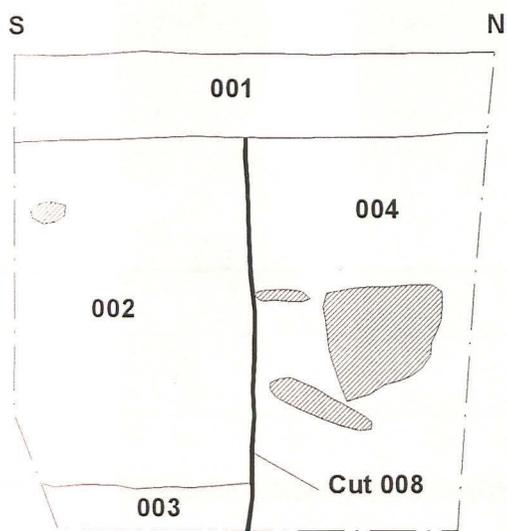
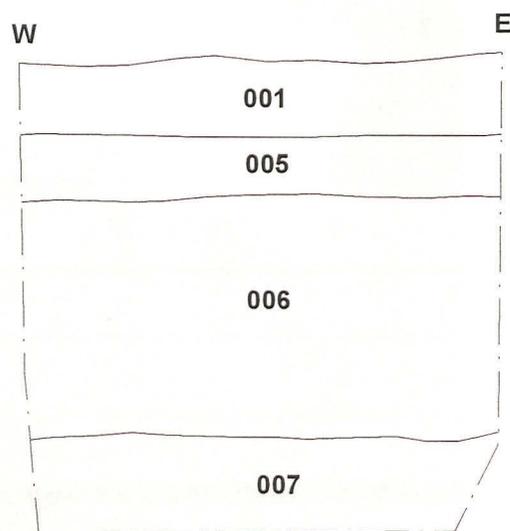
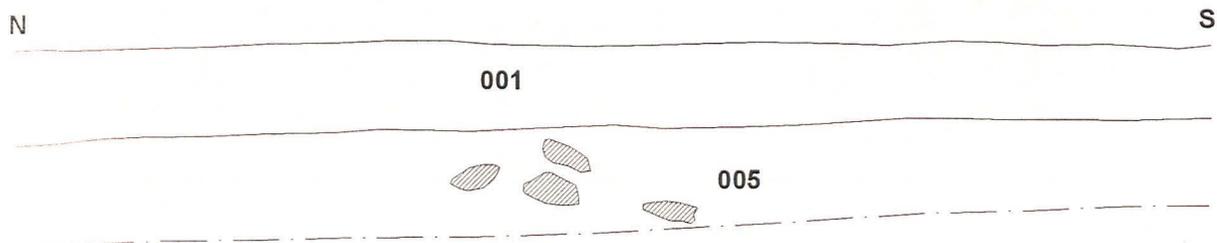
Figure 4 - Sections 1, 2 and 3

The earliest recorded deposit within the trenches comprised brownish yellow silt (004 and 007). This was exposed at a depth of 0.8m below the modern ground surface, and continued beyond the limit of excavation.

Overlying the Phase 1 deposits was a dumped layer of yellowish brown clayey silt (002 and 006). Although the finds retrieved from (006) are consistently of the 11th century, one fragment of ceramic tile from (002) is 19th or 20th century in date. It is considered that this tile is a later intrusion.

Cutting through this deposit was a possible grave (008), 1m wide and 0.82m deep, though it continued beyond the limit of excavation. This was filled by a brown silt (003), that contained pottery and tile dated to the 13th or 14th century, together with redeposited 10th - 12th century pot.

Sealing Phase 2 deposit (006) was a layer of yellowish brown silt subsoil (005). The subsoil and the grave fill (003) were overlaid by a deposit of dark brown silt topsoil (001) that contained a fragment of 19th - 20th century pot.

Above this was a layer containing medieval, particularly 11th century, pottery which may represent the former medieval ground surface. The 11th century pottery may have derived from settlement in the vicinity prior to the construction of the church. A grave was recorded cutting through this deposit. No human remains were found to confirm this as presumably they lay at a greater depth. Pottery of the 13th and 14th century was retrieved from the fill, together with fragments of broadly 11th century date which were probably redeposited from the medieval ground surface.
