**Bonemill Lane, East Rd, Sleaford**

**Site Code: SBL 99 LCNCC**

## **Archaeological Evaluation Trenching**

**LAS Report No. 371  
November 1999**

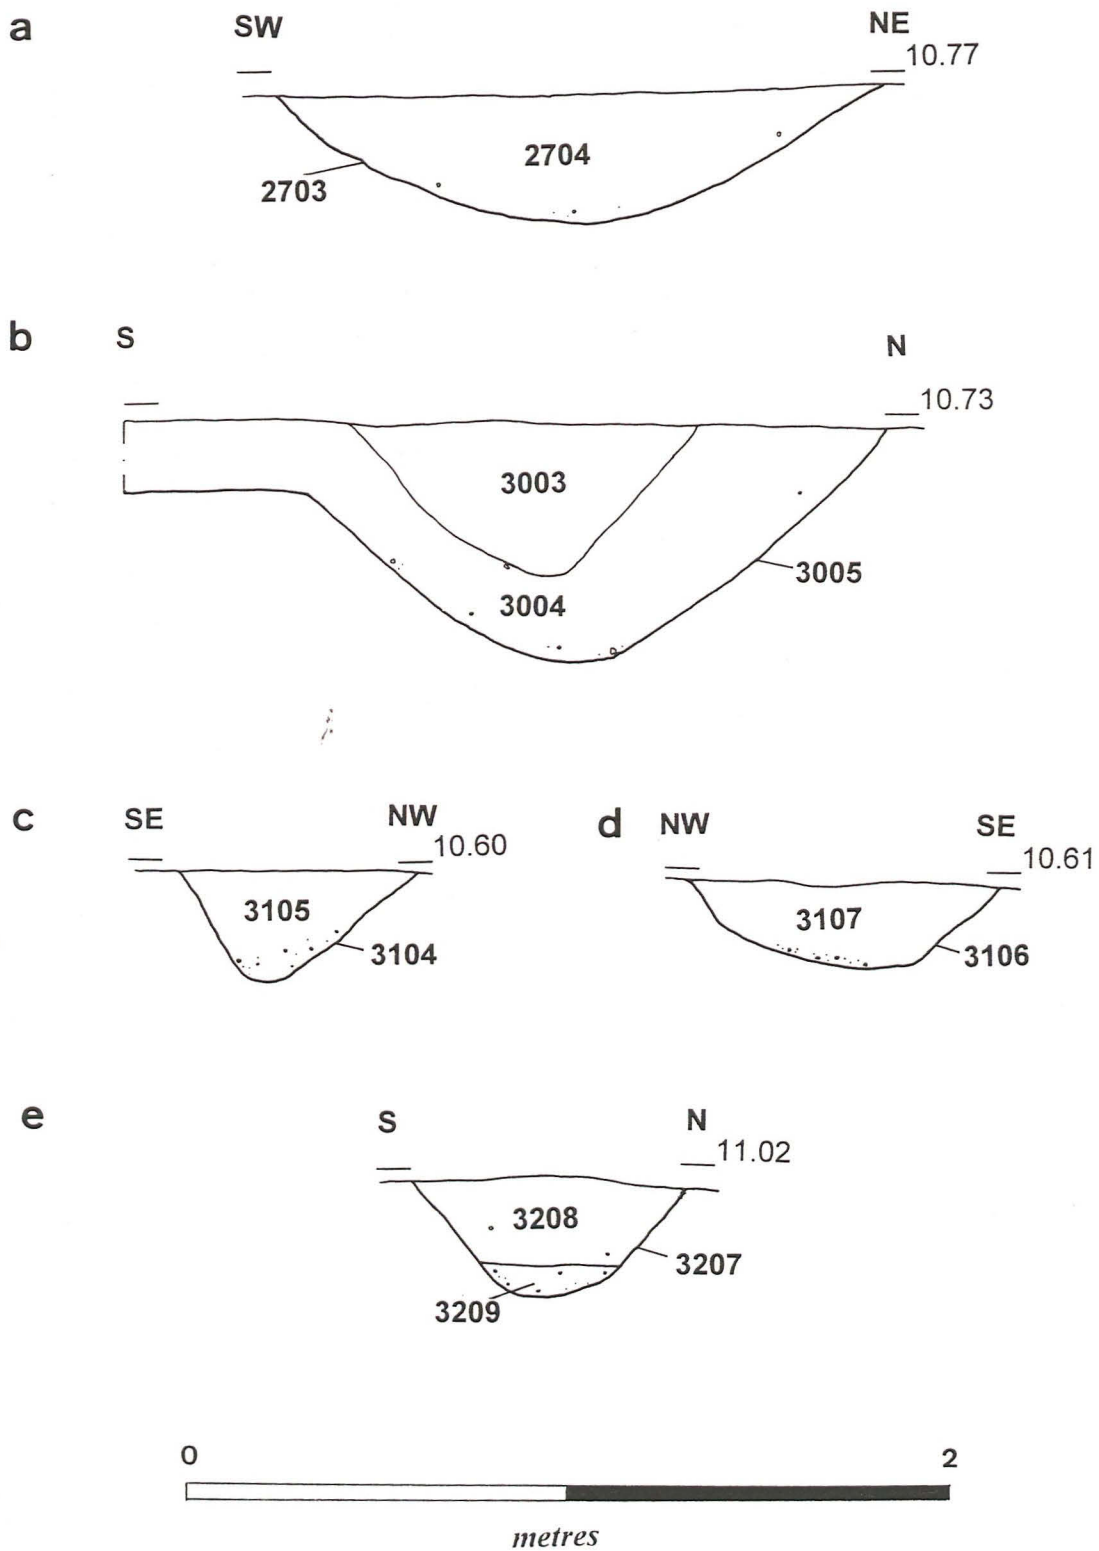
Fig.25a) Ditch 2703, south-east facing section b) Ditch 3005, east facing section c) Ditch 3104, north-east facing section d) Ditch 3106, south-west facing section e) Gully 3207, east facing section.

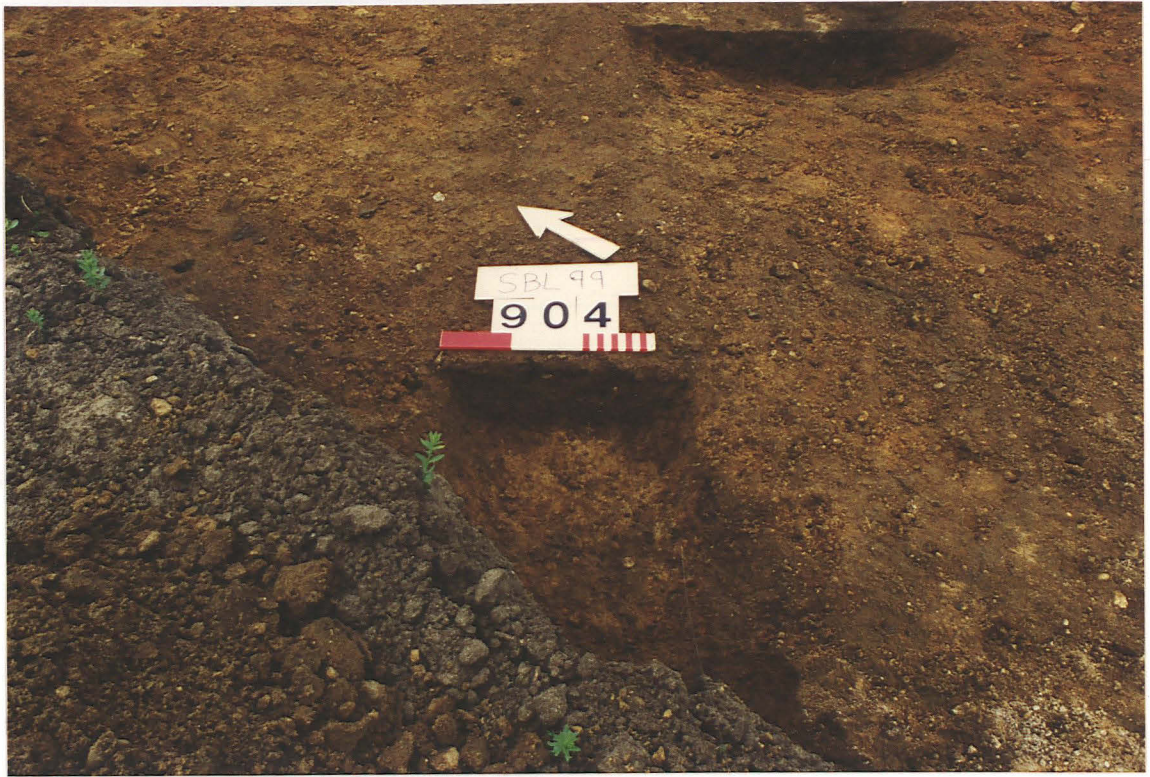
Pl. 15 Gully 904 with treebole 906 to the north-east, looking north-east. Scale 0.3m.

Gully **904** cut through the northern edge of a treebole, **906**. This irregular natural feature contained **905**, a grey brown silty sand with occasional rounded stones and some evidence for the removal of roots by burning.

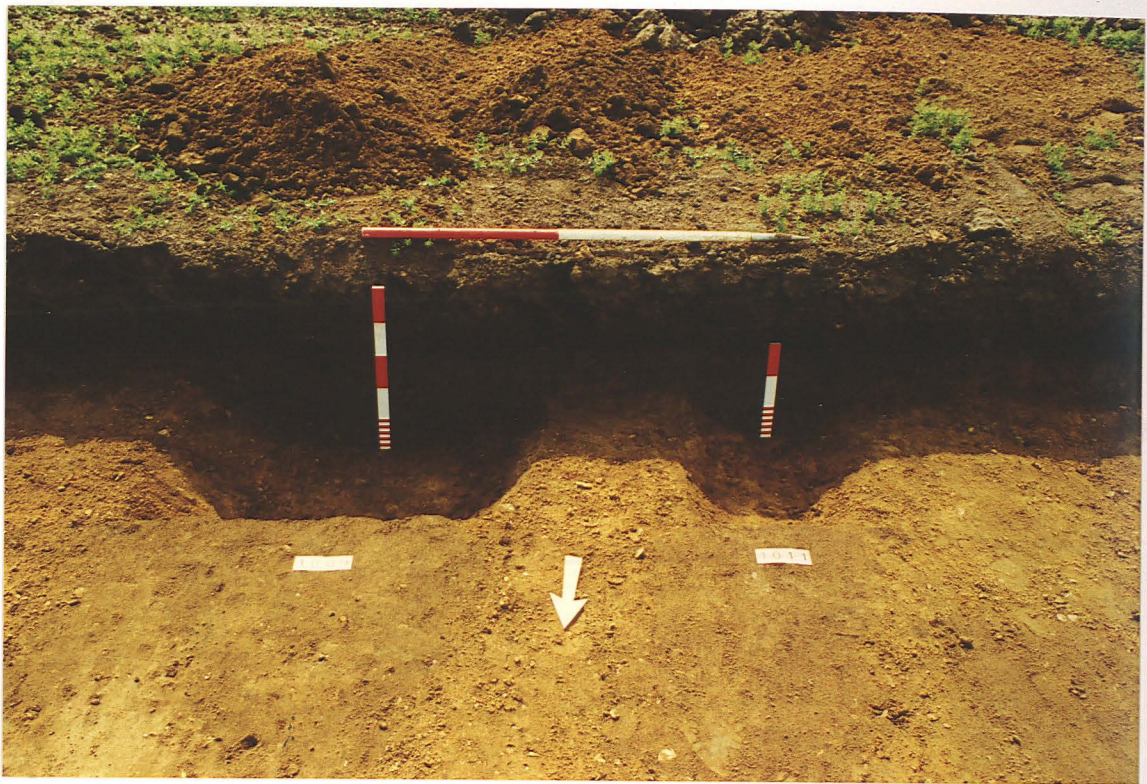
Pl. 18 Ditch 1006 and gully 1004, looking south. Scales 1m, 0.5m & 0.2m.

Approximately 2.75m west of **1011** was ditch **1006** (Pl. 18). Following the same alignment as **1011**, this ditch was 1.20m wide and 0.53m deep. It was filled by **1007**, a loose dark grey sandy silt deposit from which an iron nail was recovered. This feature was cut by a north-south aligned modern drain, **1008**.

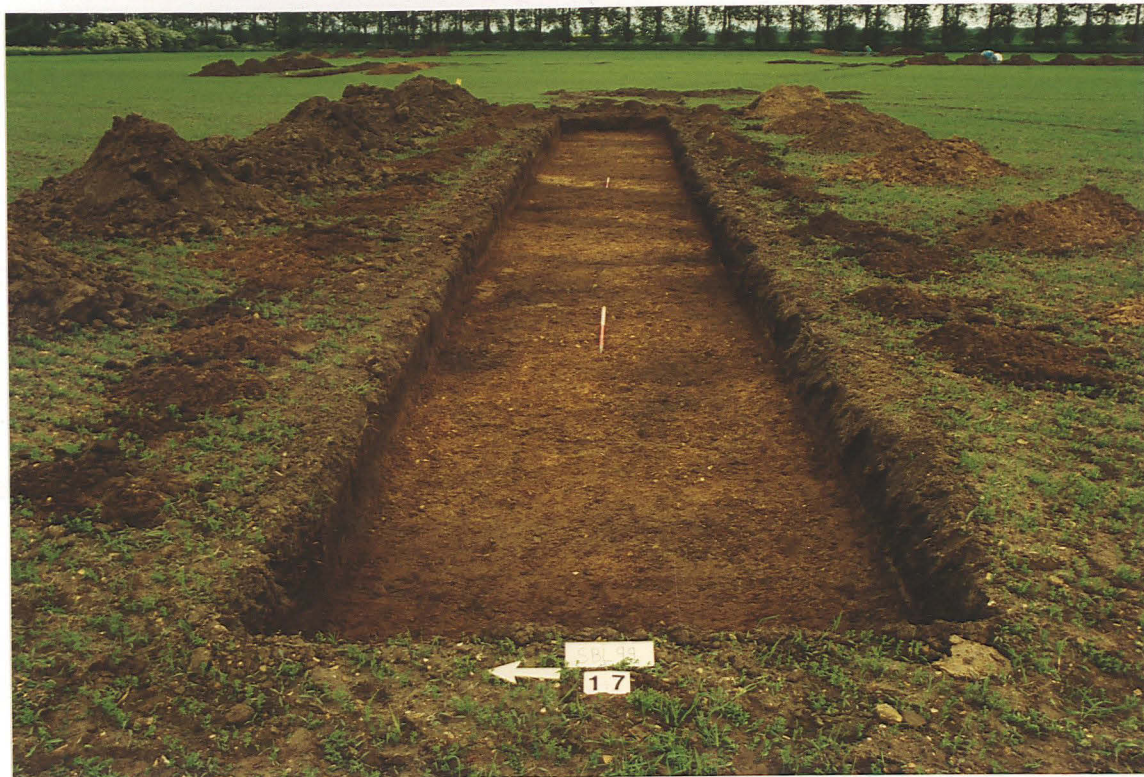
Pl. 27 Trench 17, looking east. Scales 1m.

*Trench 17 (Fig. 11, Pl. 27)*

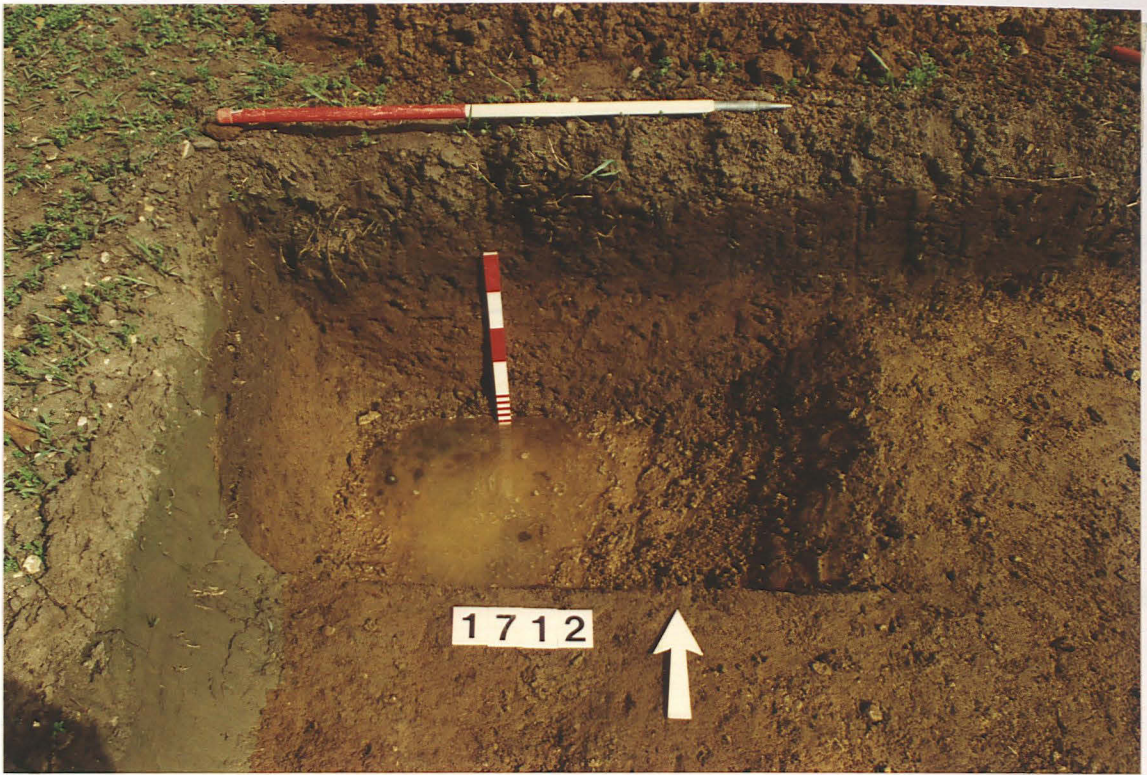
Pl. 34 Trench 19, looking north. Scales 2m & 1m.

*Trench 19 (Fig. 12, Pl. 34)*
