**Bassingham Water Main Replacement
Water Lane**

Archaeological Watching Brief

**NGR: SK 9094 6019
Site Code: BAS 99
LCNCC Museum Accn. No. 199.99**

**Report prepared for
Anglian Water Services Ltd**

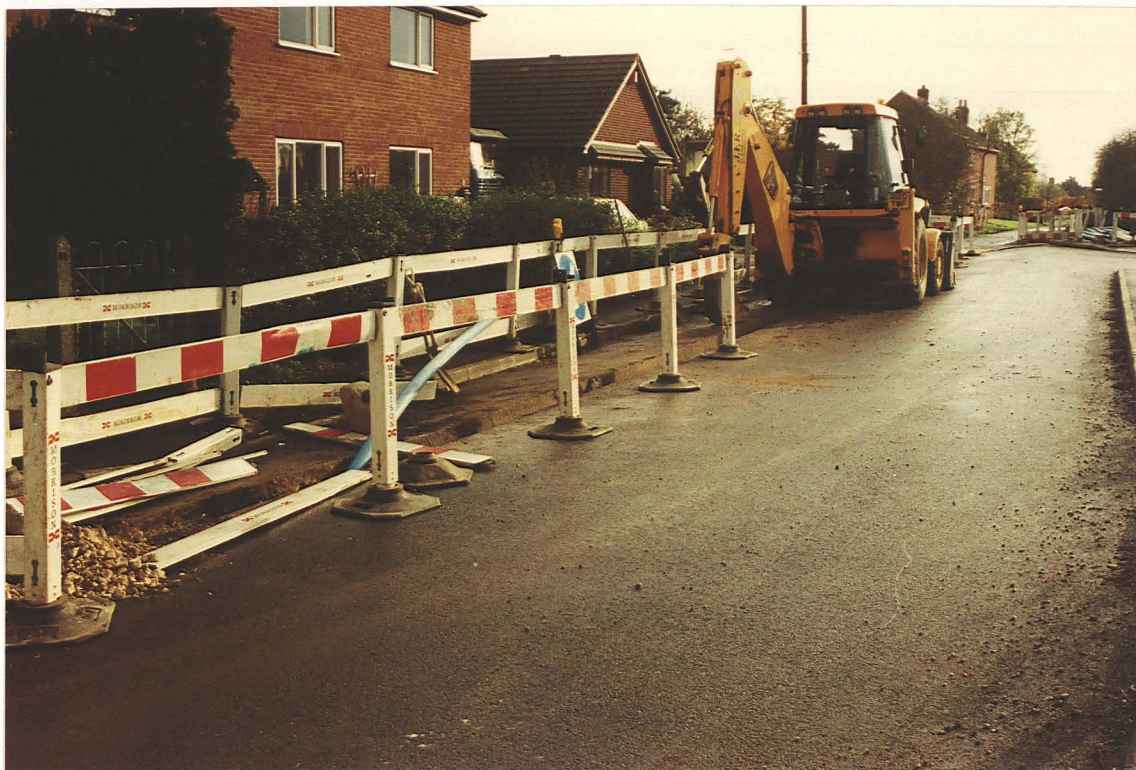
Pl. 1 Trenching north of Hall Field. The junction of Hall Field is visible on the right (looking south).

The total length of pipeline identified as being of potential archaeological interest comprised about 300m. The 0.3m wide and 1m deep trench was excavated with a JCB with toothed bucket along the south and east edge of the lane as far as the junction with Hall Field, before crossing to the western verge (Pl. 1).

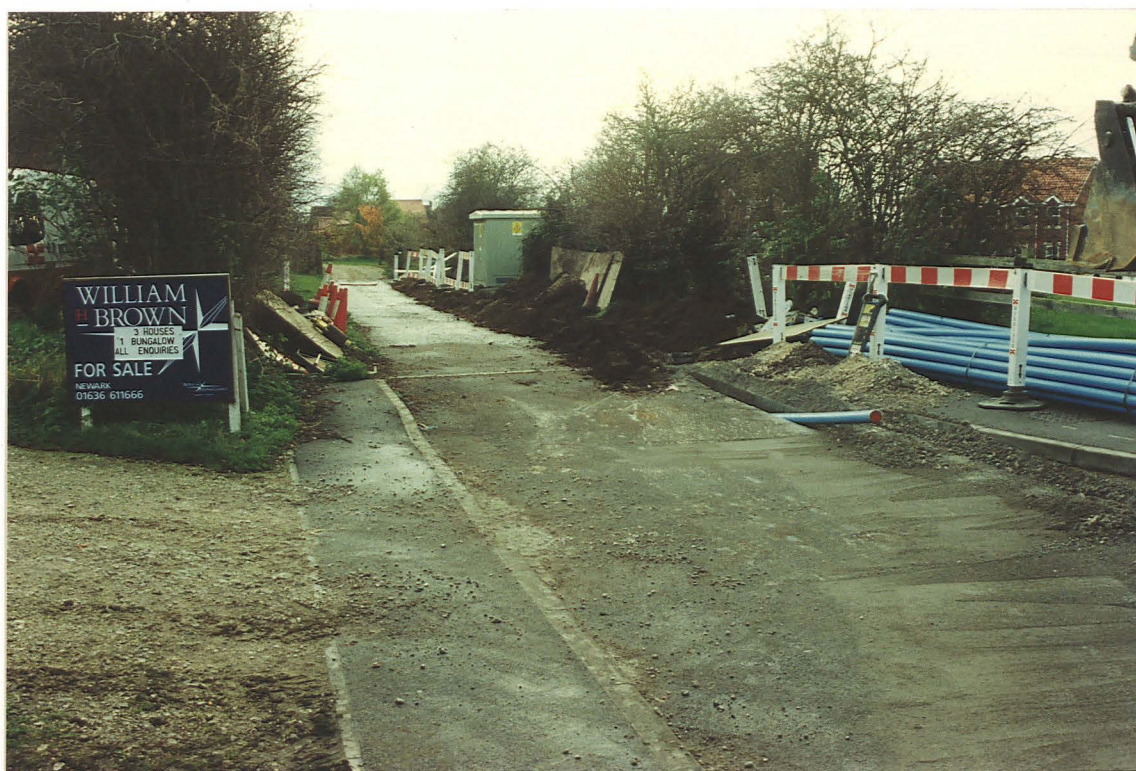
Pl. 2 Trench position in the roadside verge, south of Hall Field (looking south).

7. Immediately south of Hall Field, the trench crossed to the western roadside verge (Pl. 2). The topsoil overlay sand and gravel deposits, possibly track metalling, above dark brown and black sandy loam that extended below the trench base (Pl. 3). This was interpreted as the fill of a post-medieval field/track boundary ditch.

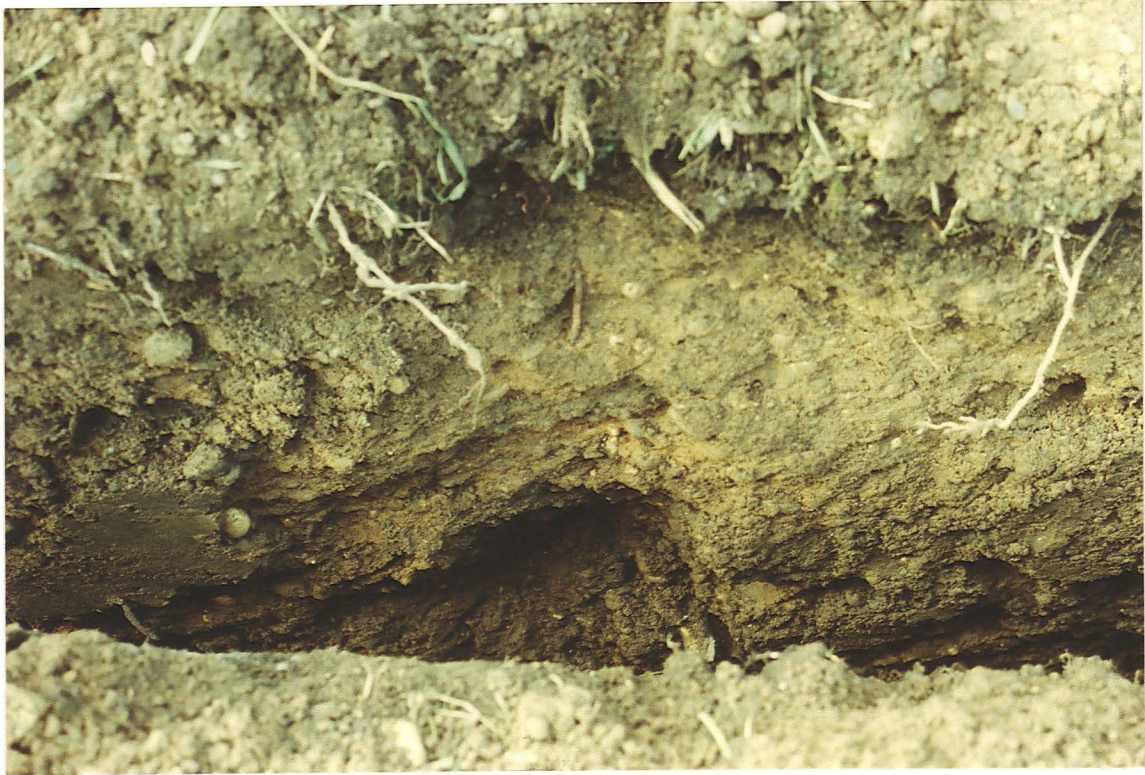
Pl. 3 Deposits visible in the roadside verge 7 south of Hall Field.
