**ARCHAEOLOGICAL WATCHING BRIEF
ON WATER MAIN TRENCHES
AT HELPRINGHAM, LINCOLNSHIRE
(HVP 99)**

**Work undertaken for Anglian Water
December 1999**

APS Report No: 6/00

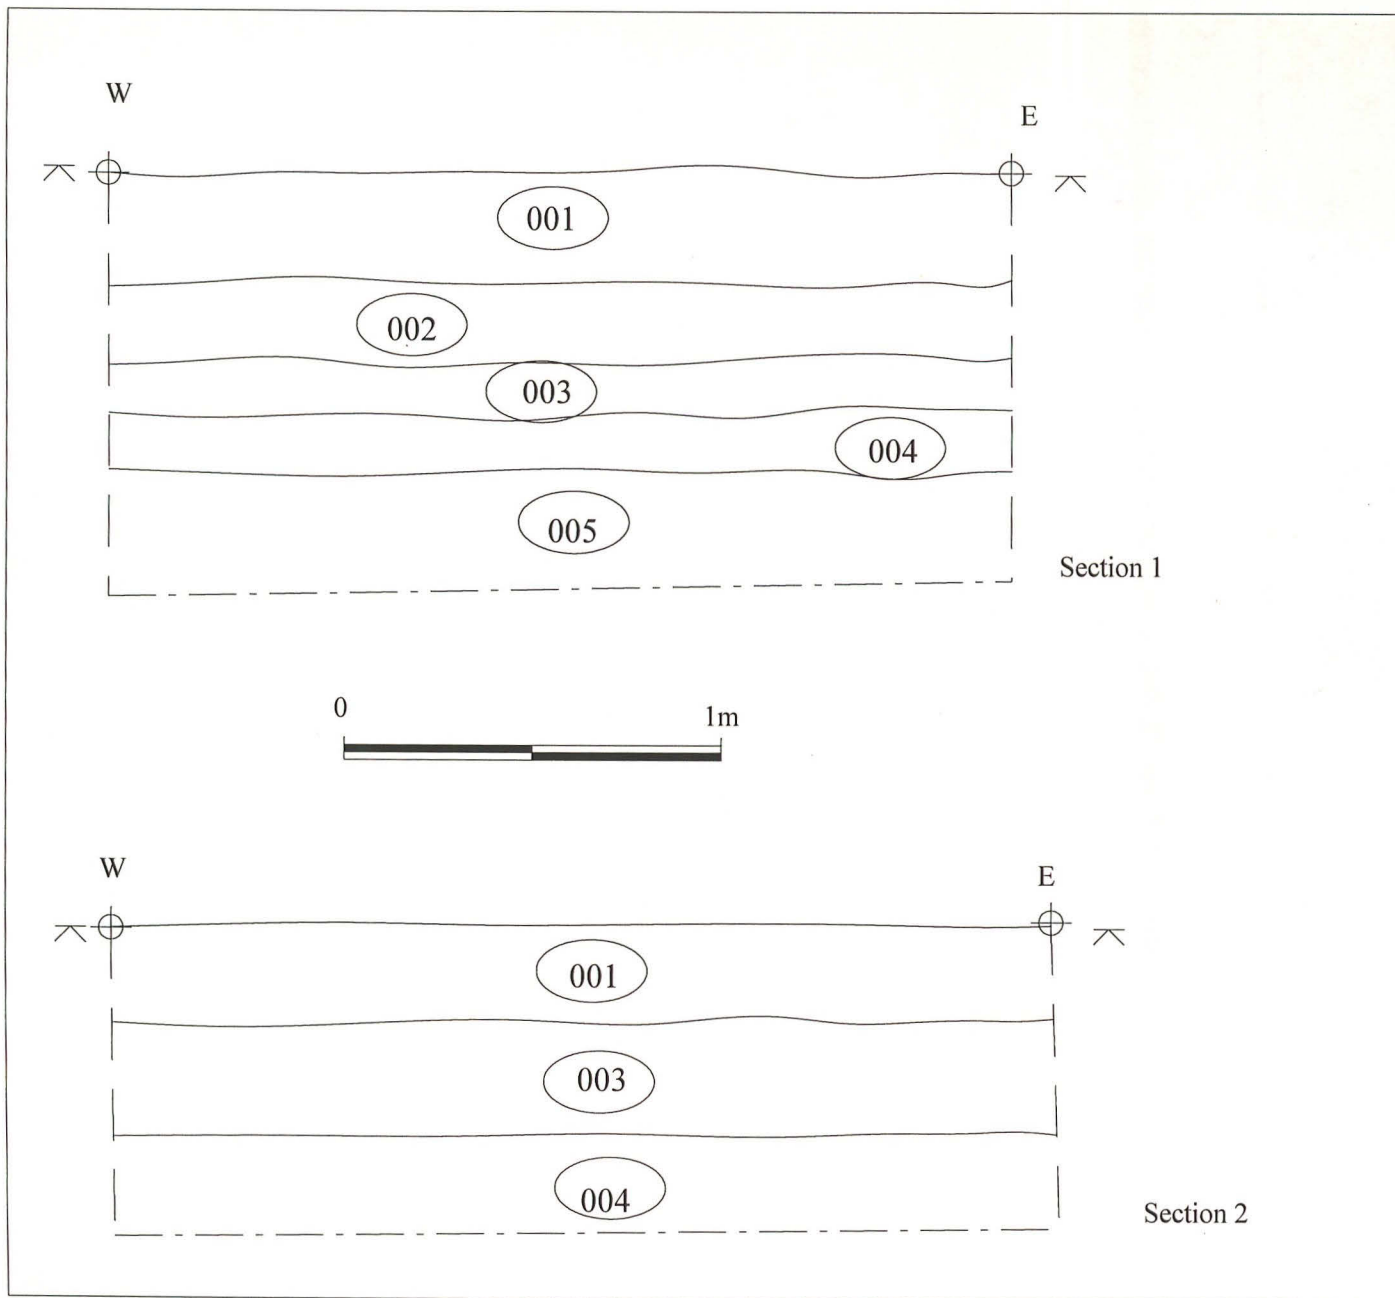
Figure 3 Sections 1 and 2

A sterile, firm, orange, sandy clay, banded with mid grey clay (5) was encountered at a depth of 0.80m below the ground surface in trench 1 (Fig. 3).

Above the natural orange clay was a 0.20m thick layer of soft, very dark grey silt (4), containing moderate quantities of rounded pebbles. This was recorded in both trenches 0.60m below the present ground level.

A total of three modern deposits were observed in the course of the watching brief. A sterile, orange sandy clay and gravel (3) was present in both trenches above the phase 2 silty layer. This deposit was overlain by a dark grey, sandy clay and gravel (2) in trench 1. The uppermost deposit in the sequence consisted of a 0.25m thick layer of tarmac (1).

The sterile sand and clay encountered at the bottom of the deeper trench 1, appears to be a natural deposit. The banding observed and the composition of the deposit, indicate it was water lain.

The stratigraphic position of the homogenous grey layer, (4), above natural material and below a series of modern deposits, suggest it represents a pre-road ground surface, probably a buried soil. No finds were recovered from this context and so dating is not possible, however, the depth at which it was encountered suggests it is not a recent deposit.

The construction of the road is represented by two layers of gravelly make up covered with tarmac. A map of the area drawn in 1779 by A. Armstrong shows the existence of a road on the same alignment, so it is possible one of

the gravelly make up deposits is associated with the 18th century road.
