**Waddingham, land west of Silver Street**

**Archaeological Watching Brief**

**LAS Report No. 388**

**March 2000**

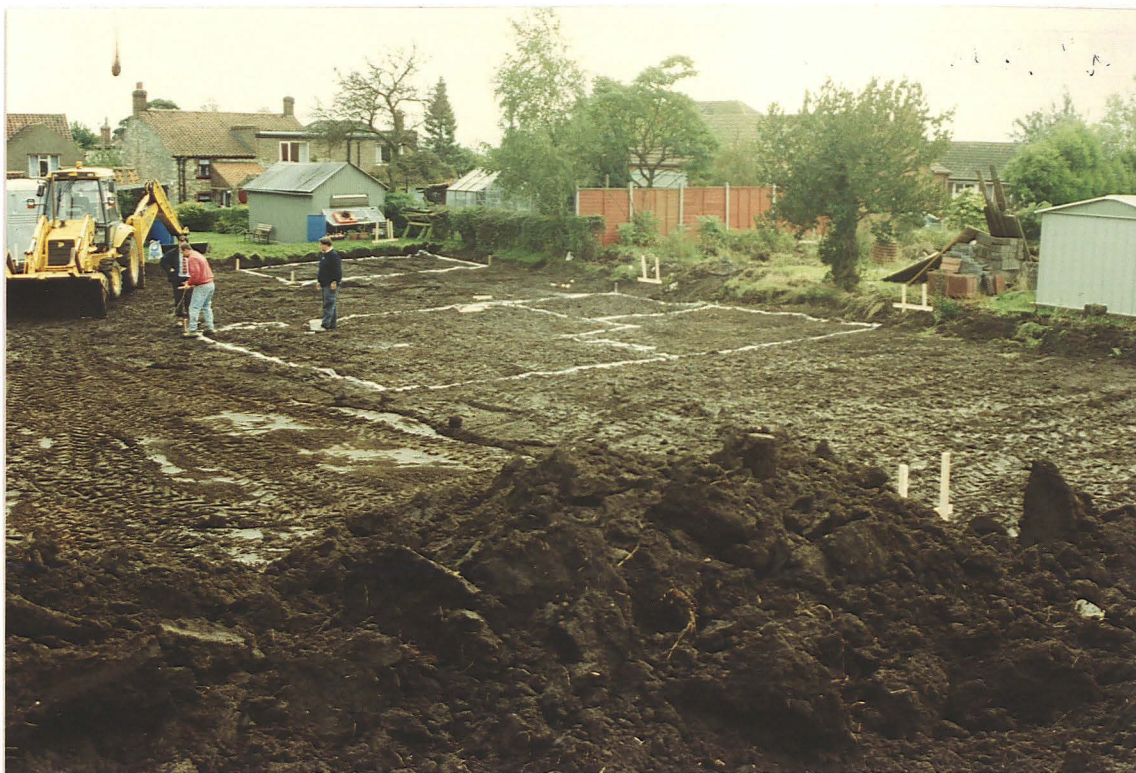
**Pl. 1** Site of House Plot 1 and its garage, with the centre of the trench lines marked in white. Looking SE towards Silver Street.

This bungalow was positioned to the south of the building plot, close to a former hedgeline which separated this development from existing recently built bungalows (Pl. 1). The southern foundation trench was excavated alongside the hedgeline through 0.5m dark brown topsoil **1** and 0.5m brown subsoil **2**. The topsoil produced seven sherds of pottery (one medieval, the remainder eighteenth or nineteenth century) and a single fragment of clay tobacco pipe stem (Appendix 1). Three other sherds (two late ninth or tenth century, one late seventeenth or eighteenth century) were found in the subsoil layer. The greater depths than usual of these layers close to the southern edge of the plot probably indicates that this trench cut through a former upcast bank on which the hedge had originally grown. It is also possible that a number of shallow pits were present but not recognised. No sign survives of a west-east ditch associated with this field boundary hedge, although vestigial traces of a bank remain. Topsoil depth away from the hedgeline was about 0.15m, covering the 0.15m thick subsoil layer.

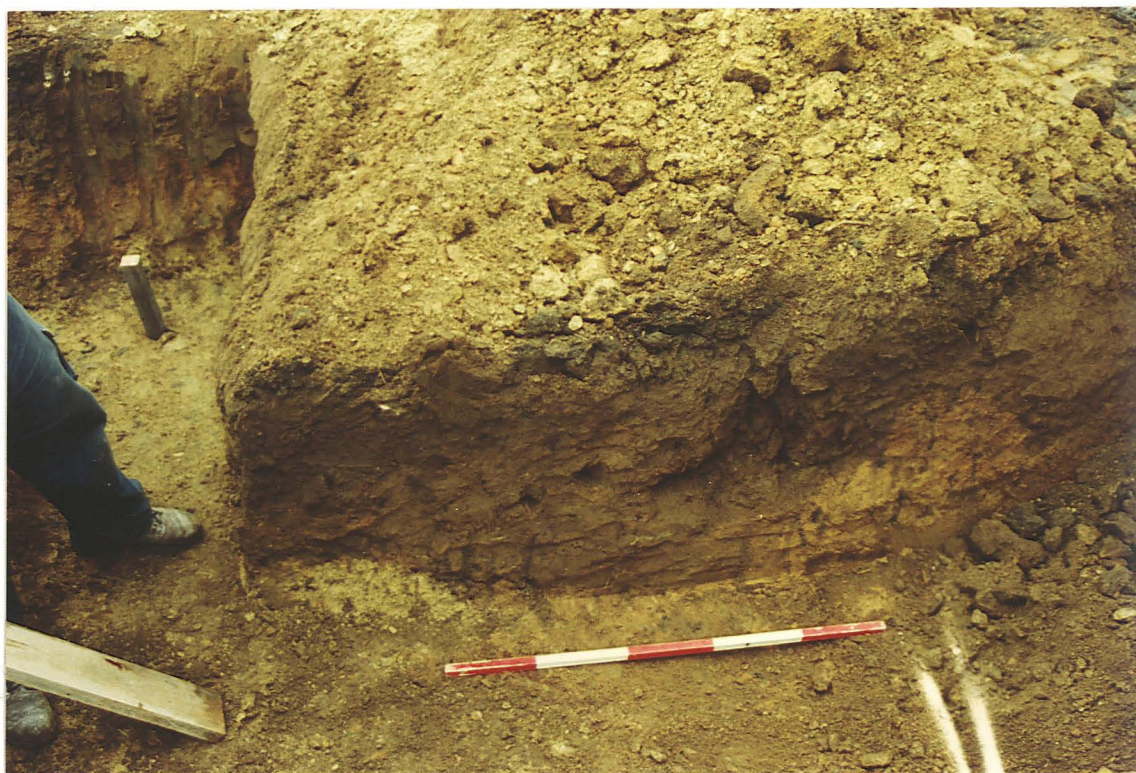
**Pl. 2** Eastern side of boundary ditch 13 in House Plot 1 (centre and left), cutting the orange clay and brash layer (to right). Looking south, scale divisions 0.2m).

A backfilled north-south aligned field boundary ditch **13** was seen in the foundation trenches of this house plot, but it did not appear to equate with any of the ditch features in House Plot 2 (Pl. 2). The ditch was 1.3m wide and 0.5m deep, cut through a layer of orange loam into the limestone brash. It appeared to become shallower to the north, but it was suspected that this was the result of truncation of deposits away from the protection given by the existing hedgeline. A mature holly bush grows on the hedgeline at the point where this ditch meets the edge of the house plot; the tree may have been growing at the corner of fields (Pl. 3). The ditch could therefore be post-medieval or medieval in origin, but probably not earlier.

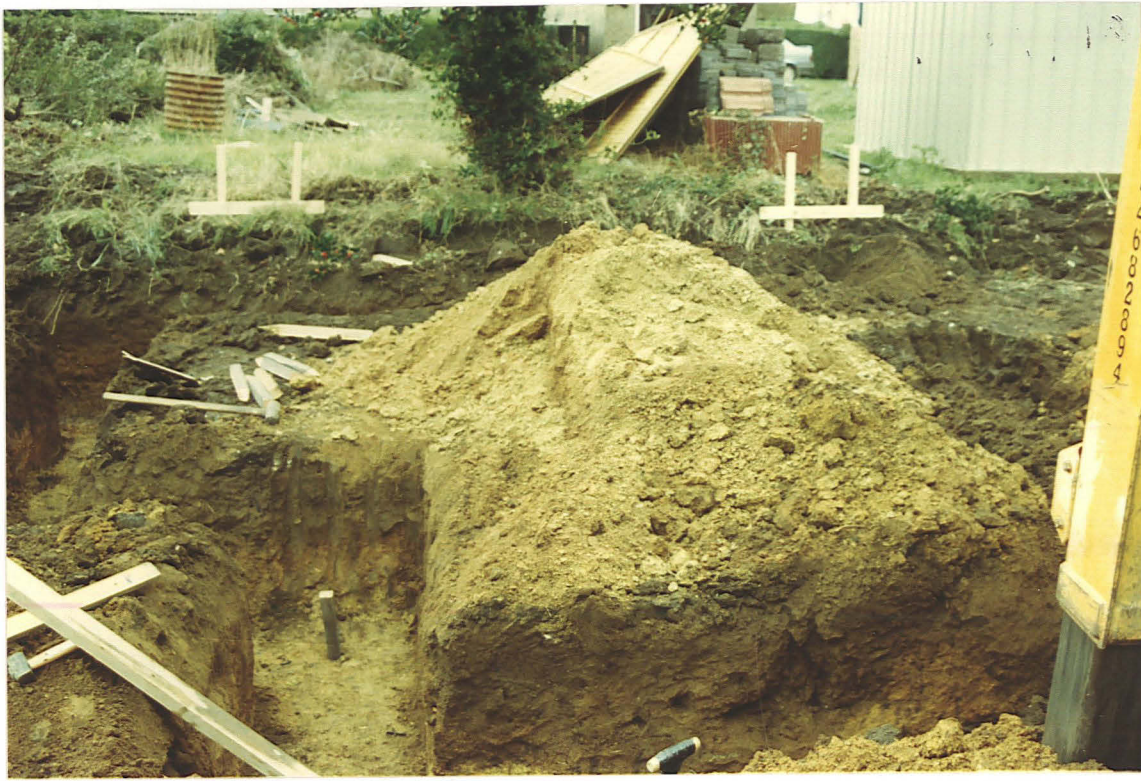
**PI. 3** Boundary ditch 13 and the position of the existing boundary. The holly bush may mark the position of a corner between fields or properties. (Looking south).

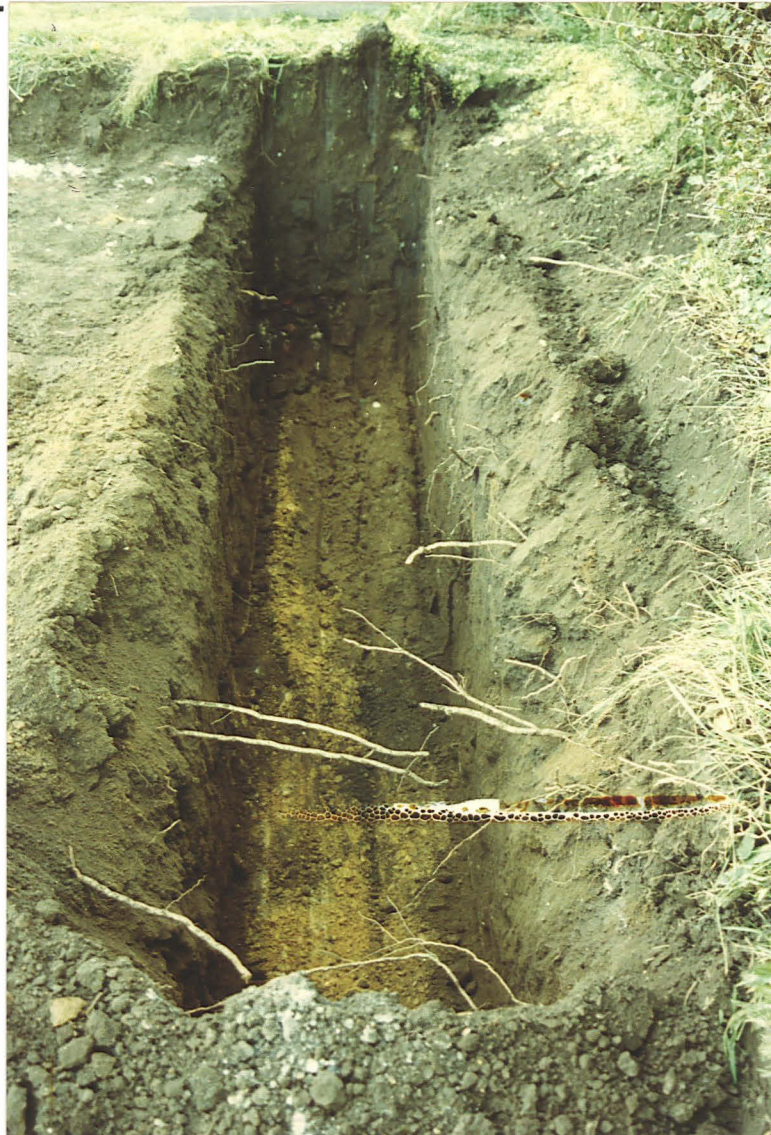
**PI. 4** Dark fill of rubbish pit 16 visible contrasting with the yellow brash at the base of the foundation trench, SE corner of the House Plot 1 garage (looking east).

trenches revealed a complex of intercutting post-medieval and early modern rubbish pits **12** and **16** along the eastern side of the garage (Pl. 4). These were clipped by the foundation trenches, so although the western limits were present, most of the pits lay beyond the new development and their depths and extents could not be established.

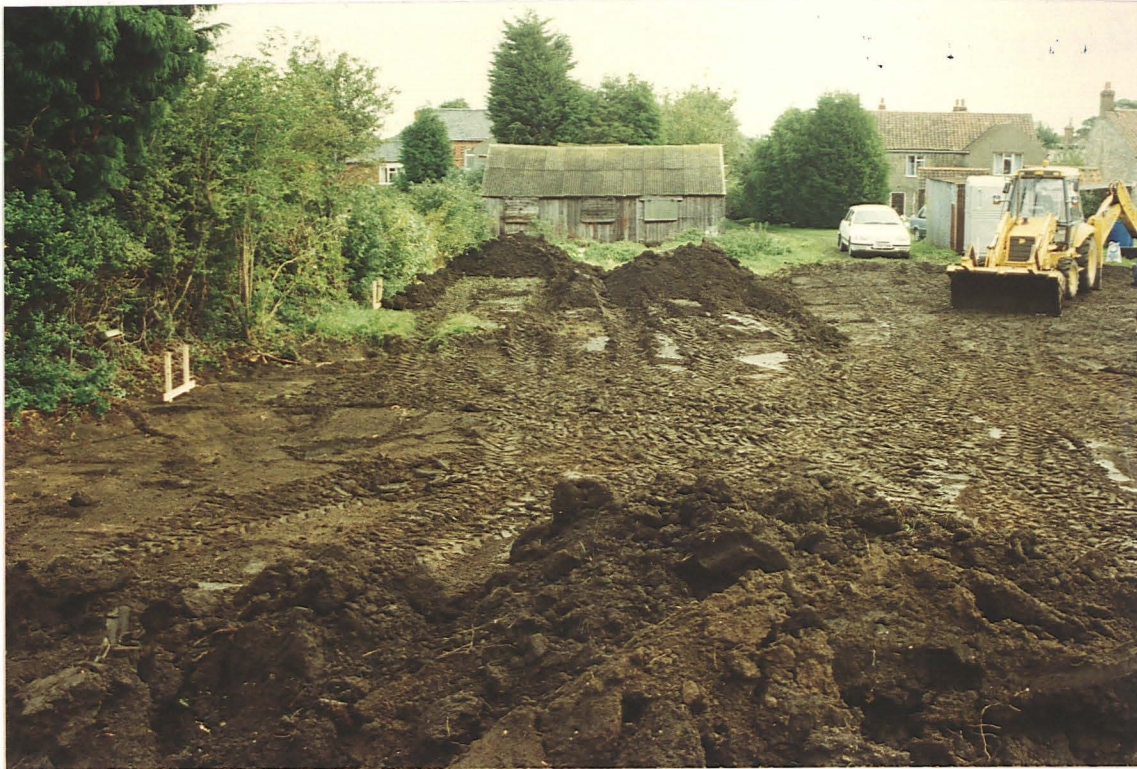
**Pl. 5** Site of House Plot 2 (looking east). The change in alignment of the boundary hedge to the north can be seen; this may be a deflection around quarry pits excavated for limestone brash.

This plot, to the north of House Plot 1, was beside an established boundary hedge and adjacent foundation trenches were excavated to a greater depth (Pl. 5). Bedrock was encountered in the NW corner at a depth of 2.1m below ground level. At these depths, access into the 0.65m wide trenches in wet conditions was not practical, and monitoring and recording took place from ground level. It was possible to work in the trenches to the south side of the plot, but concrete was poured into the foundations very shortly after excavation.

Evidence for pits extended south to where **20** and **23** had removed ditches **15** and **17**. No signs of such features were visible in either the eastern or western foundation trenches of this house plot, and this suggests that the pits were restricted to the corners of two properties divided by the NW-SE ditch. The presence of the open pits may provide the explanation for the deflection of the northern hedge boundary.

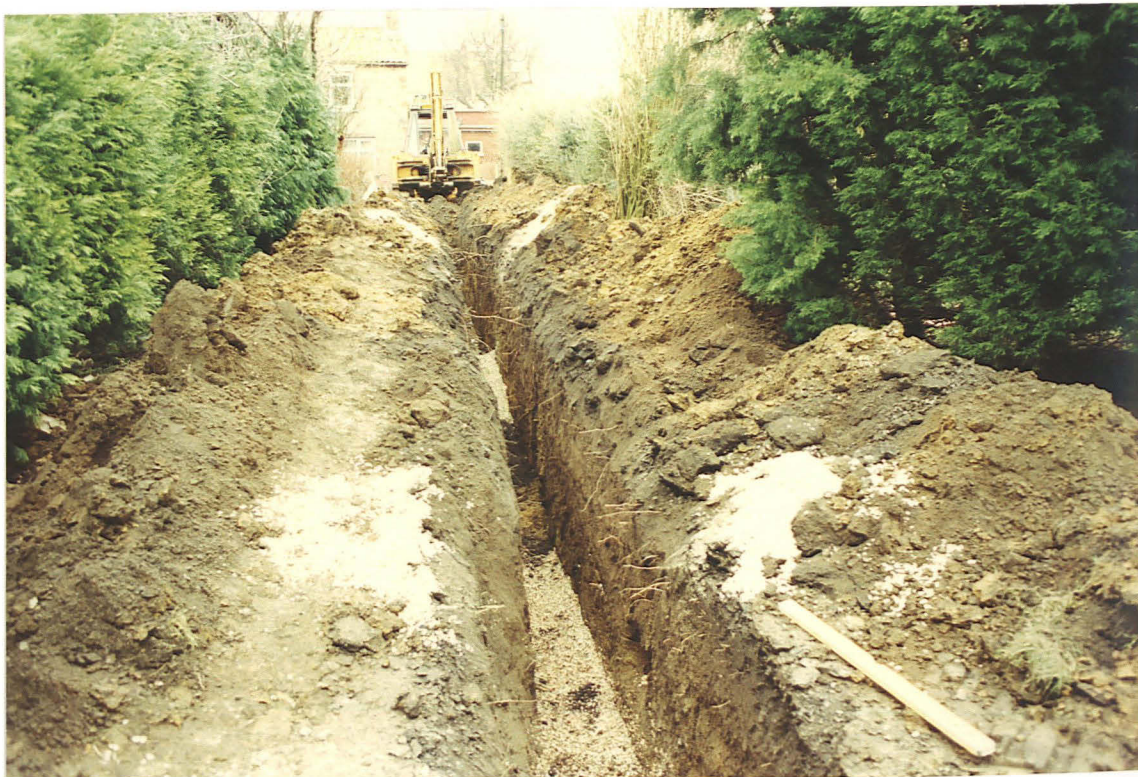
**Pl. 6** The service trench, excavated along the access to Silver Street (looking east to the street).

A 0.65m wide trench was excavated by machine between the bungalows and Silver Street. 20m of the trench (close to the bungalows) had been excavated and backfilled without monitoring. The 30m length closest to Silver Street was observed in good lighting conditions, although the ground conditions were not suitable for recording within the trench at the depth reached (Pl. 6).

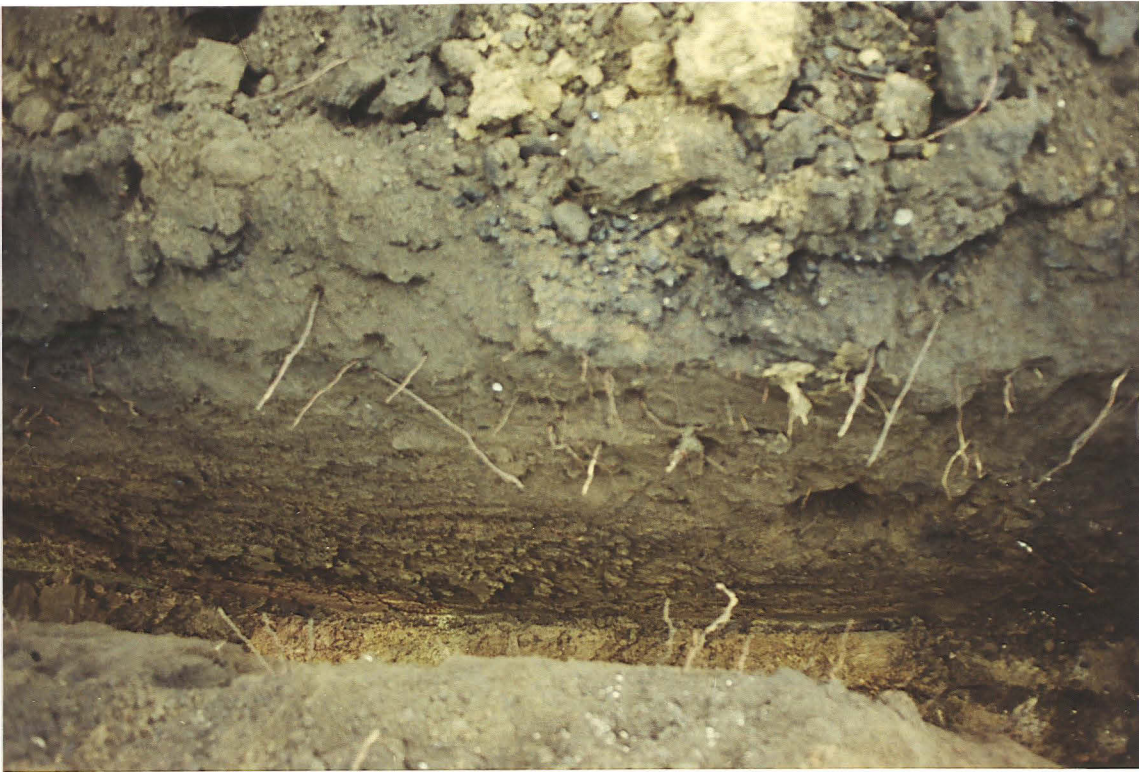
**Pl. 7** Dark fill of pits in the service trench, with yellow clay and brash at the trench base.

Two deeper pits had been dug through the brash with clay layer at the western end of the monitored trench, 25m west of Silver Street (Pl. 7). The easternmost had a dark brown clay loam fill with a green tinge, the colour suggesting that cess had been present. The base of the deeper pit was at least 1.5m below the surface.
