Development at Back Lane Wood Enderby, Lincolnshire

Archaeological Watching Brief

Site Code: WEBL99 LCCM Accession No.: 218.99 Planning Application No.: S/213/0423/99 NGR: TF 2750/6400

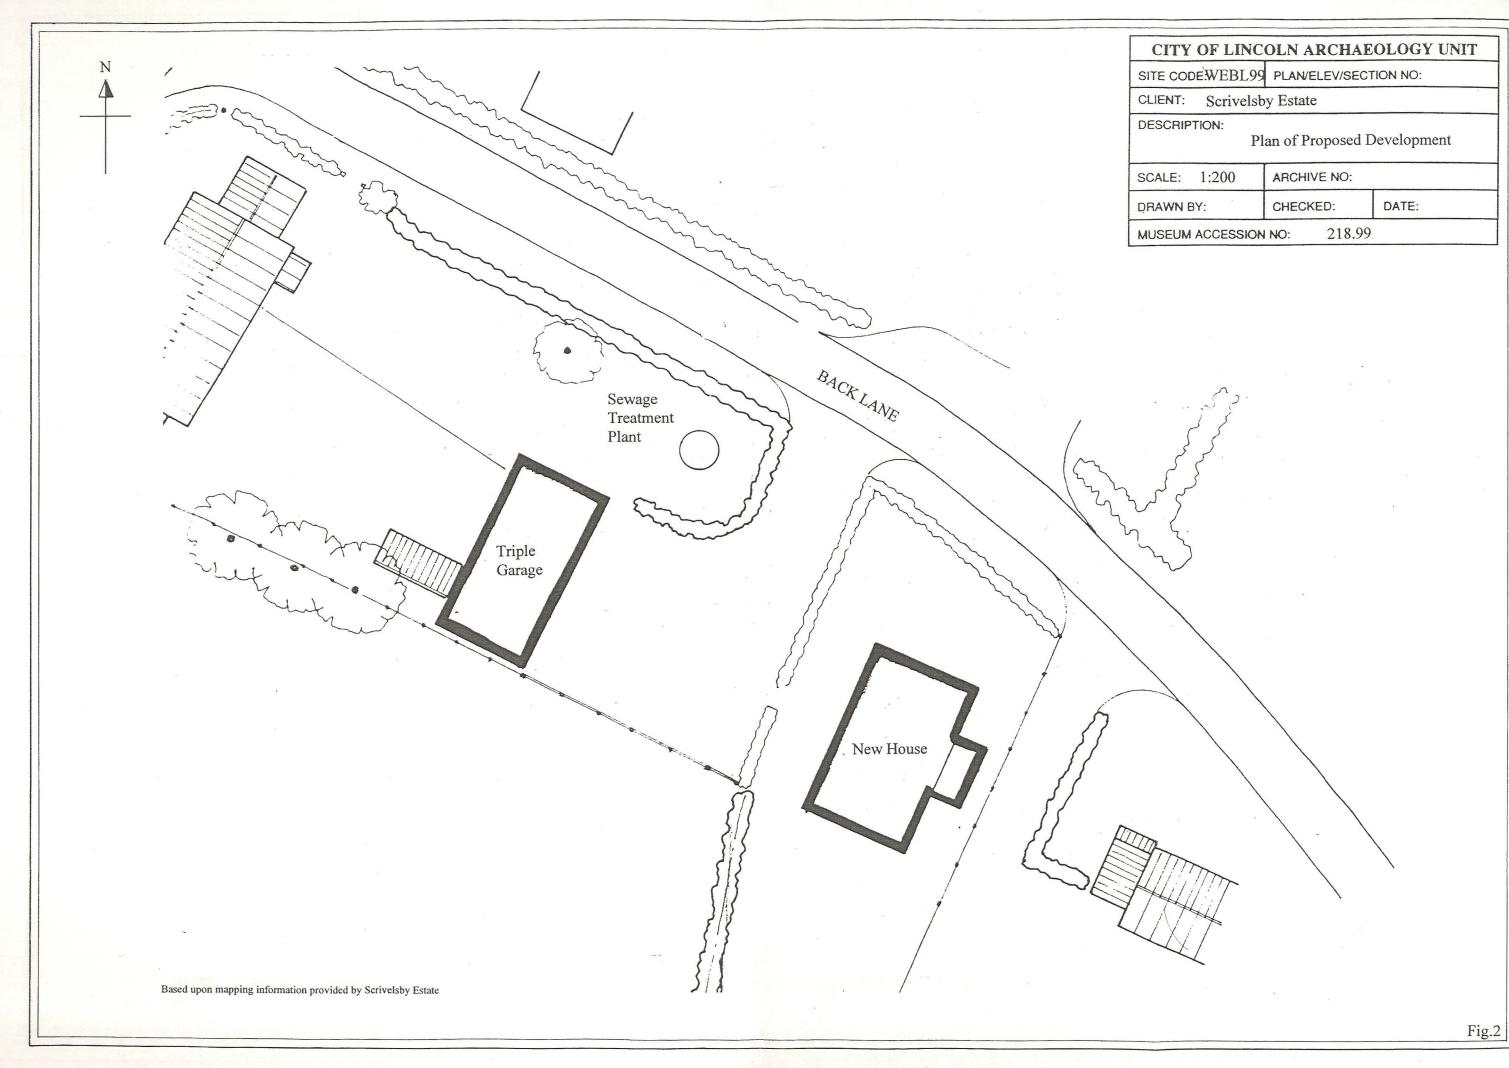
CITY OF LINCOLN ARCHAEOLOGY UNIT				
E CODE WEBL99	PLAN/ELEV/SECTION NO:			
IENT: Scrivelsby Estate				
SCRIPTION: Plan of Proposed Development				
ALE: 1:200 ARCHIVE NO:				
AWN BY: CHECKED: DATE:				
ISEUM ACCESSION NO: 218.99

The deepest excavation was for the new sewage treatment tank which was located along the site boundary fronting on to Back Lane (see Fig.2).

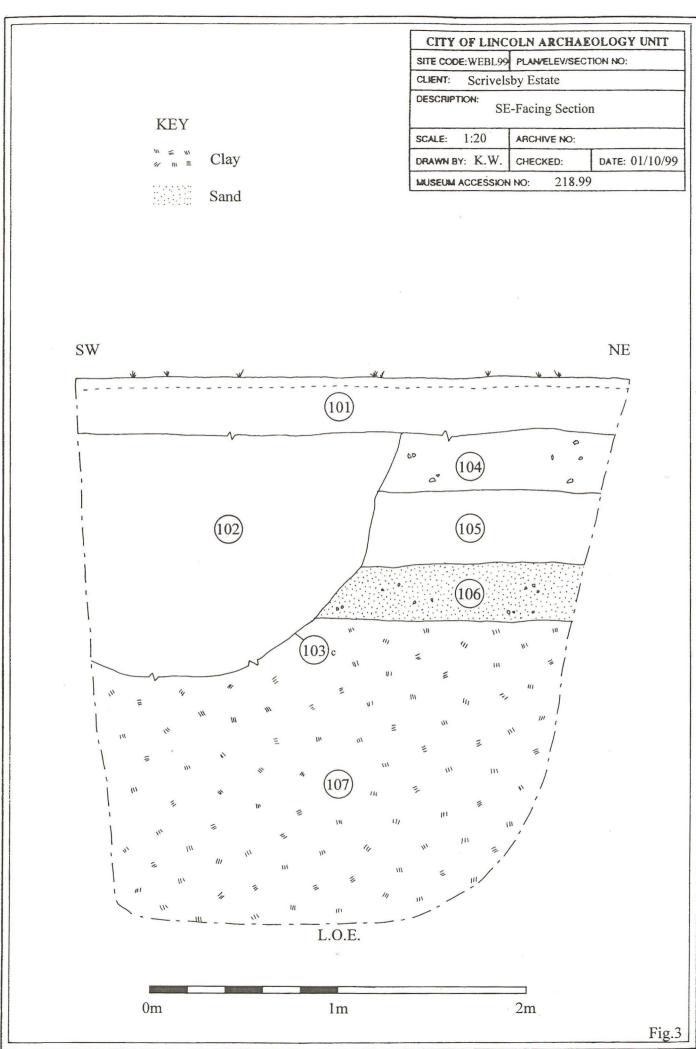
Fig.3 South-east facing section - scale 1:20

In this area, the trench reached a depth of 3m and exposed both the natural strata and the remains of an old septic tank (see Fig.3).

The earliest deposit was [107], a well compacted yellow-brown/off-white clayey chalk layer.

This was at least 1.6m thick to the limit of excavation (L.O.E.), with its upper boundary appearing at a depth of between 1.3m-1.4m below the existing ground level (G.L.).

The natural chalk was overlain by a series of three layers, [104], [105] and [106].

The earliest of these, [106], was c. 300mm thick and comprised a mid-dark orange-brown sand and gravel layer. This was sealed beneath two layers of sandy silt, [105] and [104].

These two deposits were very similar in appearance, although [105] contained frequent chalk inclusions, while [104] contained only occasional flint/stone pieces.

These layers were then cut by a large modern pit feature [103], which appeared to be the remains of a collapsed/demolished septic tank.

This feature was not revealed in plan, but was seen to extend for at least 1.7m (N-S) in the trench section. It was also at least 1.3m deep.

The cut feature was infilled with [102], a foetid, waterlogged mixture of clayey silt, flint & chalk pieces, tree roots, corrugated iron, drain pipes, brick & tile, wood, and assorted modern refuse.

The top of this dumping/infill material lay approximately 300mm below the existing G.L., and was overlain by the topsoil deposit present across the whole site.

This layer, [101], comprised a mid grey-brown sandy silt, which contained occasional small flint and stone pieces, infrequent pottery inclusions, and occasional areas of modern dumped material (ash/clinker, brick etc.). The upper surface of the topsoil layer also bore a thin covering of rough turf. The various trenches for the foundations and the interconnecting drainage pipework, in contrast, only reached depths of between 900mm and 1m. As a consequence, the only layers revealed in these parts of the development were the topsoil/turf [101], and the subsoil deposits [104] and [105].
