**74 Wragby Rd, North Greetwell**

**Site Code: NGWR 99**

## **Archaeological Watching Brief**

**LAS Report No. 387**

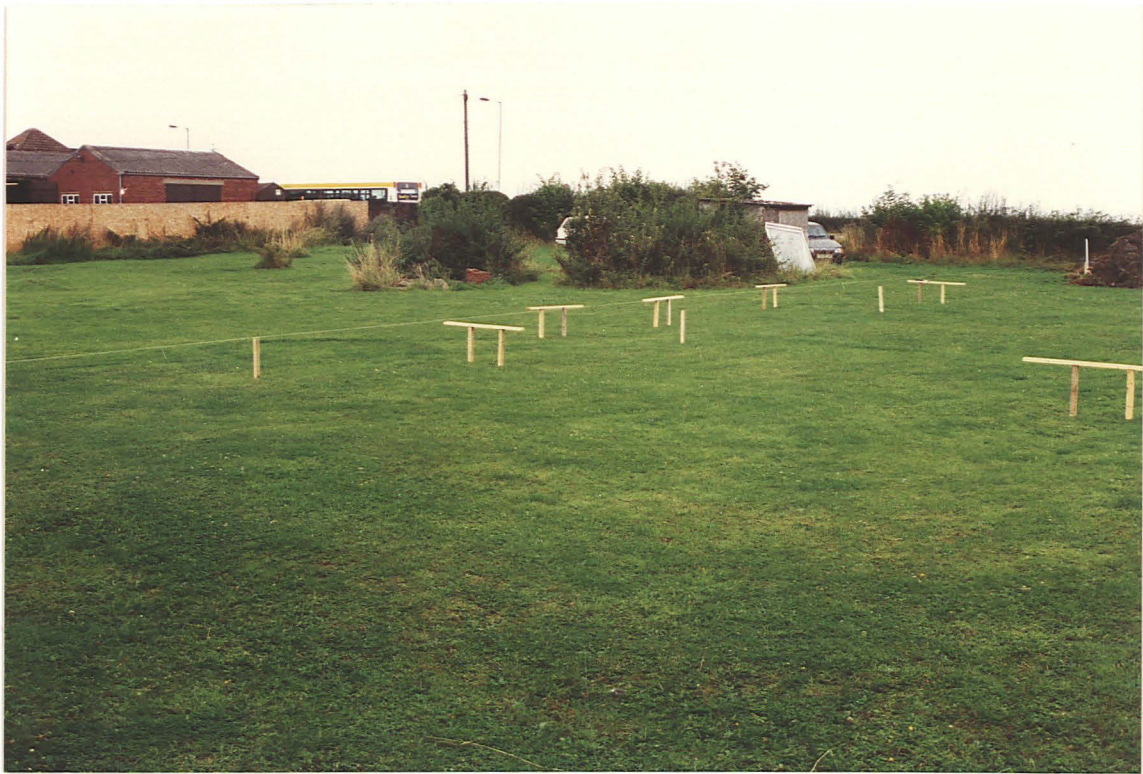
**Pl. 2 Garden landscaping and remains of brick structures to west of the house plot.**

The building plot sloped slightly downhill from north to south (Pl. 1). The 5-bedroomed house and garage were constructed on land which had previously been occupied by minor buildings and a garden; brick building foundations had been cleared from land to the west of this house plot (Pl. 2).

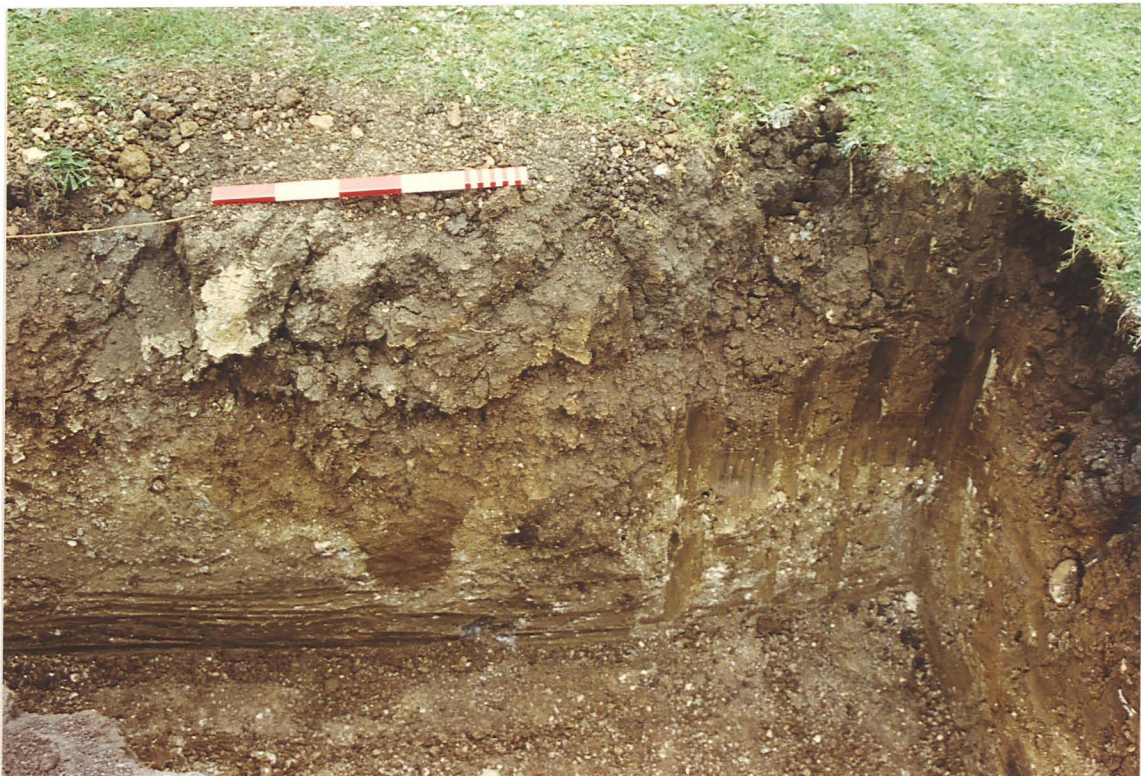
**Pl. 3 Feature 1, interpreted as a post-medieval gully or more recent mole drain (looking south, scale 0.5m).**

1. At the SW corner of the Family Room, a north-south aligned narrow gully or mole drain had been excavated into the chalky clay, 0.3m below the ground surface (Pl. 3). The 0.4m wide feature had been backfilled with dark brown clay loam, with a small pocket of chalky clay above it. A shallower shelf to the east, backfilled with light brown clay loam, may have been an earlier form of

the same feature. Although this appeared to be a post-hole, it was visible in other foundation trenches across the house plot.

The backfilled gully was overlain by the subsoil layer and the modern topsoil. As the subsoil is probably the result of cultivation, the gully is probably not a recent feature; a post-medieval date is likely. A mole drain might have produced the same sequence of deposits, however, in which case a twentieth century date is probable.

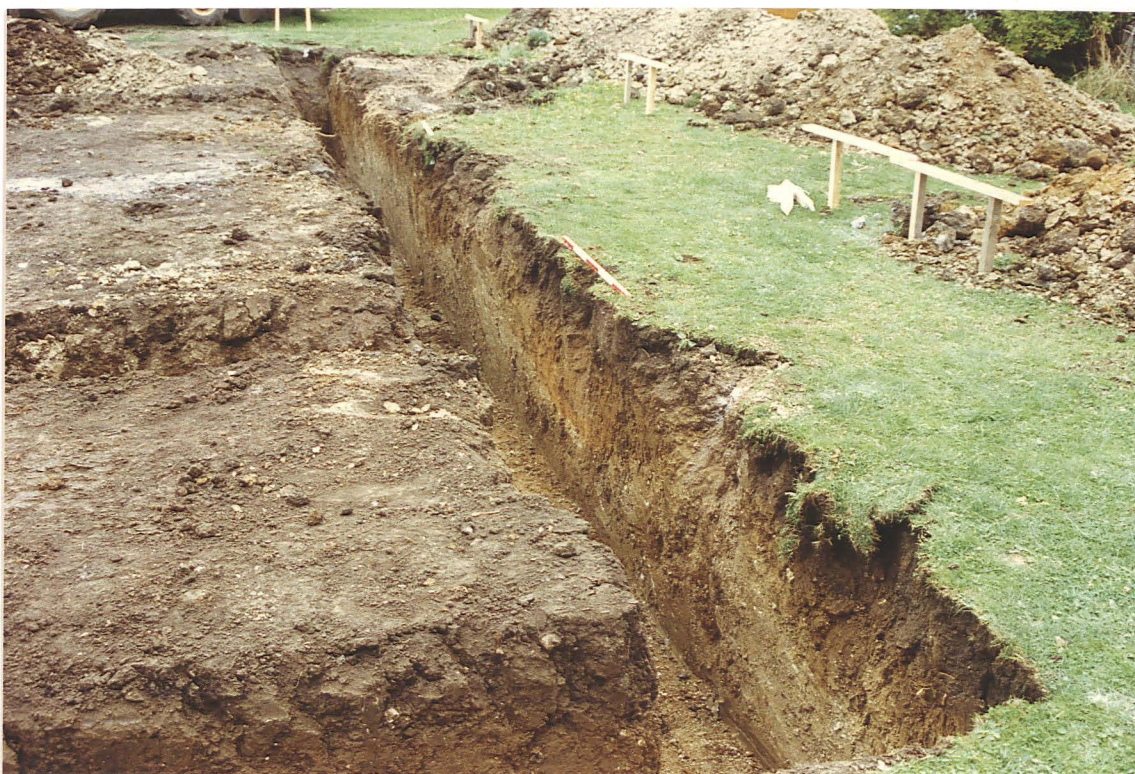
Pl. 4 Eastern foundation trench of the new house (looking north). The 1m red/white scale marks the position of 2, with a small marker beyond it above 3. The darker fill of 4 is visible at the northern end of the trench.

2. At the eastern side of the kitchen foundation trench, a 0.25m deep and 2m wide shallow depression was sealed by the subsoil layer and had been cut into the chalky clay (Pls. 4 and 5). The orange sandy clay loam fill, with no obvious humic content, suggests that this is a naturally filled post-glacial irregularity in the ground surface.

3. A second gully-like feature was seen crossing the eastern side of the house plot, but was not visible in the western foundation trench of the garage (Pls. 4 and 6). The 0.3m wide, west-east aligned gully contained a fill which was indistinguishable from the subsoil layer, apart from a pocket of chalky clay immediately under the topsoil. This material indicated disturbance of the subsoil, and this is evidence for the 0.65m deep feature being relatively recent. Its shape was narrower and more pointed than 1, and the two are unlikely to be associated.

4. At the NE corner of the foundation trench for the new building, a 2m wide, 0.5m deep feature was seen. It had sloping sides, a broad flat base and a narrow, almost central, slightly deeper point (Pls. 4 and 7). The fill was an orange/brown sandy clay. This feature was overlain by the subsoil layer (which thinned slightly above it) and had been cut into white chalky clay. If this depression had been visible to the west of the lounge area, it would have been interpreted as a medieval or post-medieval plough furrow. As it was only seen in the easternmost trench, it was recorded as a small anomaly of the original ground surface, and probably not of archaeological origin. It may have been filled deliberately in a levelling exercise.

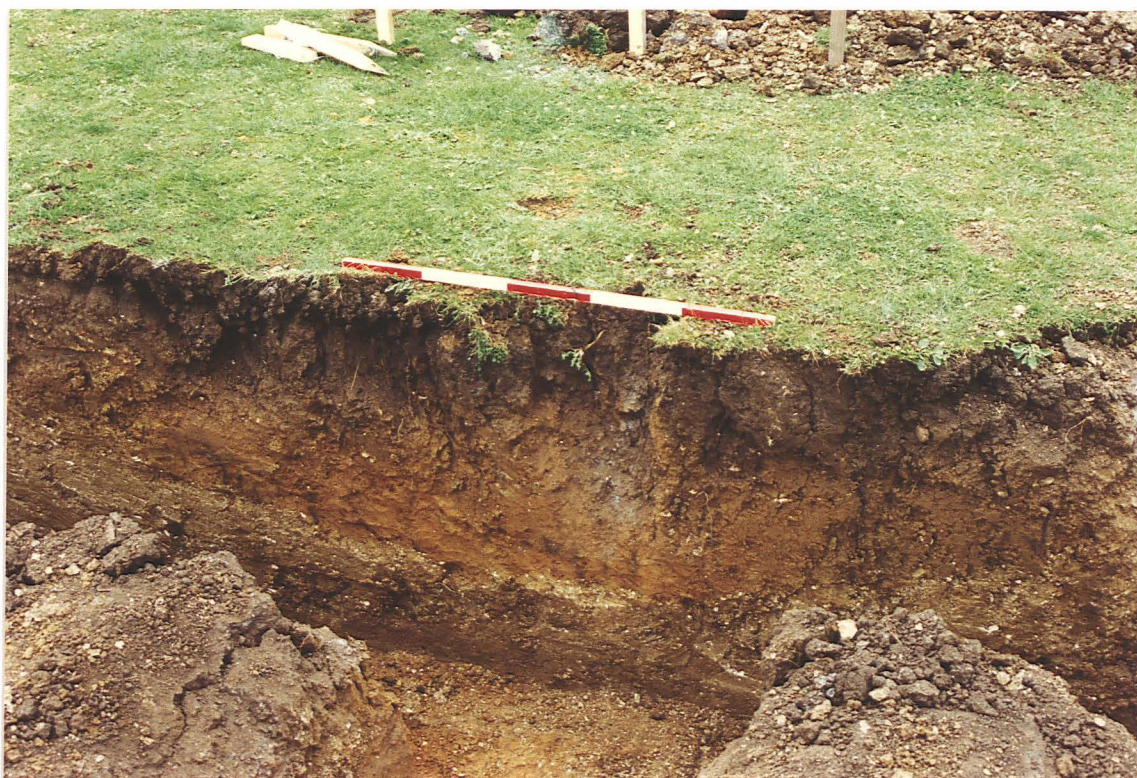
Pl. 5 Orange sandy clay fill of depression 2 (looking east, scale 1m).

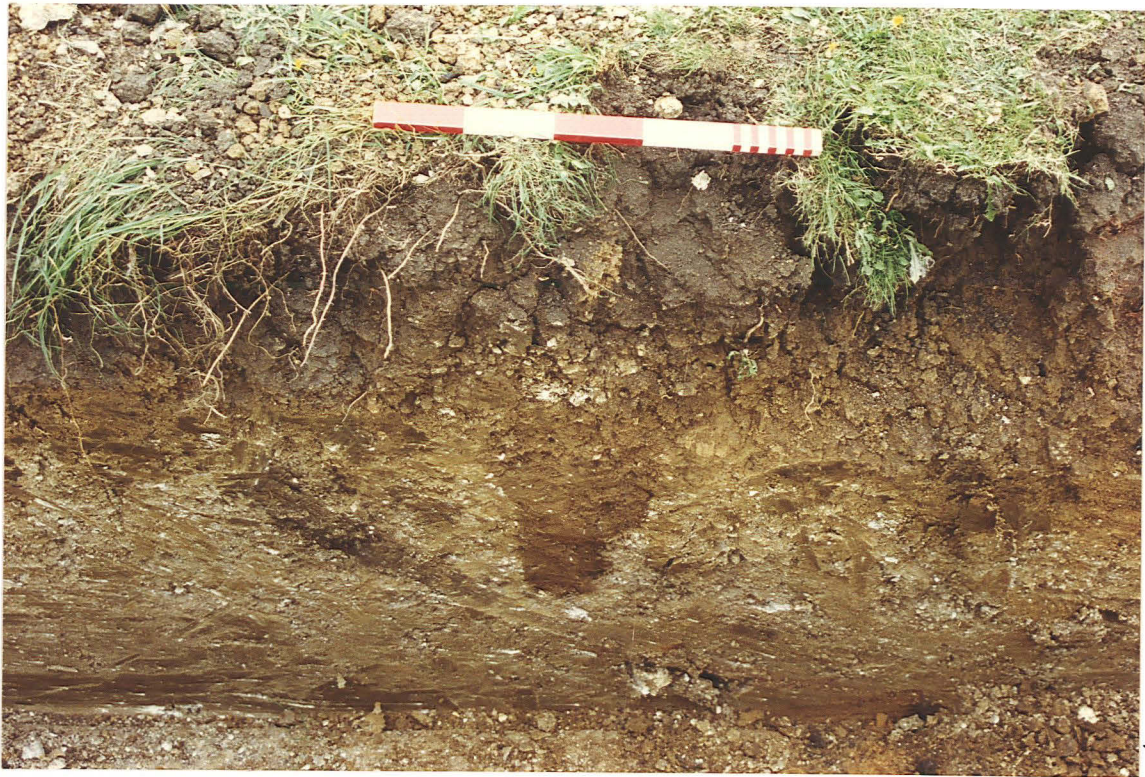
**Pl. 6 Dark fill of gully or mole drain 3 (looking east, scale 0.5m).**

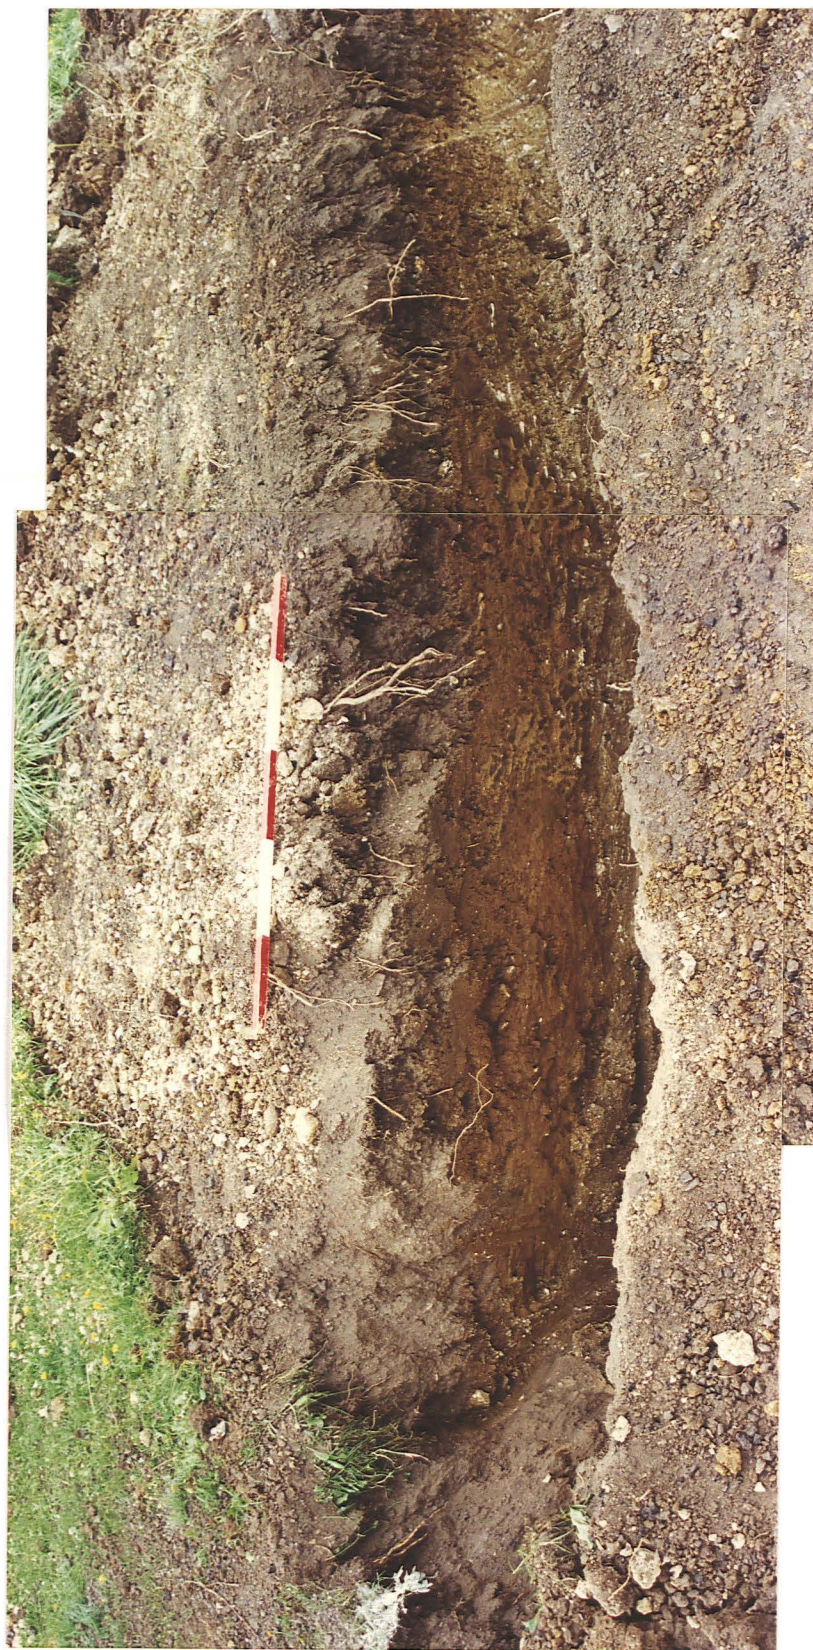
Pl. 7 Dark brown clay fill of 4 (looking east, scale 1m).

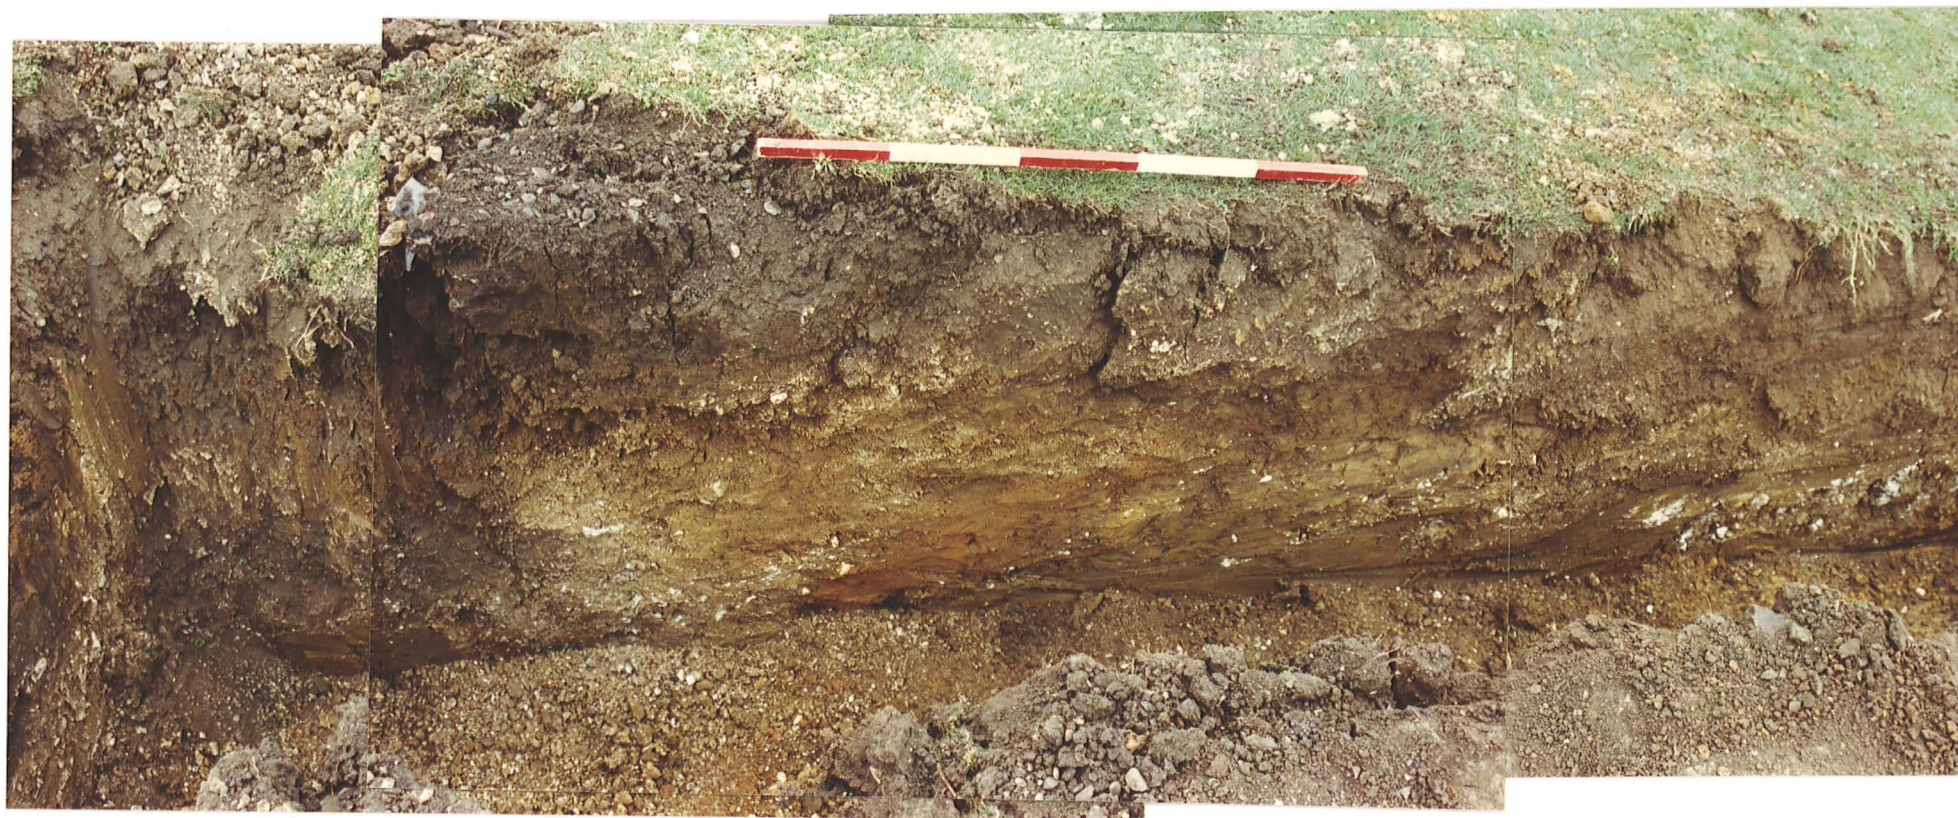
Pl. 8 Sloping deposits at 5, interpreted as glacial outwash fills of a natural deep depression extending over the eastern side of the building plot. (Looking south, scale 1m).

5. Close to the SW corner of the rear wall, the trench cut through very mixed deposits which appeared to be filling a depression to the east (Fig. \*; Pl. 8). Initially, these were interpreted as fills of an archaeological feature, but no artefacts were found and the eastern side of the feature was not located. It now seems probable that it represents natural deposits close to the edge of a glacially filled depression, and that all the other deposits recorded to the east are later fills of the same depression.
