**Roman Bank, Ingoldmells, Lincs.
New McDonald's Restaurant, Fantasy Island Theme Park
Archaeological Watching Brief**

**Report prepared for Universal Construction Services Ltd
(on behalf of McDonald's Restaurants Ltd)**

LAS Report No. 404

March 2000

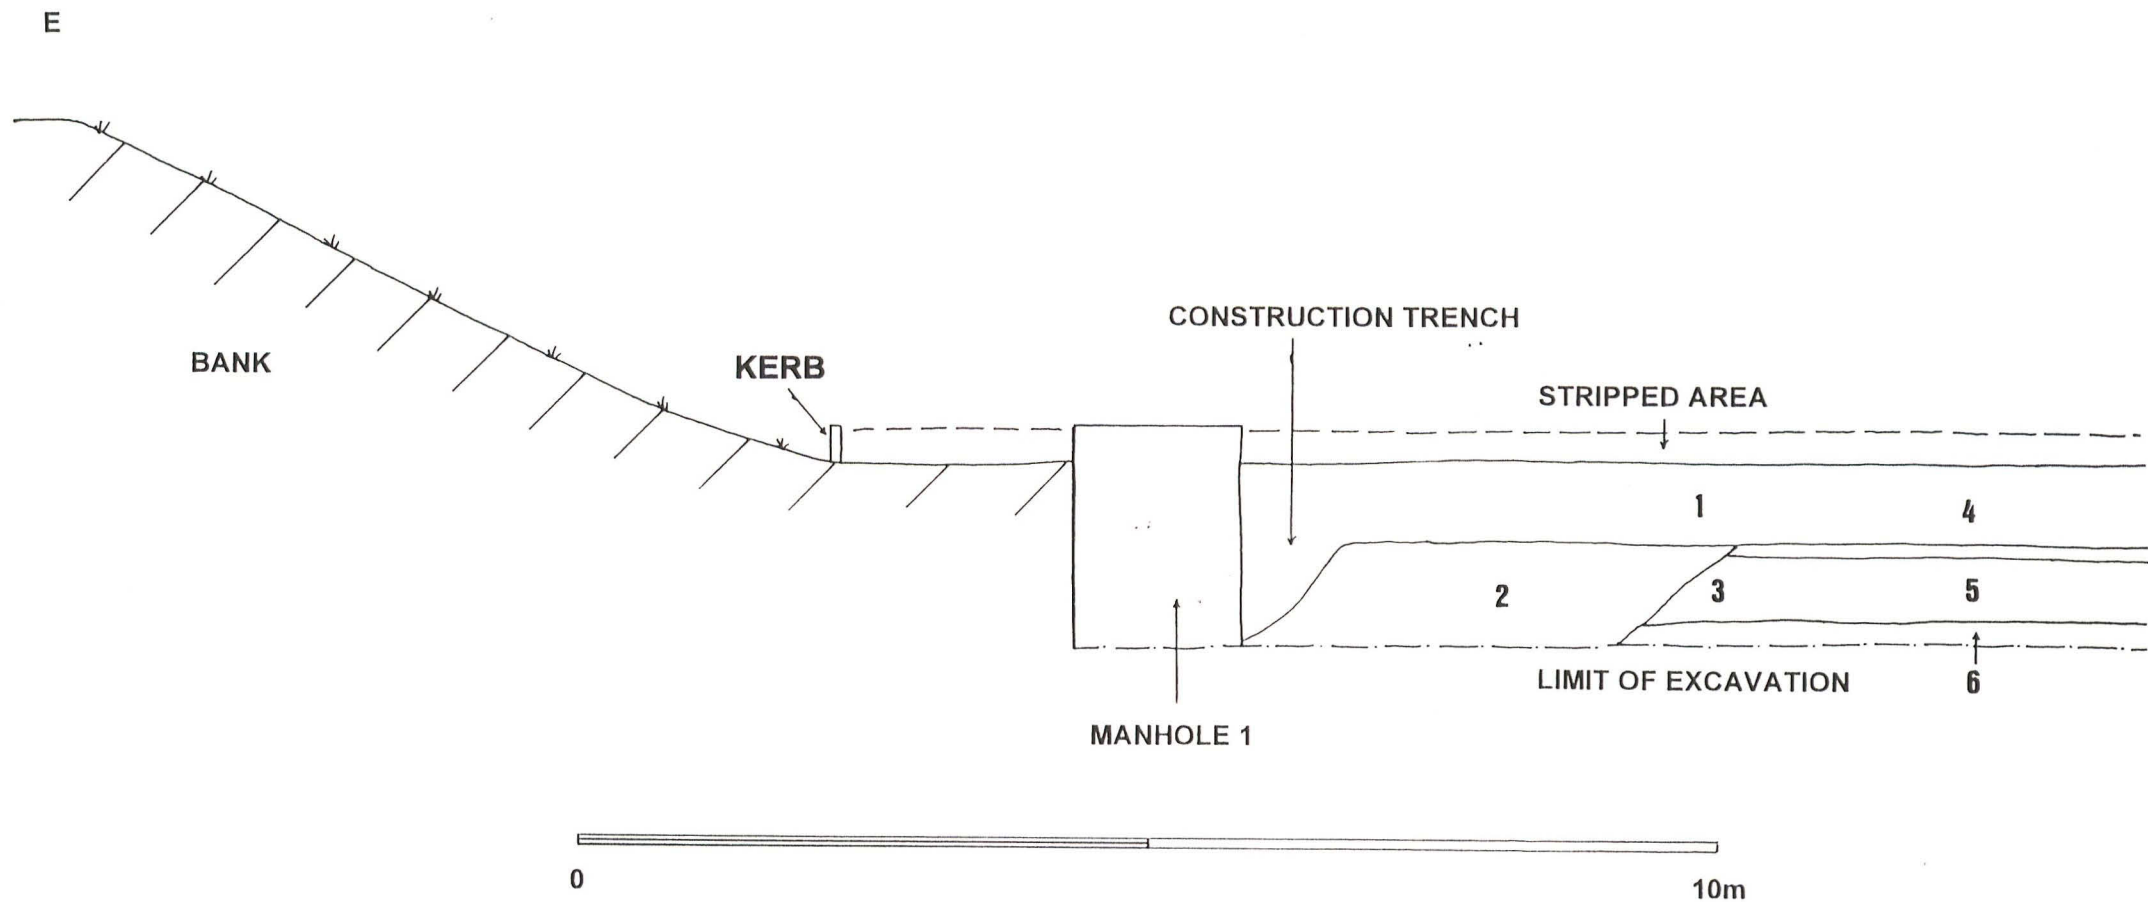
Fig. 4 Profile/section of deposits revealed in the northern drain trench, showing ditch 3 at the foot of the undated flood bank. (McDaid, after Tann).

The trenches were excavated with a 360° mechanical excavator fitted with a 0.65m wide toothed bucket. Trench width was about 0.7m, with depths below the stripped car park of between 1.6m in the NE corner and 1.2m in the NE corner. Context numbers were assigned by LAS for recording purposes, and these are used on the sketch section (Fig. 4).

The trench connected into an existing manhole close to the NE corner of the site, at the foot of the embankment (Pl. 4). Beneath the rubble from the car park foundation 1, and limestone chips around the manhole, very dark brown silt 2 was exposed extending below the trench base (Pl. 5). The silt appeared to contain organic remains, including visible reed inclusions and peat. A small environmental sample was taken from the excavated spoil.

The dark silt ended 5.2m west of the kerb around the foot of the embankment. Its western edge was at about 45°. The feature was interpreted as a north-south aligned ditch 3 at the base of the embankment, cut into the marine silts. Despite the close proximity of the existing manhole, there was no evidence of post-medieval or modern material within the silt. Assuming the purpose of this ditch being to drain the landward side of this sea flood bank, a Roman or medieval date is probable. No finds were seen, and there were no further opportunities to examine this feature.

To the west of ditch 1, the modern rubble overlay a layer of yellow/brown silt 4, which may have been truncated at the eastern side of the site. In the centre of the trench, this layer was 0.2m thick, thinning to 0.1m where it had been cut by ditch 1. This layer seems to represent a subsoil formed on the surface of the marine silt deposit, although it could be upcast from the ditch, or colluvium washed from the flood bank before the ditch was dug. There were slight indications that it was filling small variations of the underlying horizon. Again, no finds were seen in this layer.

Beneath 4 was a 0.55-0.65m thick layer of red/brown silt 5, with a grey hue in places (Pl. 6). This was interpreted as a marine silt deposit left by an extended period of marine transgression. An orange sandier silt deposit 6 at the trench base could possibly be an earlier ground surface, but it may reflect variations within the marine silt deposit.

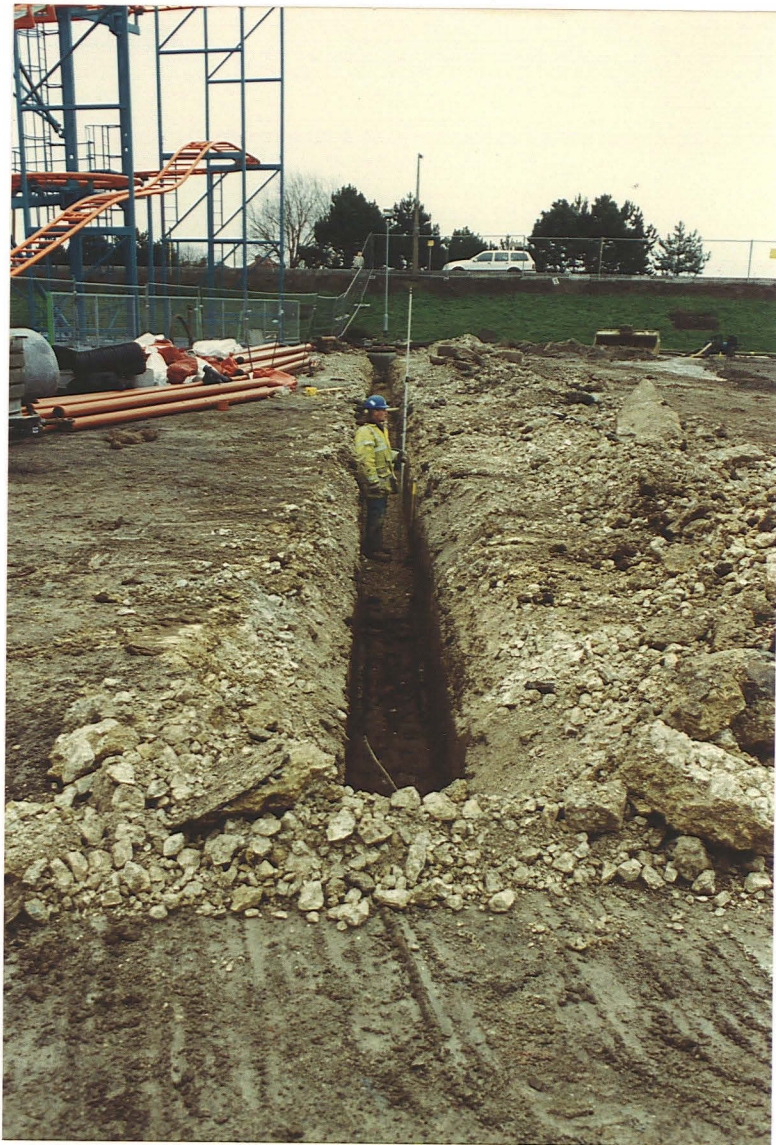
PI. 4 Drain trench along the northern side of the site (looking east).

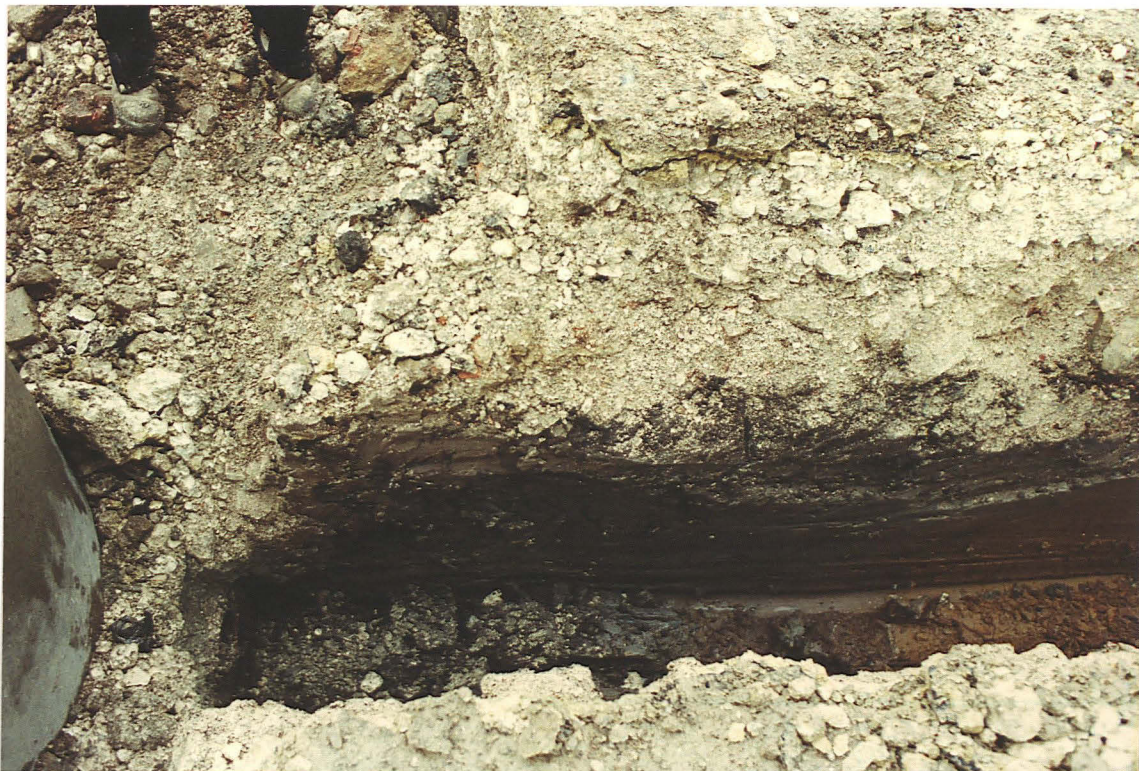
PI. 5 Dark fill at western edge of ditch (centre), alongside the foot of the embankment in the NE corner of the site (looking south).

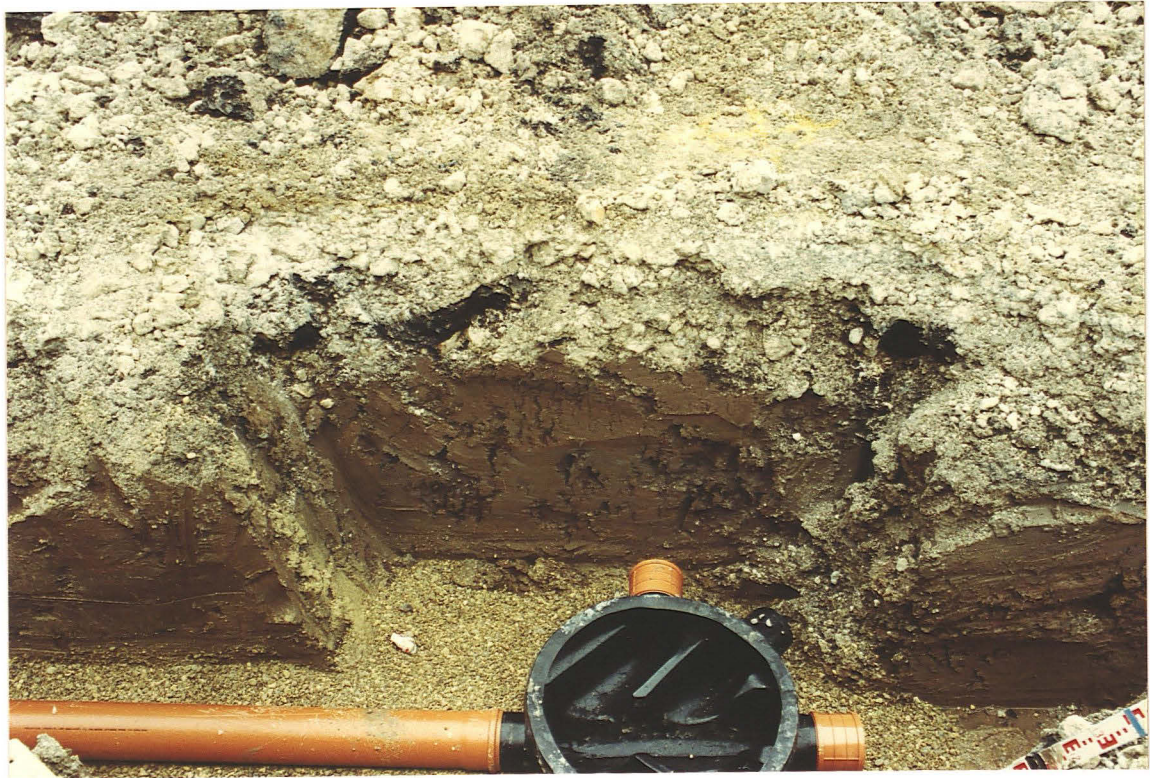
Pl. 6 Red/brown marine silt deposit 5 in the northern drain trench.

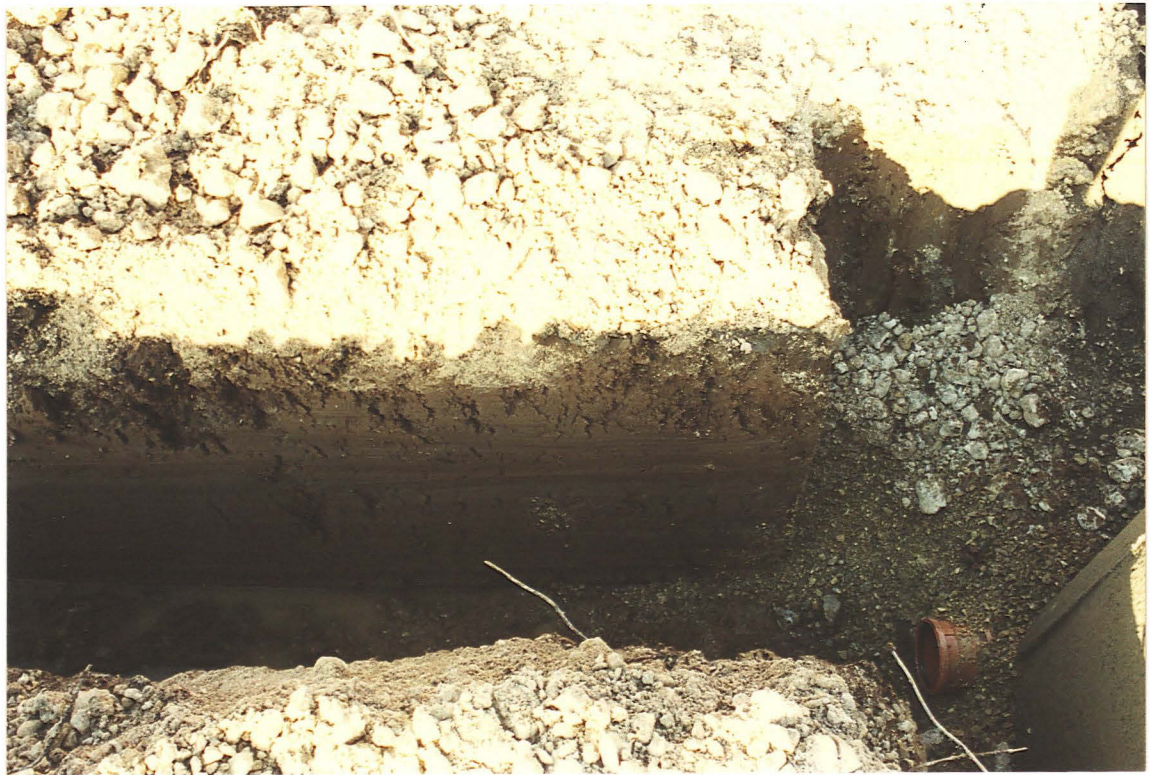
Pl. 7 Grey/brown marine silt deposit 5 in the western drain trench, possibly discoloured by poor drainage.

The 0.3m thick silt layer 5 was greyer in colour in this part of the site, and overlay 6, which here was a light brown colour (Pl. 7). The greyer coloration of deposits further from the bank may be an indication of poorer drainage.
