**Church Lane, Bardney, Lincs
Replacement Water Main**

Archaeological Watching Brief

**Report prepared for
Anglian Water Services Ltd**

**LAS Report No. 403
March 2000**

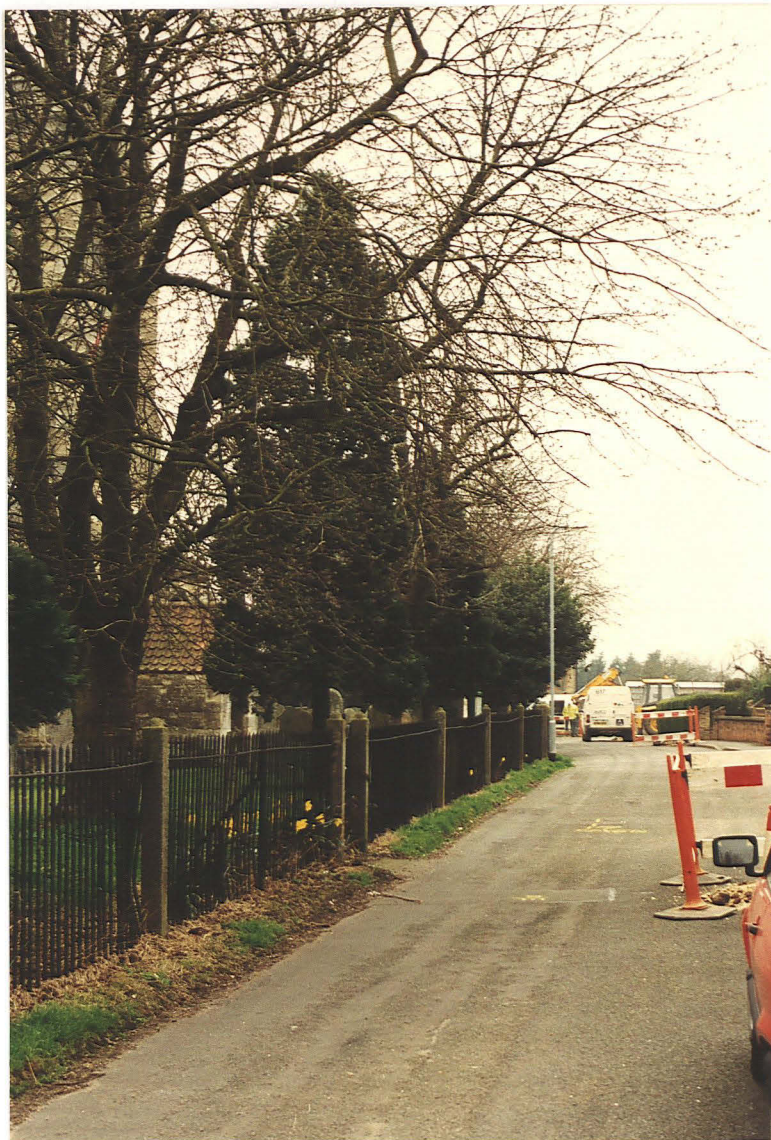
Pl. 1 Church Lane, Bardney, showing access holes 2, 3 and 5 (looking south-west).

1. Outside the Vicarage, an access hole against the kerb outside the Vicarage cut through 0.1m of tarmac into a make-up layer consisting of orange/brown sandy silt and gravel (0.2m). A 0.35m mixed grey-brown clayey silt band was visible below this, with red/brown sandy silt to the base of the hole.
2. A second hole was excavated in the road between the Vicarage and No. 12, Church Lane. This revealed an existing cable trench, with brick and limestone rubble backfill.

5. A large access hole was excavated at the end of the road. The removal of 0.12m of tarmac revealed a layer of mixed make-up material 0.22m deep. Below this a layer of orange/brown sandy silt mixed with deposits of grey/brown sandy silt was visible to the base of the trench. A narrow trench was extended to the west, and the same series of deposits were noted here, with a band of limestone hardcore associated with existing services.

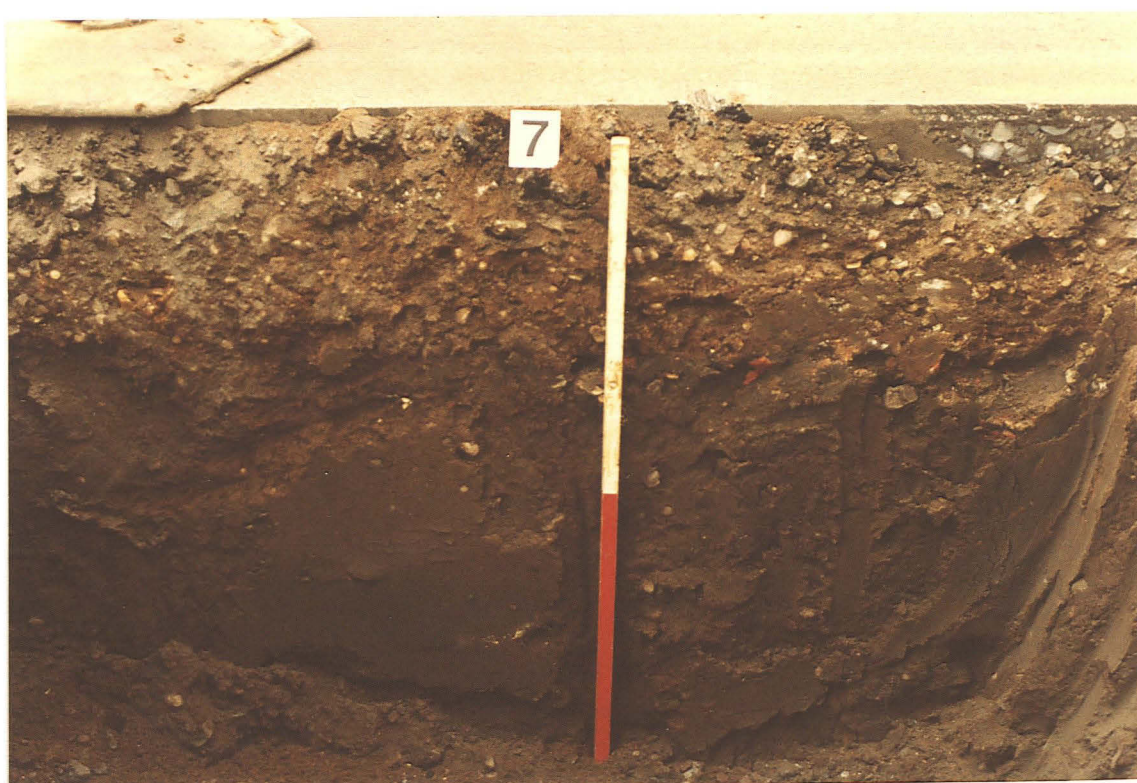
Pl. 2 Deposits visible in access hole 7 (looking west)

7. An access trench excavated at the end of Church Lane exposed a mixed hardcore deposit below a layer of tarmac 0.18m thick (Pl. 2). A grey/brown clayey silt deposit 0.20m was visible directly above an orange/brown clayey silt deposit.

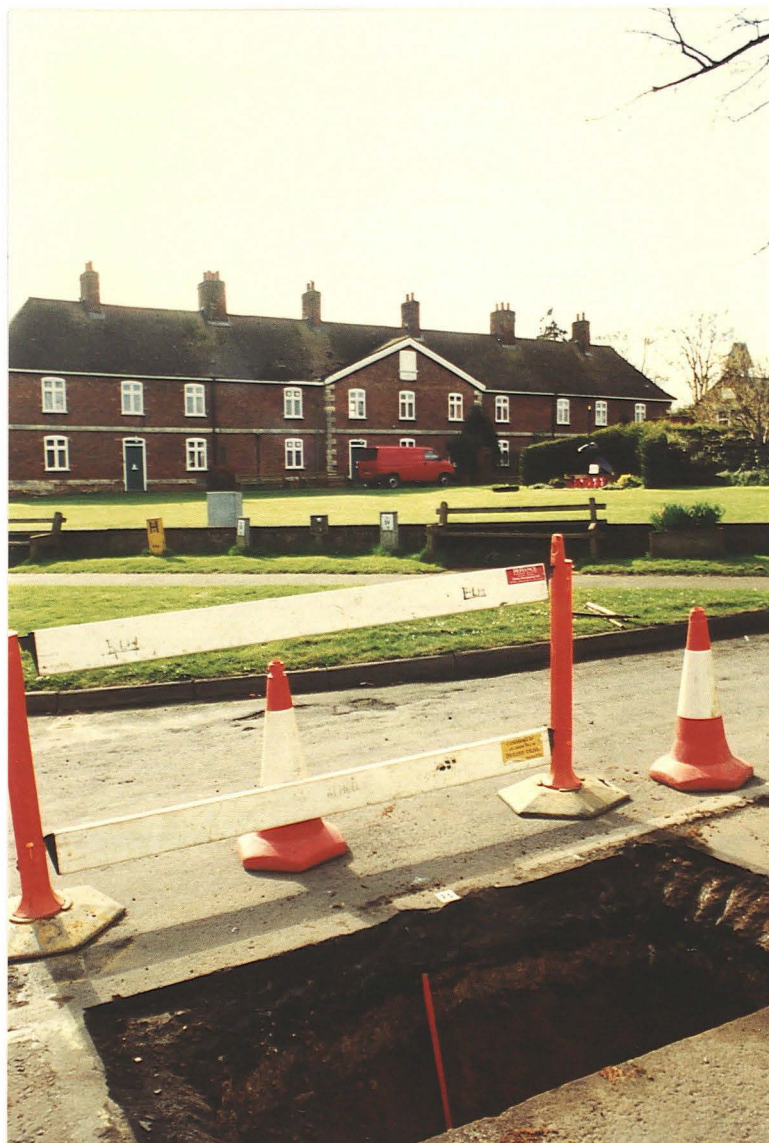
Pl. 3 Access hole 8, with War Memorial in the background (looking south)

8. A large access hole located close to the junction of Church Lane with Mill Lane exposed a thin layer of tarmac, below which was limestone hardcore to a depth of 0.30m (Pl. 3 and 4). This overlay orange sand, which had not previously been disturbed.

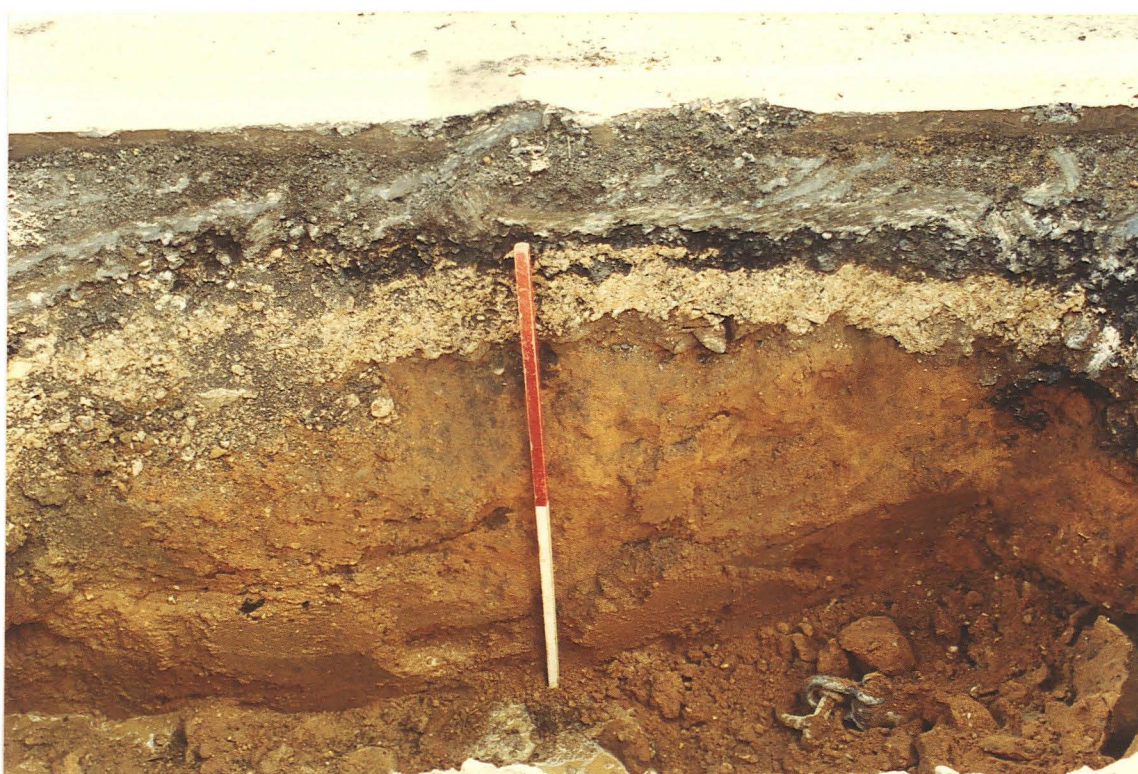
Pl. 4 Location of Trench 8 (looking south)
