WILSFORD RELAY PIPELINE 1993

NGR. SK 9970 4358 - TF 0070 4310 - TF 0038 4248

Introduction

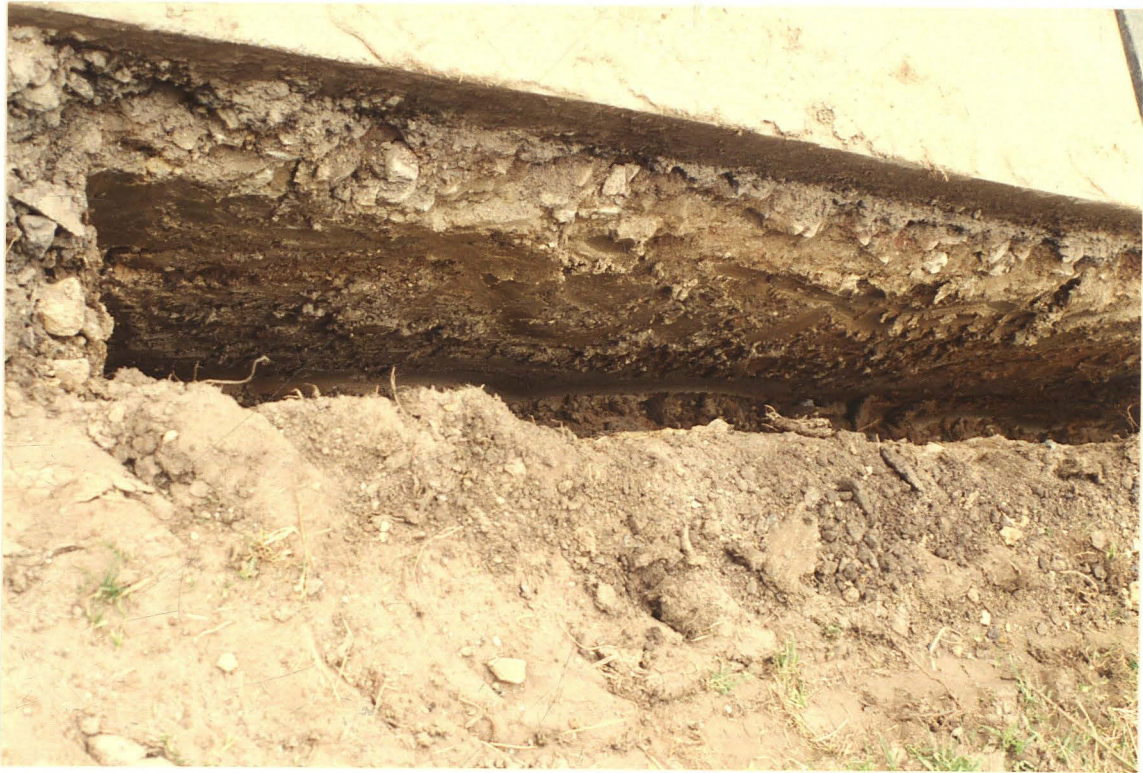
P1.2 Trench section at junction opposite Old School

In the vicinity of the junction the trench cut through mixed soil and stony material which seemed to have been disturbed although no ceramic material was found to confirm this (Pl.2). The cultivated field east of the road at this junction is considerably lower than the road level and rises steeply up a slope to the south, suggesting past quarrying. The remains of an abandoned stone quarry remain visible to the NW of the junction behind the former school building (Pl.3). This quarry was apparently active in the mid 19th century and may have provided an income for the school teacher and upkeep of the building (Lincolnshire Archives Office (LAO): Wilsford Parish Records 16/PW/1 1857). The observations of the pipe-trench here were inconclusive but a possibility remains that these roads had once led to an extensive quarry in the location of the present junction; waste soil and rock material had perhaps been used to raise part of the quarry sufficiently to construct a thoroughfare to neighbouring villages. Available cartographic evidence was examined but there was no evidence that an earlier quarry had been backfilled.

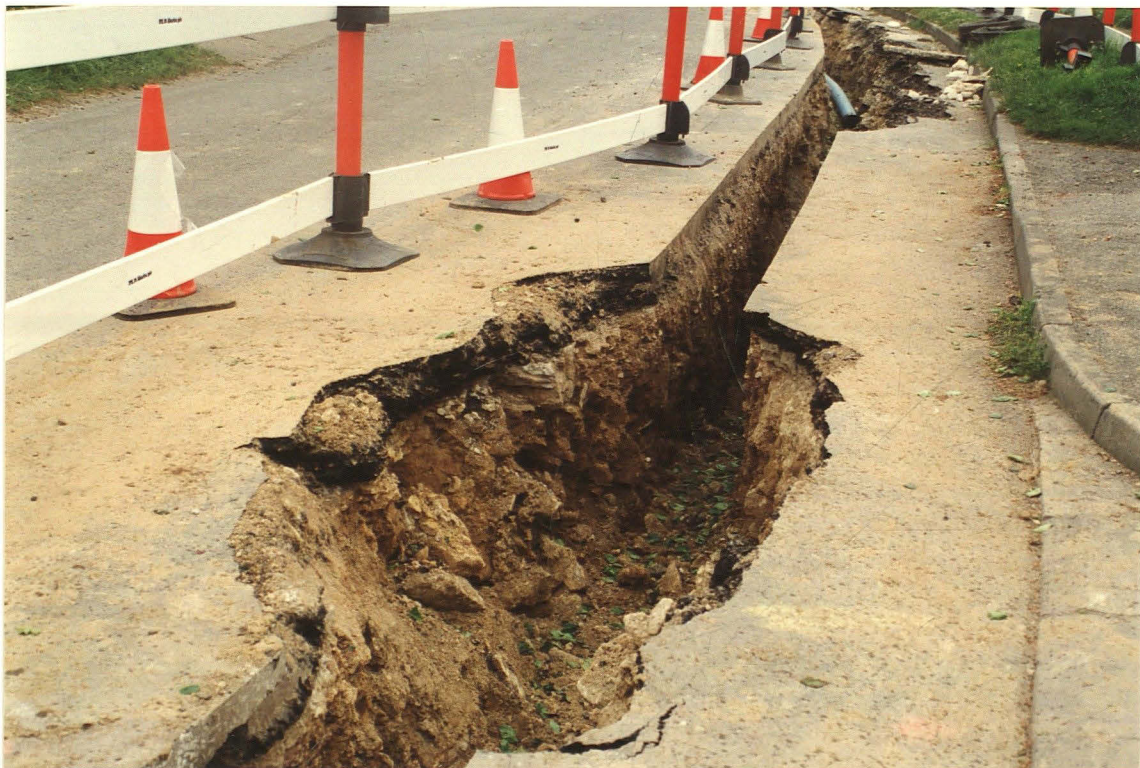
Pl.5 Soil-filled depression opposite track to Hall Farm

paths there was a soil-filled depression. This was about 6m wide and continued below the base of the trench (Pl.5). It seemed unlikely that cart or foot traffic between the village and Hall Farm had created a pronounced hollow-way given the rock formation, but deliberate quarrying of this narrow area seemed equally unusual. The feature may have been a natural stream course filled either naturally or deliberately and later used as a path. A small stream is marked on the 1775 Enclosure Award plan (Fig.3) and this appears to confirm that interpretation (LAO Kesteven Award 88/8). No archaeological material was seen in the trench section here but the soil had probably been introduced deliberately.

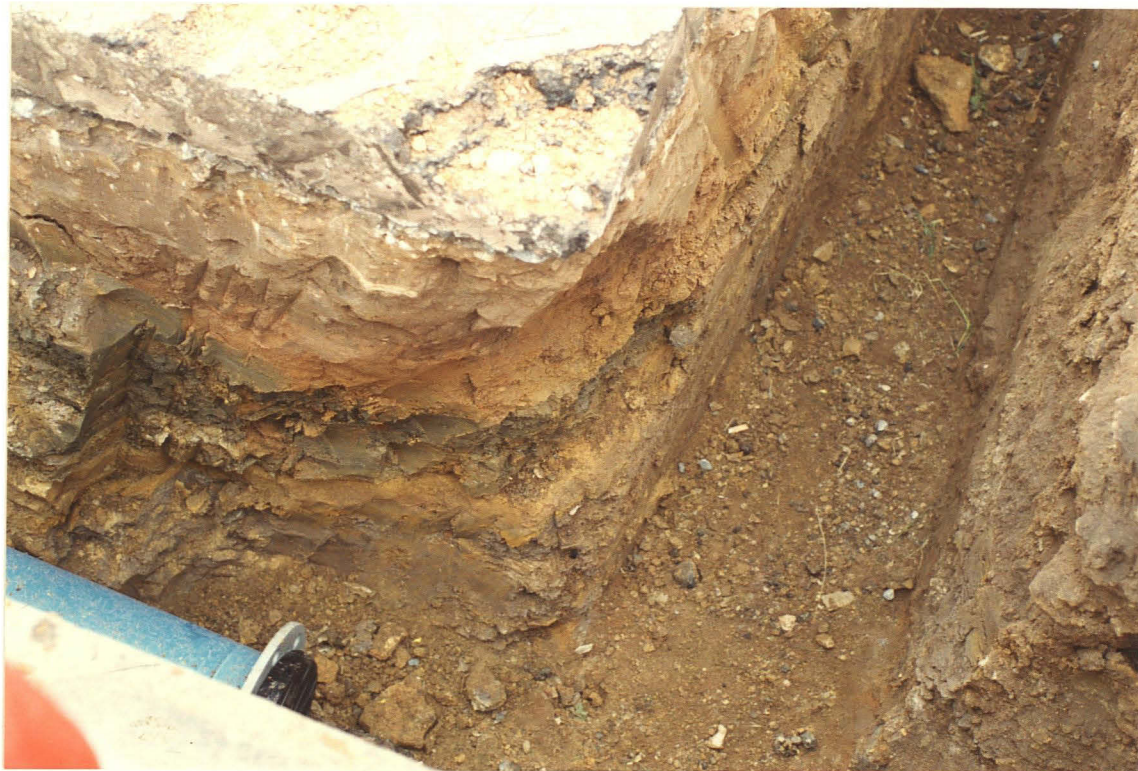
Pl.7 Road junction west of the Plough Inn showing undisturbed stratigraphy

In contrast to the area east of the Plough Inn, the soils at the road junction to the west showed intact stratigraphy of aerobic/anaerobic clays and sands which appeared to be natural (Pl.7). The width of the trench was again too small to indicate whether a narrower earlier road passed beside it but had been missed by the pipe trench. It is surprising that the trench produced no evidence for habitation below the present road surface here as the frontage onto the village street would have been a prime location. A subsequent study of the Enclosure Award map of Wilsford found that the junction has not moved since at least 1775 but the lane towards Wilsford Heath cuts through three planned croft areas, as if it represents a late medieval route diversion (Fig.3) (LAO: Kesteven Award 88/8 1775; copy). The route of the earlier road is open to conjecture but may have left the village centre to the east of the church and through the farmyard of Hall Farm before respecting the back of the crofts and continuing on its present course. A path linking the rear of the crofts to the village street west of the junction on the OS 2nd edition 6" map (Fig.5) was not marked on the Enclosure Award and is unlikely to preserve a medieval alignment (OS 105 Lincs. 1906)
