The Former Church of St. Michael-on-the-Mount, Christ's Hospital Terrace, Lincoln

Archaeological Watching Brief

Report No.: 417

Site Code: MOMA99

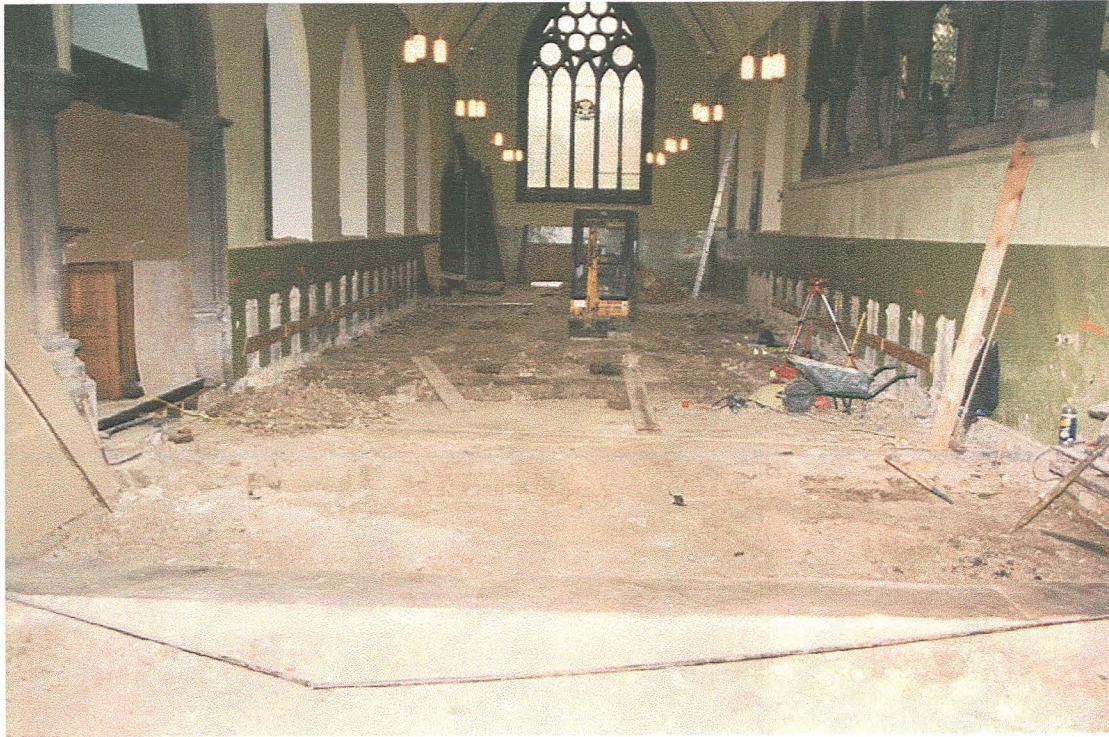
Plate 1: General view of groundworks underway inside the former church - looking west

The foundation trenches for the new toilet block and the internal partition walls involved machine-excavation (using a 'Bobcat'-type mini-excavator) to a depth of between 900mm and 1m, with the trenches themselves approximately 500mm wide.

The trenches formed a small network situated close to the centre of the church in the former nave (see Fig. 2).

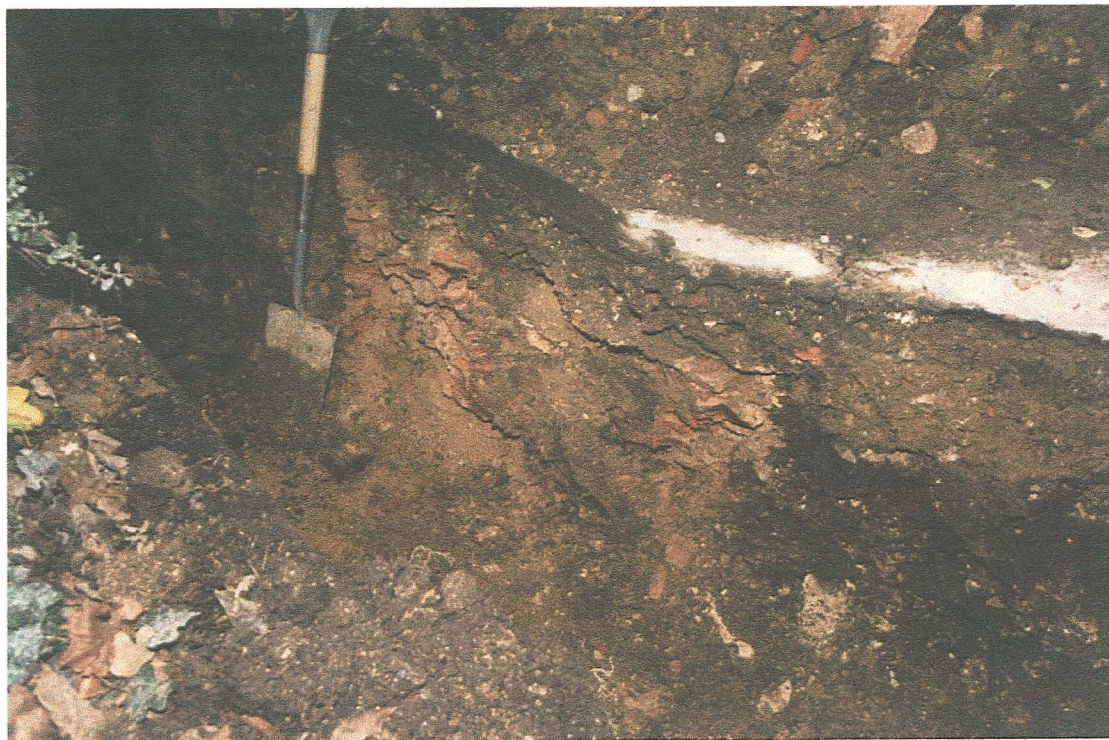
Plate 2: Overall view of tile/rubble dump [108] - looking north-east

The walls and dump of building material revealed in areas to the south of Christ's Hospital Terrace seem to relate to occupation during the Post-medieval period. The northernmost wall, in particular, with its associated floor, was possibly part of a building.

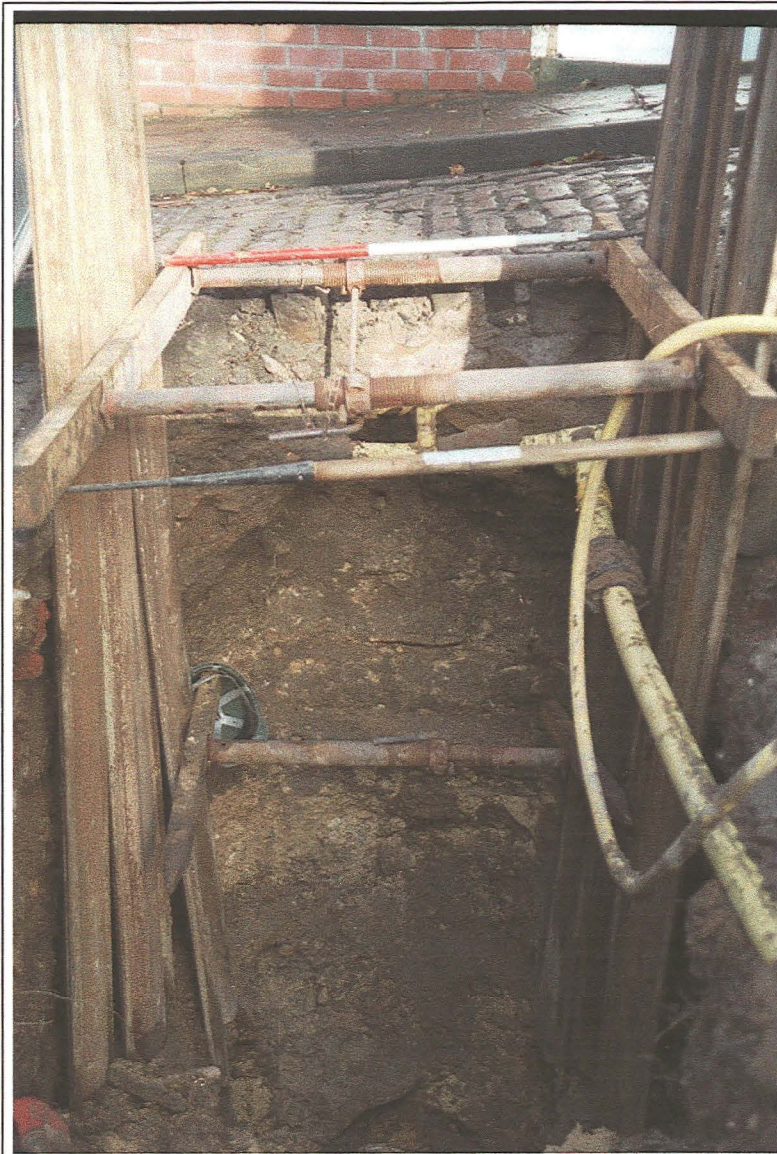
Plate 3: General view of limestone wall at edge of Christ's Hospital Terrace - looking north

The wall consisted of three courses of limestone blocks, founded on a further course of similar stones, stepped-out by 150mm. It was oriented E-W, and 'stood' to a height of c. 800mm. The blocks were roughly squared, and bonded with a yellow-brown lime mortar. The top of the wall was between 600mm and 800mm below the modern road surface.

The more substantial wall found beneath the south side of Christ's Hospital Terrace is likely to have been of medieval date. Given its alignment, and its relationship with the buried topsoil deposit to the south, it probably represents part of a terrace retaining wall.

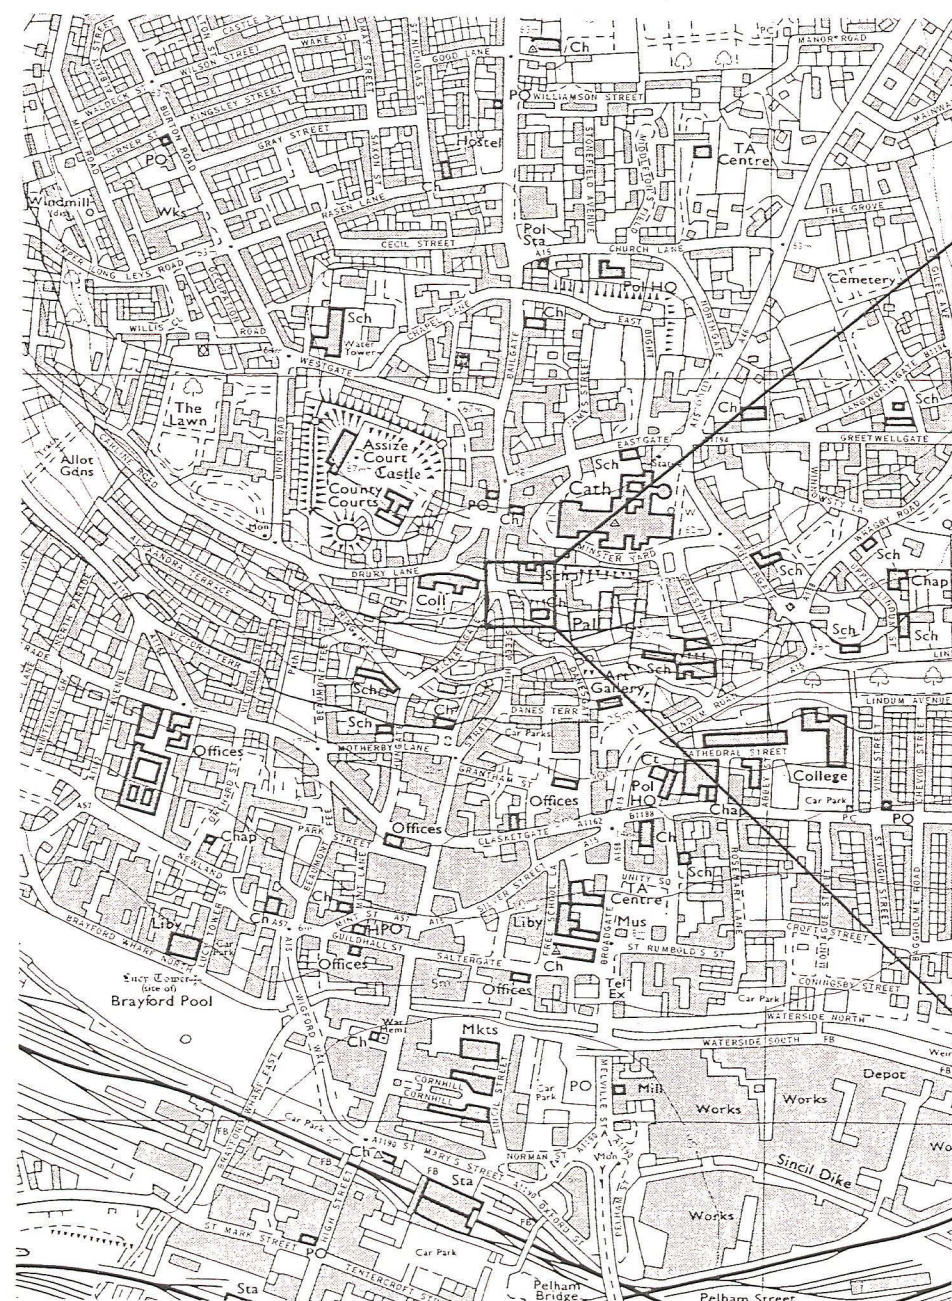
1:10 000

- Fig. 1 Site location plan - scale 1:10000 & 1:500
- Fig. 2 Plan of internal modifications - scale 1:100
- Fig. 3 Plan showing route of service trench and location of section drawings - scale 1:500
- Fig. 4 West-facing section 1 - scale 1:20
- Fig. 5 South-facing section 2 - scale 1:20
- Fig. 6 West- and East-facing sections 3 & 4 - scale 1:20
- Fig. 7 East-facing section 5 - scale 1:20
- Fig. 8 South- and East-facing sections 6 & 7 - scale 1:20

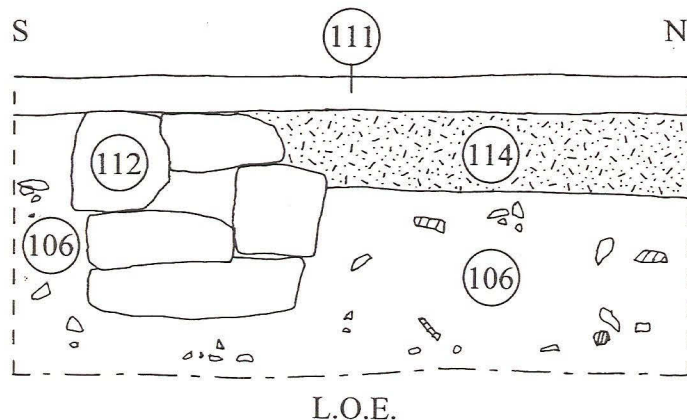
Fig.7

Approximately 5m to the south of CHT, [106]/[117] was sealed by the remains of a N-S limestone wall, [112] (see Fig. 7). This comprised 2-3 courses of roughly squared limestone blocks with no obvious bonding, measuring approximately 500mm in width and 600mm high. To the west of the wall, it was abutted by [114], a layer of moderately compacted light yellow-brown sandy lime mortar. This was between 100mm and 200mm thick and appeared to form a floor surface.

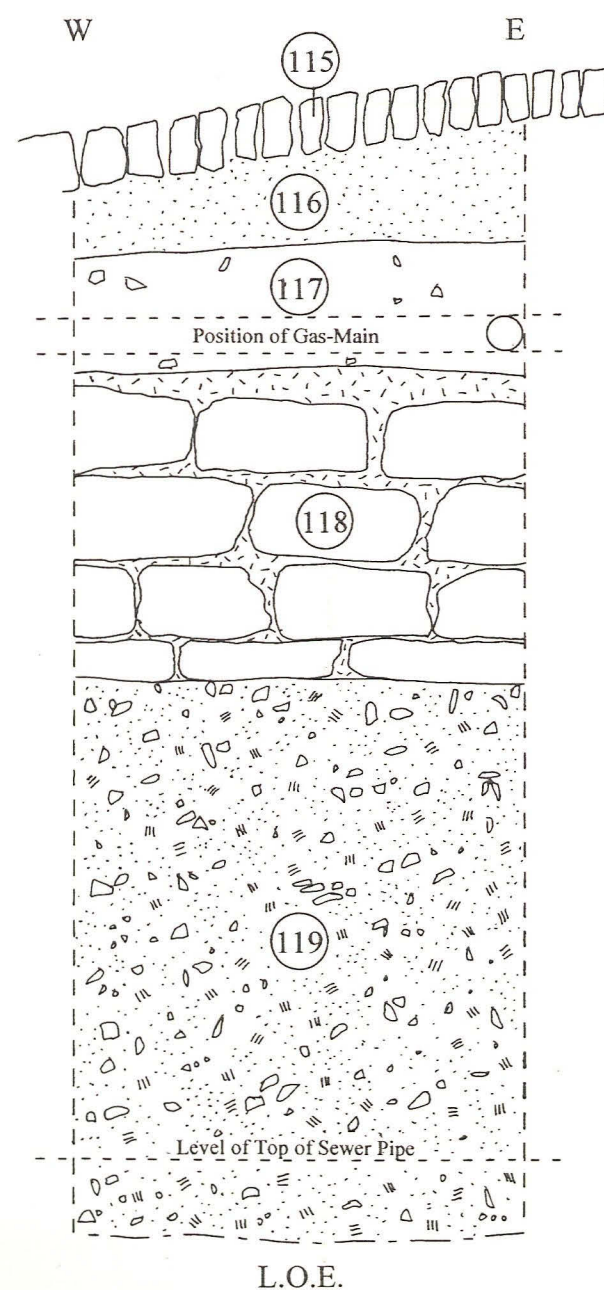
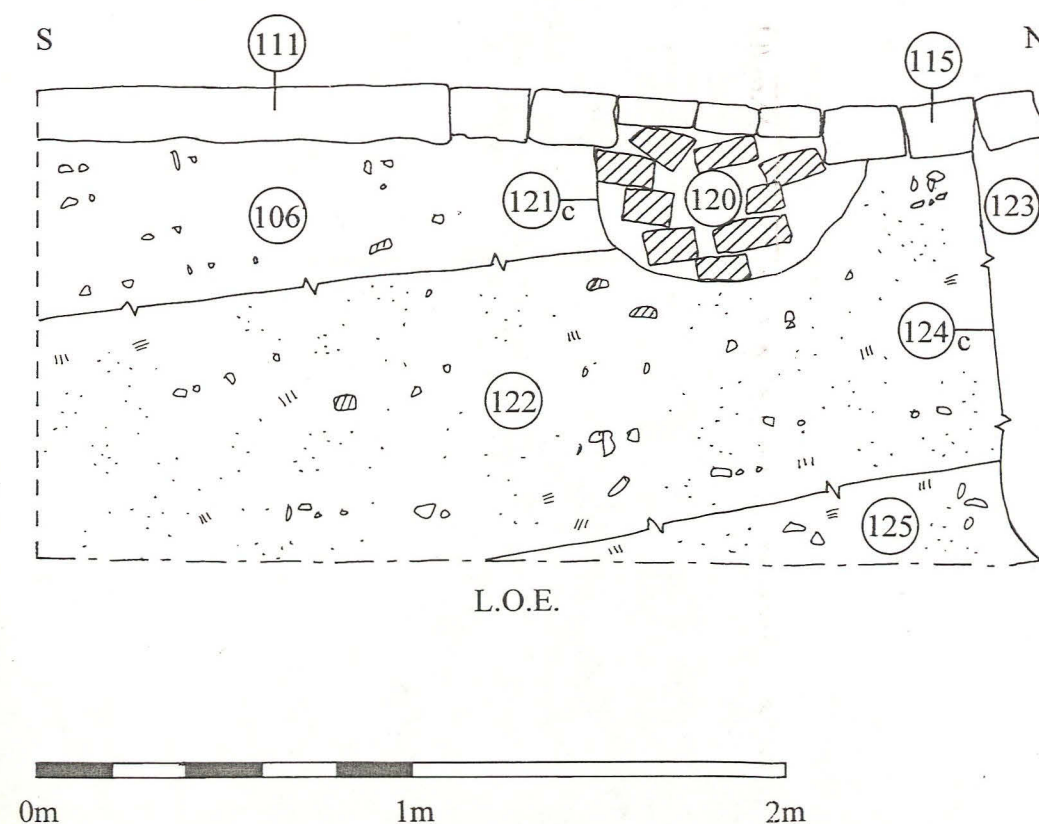
Section ⑥

At the northern end of the trench, approximately 1.2m north of the south footway on CHT, the 'brash' was sealed by part of a limestone wall [118], and a layer of what appeared to be buried topsoil [125] (see Fig. 8).

Layer [125] was present at L.O.E. a few metres to the south, and appeared to be a buried topsoil deposit. It was made up of a moderately compacted mid grey-brown sandy, clayey silt, containing small roots, and occasional small limestone flecks. No direct relationship could be seen between the wall and this layer owing to the presence of a modern sewer trench, but it appeared likely (after comparing relative levels) that the topsoil would have originally abutted the face of the wall. If the wall represents part of a medieval terrace, layer [125] could be the surface of the hillside below.
