Land South of 72 Main Road, Toynton All Saints

Archaeological Watching Brief

Site Code: TAS 98

LAS Report No. 401

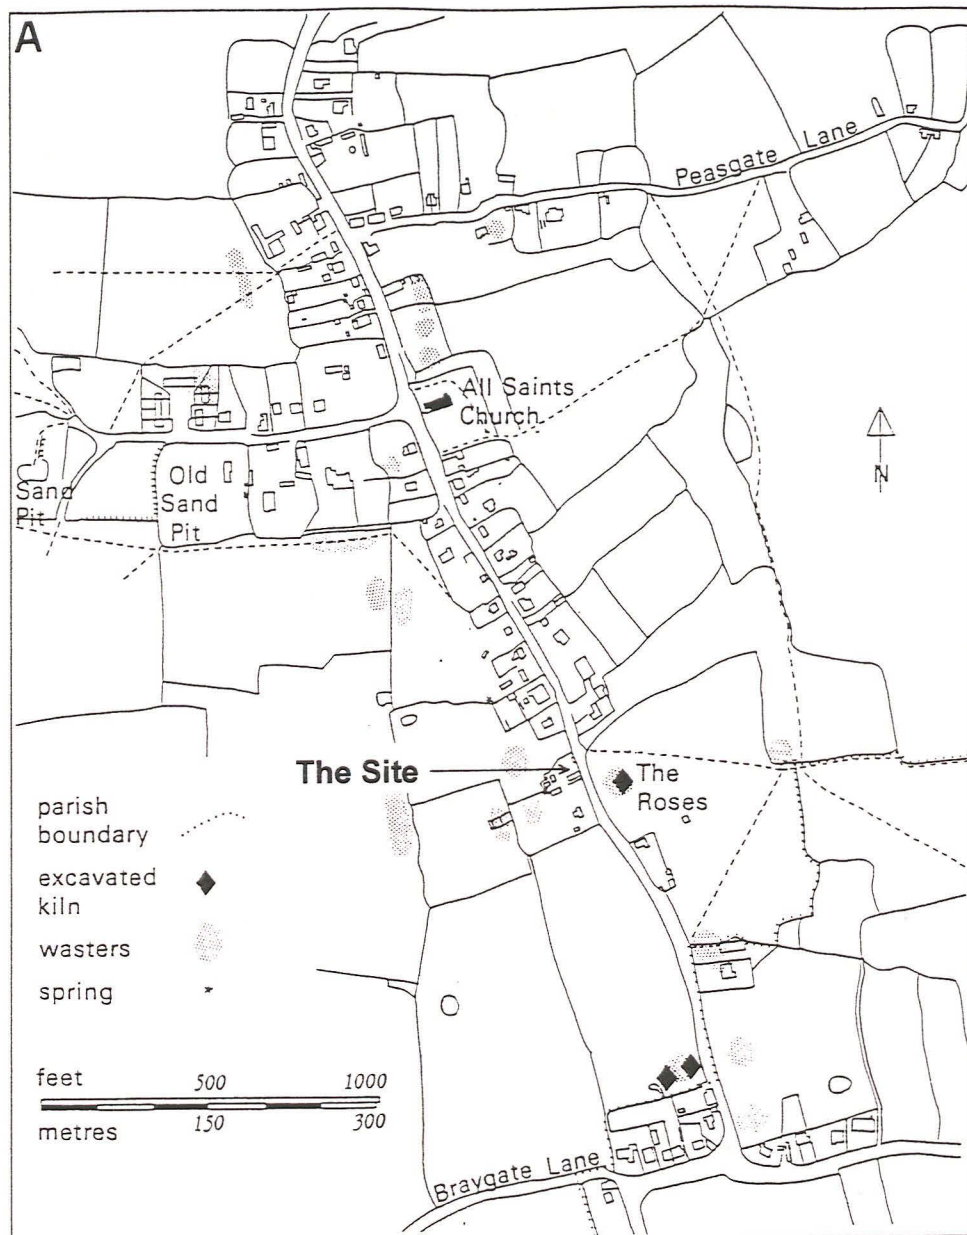
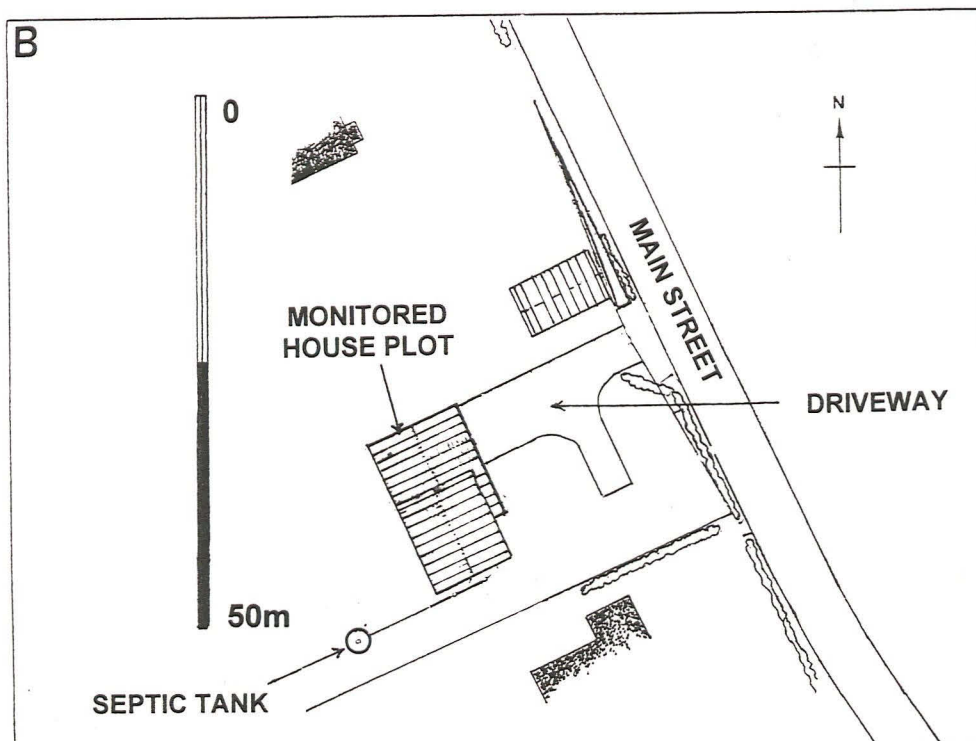
Fig. 2 Location of the monitored house plot, showing the position of known pottery kilns and pot waster heaps in the village; a) reproduced from Healey 1984; b) McDaid, based on a plan supplied by the client).

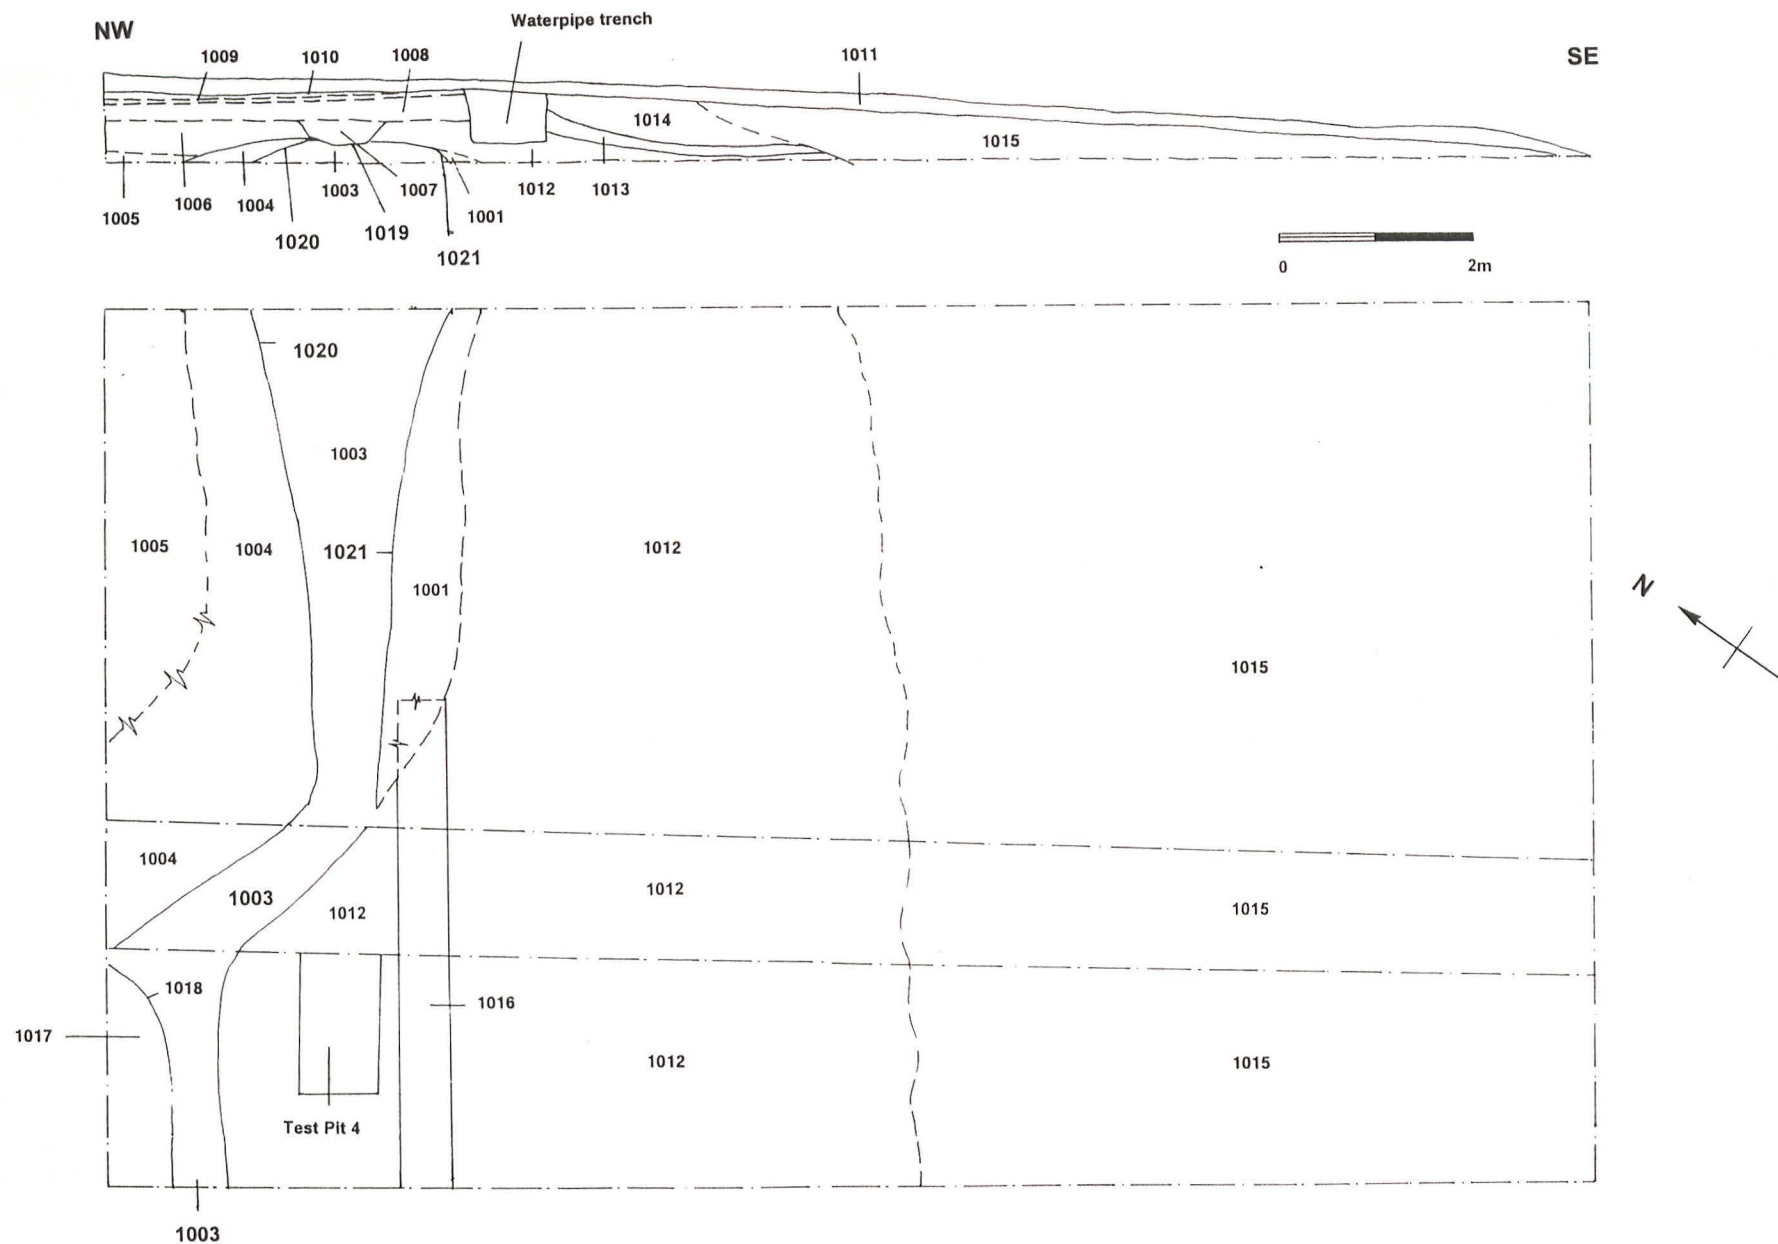
Fig. 3 Archaeological deposits exposed by the groundworks: a) section along the eastern edge of the house foundation; b) plan of the house area. (McDaid, after Tann).

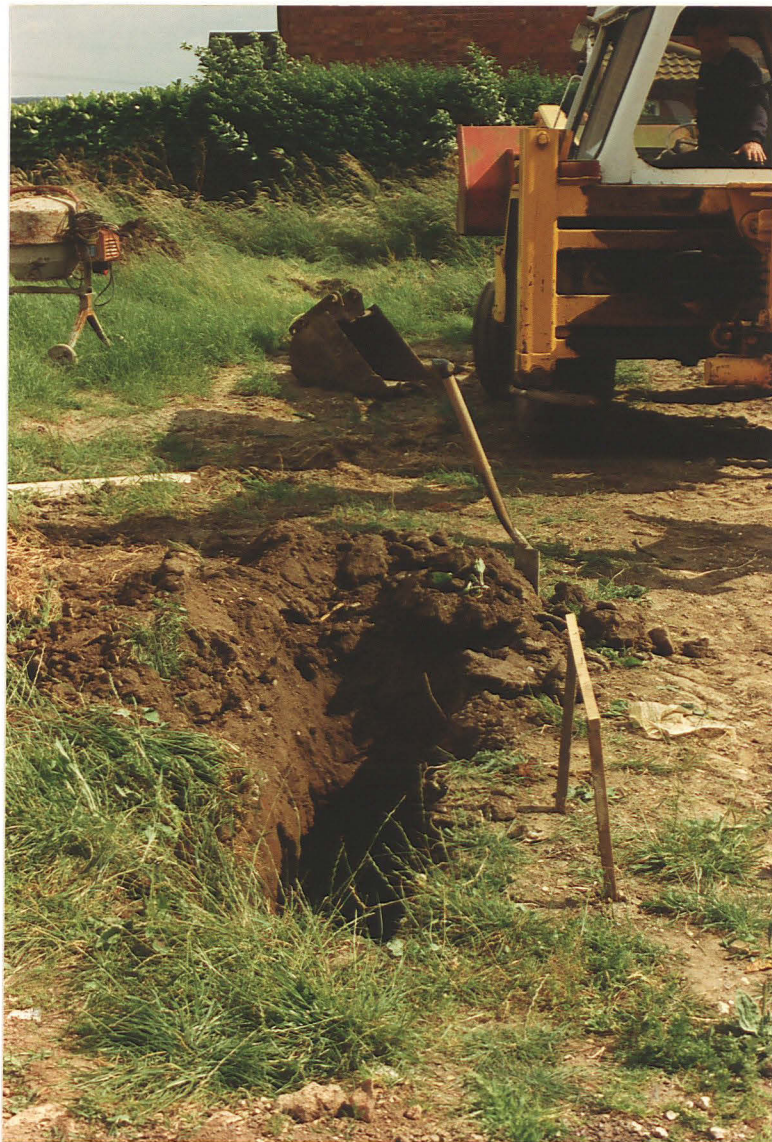
Test Pit 3, at the NE corner, was 1.45m deep. Beneath the 0.35m thick topsoil layer was 0.45m of subsoil, sealing a blue clay deposit, which sloped down from 0.2m thick at the western edge, to 0.5m thick at the eastern side of the test pit. It overlay a thick deposit of fired clay, ash and material apparently raked from a pottery kiln stokehole (Pls. 1 and 2). Although little pottery was present in this deposit, the NW corner of the trench exposed solid fired clay, which may have been at the edge of a kiln flue. It appears that this test pit had clipped the periphery of a pot kiln sited inside a clay extraction pit. Kilns are often found in features such as pits or ditches as they offer shelter from draughts as well as providing a place for raking out ash and fired soil created by firings.

Pl. 1 Test Pit 3, at the NE corner of the intended house site, looking south.

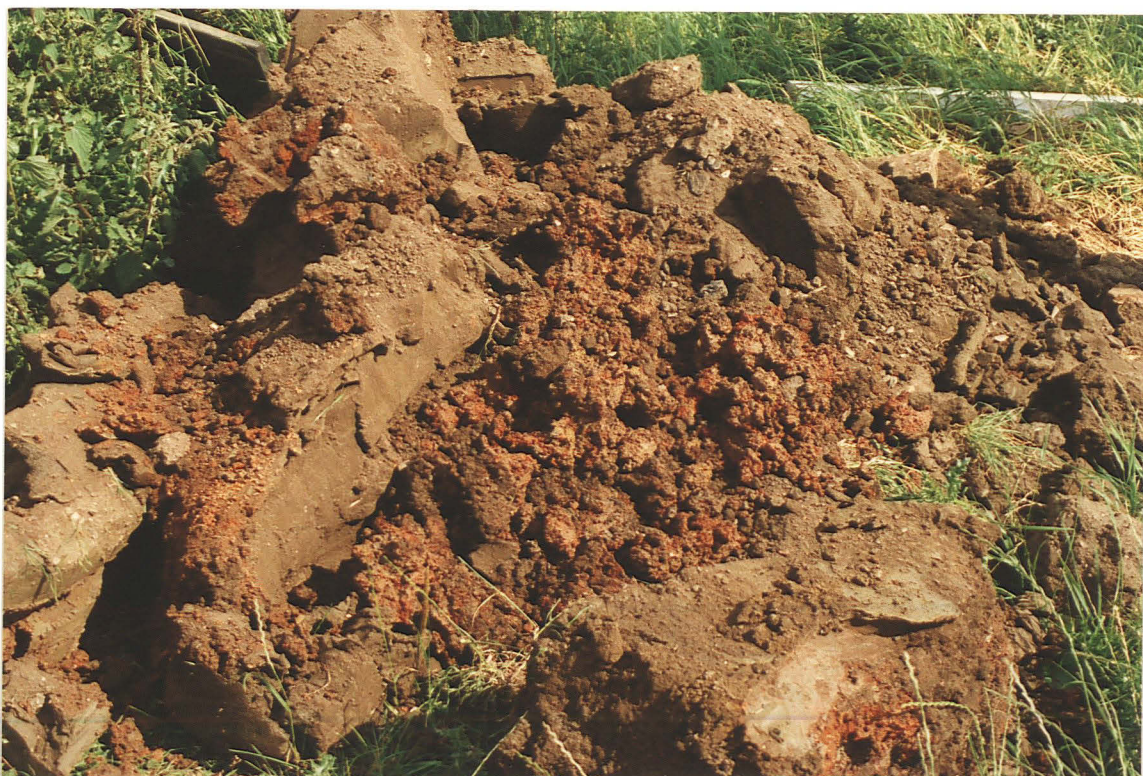
Pl. 2 Red fired soil and kiln material from Test Pit 3.

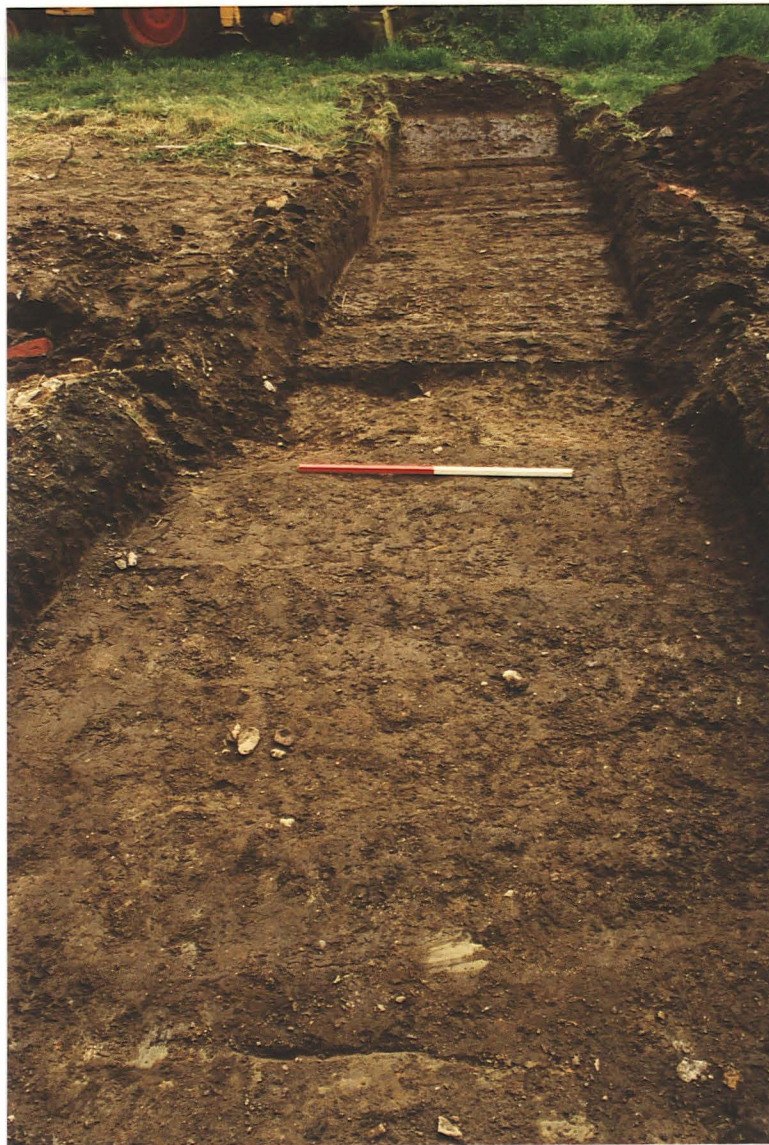
A 1.8m wide trial slot was machined, with a ditching bucket, across the proposed position of the house in order to check the depth at which archaeological features or natural clay would be encountered (Pls. 3 and 4). The slot was found to cross an area completely disturbed by pits, with ubiquitous pottery fragments and kiln debris. Context numbers **900 - 908** were assigned to finds from this trial slot. Using the information gained as to the nature and depth below the surface of underlying archaeological features, the intended position of the house was moved to the west. This was sufficient to reduce the depth of excavation close to the kiln site revealed in Test Pit 3. The ground slopes down to the west, and the creation of a flat raft foundation had its greatest impact on the eastern side of the house plot.

Pl. 3 West-east trial slot across the intended position of the house (looking south).

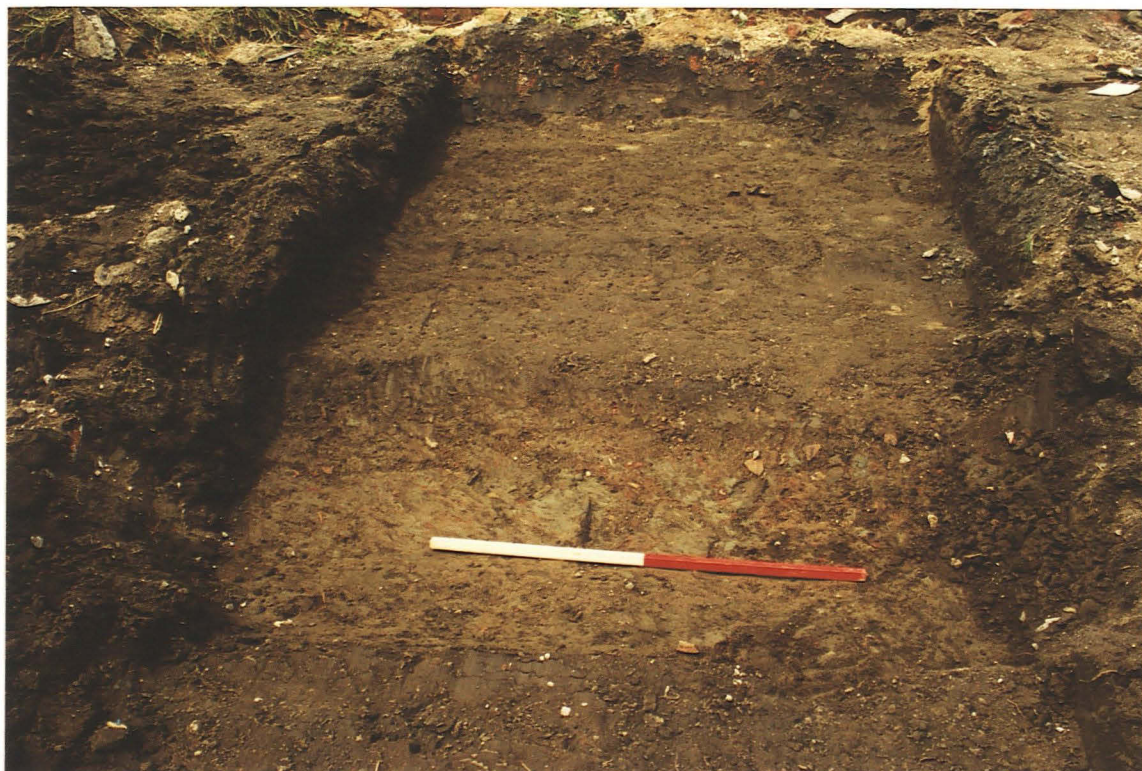
Pl. 4 Pottery fragments and burnt soil in the fill of clay extraction pits, visible in the trial slot (looking north).

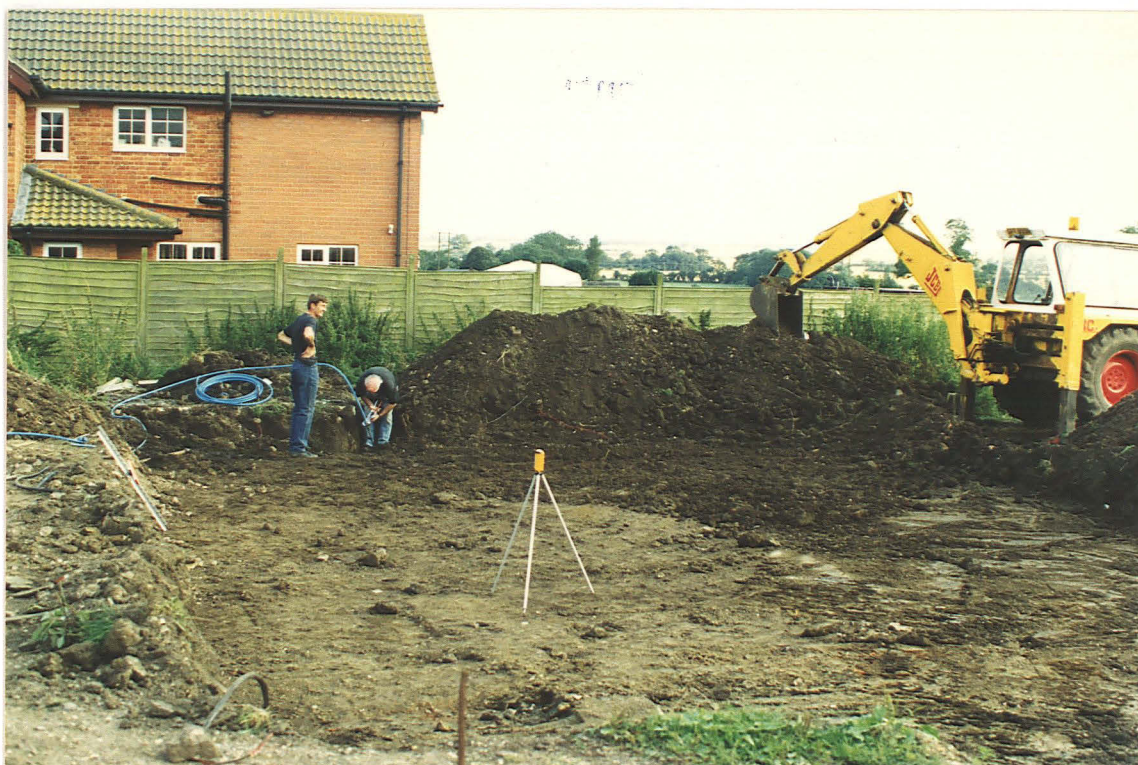
The raft area was eventually machined in the revised position to a depth agreed with the local planning authority (Pl. 5). The groundworks were done with archaeological monitoring, and the soil was removed in thin scrapes to ensure minimal loss of any archaeological features.

Pl. 5 Topsoil stripping in the revised house position (looking south).

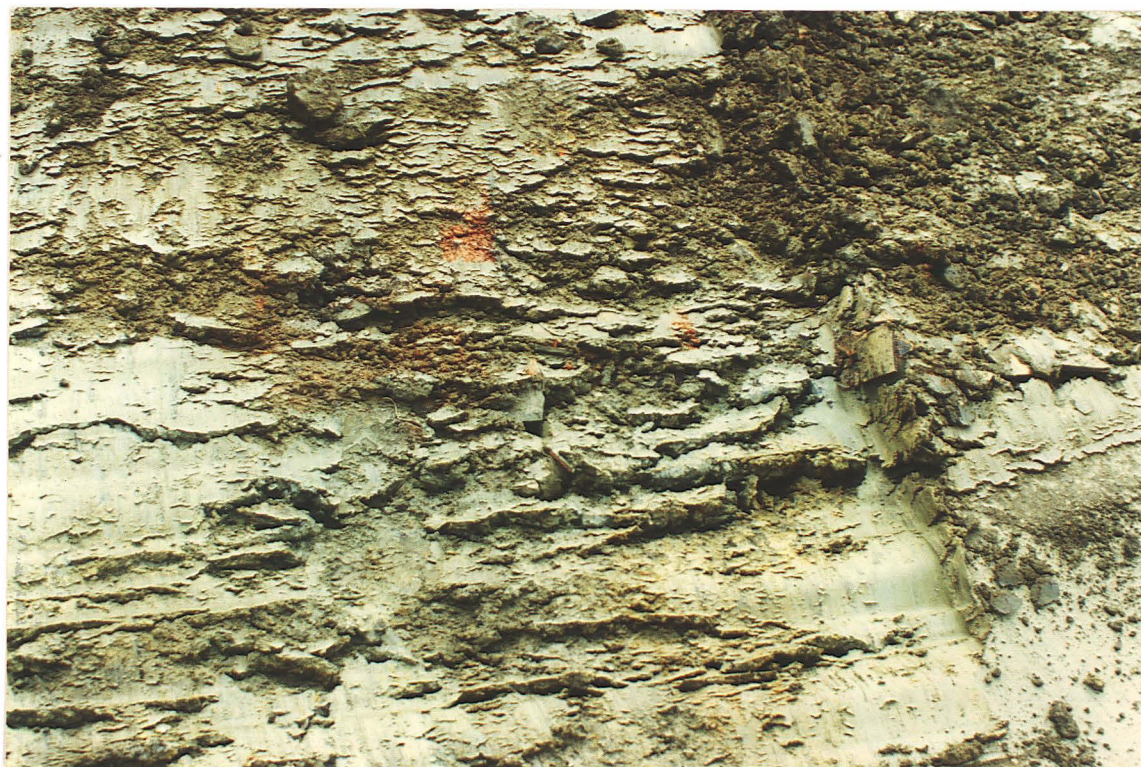
Below the dark brown layer was a clay horizon, containing numerous pottery waster sherds (Pls. 6 and 7). The clay was very mixed, and appeared to be the fills of several intercutting large features, assumed to be clay extraction pits. Pottery was collected from one identified deposit **1001**, but most of the pottery seen was unstratified, and assigned the reference number **1000**. No other features or structures were visible, and the small depth that the foundation cut into this horizon in the eastern part of the site was not thought to have caused significant damage to the archaeological deposits.

Pl. 6 Pottery waster sherds on the stripped surface.

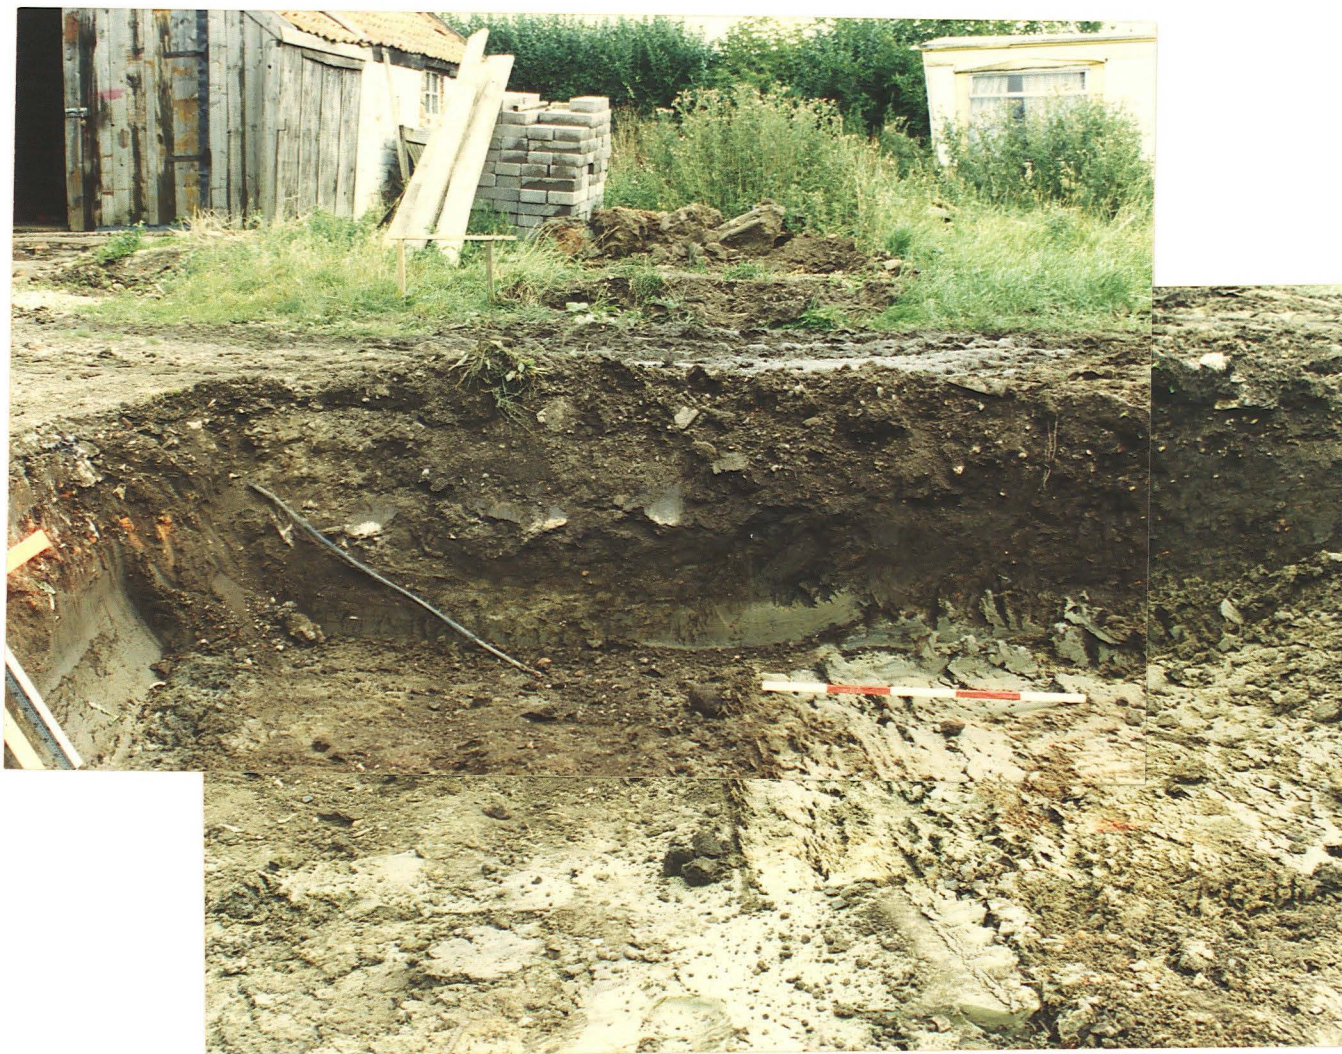
Pl. 7 Clay fills of the backfilled clay extraction pits, NE corner of the house plot (looking east past Test Pit 3 to the Main Street frontage). This was the deepest point of the new house foundation.

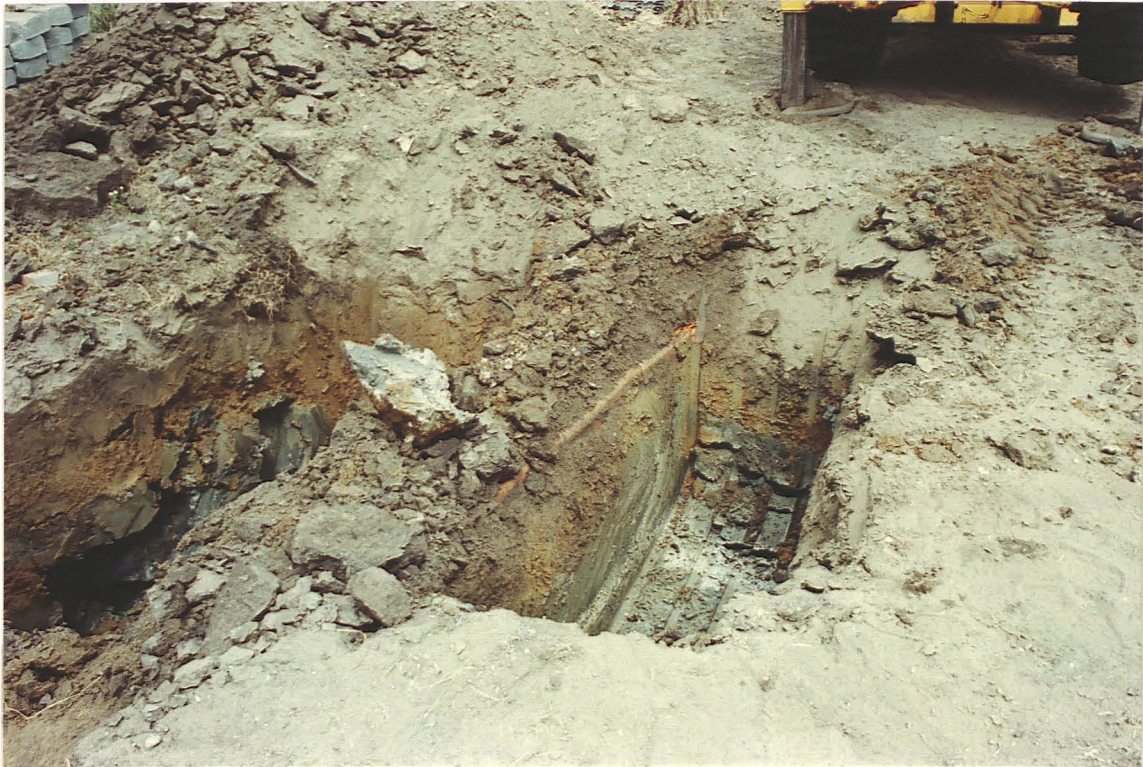
On a subsequent visit, a 2.1m deep trench 3m x 3m was excavated for a septic tank close to the northern boundary behind the house plot (Pl. 8). The topsoil in this area was 0.35m thick, sealing a 0.45m thick orange/brown subsoil layer. Beneath the subsoil was a compacted blue clay layer, similar to shale. There was no evidence for clay pits or pottery sherds.

The trench cut through a modern drain (which is suspected to have served stables which were cleared from the site prior to development), and an immediately adjacent ceramic land drain, both at a depth of 0.45m below the modern ground surface.

Pl. 8 Backfilled clay extraction pits in the septic tank position, with land drain cutting across them.

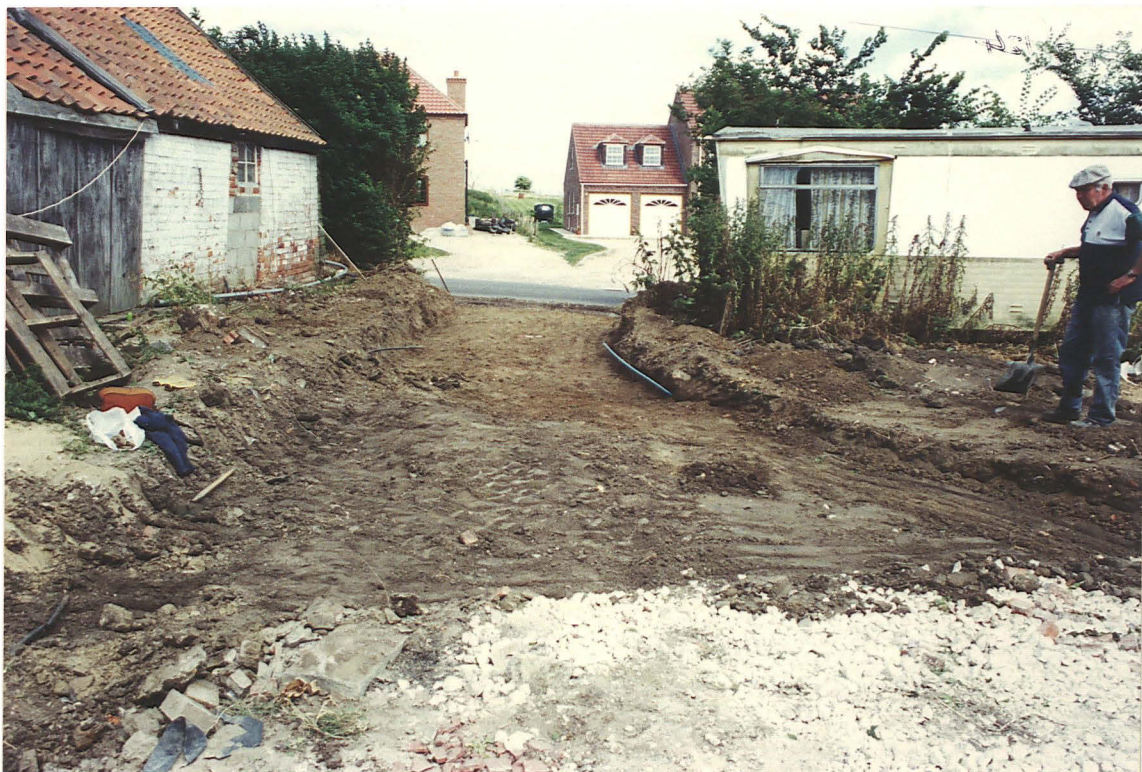
The access was known to cross an area of particular archaeological sensitivity, close to where part of a pottery kiln had been seen in a Test Pit 3. The drive was designed to remove as little material as possible across the street frontage. Close to the new house, the drive was stripped to a depth of 0.15-0.2m, increasing to 0.35m in the centre of the drive, and 0.75m where the hedge was breached (Pl. 11).

The drive was stripped to a width of about 2.5-3m, splayed at its junction with Main Road, and broadening out to the east of the new house. The excavation removed topsoil and the existing yard surface, but did not disturb the orange/brown sandy layer below, which was interpreted as a subsoil. The surface of the subsoil incorporated numerous late medieval and post-medieval pottery fragments but only water services associated with the existing sheds were seen.

Pl. 9 New vehicular access to the building plot (looking east to Main Street).

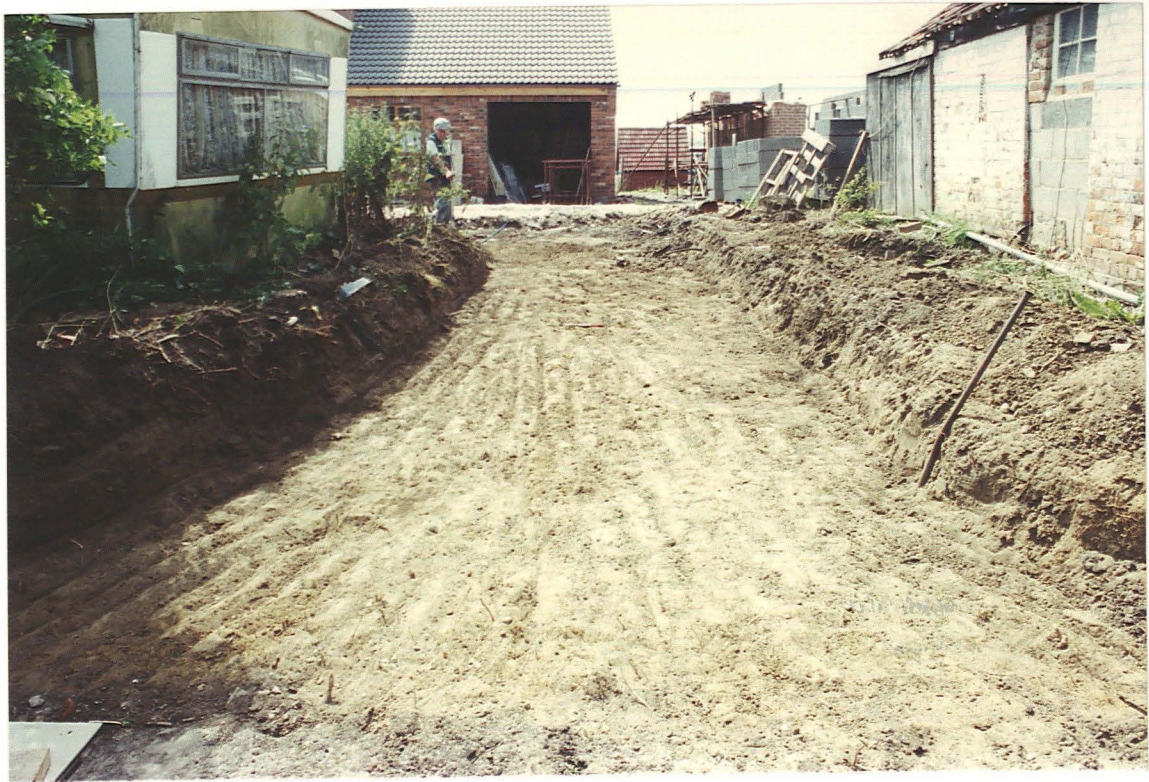
Pl. 10 View along the new access from Main Street to the new house (looking west).

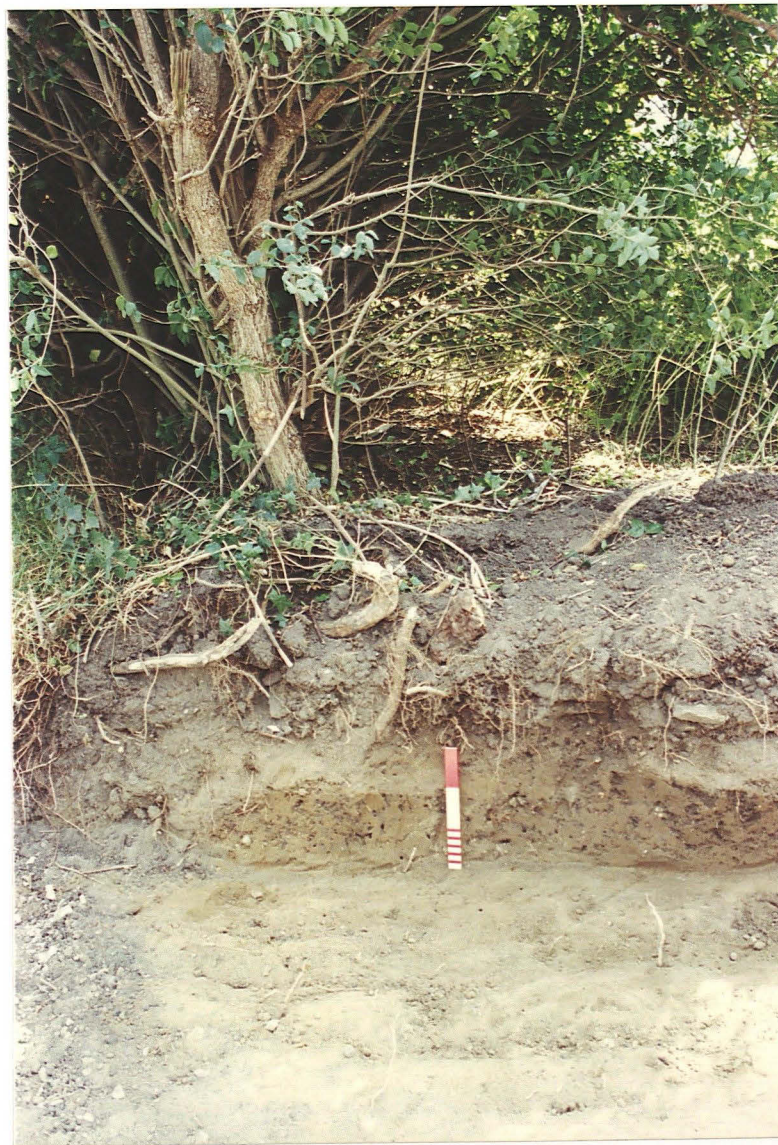
Pl. 11 Deposits visible below the hedge bank at the Main Street frontage (looking south from the new access).
