## **Bracebridge Heath - Canwick Mains Replacement Scheme**

### **Mains Laying in Bracebridge Heath**

### **Archaeological Watching Brief**

**LAS Report No. 413  
April 2000**

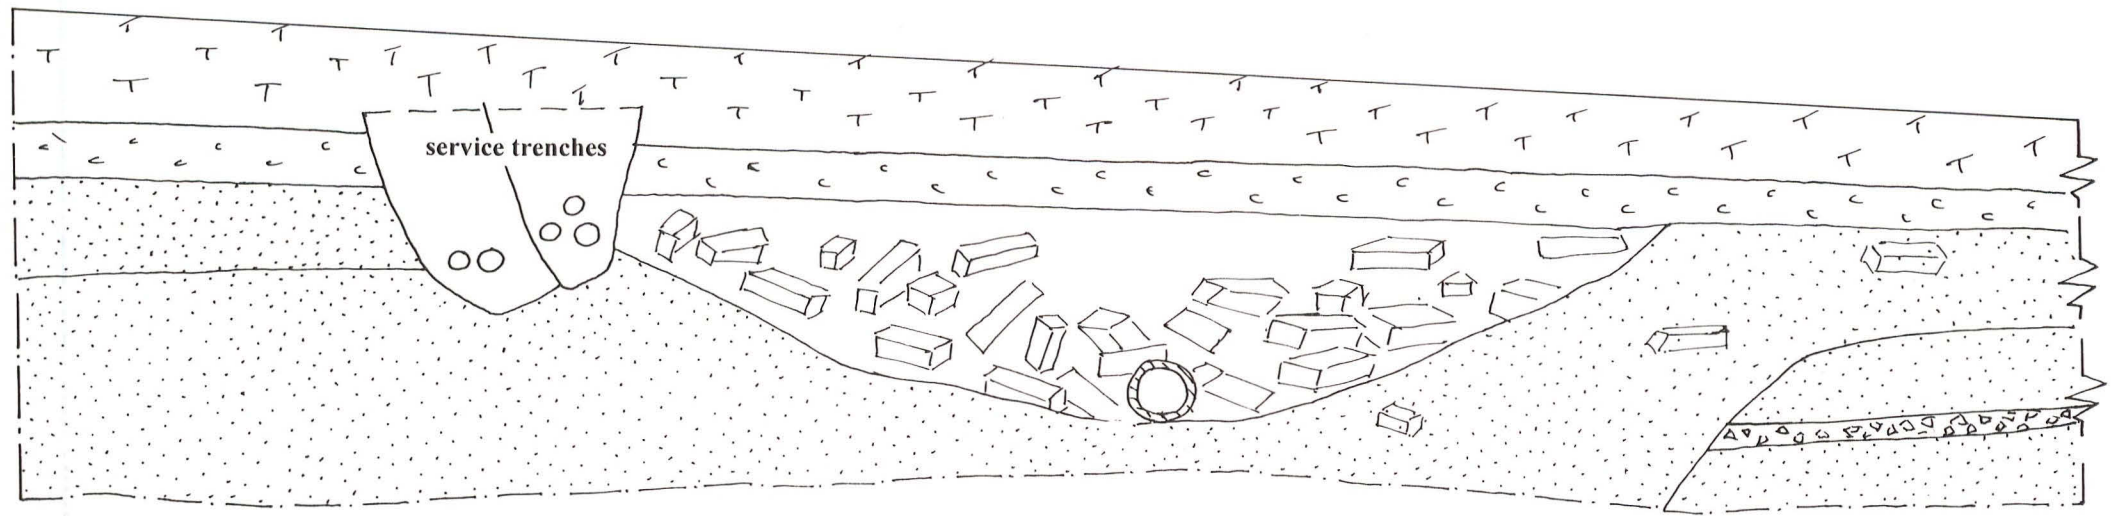
Fig. 3 Section across part of the eastern ditch of Ermine Street, seen at the junction of Heath Road and Grantham Road 37 (McDaid, after Tann).

At the junction of Heath Road with Grantham Road **37**, a north-south aligned ditch was seen below the modern road, with an upcast bank to the east (Fig. 3). This was interpreted as the eastern ditch flanking Ermine Street. The ditch here was at least 4.5m wide, with its base over 1.3m below the road surface. The road junction is on a slope here, with Grantham Road on the Roman raised carriageway or *agger*, and Heath Road on the former ground level (Pl. 10). The steepness of the slope has been reduced by modern raising of the west end of Heath Road.

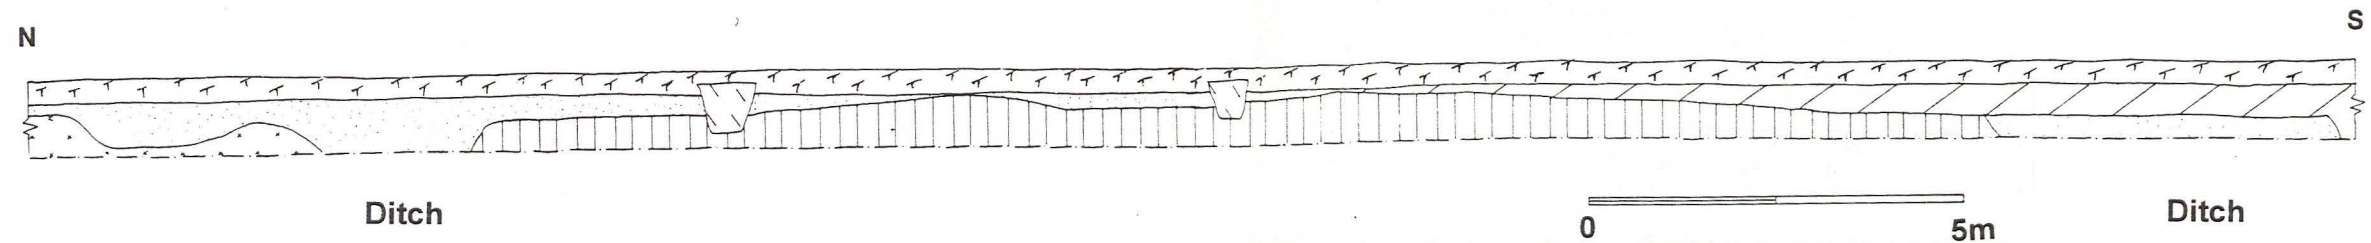
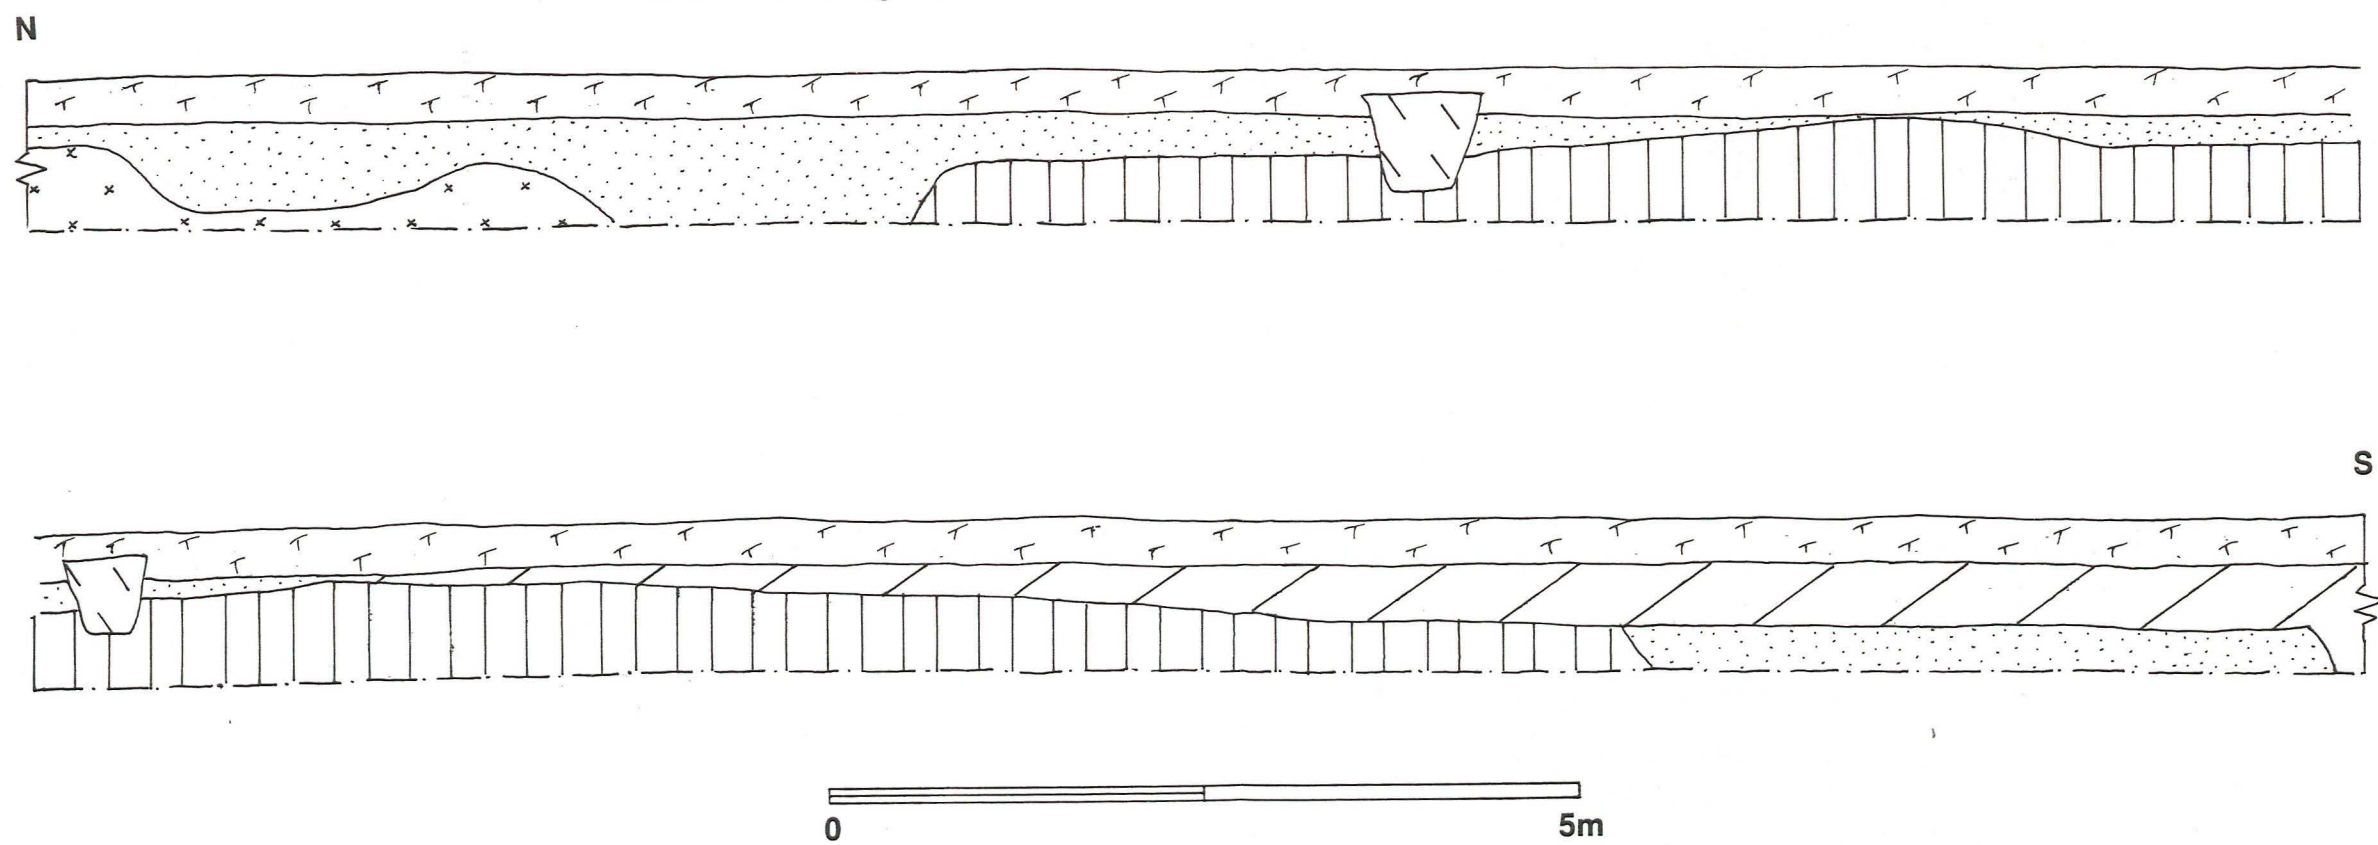
Fig. 5 a) Section across Ermine Street, as seen in the pipe trench at Kennedy Road 63 (McDaid, after Tann). b) Detail of section.

Monitoring of trenching along Kennedy Road from Ridge View Road revealed nothing of interest west of Home Close. In front of Kennedy Lodge **63** a broad ditch was exposed, with pitched limestone rubble to the east (Fig. 5). This was definitely Ermine Street, and it was confirmed to lie on the course

indicated by the Ordnance Survey (Pls. 13 and 14). Unfortunately, the pipe trench section across the Roman road was not at 90°, and the measurements of width are not those of a cross-section through it. Land to the west, in the rear garden of 44 Grantham Road, is at a considerably lower level, and seems to be within a former limestone quarry. This quarry may have extended across the present position of Kennedy Road, as backfill material of brick rubble was found filling a deep feature which had removed the eastern side of the road ditch.

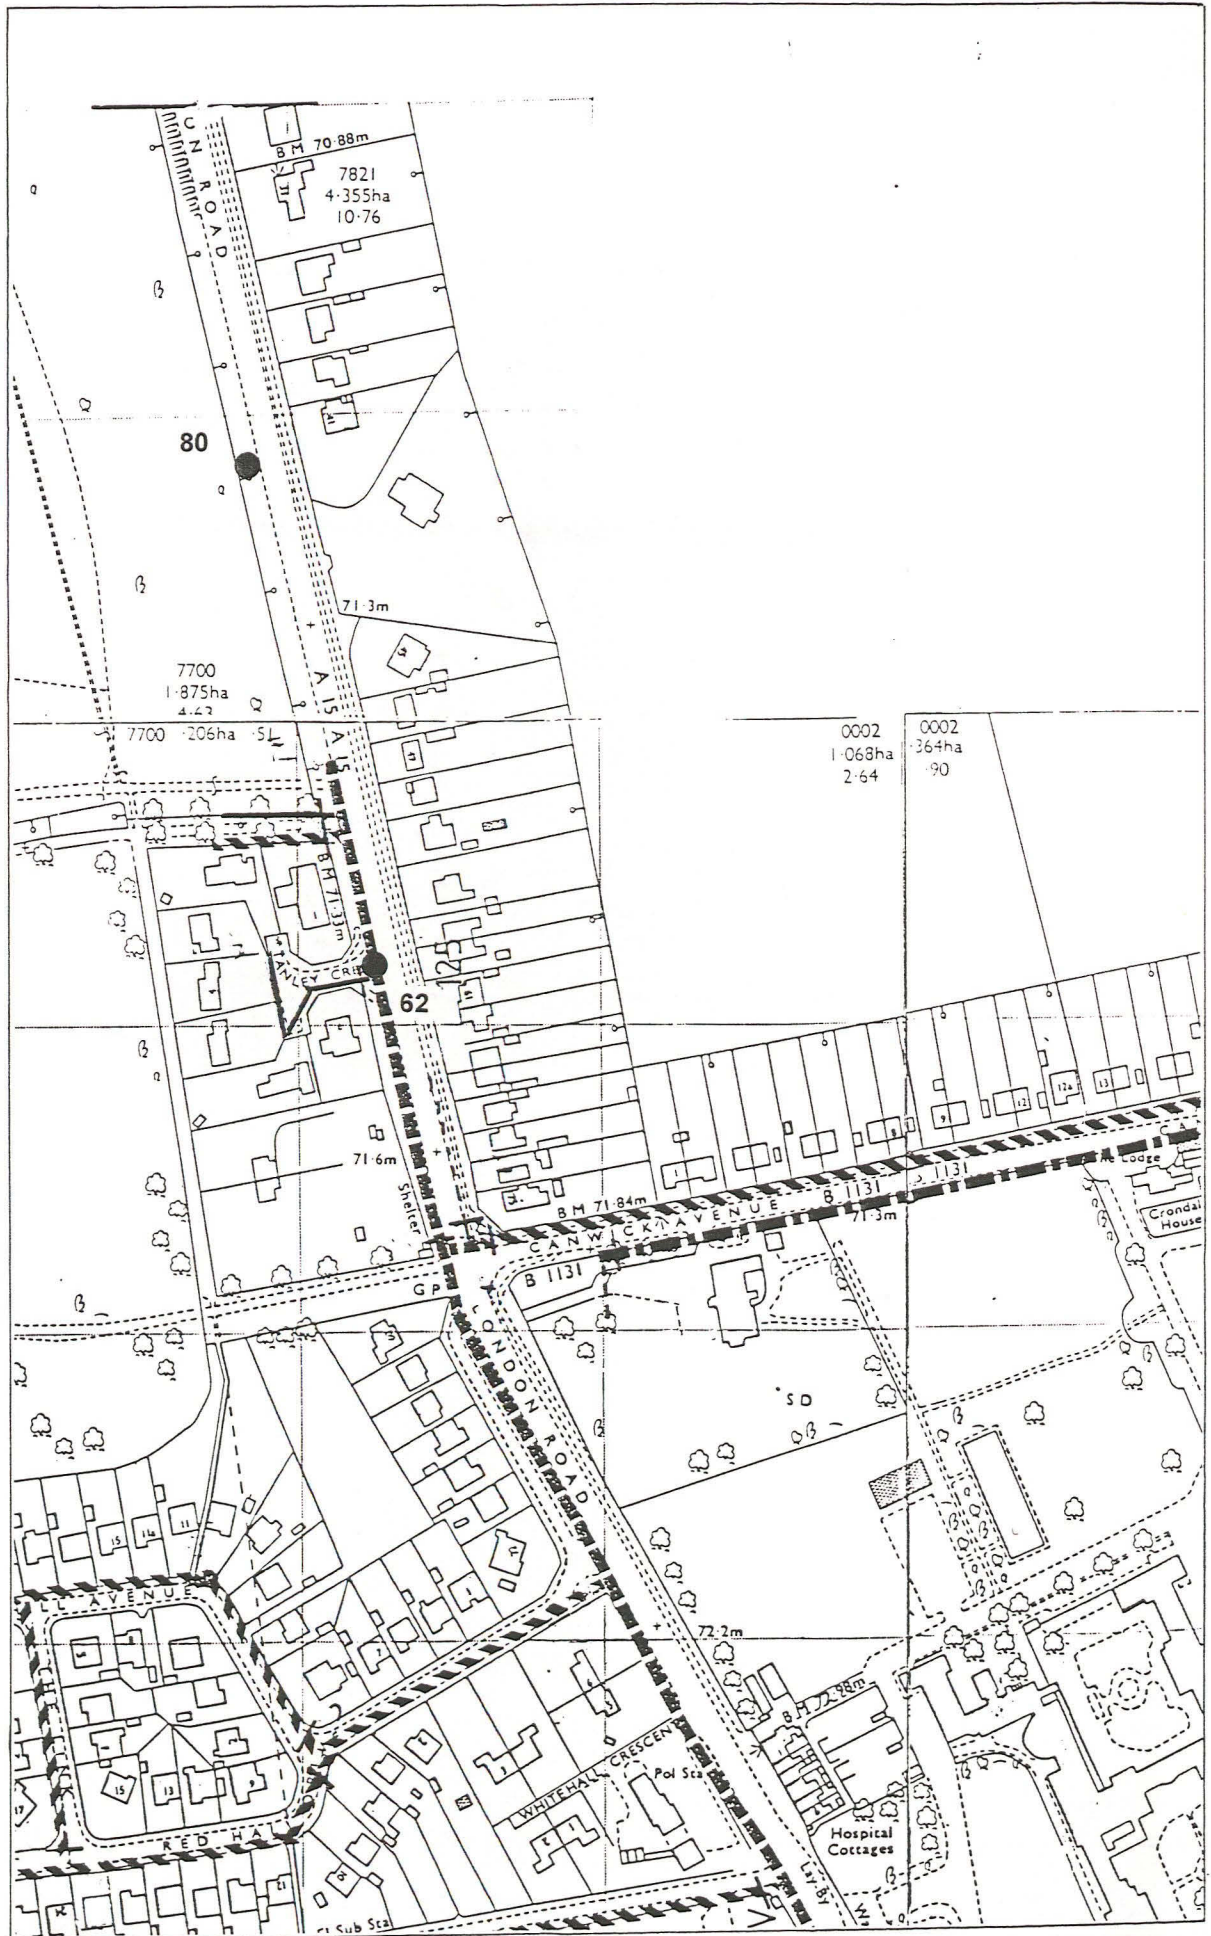
Fig. 7 Location of observations noted in the text: Sleford Road, Davy's Lane and Western Avenue (based on the 1:2,500 plan supplied by Anglian Water Services Ltd. © Crown Copyright, reproduced with the permission of the Controller of HMSO. LAS Licence No. AL 50424A).

#### **Davy's Lane** (Fig. 7)

#### **Sleaford Road** (Fig. 7)

#### **Western Avenue (Fig. 7)**

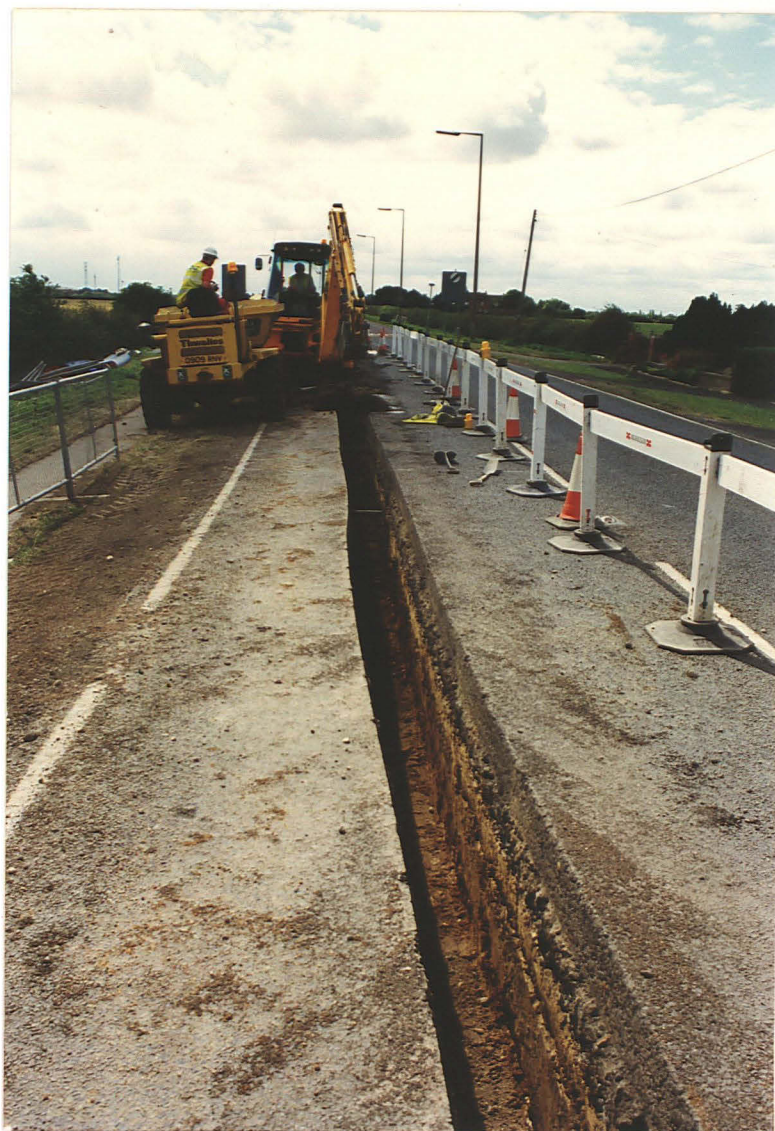
PI. 1 Trenching in Grantham Road at the northern edge of Waddington parish 36 (looking south).

The new water main trenches were laid along the eastern edge of the carriageway. Trenching for the new water main was closely watched from just south of 120 Grantham Road in case more inhumations or cremations were present west of the Roman road. In this position **36**, about 60m west of the Roman road, a sequence of the present road overlying a medieval forerunner, above limestone bedrock was anticipated. The presence of a 0.02m thick layer of fine gravel, beneath the asphalt foundation and above a 0.35m thick layer of crushed limestone, was puzzling because of its similarity with the Roman road. The existing road here is 0.7m higher than the former ground level (marked by a thick layer of brown clay loam) and 1.2m above the limestone bedrock (Pls. 1 and 2).

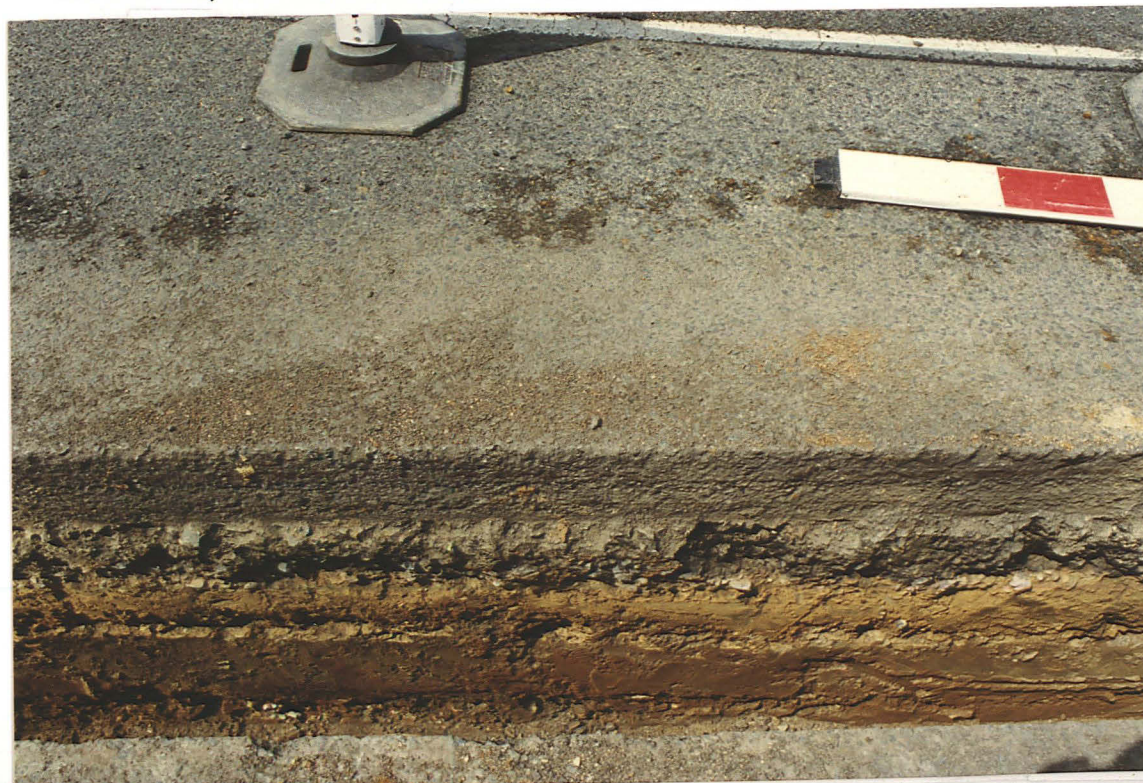
P' 2 Deposits seen below Grantham Road at 36, probably representing only a medieval and later road. Note the thin gravel band immediately under the tarmac, and the weathered limestone at the trench base.

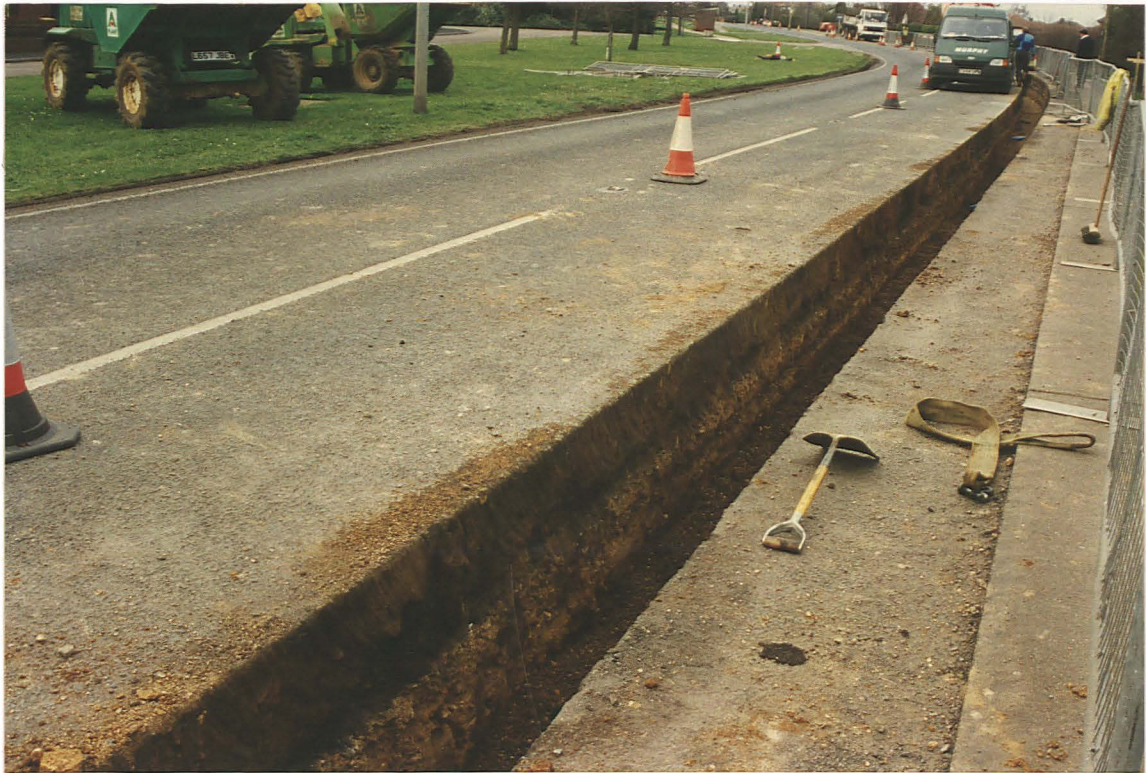
Pl. 3 Grantham Road changes alignment to join Ermine Street (beyond the green van). In the foreground 35, the medieval or later road contains gravel metalling above the crushed limestone bedding. The brown loam (an early topsoil or subsoil) overlies weathered limestone bedrock.

It is assumed that Grantham Road (formerly called Broad Way, and recently demonstrated at Waddington village to overlie a seventh-century cemetery) may have been constructed using very similar materials to Ermine Street, but this observation introduces the need for caution. The trench was positioned close to the modern road edge, and may have been within a much more recent widening of the medieval road. There is no certainty that gravel metalling overlying a crushed limestone bedding indicates that a road in this vicinity is of Roman date. There is the slight possibility that **36** exposed a minor Roman track leading west from Ermine Street to the known settlement site west of Grantham Road, but this is unlikely. No gravel metalling was seen 30m north of that observation, at **35**, but the modern road there was raised a similar height above the brown clay loam former ground surface (Pls. 3 and 4).

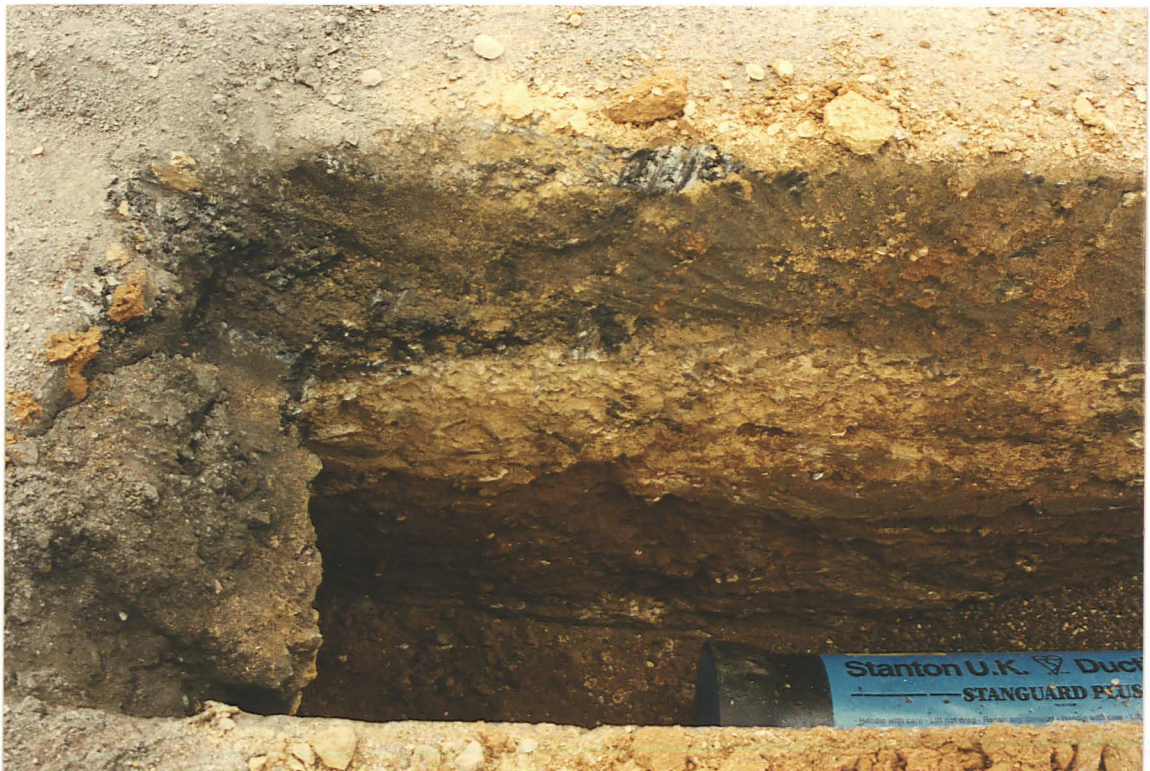
Pl. 4 Detail of deposits below Grantham Road at 35.

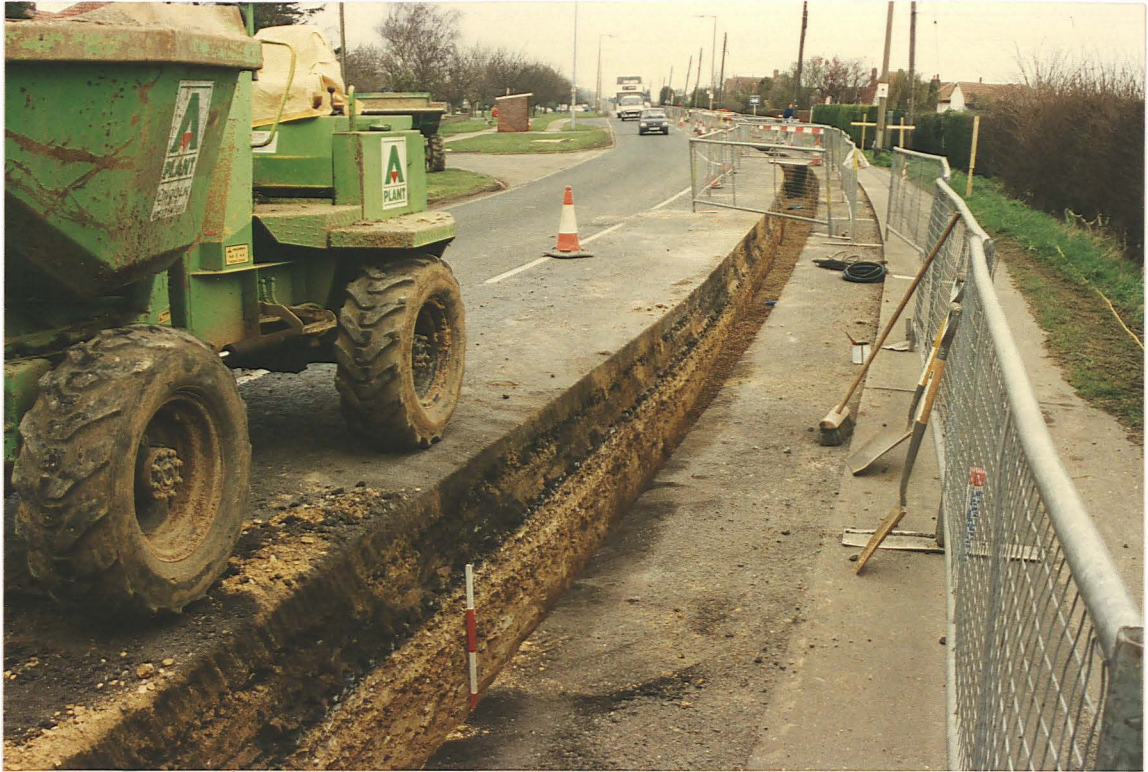
Pl. 5 Gravel metalling thought to represent Ermine Street below Grantham Road at 31 (looking north, scale divisions 0.2m).

The most southerly tentative evidence for Ermine Street was 60m south of Heath Road **31**, south of the allotment track (Pls. 5, 6 and 7). The tarmac road sealed 0.45m of gravel, and beneath the gravel was a 0.3m thick bedding of crushed limestone. At the base of the trench was at least 0.45m of brown clay loam. The greater thickness of gravel here coincides with the projected western edge of the Roman road. One possible interpretation is that here the fill of the western Roman road ditch was revealed, and that the limestone and gravel represent either slumped material from the road, or a widening of the Roman carriageway across its original flanking ditch. Similar indications of the road being constructed over a backfilled ditch were recorded near 149 Grantham Road **30**, and 133 Grantham Road **29**; in both instances the tarmac covered about 0.2m of gravel, bedded on 0.2m-0.27m of crushed limestone, with over 0.9m of brown loam below which might represent the eastern ditch (Pls. 8 and 9).

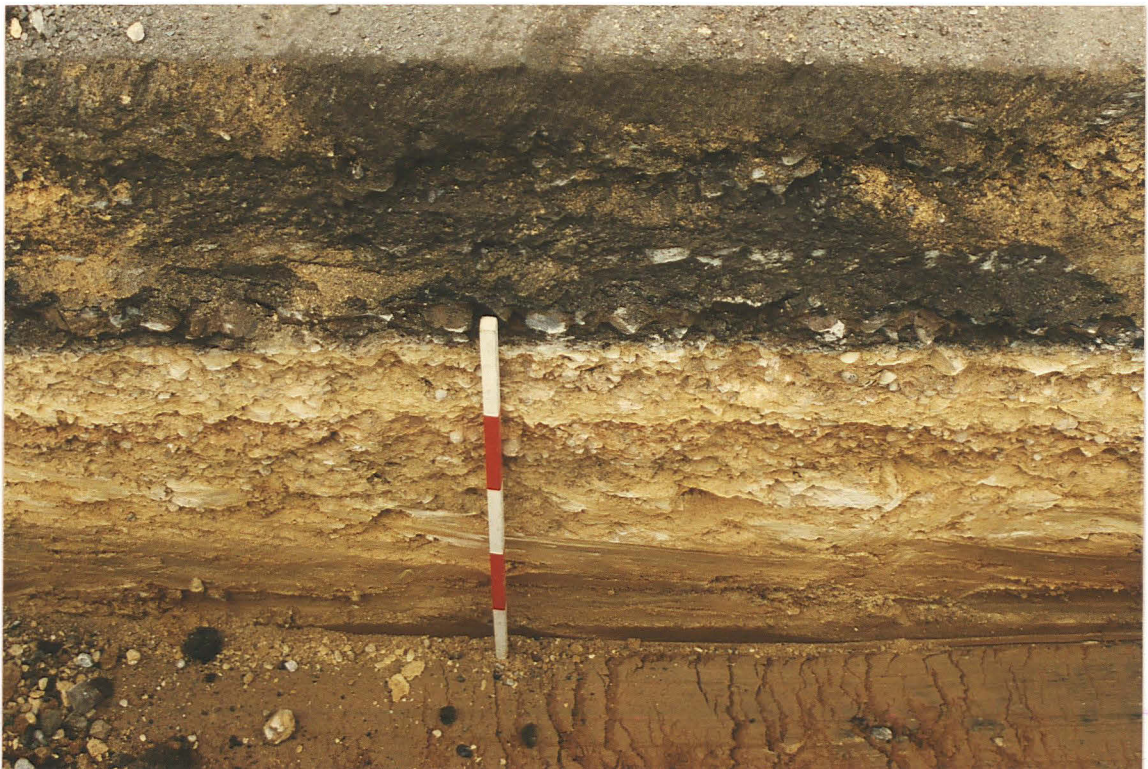
Pl. 6 Detail of the thick gravel metalling surfaces 31, representing Ermine Street.

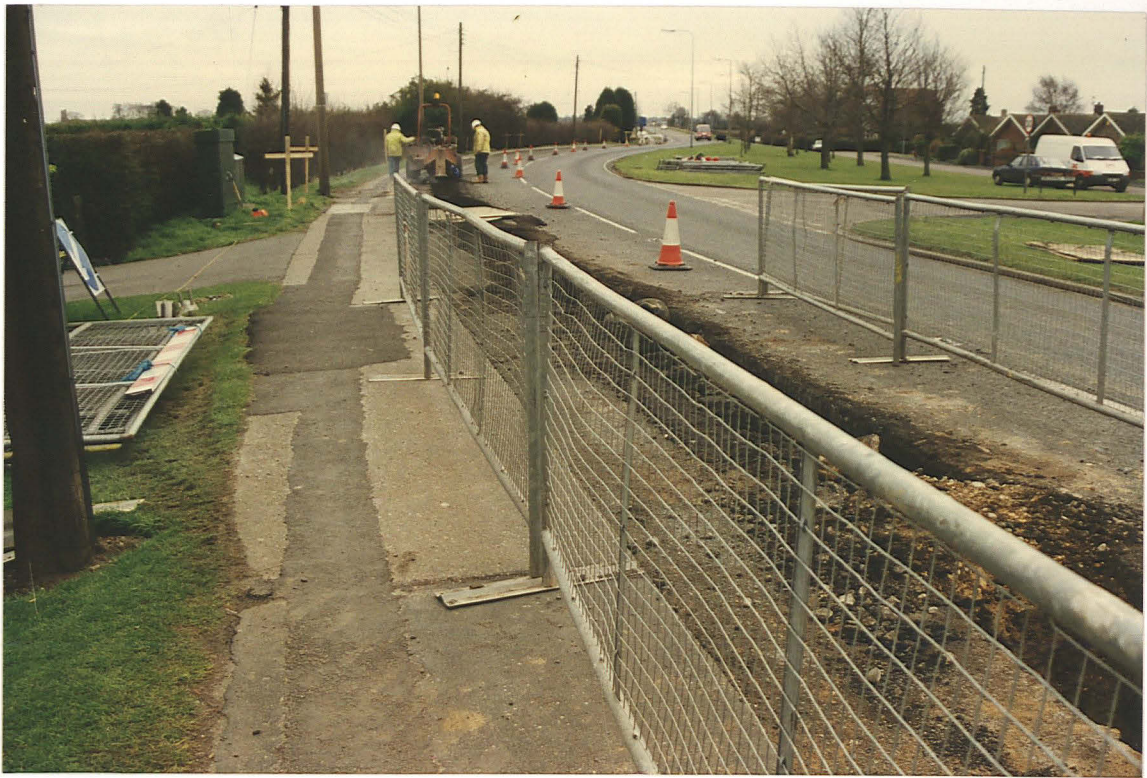
Pl. 7 To the north of Vauxhall Road (right) the modern road overlies the Roman Ermine Street (looking SW).

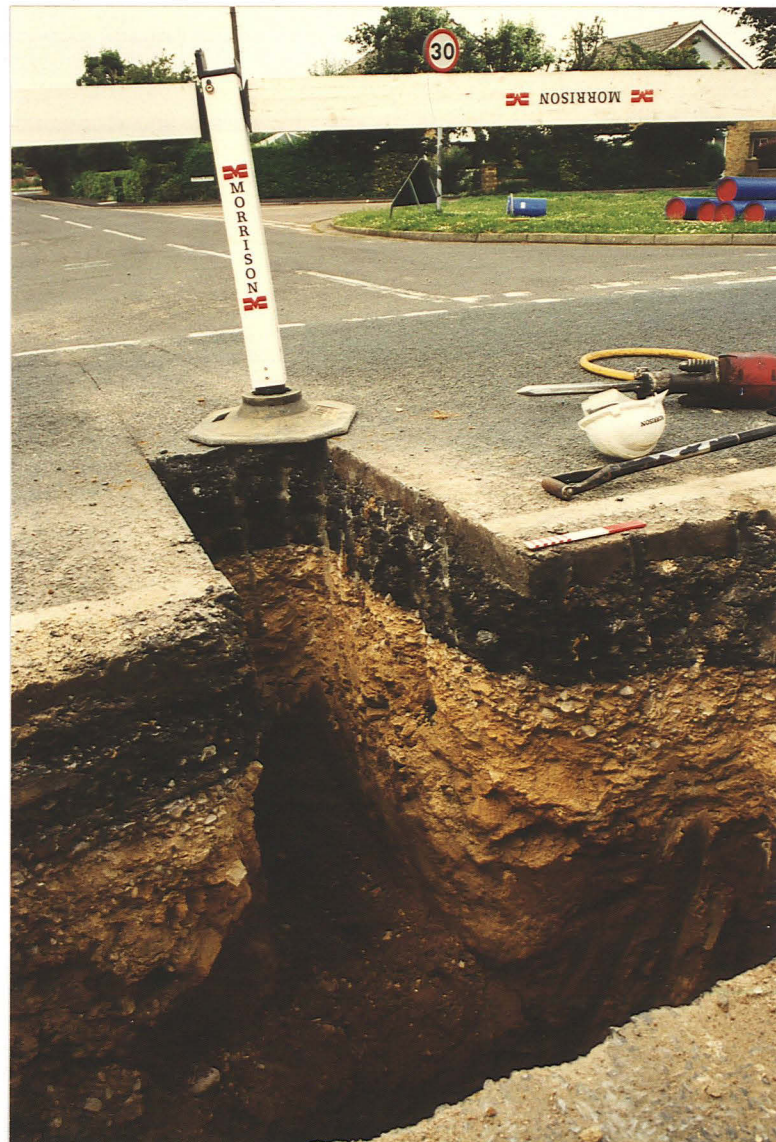
Pl. 8 Gravel metalling in the centre of Grantham Road 30, at the junction of Jensen Road (looking west).

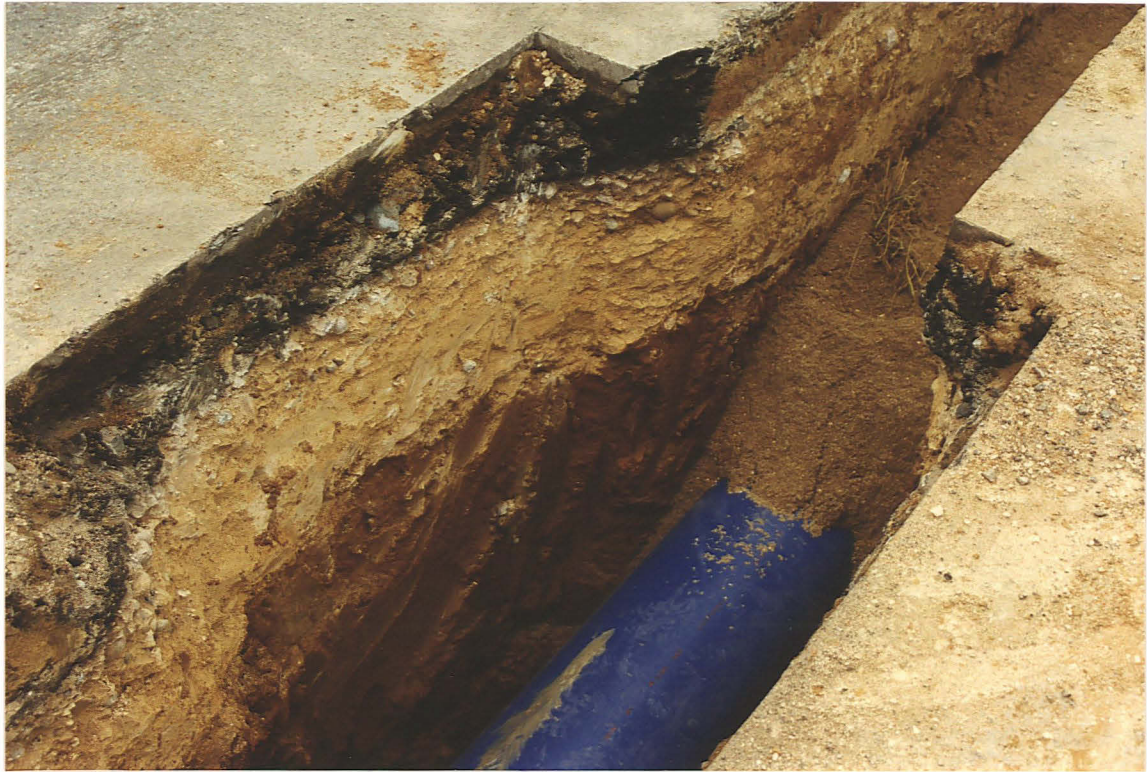
PI. 9 The dark clay loam beneath Grantham Road at 29 appears to be a backfilled roadside ditch, but note the gravel road metalling immediately below the tarmac.

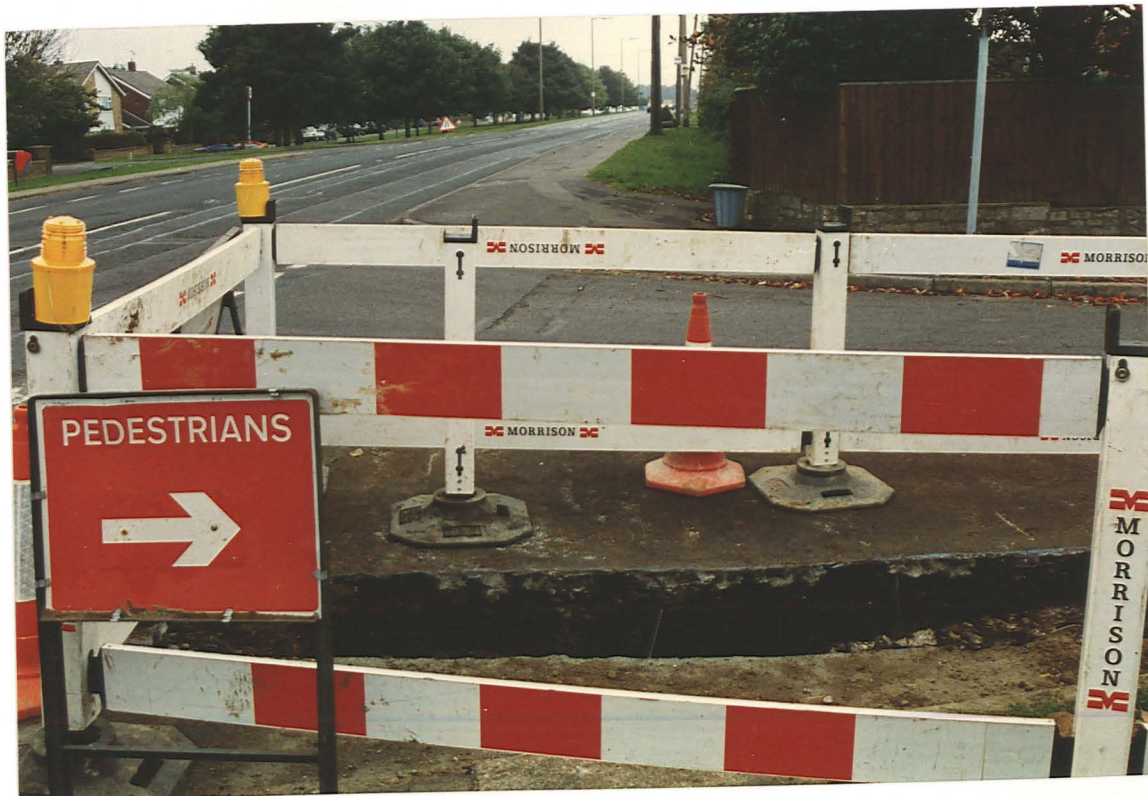
PI. 10 At the junction of Grantham Road and Heath Road 37, evidence for the eastern roadside ditch of Ermine Street was recorded (looking north).

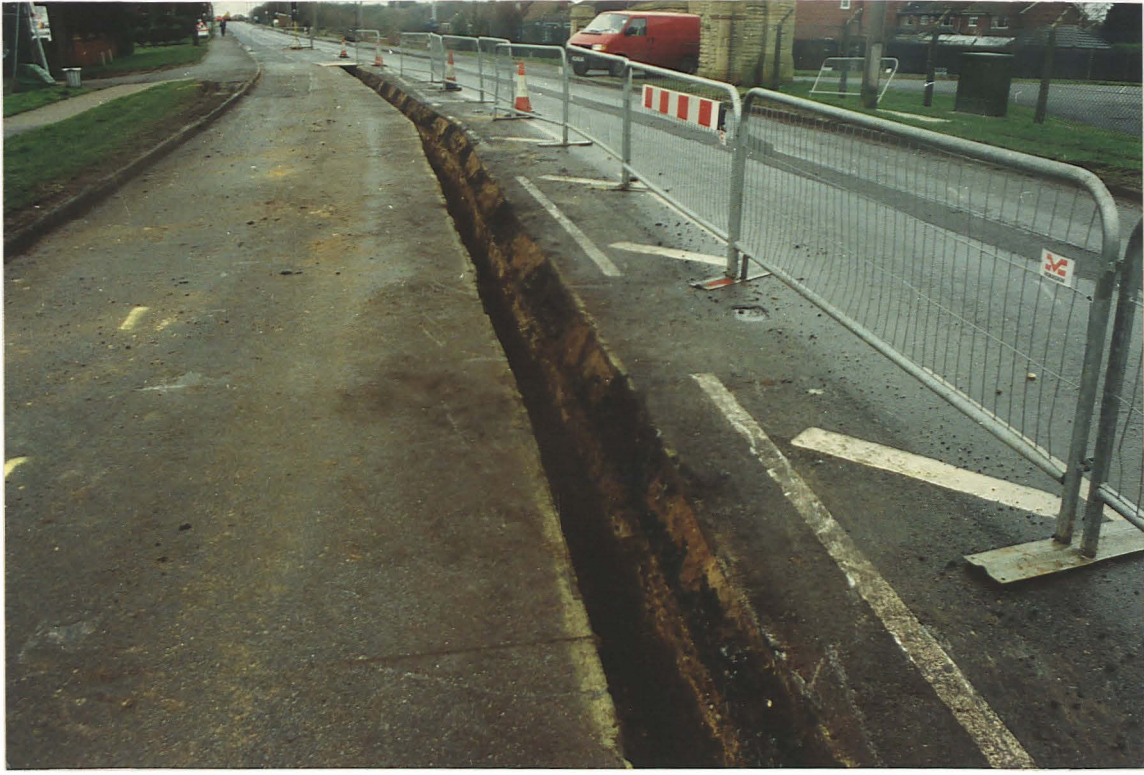
PI. 11 Ermine Street continues north where Grantham Road diverges beside the Bracebridge Heath reservoir 24 (looking SW).

Outside the entrance to the reservoir/pumping station, a trench on the western side of the road **24** showed that the post-medieval road had been laid on the exposed gravel surface of Ermine Street (Pls. 11 and 12). Most of the early road here had been removed by recent service trenches.

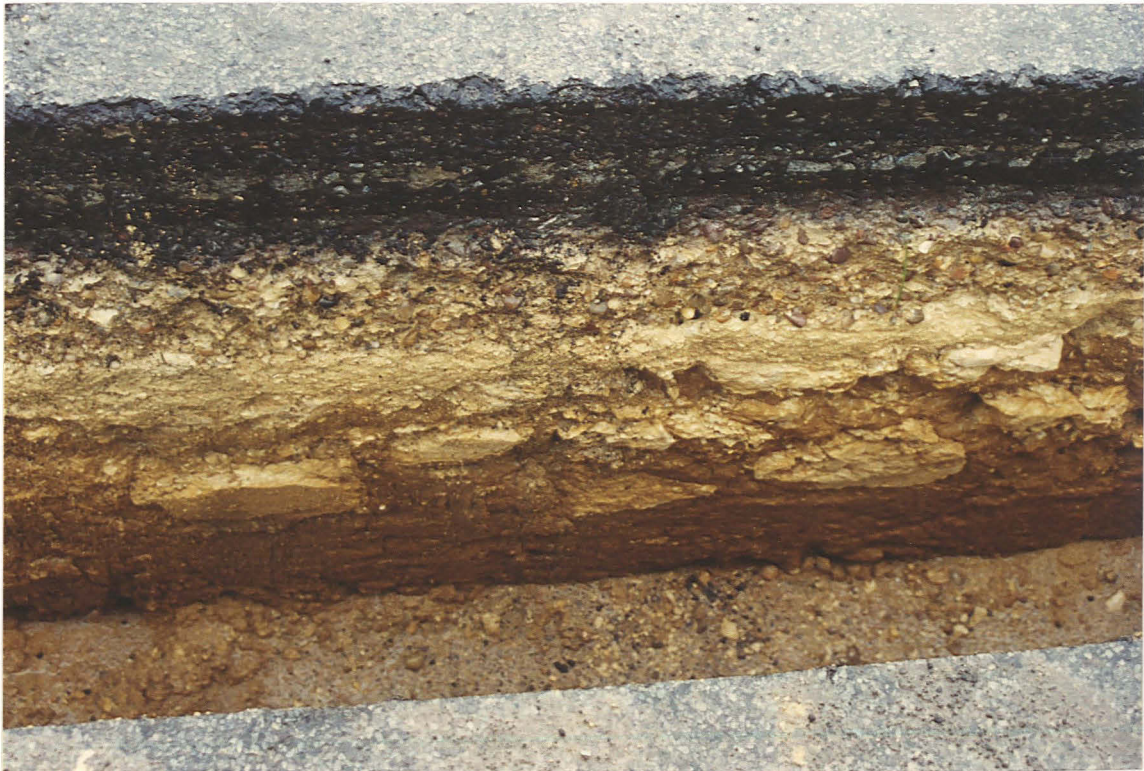
PI. 12 Gravel metalling and limestone block bedding under Grantham Road outside the reservoir 24.

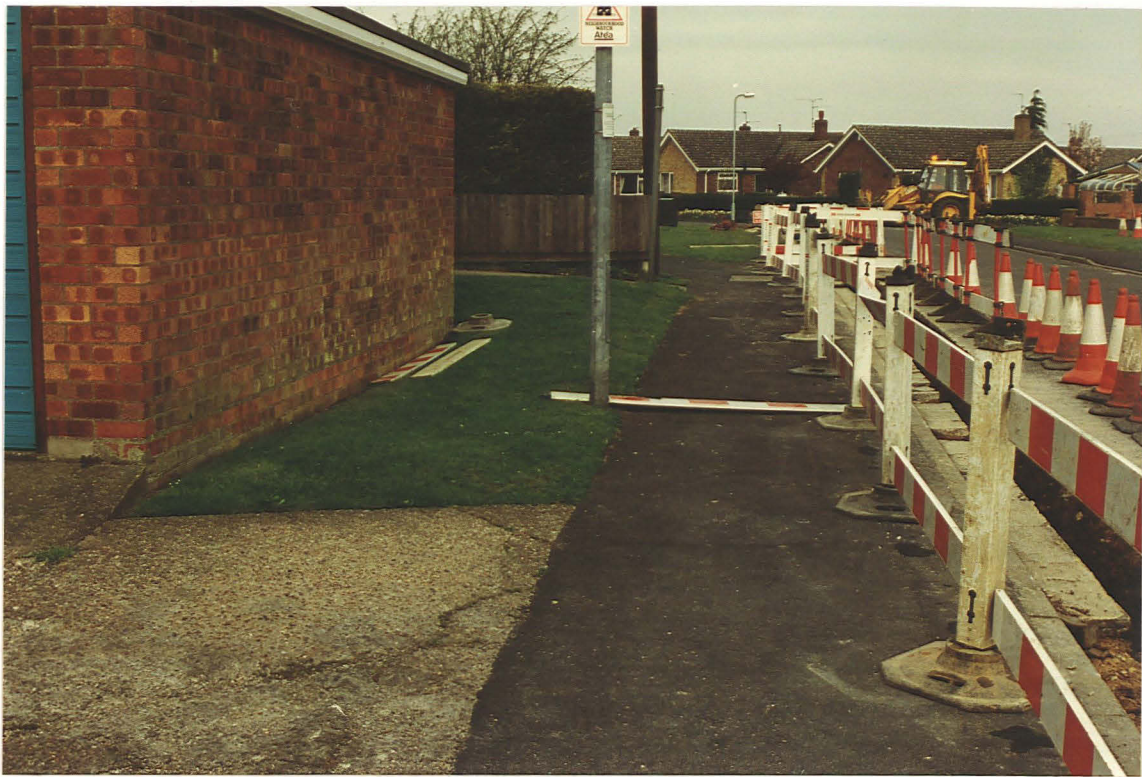
Pl. 13 Kennedy Road 63, looking NW. The footpath marking the line of Ermine Street is in front of the wood fence. The approximate edges of the Roman carriageway are marked by the flat barriers across the path.

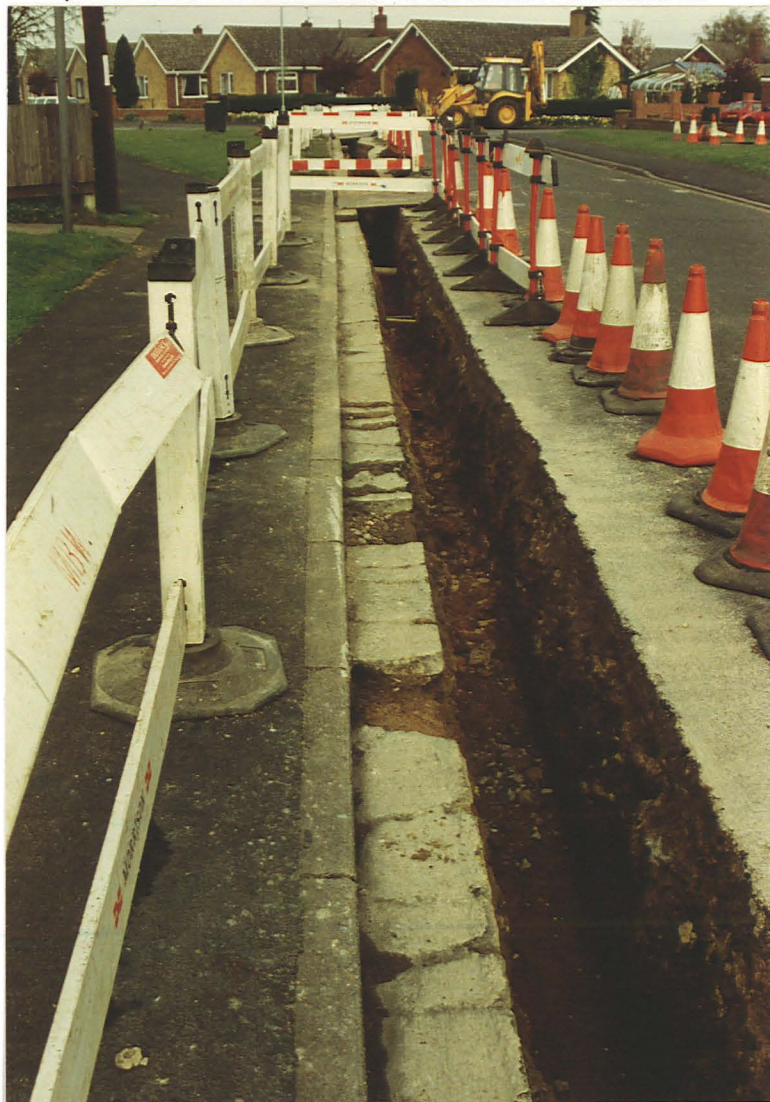
Pl. 14 Deposits exposed in the trench face, Kennedy Road 63 (looking NW). The brown soil fill of the eastern Roman roadside ditch is visible in the foreground, with the rubble road foundation behind it.

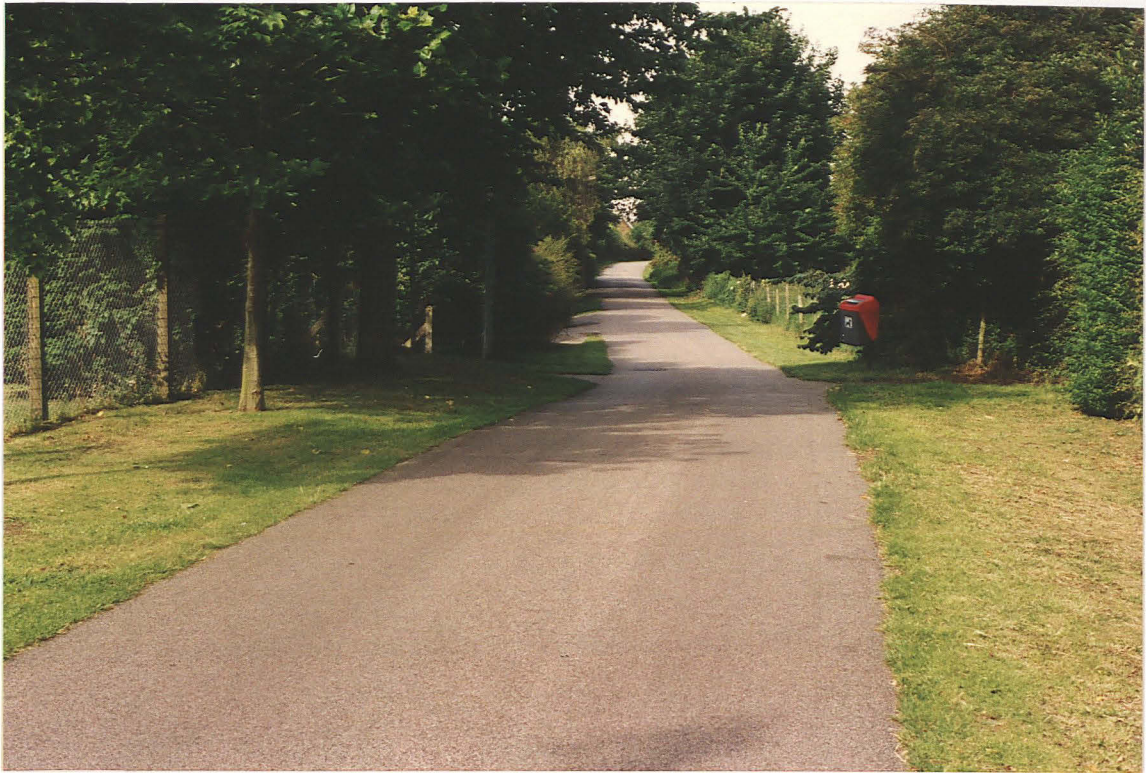
Pl. 15 Red Hall Farm Lane (looking west). The footpath crosses on the presumed line of Ermine Street 57, but no evidence of the road was seen in the pipe trenches. Note the drop in ground level of the lane.

The next expected opportunity to see Ermine Street to the north of Kennedy Road in the trenches for the new main was along Red Hall Farm Lane, where a footpath is thought to follow the course of the Roman road (Pl. 15). Beside the footpath **57**, a series of existing service trenches had removed any sign of road metalling or roadside ditches. Other observations along this lane were inconclusive, partly because no solid bedrock was encountered. It was unclear whether this marked a change in the natural deposits or whether all this area had been disturbed in the past to depths over 1.2m.

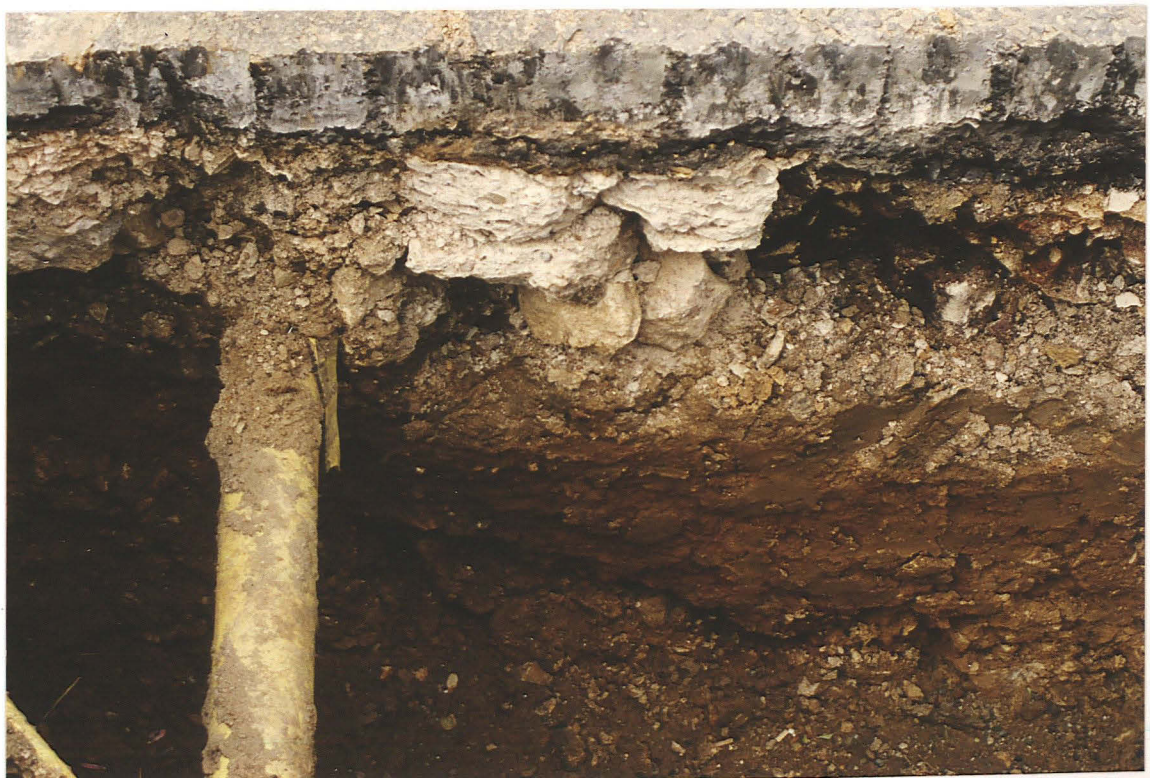
Pl. 16 Clay loam above limestone at the junction of Red Hall Farm Lane and London Road 54, overlain by the modern road.

At the eastern end of the lane, at the junction with London Road **54**, bedrock was seen at 1.3m below the modern road (Pl. 16). This might be evidence for a roadside ditch beside a Roman precursor of Sleaford Road.
