## **Bracebridge Heath - Canwick Mains Replacement Scheme**

### **Mains Laying in Bracebridge Heath**

### **Archaeological Watching Brief**

**LAS Report No. 413  
April 2000**

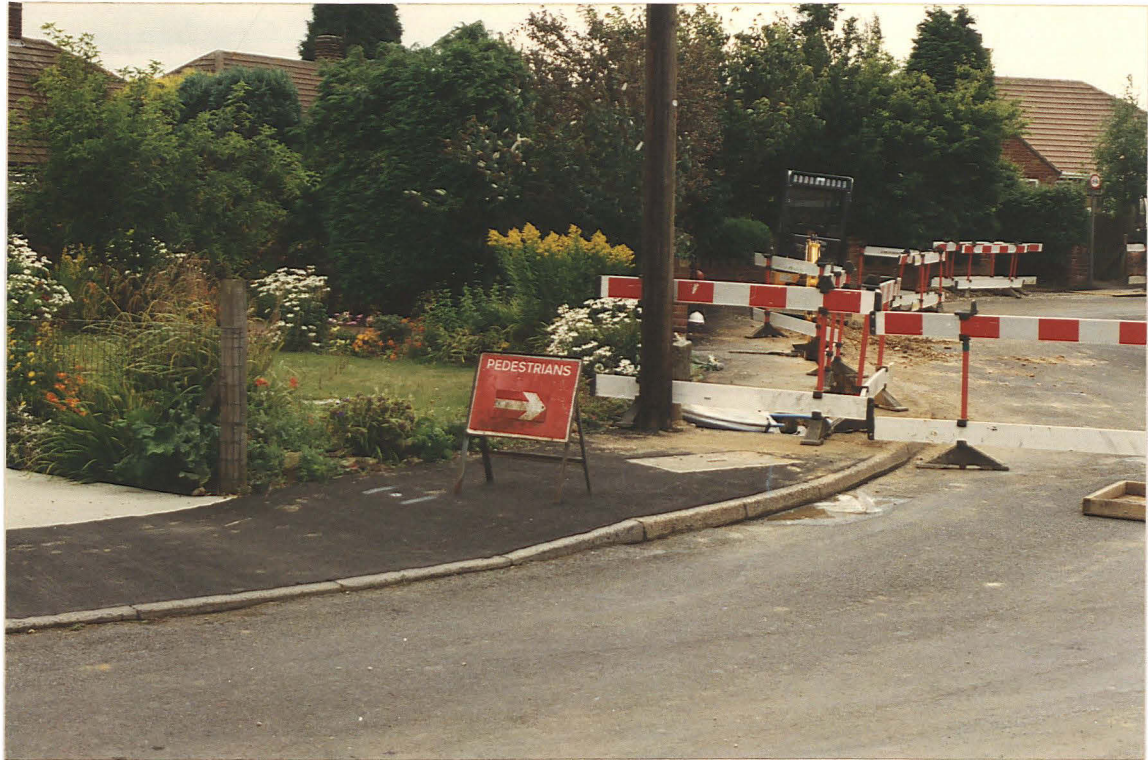
Pl. 17 Evidence of Ermine Street in Red Hall Drive 46-47 was also elusive. The footpath (far right) marks the presumed course, but no gravel metalling or certain road foundation was seen either side (looking SW).

An indication of the depth of undisturbed natural deposits to the east of the Roman road was garnered 50m east of the projected line, beside 5 Red Hall Drive **45**. The bedrock here was 0.5m below the modern road surface, reducing to 0.2m at **44**, outside No. 2. Immediately to the west at **46**, the sequence became much less clear, with very mixed deposits of clay loam with limestone rubble. Across the public footpath **47** following the line of Ermine Street, the path overlay brown loam, with bedrock at about 0.8m deep on the west side of the path **48** where the trench exposed it (Pls. 17 and

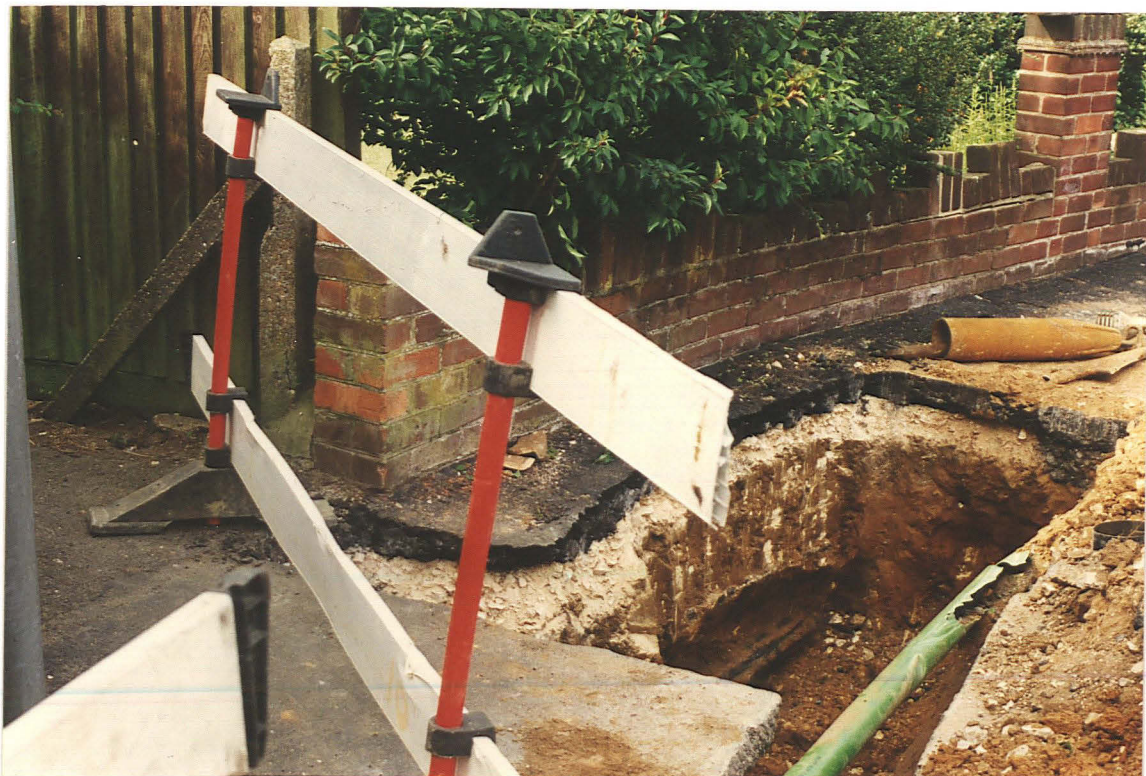
Pl. 18 To the west of the footpath, a thick clay loam deposit 48 may represent a roadside ditch (looking SW).

18). The width of this brown loam was about 10m, too wide to be the fill of the expected ditch if the trench crossed it at 90°. Another opportunity was taken to look for the road ditch in a trench about 30m to the north, outside 2 Churchill Avenue **52**. Here the sequence was much simpler, with the modern tarmac road with 0.09m thick stone bedding layer overlying brown loam at least 0.7m thick. The brown loam was seen in a number of holes dug across the road, and seemed to be fill of a ditch.

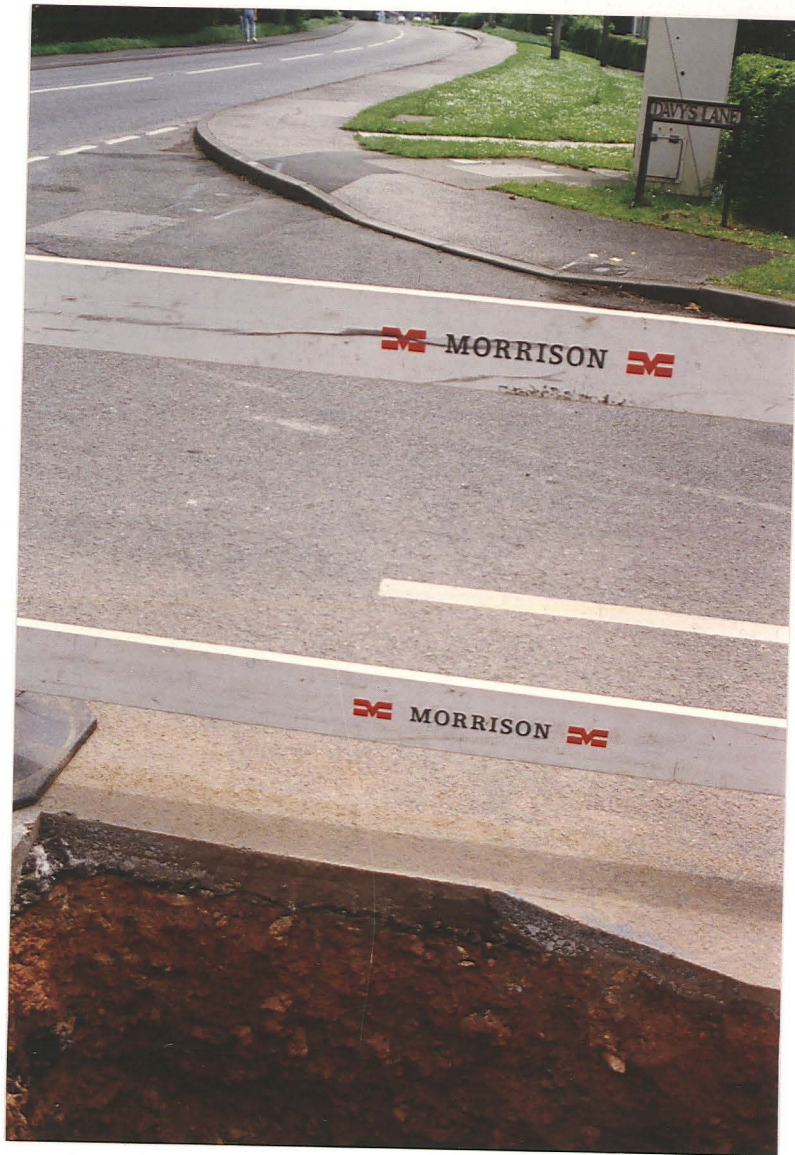
Pl. 19 Crushed brick below the tarmac surface of Davy's Lane 67 (looking south).

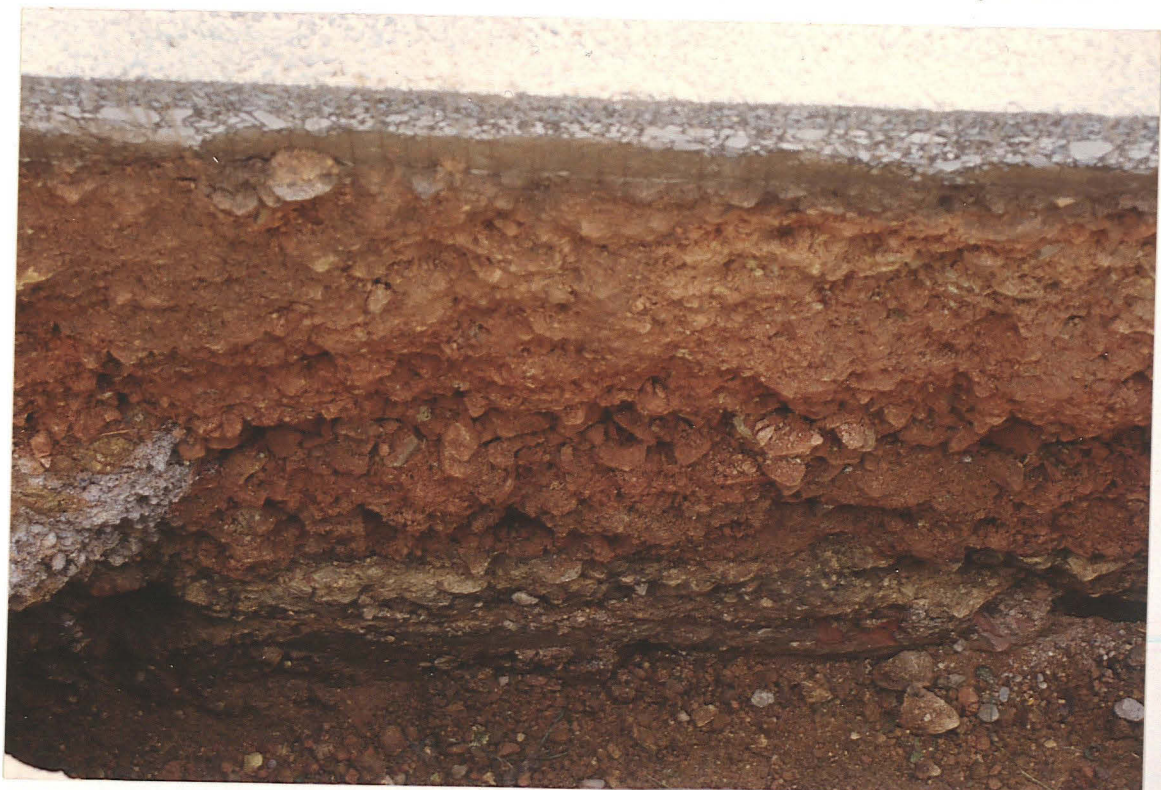
Pl. 20 Detail of the crushed brick and underlying deposits in Davy's lane 67.

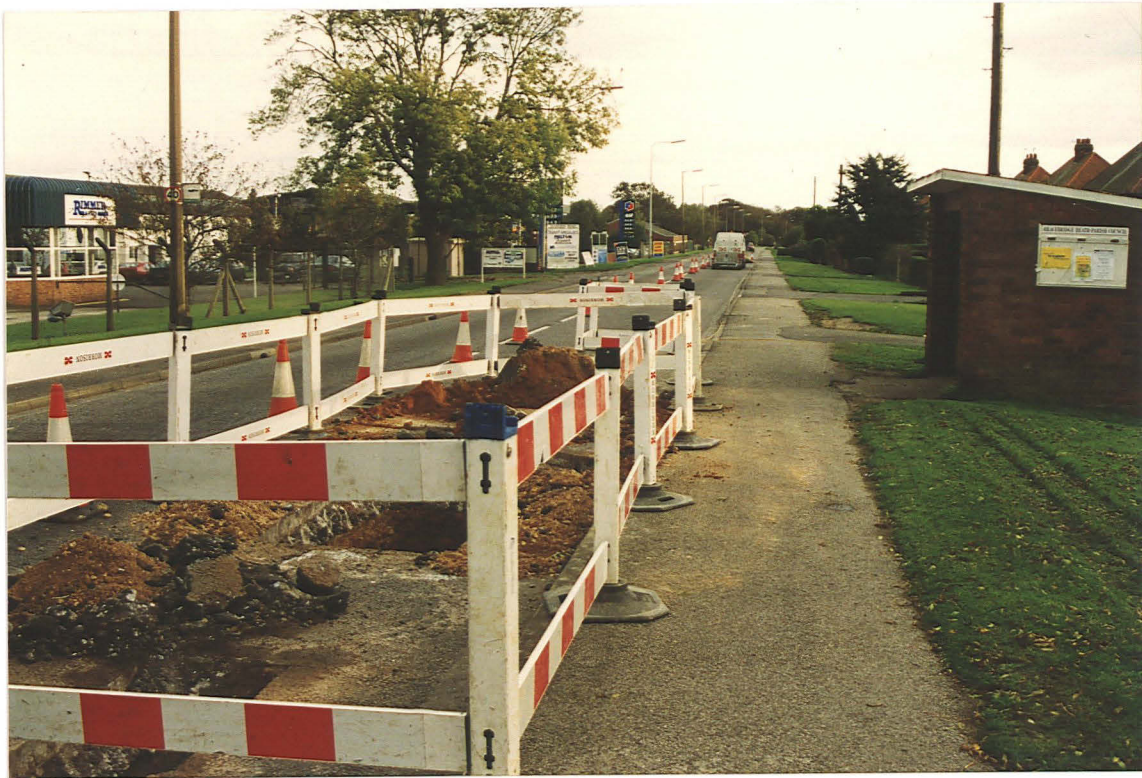
Pl. 21 Moling access holes, Sleaford Road 64 (looking SE).

All trenches observed to the SE of Main Avenue **64** contained a similar sequence which could represent fill of a roadside ditch (Pls. 21 and 22). The modern tarmac surface, 0.3m thick, was

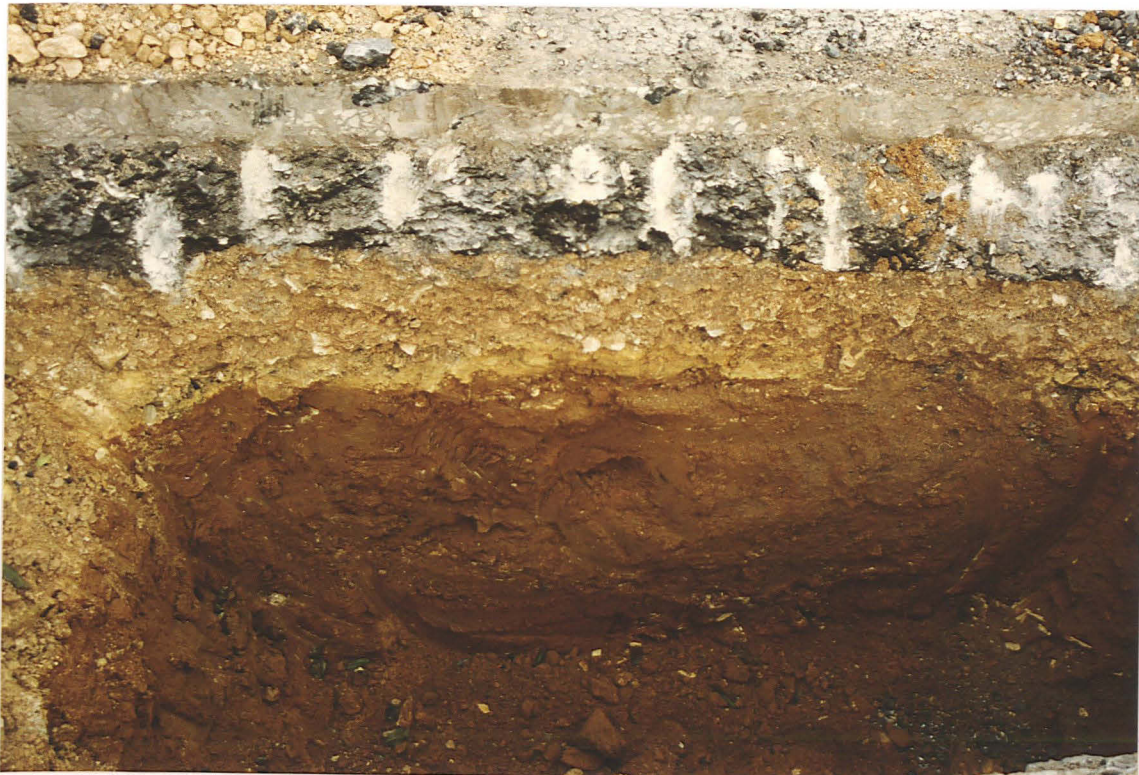
Pl. 22 Thick layer of clay loam beneath the road foundation, Sleaford Road 64.  
The loam may be fill of a Roman roadside ditch.

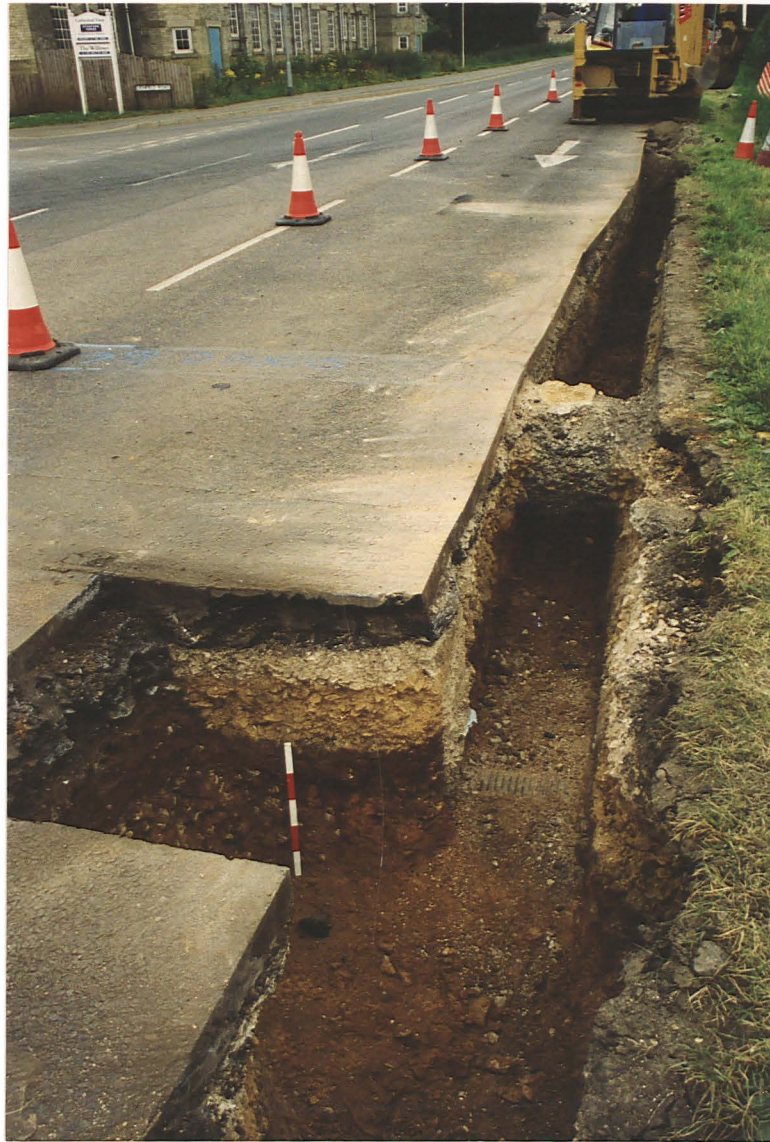
PI. 23 Along the southern edge of Canwick Avenue 40, the widened road overlay a band of brown clay loam above weathered bedrock (looking west, scale divisions 0.1m).

The Bracebridge Heath/Canwick parish junction crosses Canwick Avenue east of the former St. John's Hospital site, and this point **40** was selected as of particular archaeological interest by the County Archaeologist. The trenching of this particular section was conducted between monitoring visits but nothing was reported. To the immediate east and west, only foundation material for Canwick Avenue was seen, heavily disturbed by existing service trenches (Pl. 23). Only two features unrelated to the existing road were observed along Canwick Avenue. At the eastern end of the road **38**, where the road turns a sharp bend towards Mill Lodge, a farm track leads off to the south towards Canwick Manor Farm. Here the 0.7m thick modern road sealed a 0.3m thick layer of gravel, over 0.2m of brown loam. Limestone bedrock was 1.2m below the road surface. The observation was interpreted as a medieval or later metalled track continuing the line of the existing track (towards Canwick village), and pre-dating Canwick Avenue.
