00/10  
ARCHAEOLOGICAL WATCHING BRIEF  
REPORT  
GLENTHAM AREA WATER MAIN  
REPLACEMENT SCHEME

Site Code: GAW99  
LCNCC Acc No: 182.99  
NGR: SK005864 - SK075988

Report prepared for Anglian Water Services  
Ltd.  
By A. M. Hardwick  
April 2000-04-10

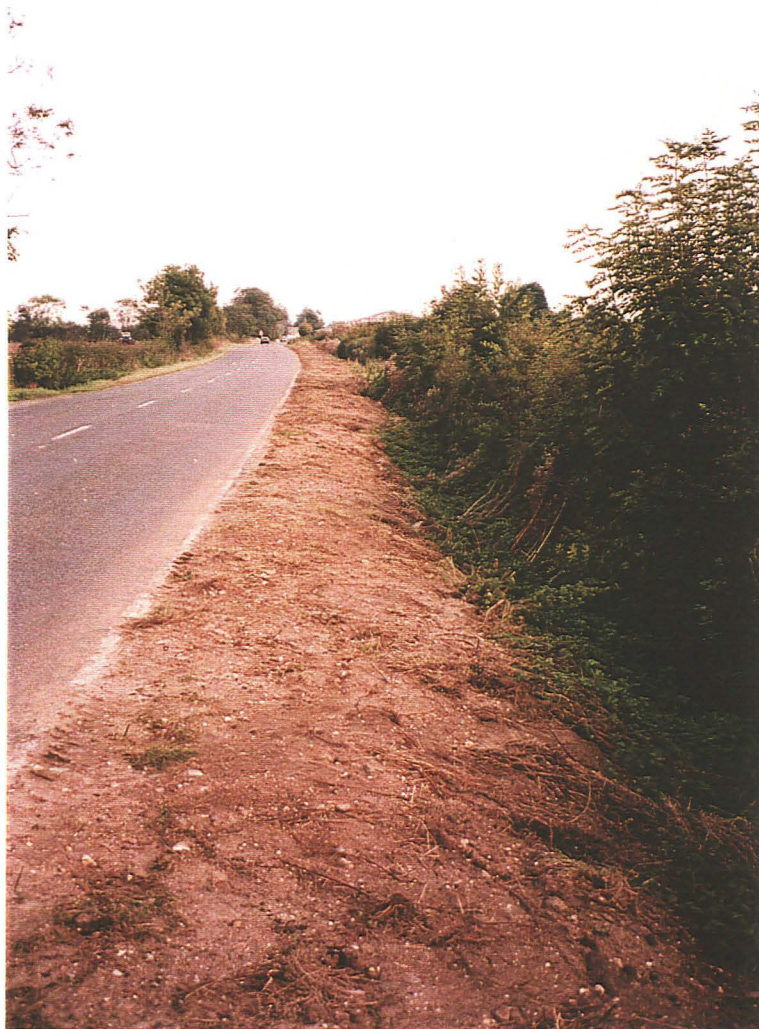
Monitoring of excavations was not possible in this area, as works were concluded before PCA was notified.

**Plate 2.** Backfilled trench at Osgodby (not monitored) looking east

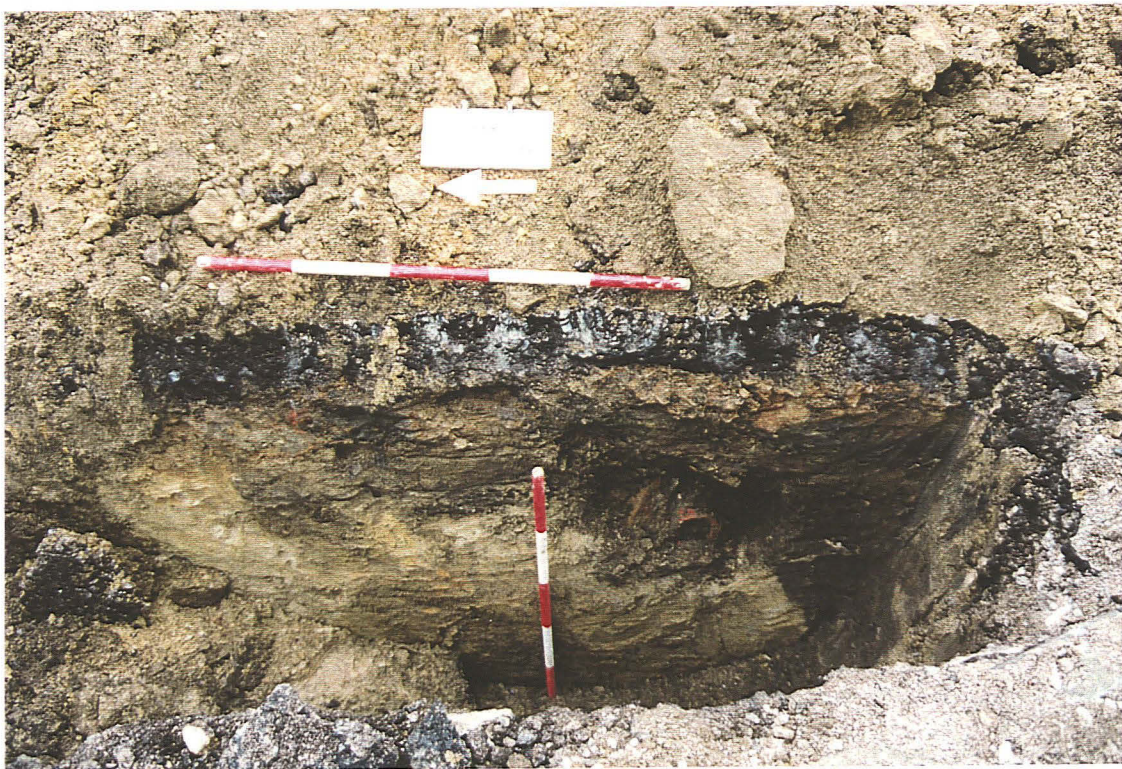
Trench 3 (Fig 4) exposed similar modern deposits and an earlier feature that was aligned east-west. Very little of this was visible and therefore its date, extent and significance remain uncertain.

Plate 4. Trench 3, Owmbly by Spital, looking east
