**A Report to
V N Tapp Builders**

**DEVELOPMENT ON LAND AT
St. MICHAEL'S TERRACE,
MICHAELGATE, LINCOLN**

ARCHAEOLOGICAL WATCHING BRIEF

Report No.: 415

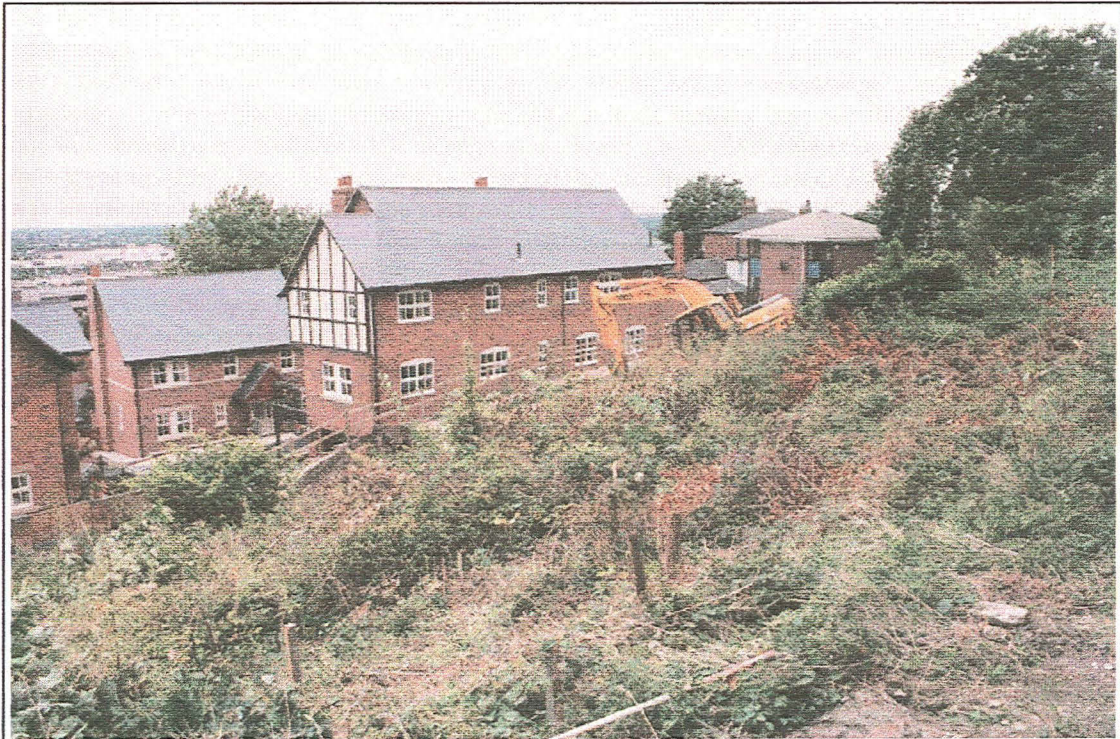
Plate 1: General view of the site looking south-west towards Stanthaket Court prior to the excavation and formation of terracing for Plots 1 & 2.

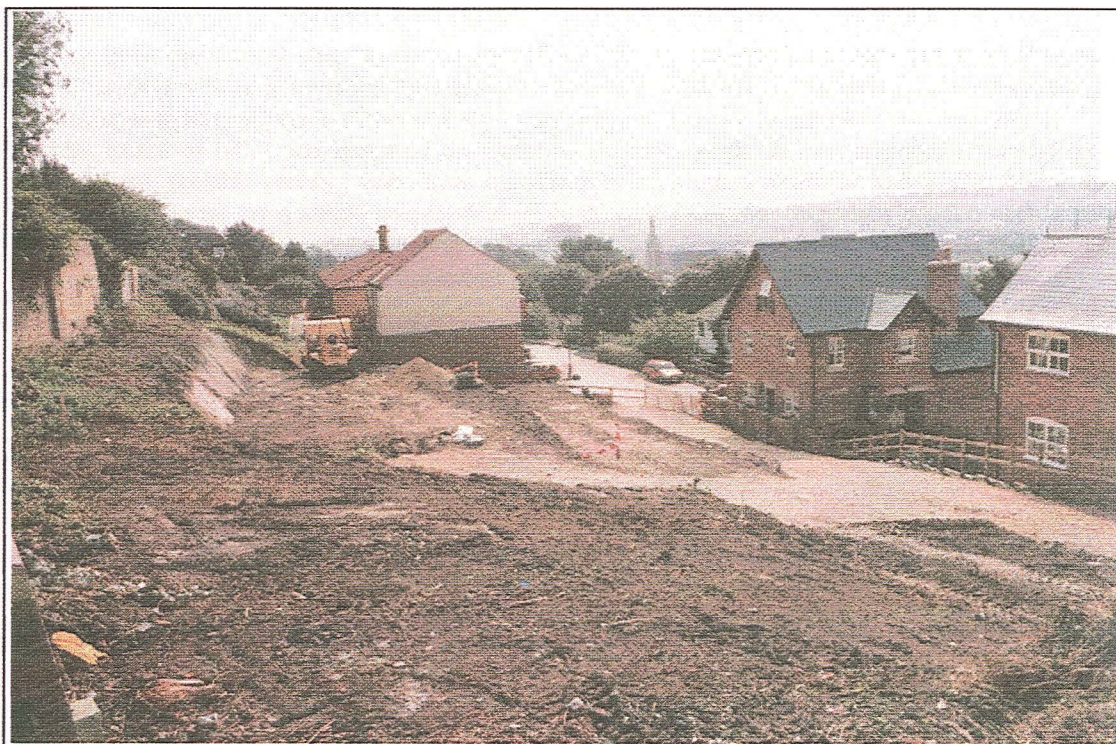
Plate II: View of site after terracing (looking south-east). Although extensive, little damage was caused to the buried archaeology, the majority already having been lost during the construction of terraced housing on the site during the Victorian period.

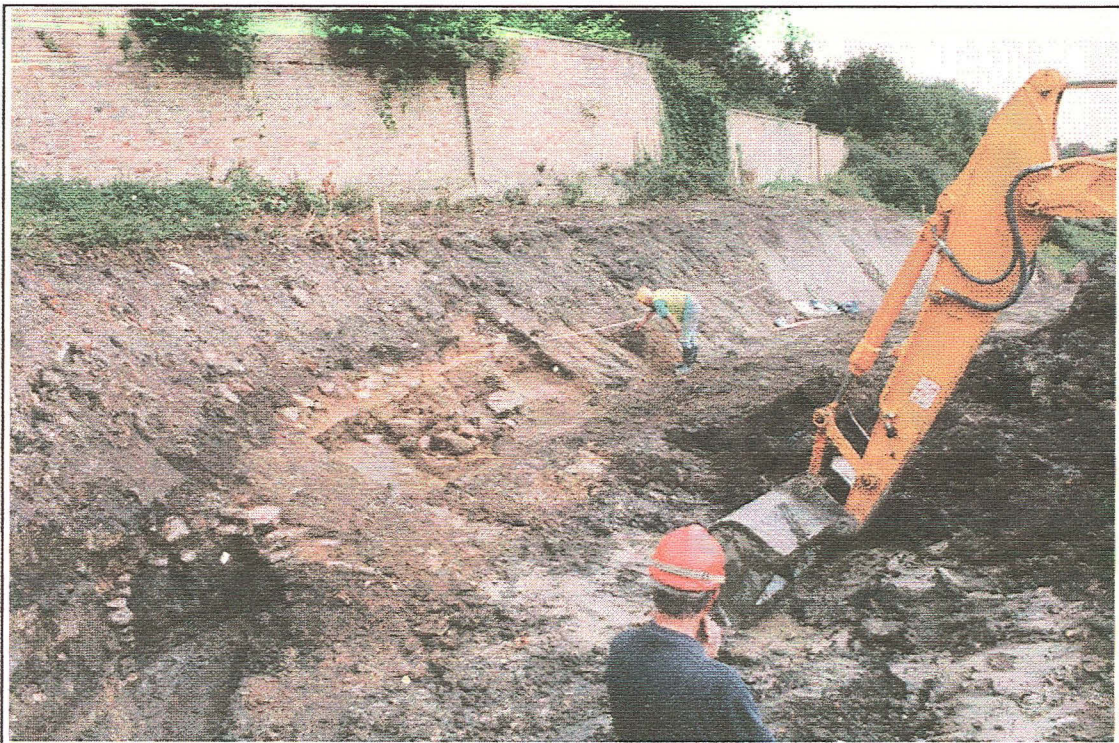
Plate III: General view showing the recording of the buttressed Roman building (looking north-east). The area to the right of this building (being examined in this photo) is the probable site of the Roman street. The Post-medieval stone-lined well lies in the lower left corner of the photograph. The area of dark material being machined off in this photograph reveals the position of the Victorian terraced housing (the pale brown material in the standing section is the surviving archaeology) and clearly demonstrates the extent of its truncation of earlier deposits and features.

Cutting in to the natural clay 2m to the east of wall [030] was [007], an east-west limestone wall (47.625m OD). Cleaning revealed the wall to be 8m long (exposed) and to have shallow foundations consisting of light grey/brown clayey soil with very frequent angular limestone inclusions ([054]). The western extent of [007] was obscured by Victorian deposits, while its east end was truncated by a medieval cut, possibly robbing stone from a north or south aligned return to wall [007]. Above this foundation material lay a single course of roughly dressed limestone fragments bonded with a pale yellow/brown sandy mortar (investigation to the east of the structure revealed this wall to stand c. 1m high and 800mm wide). Limestone fragments which formed the wall's core appeared to be pitched.

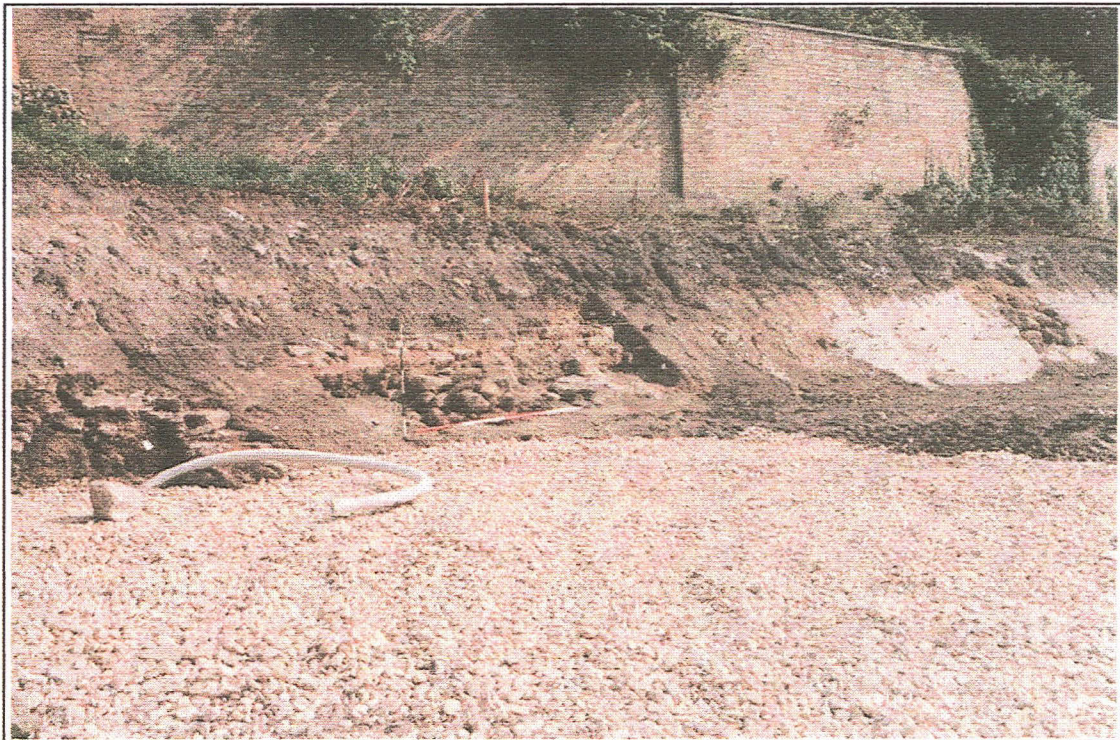
Plate IV: General view of the south facing section of the upper terrace (looking north-east - scales are 1m & 2m). The remains of [007], the buttressed Roman building lie in the centre of the photograph, while to its right, cutting into the natural clay, can be seen the foundations for the north-south Roman terrace wall ([020]). The remains of the post-medieval stone lined well lie to the left of the Roman building.

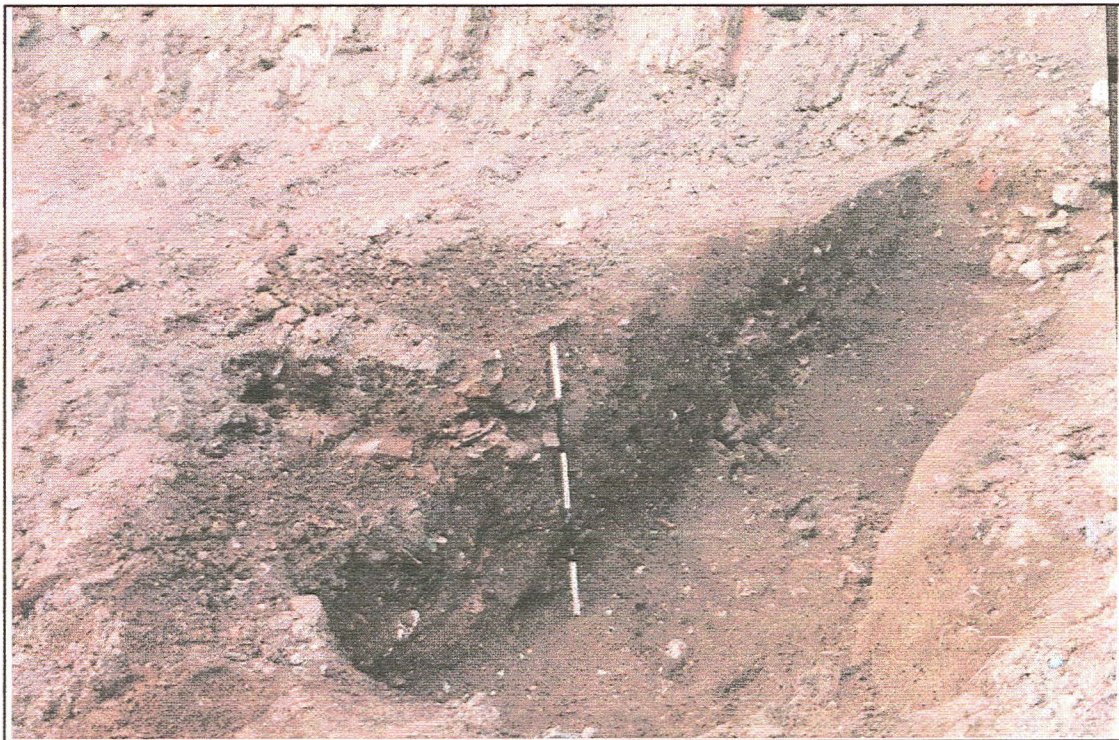
Plate V: General view of the small evaluation trench for Plot 3 (looking north-west, scale is 1m). The remains of wall [133] can be seen on the right side of the trench. Tip lines, showing the dumping of spoil, can be seen in the facing section.
